# **Frontier Field Services Madurai Pipeline Leak**

## **Closure Report U/L K, Section 29, T19S, R33E Lea County, New Mexico NRM2006237844**

**December 1, 2020**

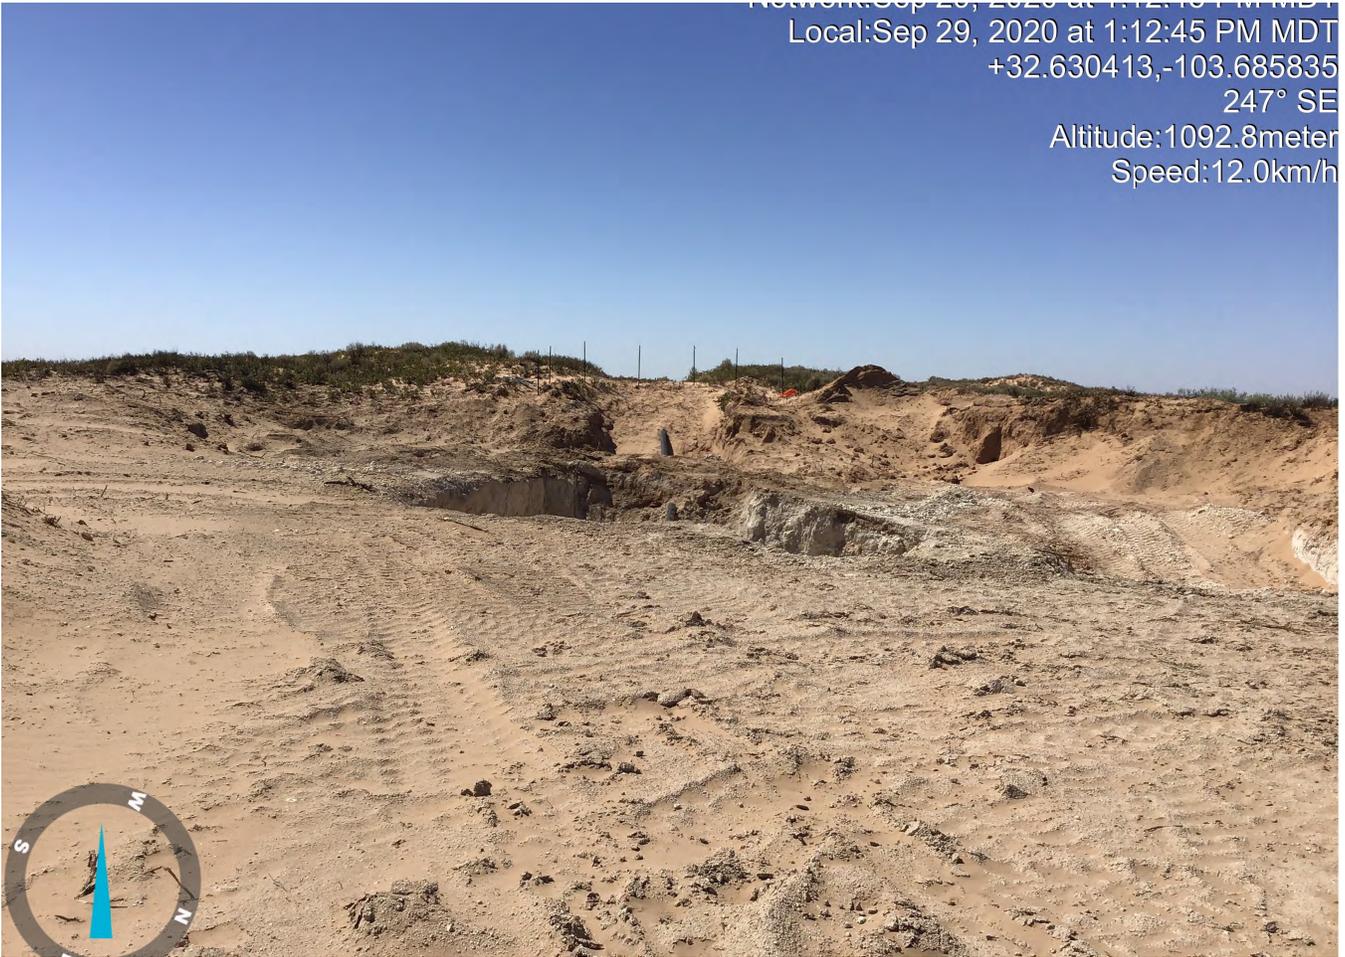
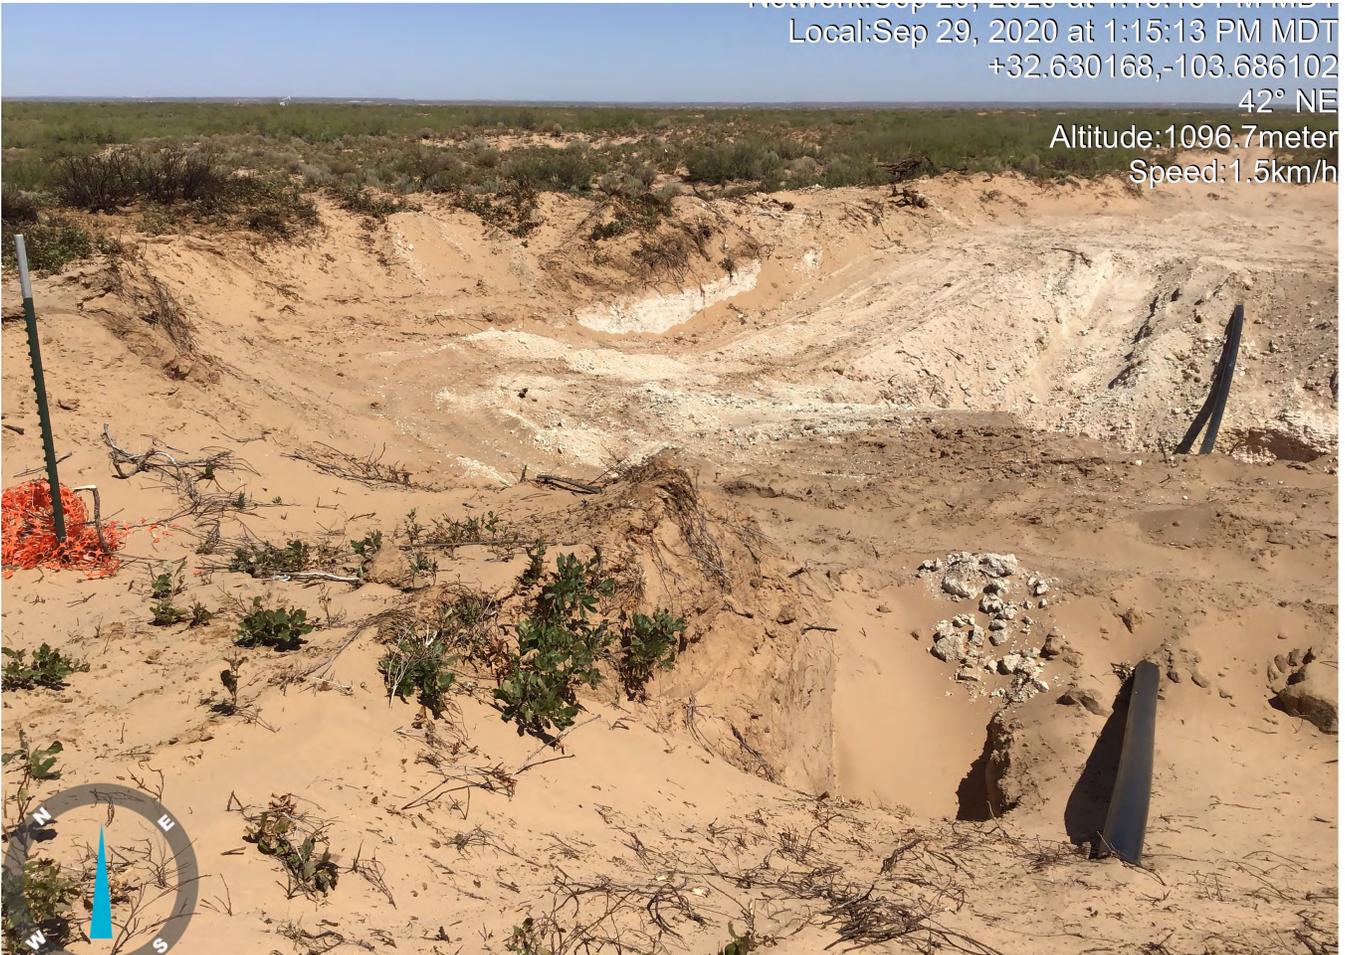
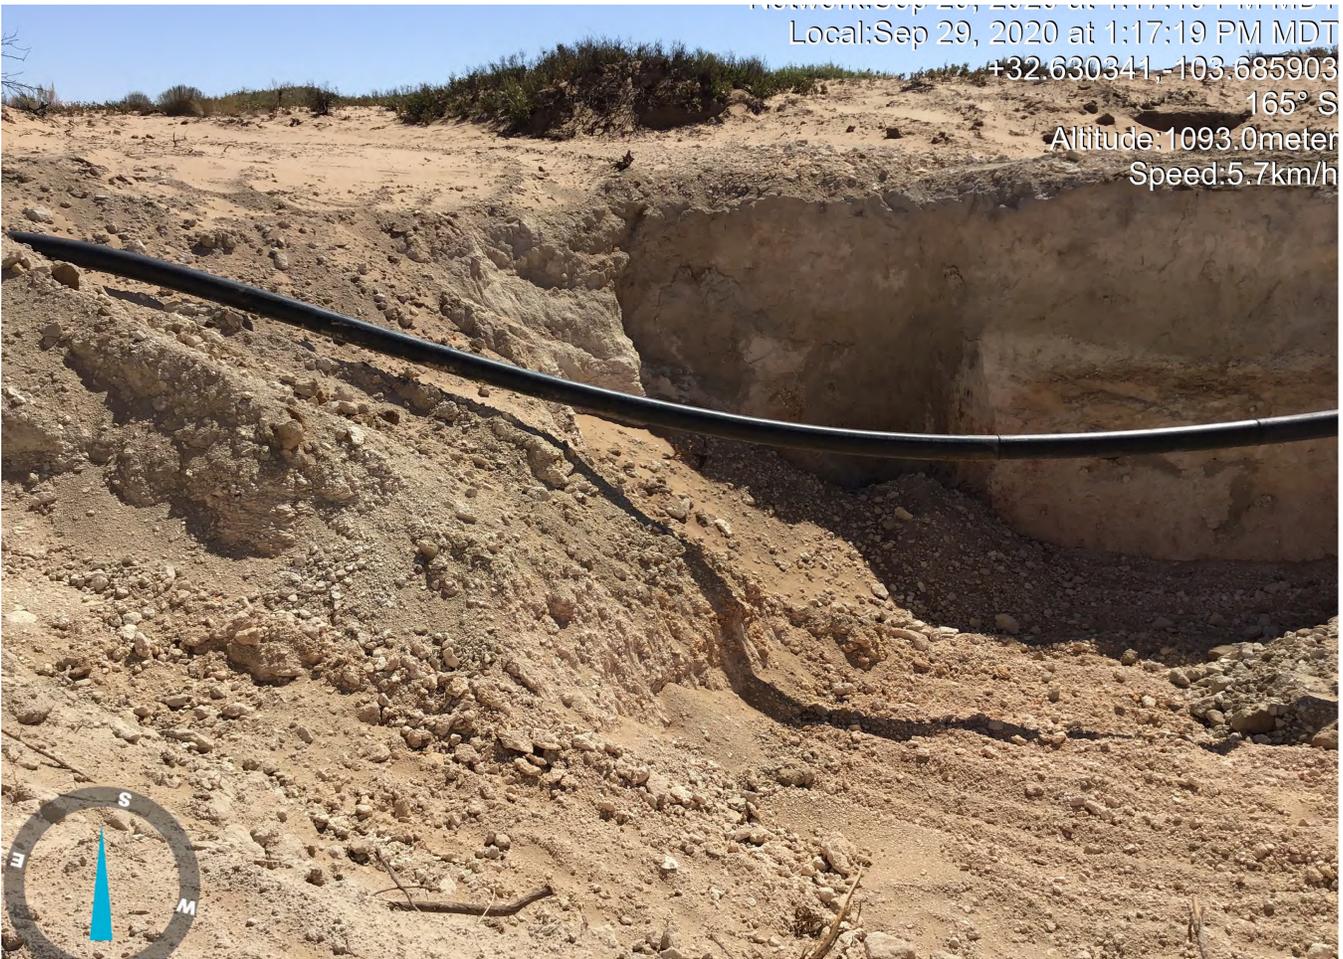
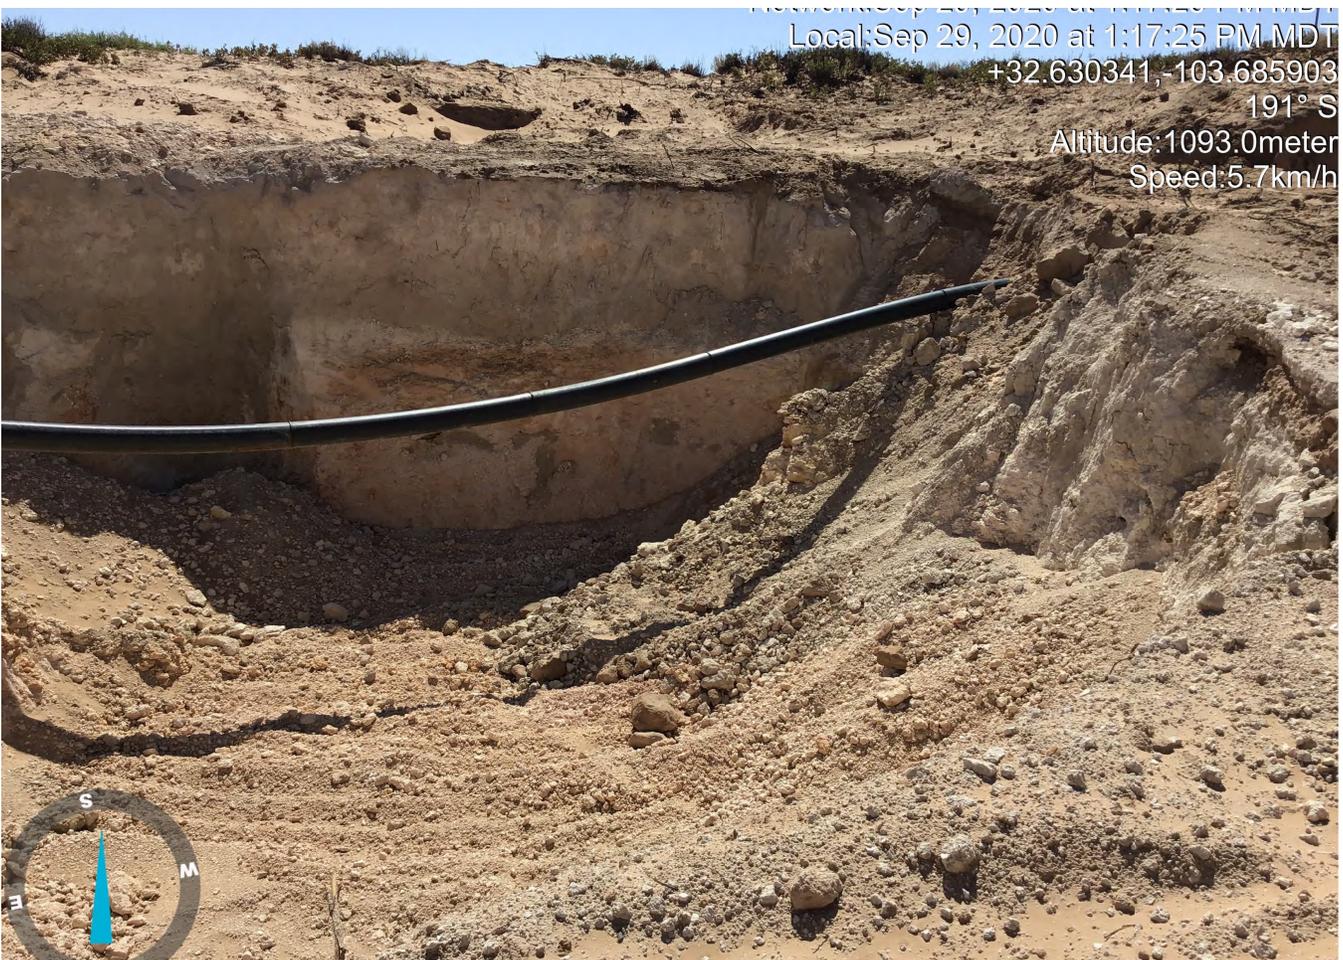
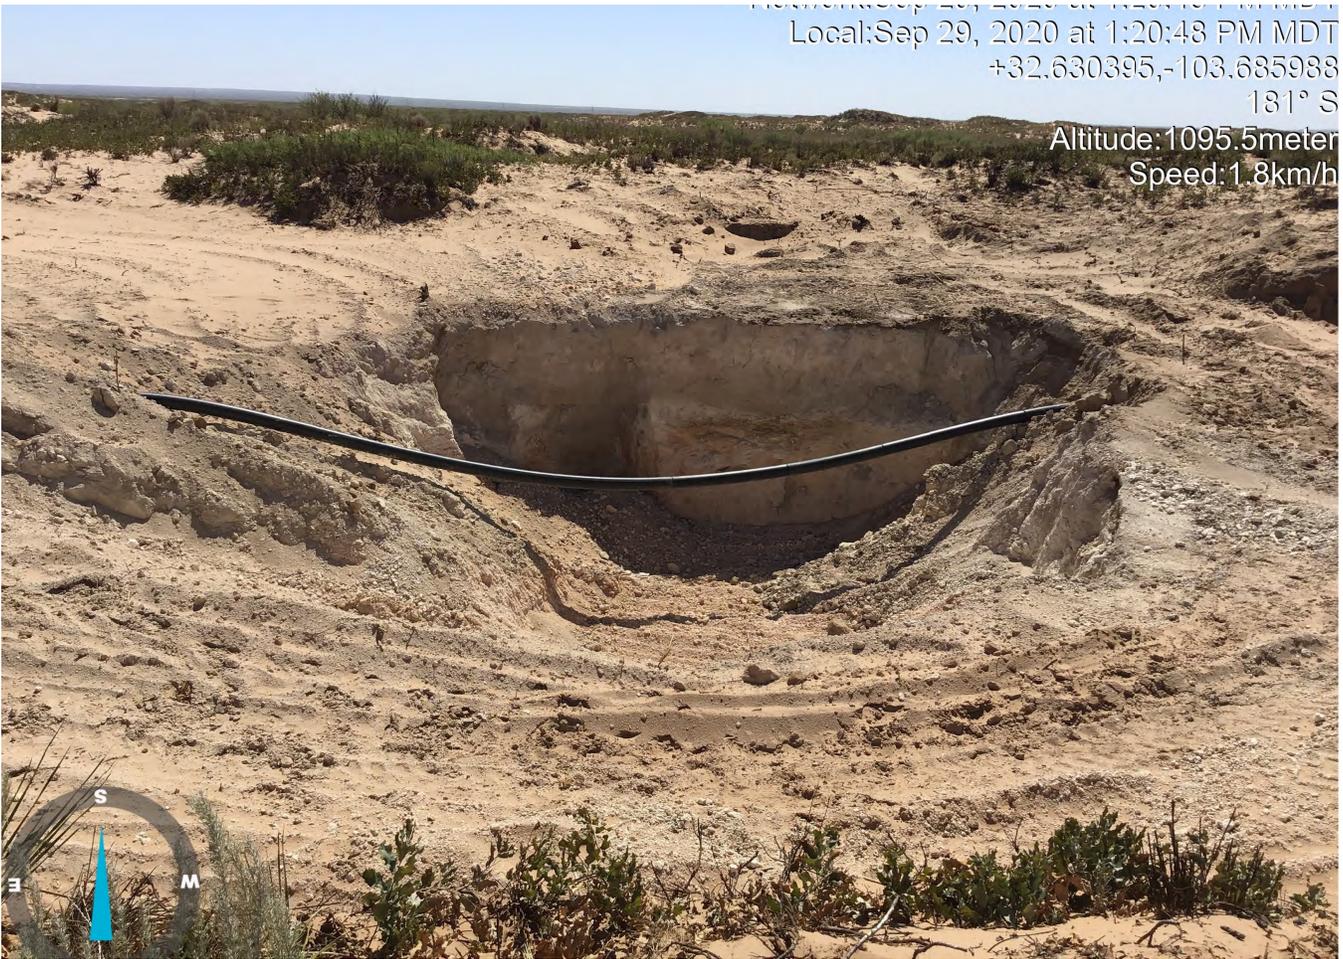
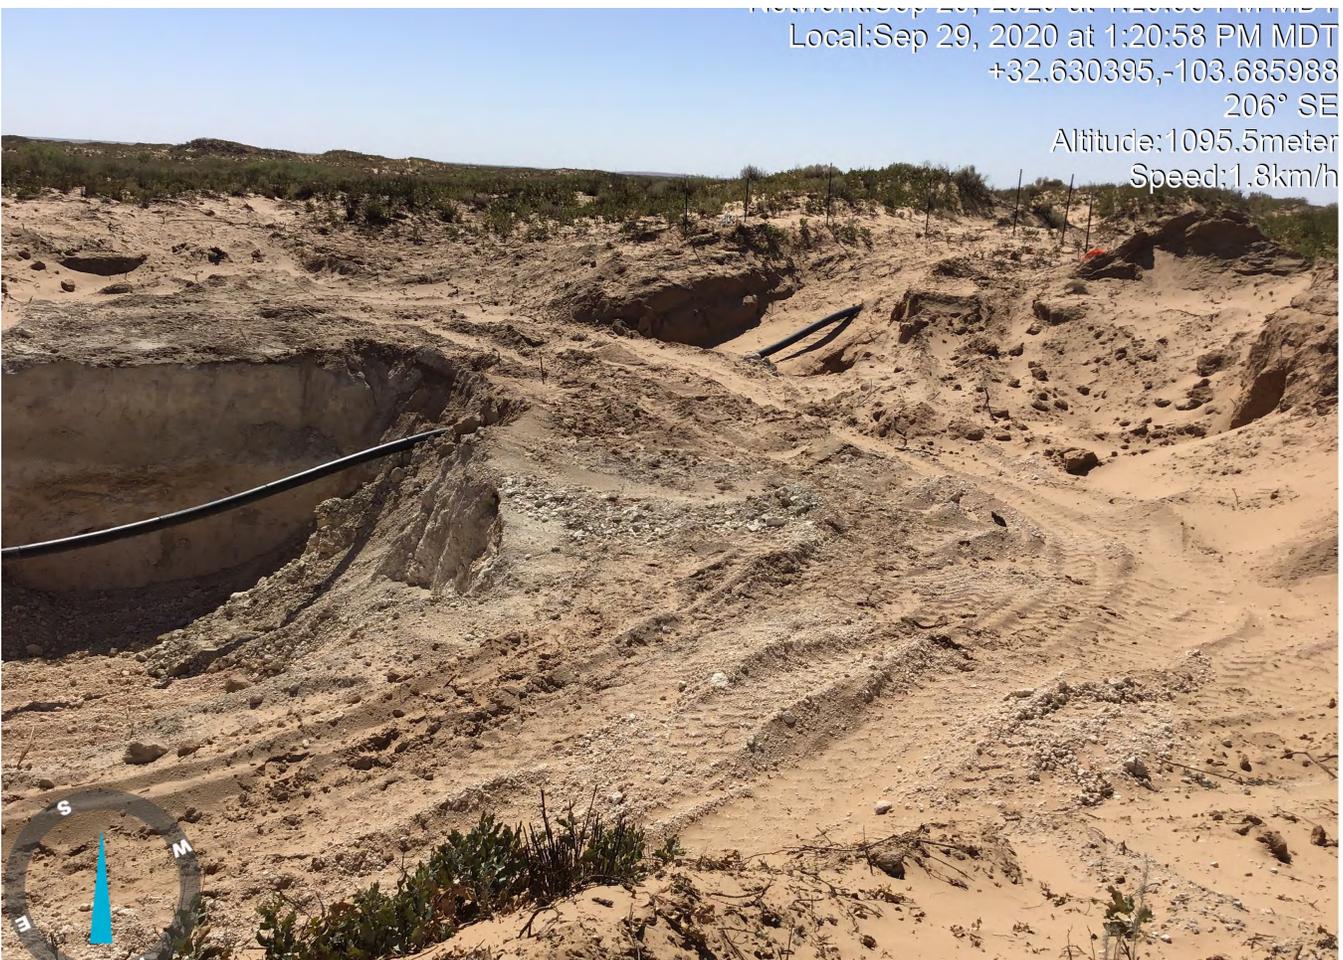
Once Frontier received the test trench results, they decided at that time to go ahead and dig up via backhoe the heavily saturated portion of the leak. Photos are included in this report, as well as a map of the excavated area. The estimated amount of contaminated soil removed is 360 yards based on disposal tickets. The soil was hauled off to a NMOCD-approved facility.

samples were used to verify successful removal of the contaminated soil. These areas included at and near the samples of AH2, AH10, AH16, AH17, and AH19. Once confirmation sample results showed vertical extent had been achieved through remediation, further excavation ceased in that area. Pictures of the remediation are included in this report.

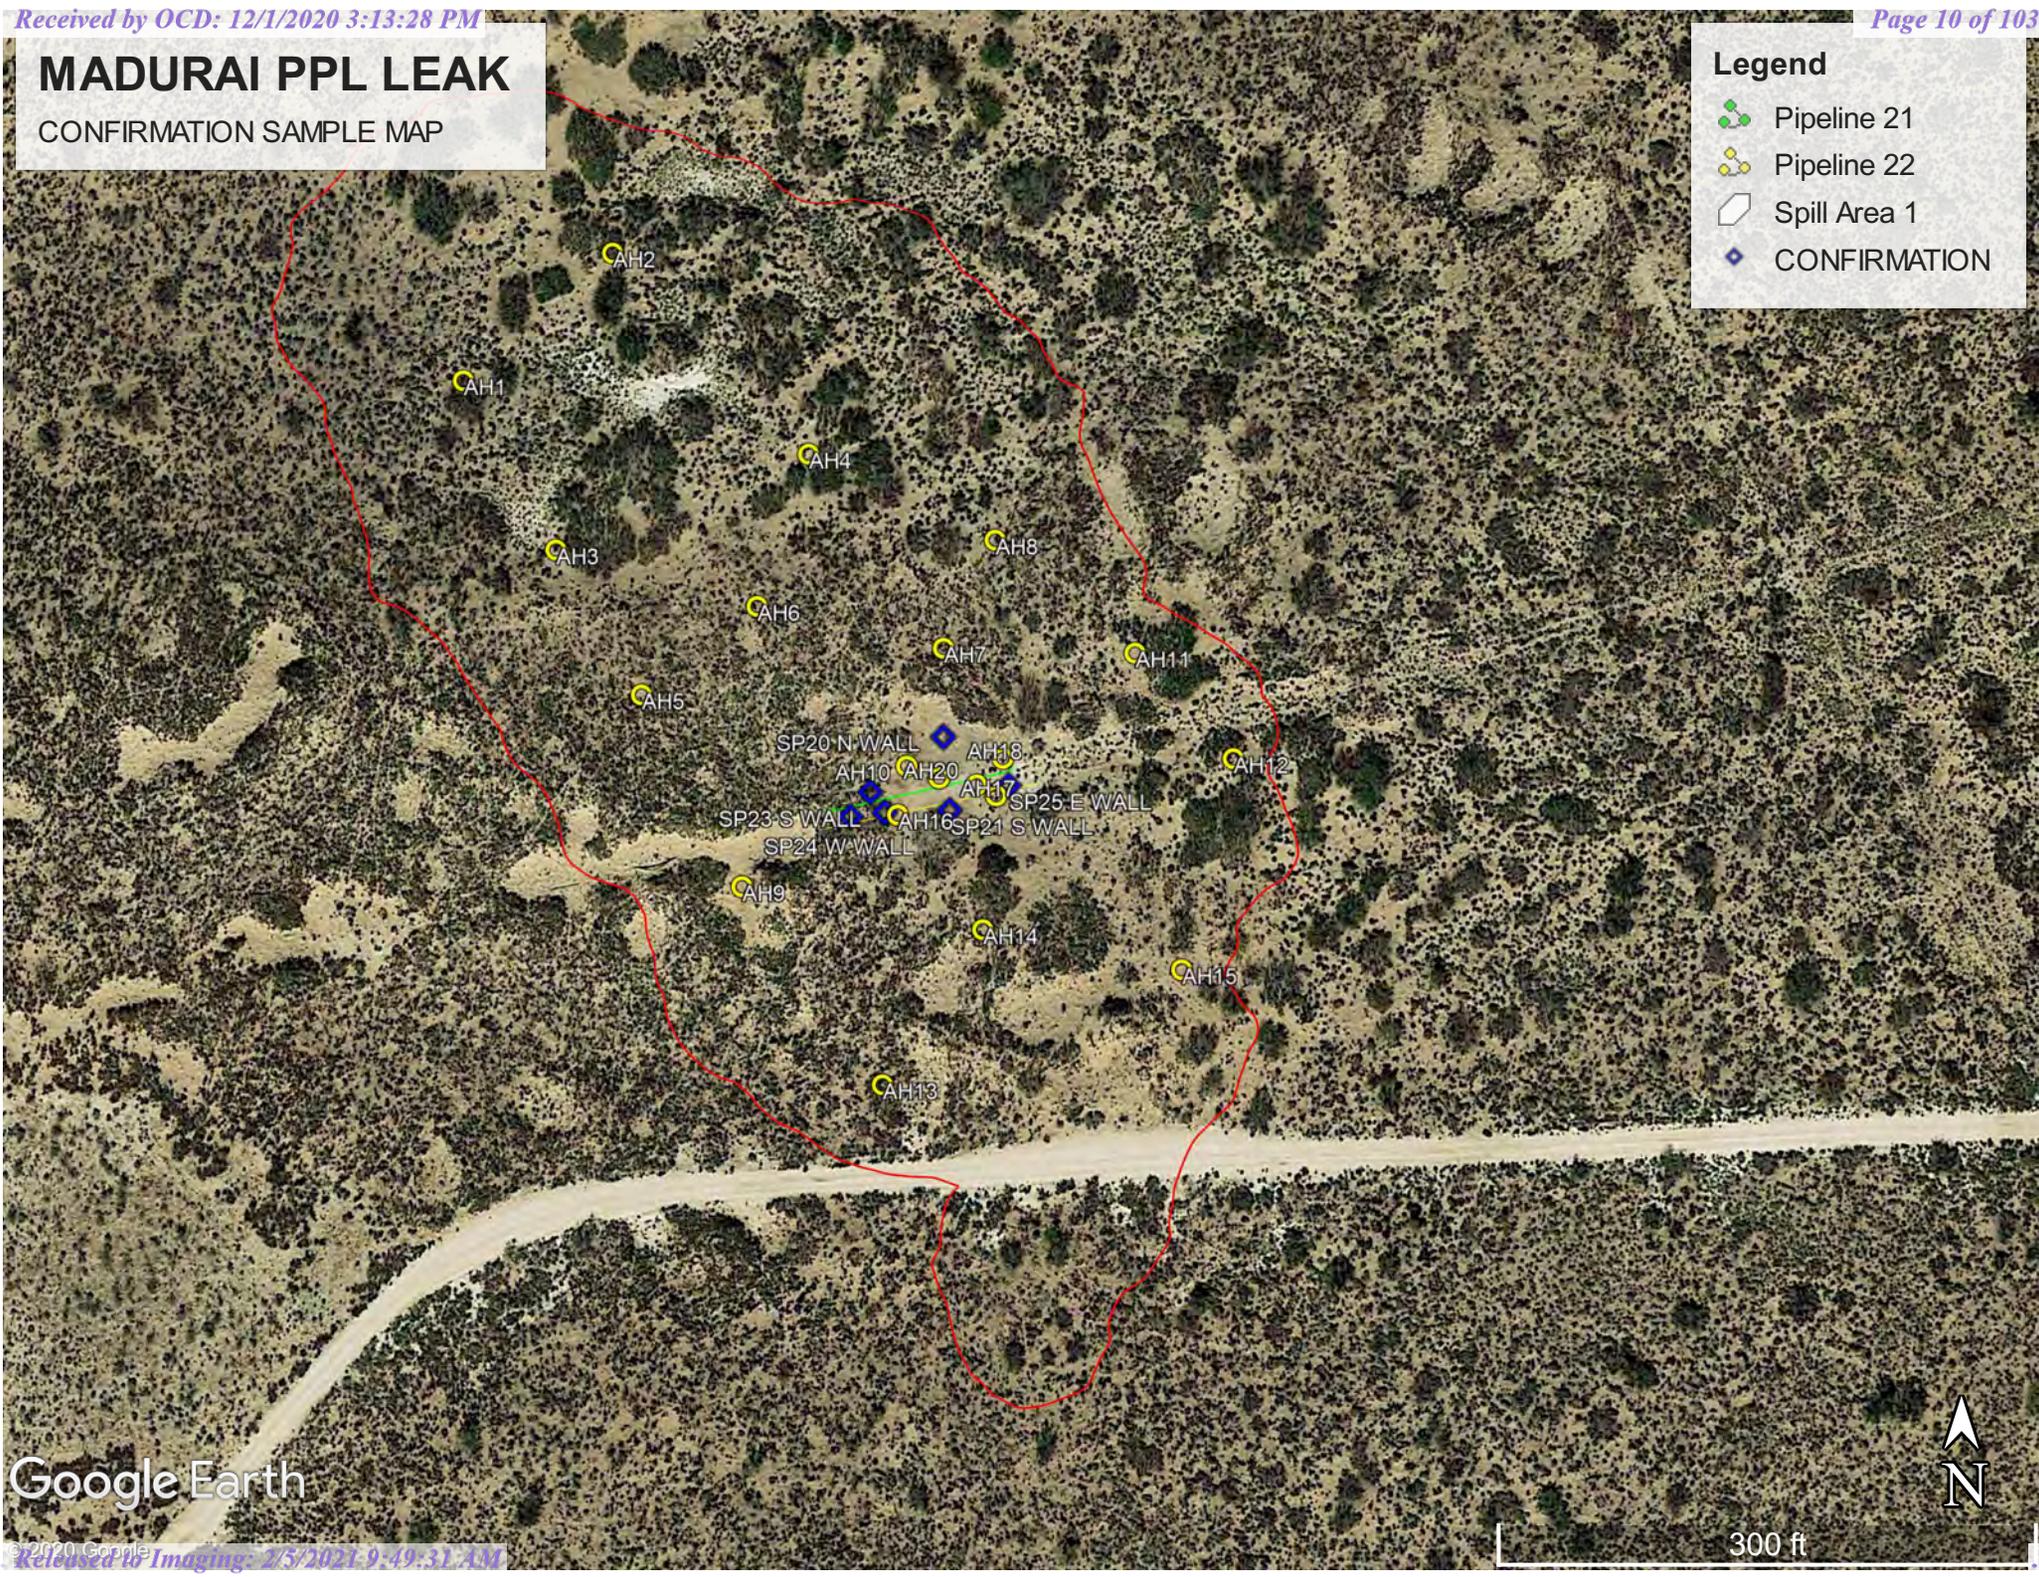
# MADURAI PPL LEAK

CONFIRMATION

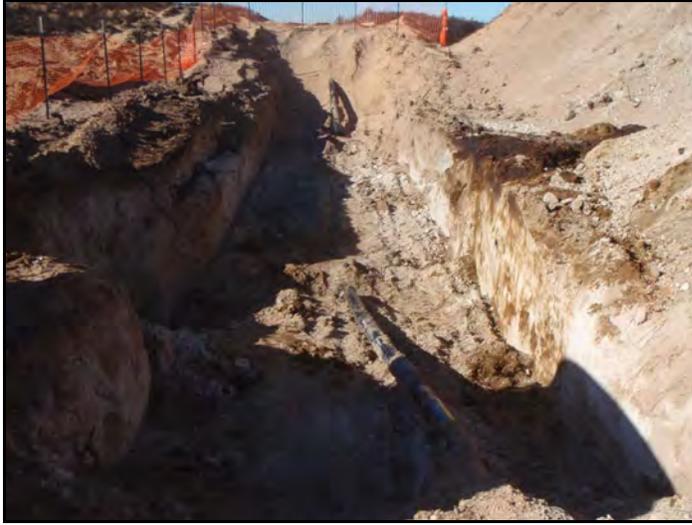
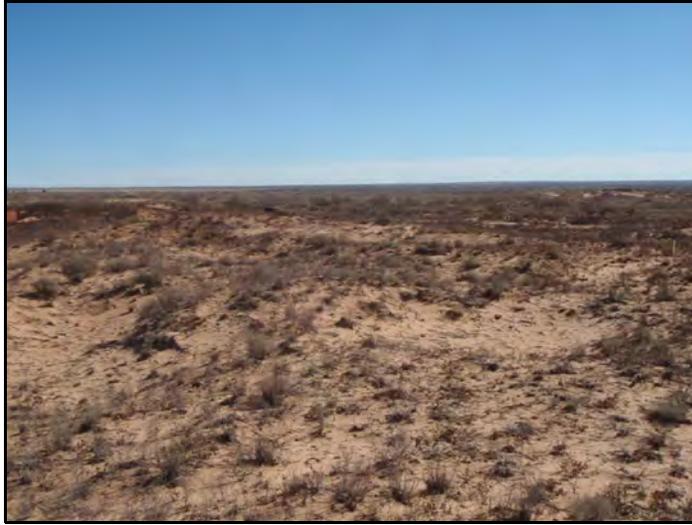
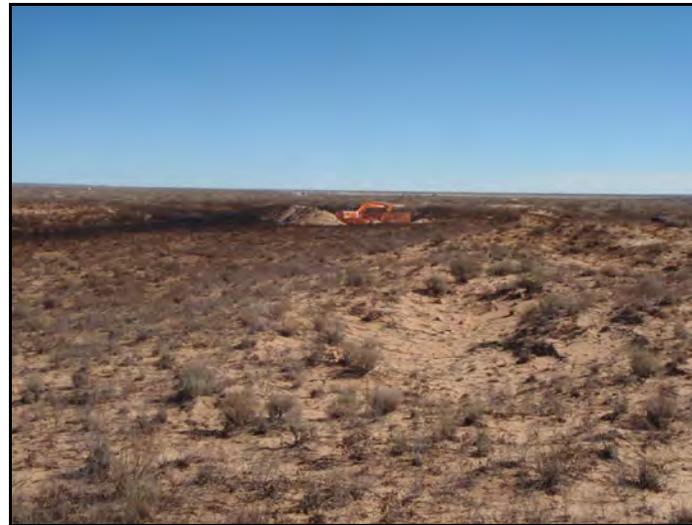
Figure 1.1: Oil spill and pit, facing southwest (top); spill, facing southeast (center); spill facing east (below).

**20. a. Percent Ground Visibility:** 60 **b. Condition of Survey Area (grazed, bladed, undisturbed, etc.):** The main disturbance to this survey area is a 60-m by 60-m oil spill with oil seepage outward to a 165-m by 150-m area. This broader area is covered by a thin film of oil. An open trench has been dug in the center of the oil spill. A caliche-capped road is to the south of the area.
