Release Notification

**RE: Closure Request
Los Dos Medanos
Incident Number NRM2026957367
Eddy County, New Mexico**

WSP USA Inc. (WSP) (formerly LT Environmental, Inc.), on behalf of XTO Energy, Inc. (XTO), presents the following Closure Request detailing site assessment, excavation, and soil sampling activities at the Los Dos Medanos (Site) in Unit P, Section 3, Township 24 South, Range 30 East, in Eddy County, New Mexico (Figure 1). The purpose of the site assessment, excavation, and soil sampling activities was to address impacts to soil following a release of crude oil at the Site. Based on excavation activities and soil sample laboratory analytical results, XTO is submitting this Closure Request and requesting no further action (NFA) for Incident Number NRM2026957367.

FIGURE 2
SOIL SAMPLE LOCATIONS
LOS DOS MEDANOS
UNIT P SEC 3 T24S R30E
EDDY COUNTY, NEW MEXICO
XTO ENERGY, INC.

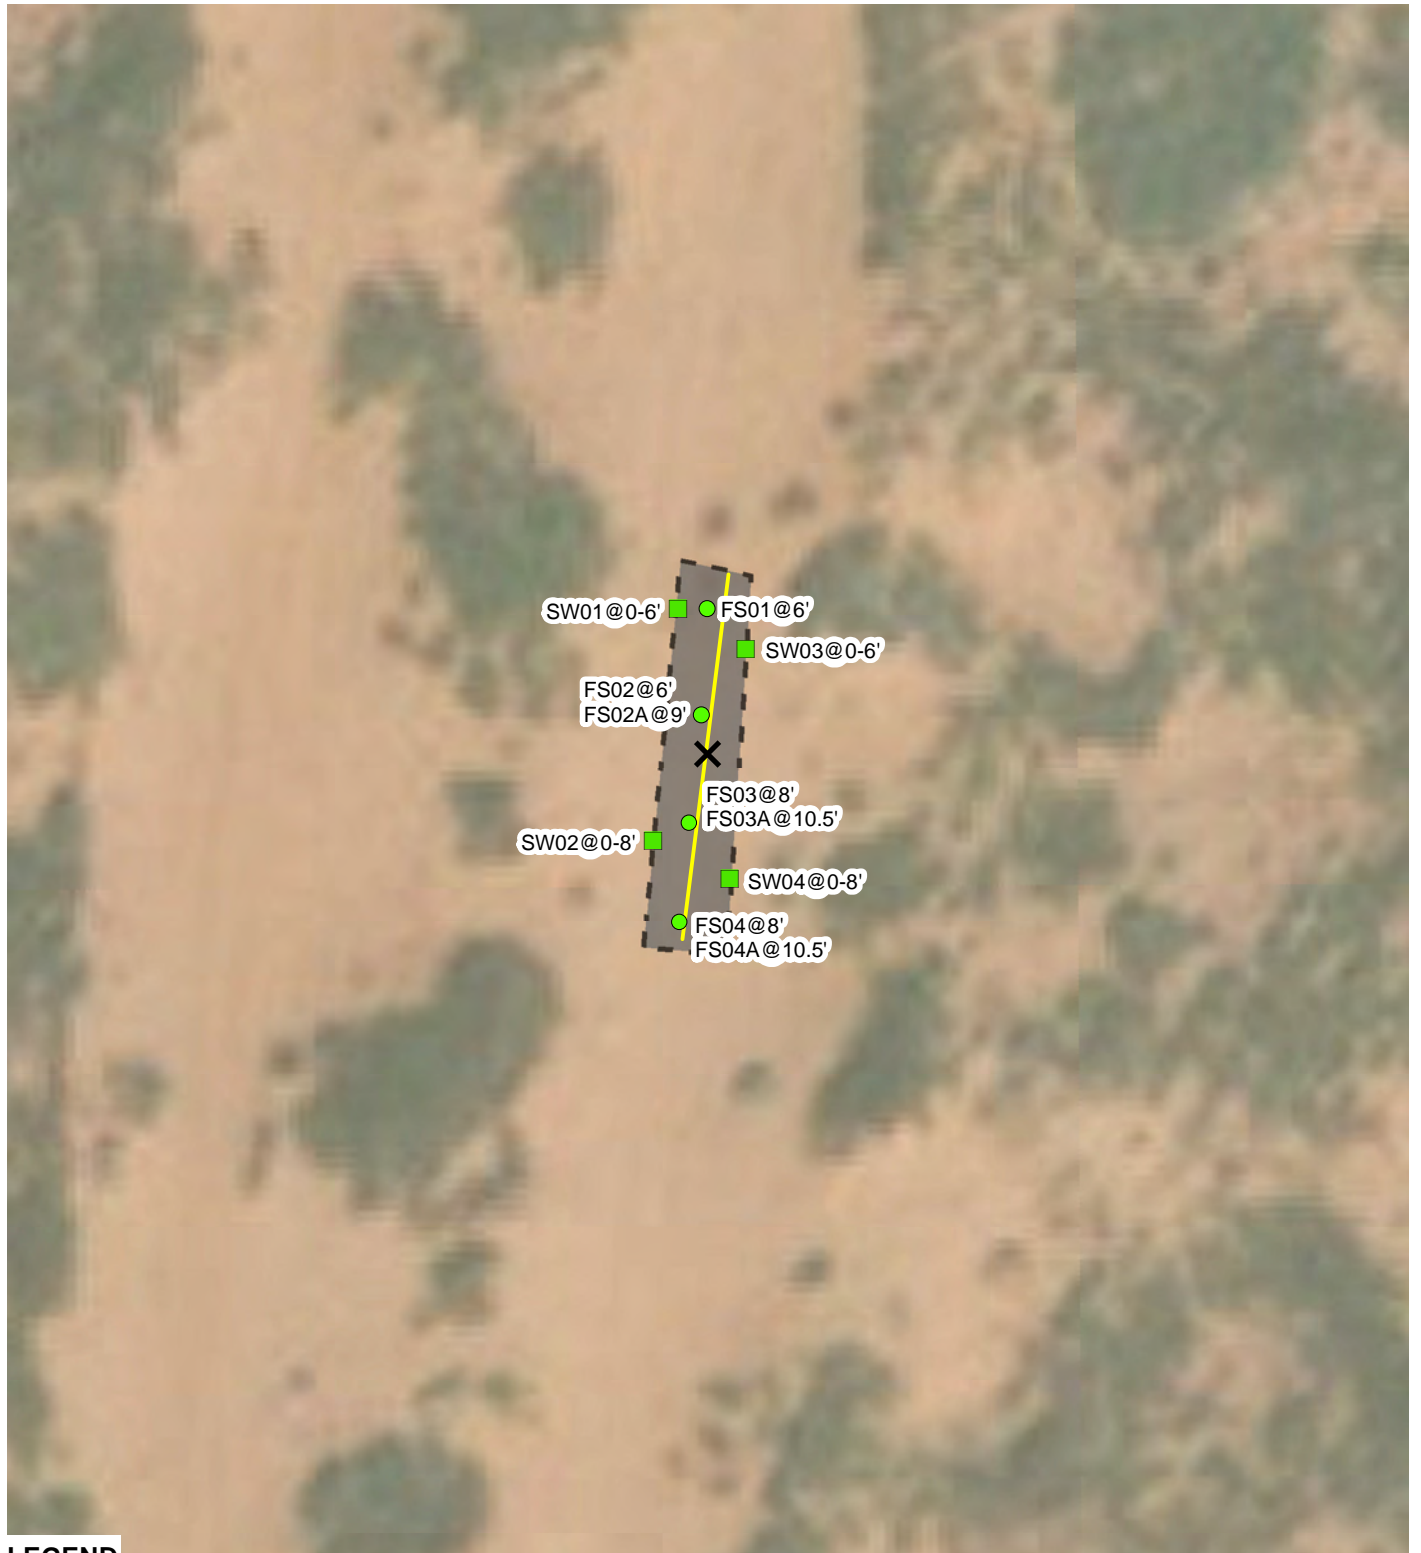
- RELEASE LOCATION
- FLOOR SAMPLE IN COMPLIANCE WITH APPLICABLE CLOSURE CRITERIA
- SIDEWALL SAMPLE IN COMPLIANCE WITH APPLICABLE CLOSURE CRITERIA
- GAS LINE
- EXCAVATION EXTENT

The excavation extent totaled approximately 725 square feet. An additional 55 cubic yards of impacted soil was removed by WSP during the excavation activities. The impacted soil was transported and properly disposed of at the R360 Facility located in Hobbs, New Mexico. The excavated area will be backfilled with material purchased locally and recontour the Site to match pre-existing site conditions.

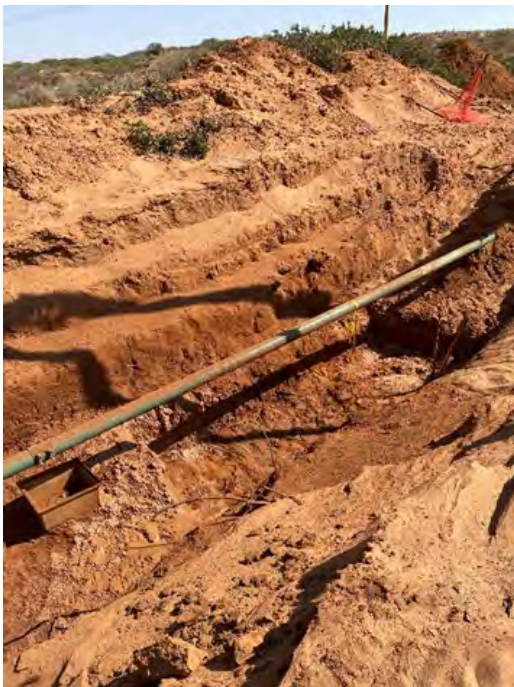
Photo No.	Date	
2	October 8, 2020	
View of excavation south of the point of release

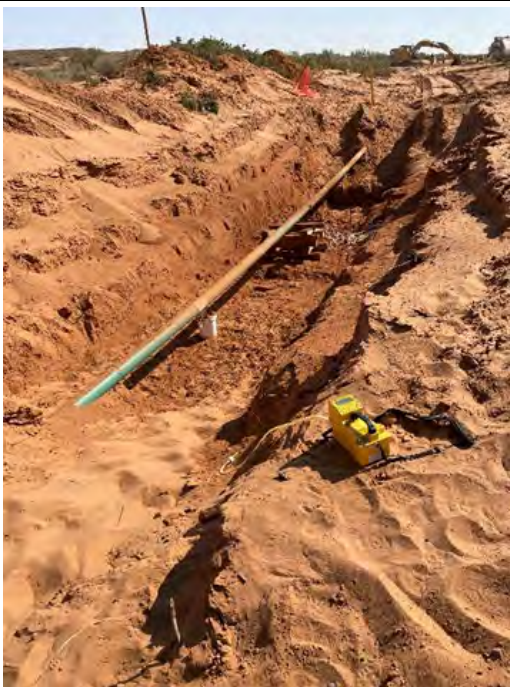
Photo No.	Date	
3	October 8, 2020	
View of excavation extent during remediation activities.

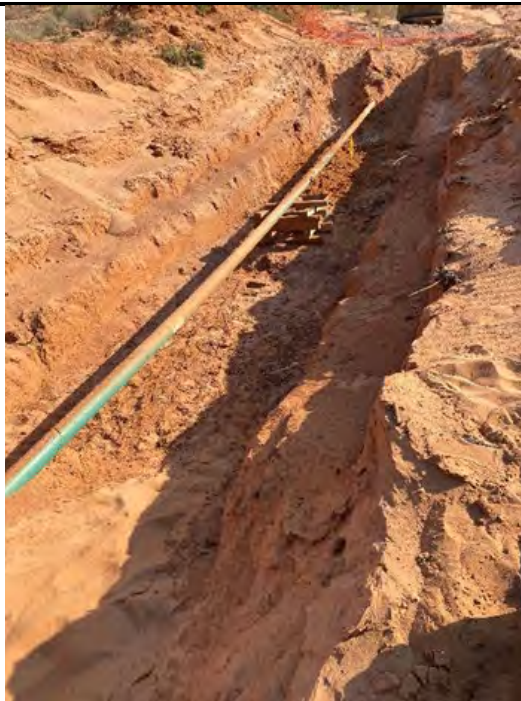
Photo No.	Date	
4	October 8, 2020	
View of full excavation after contaminated soil was fully removed.
