## Release Notification

| Site Name | Long Tall Sally #1 | Site Type | |

NRM2021936507

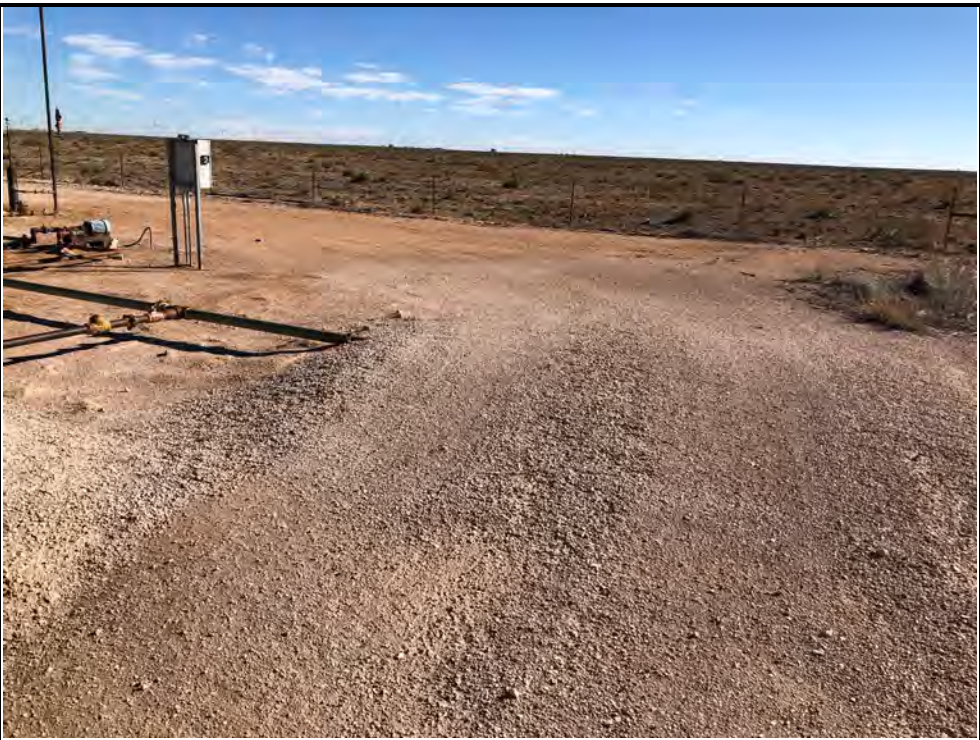
| Photo No. | Date | |
|---|---|---|
| View of staining East of Tank Battery. | | A photograph showing a wide, flat, gravel-covered area in a desert environment. In the background, there is a small, dark, rectangular structure, possibly a tank or battery, and some sparse vegetation. The sky is clear and blue. |

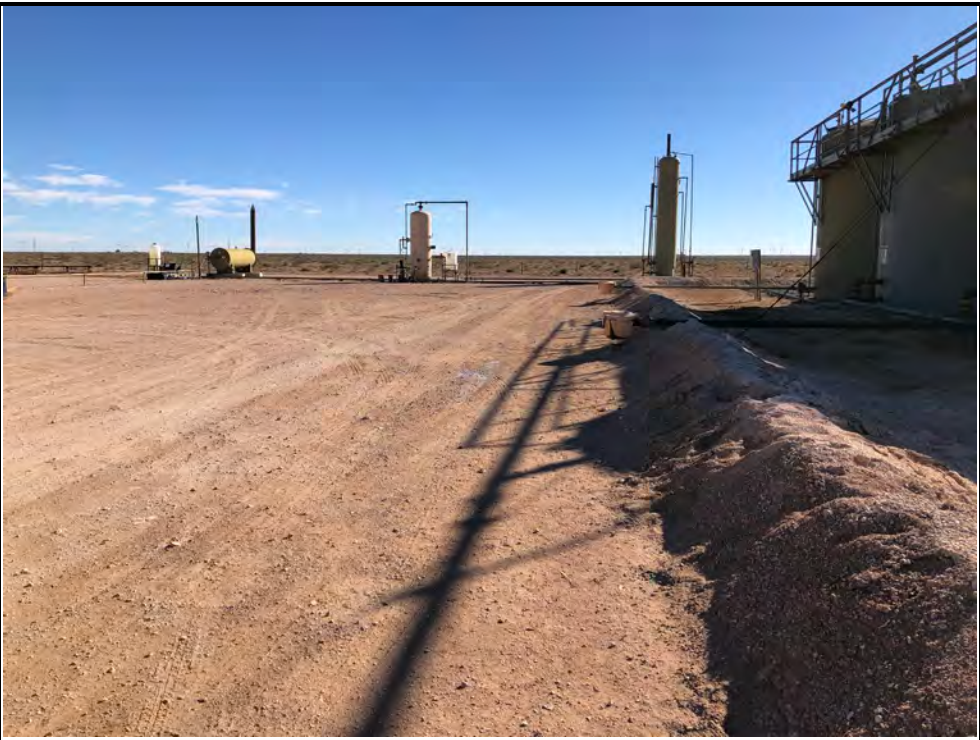
| Photo No. | Date | |
|---|---|---|
| View of staining on pad North of tank battery. | | A photograph showing a gravel-covered pad area. In the background, there are several industrial structures, including a tall, thin tower and a large, cylindrical tank. The sky is clear and blue. The foreground shows a large pile of gravel or sand. |
