## Release Notification

Site Name	REMUDA SOUTH 25 STATE 126H	Site Type	Well Location
Date Release Discovered	10/22/2019	API# (if applicable)	30-015-44392 (REMUDA SOUTH 25 STATE 126H)

**FIGURE 3**  
**DELINEATION SOIL SAMPLE LOCATIONS**  
 REMUDA SOUTH 25 STATE 126H  
 UNIT G SEC 25 T23S R29E  
 EDDY COUNTY, NEW MEXICO  
**XTO ENERGY, INC.**

<b>XTO Energy</b>	<b>Remuda South 25 State 126H</b> <b>Eddy County, New Mexico</b>	<b>NRM1935840155</b> <b>NRM2000235975</b> <b>NRM2000237294</b>
-------------------	---	--

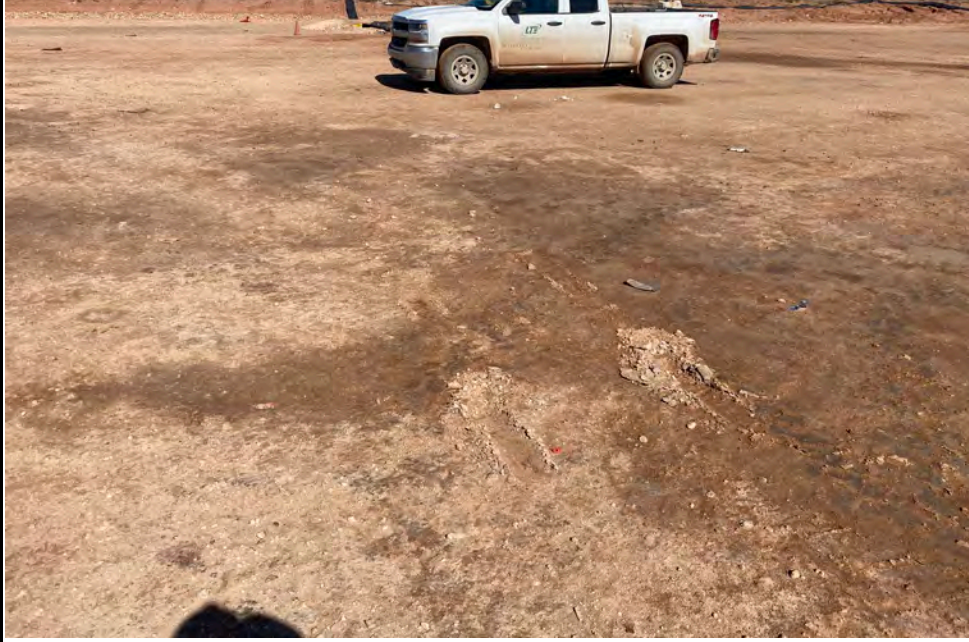
Photo No.	Date	
2	February 10, 2020	
View of staining remaining on pad.

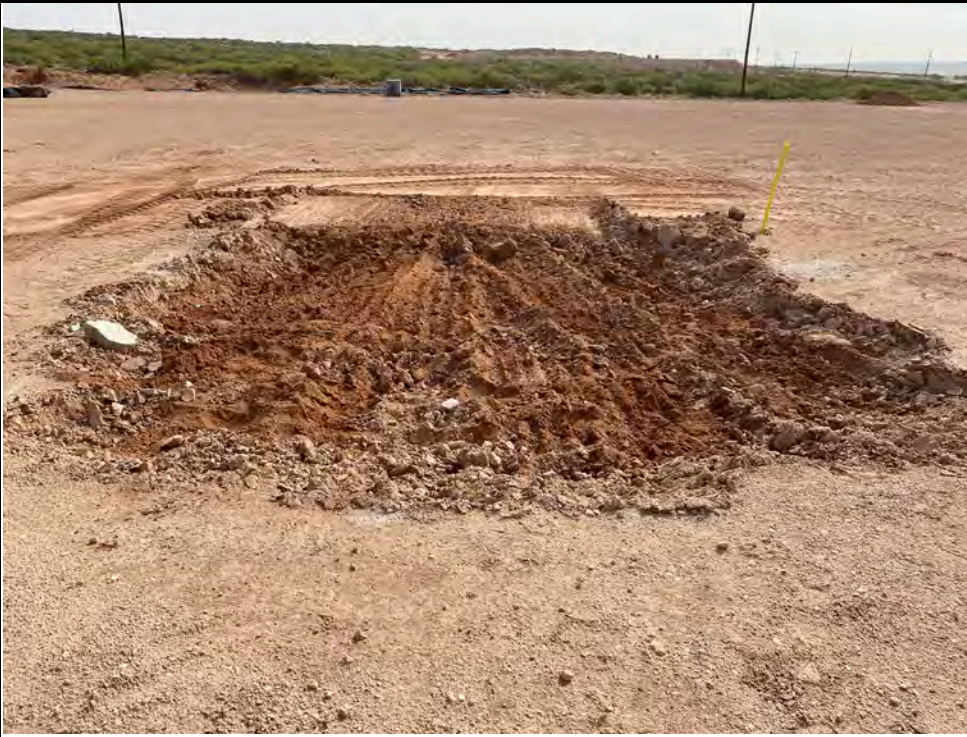
<b>Photo No.</b>	<b>Date</b>	
3	September 21, 2020	
View of excavation facing East

A photograph showing a large, rectangular excavation pit filled with reddish-brown soil and rocks. The pit is situated in a flat, sandy area. In the background, there are some green bushes and a clear sky. A yellow survey pole is visible on the right side of the excavation.

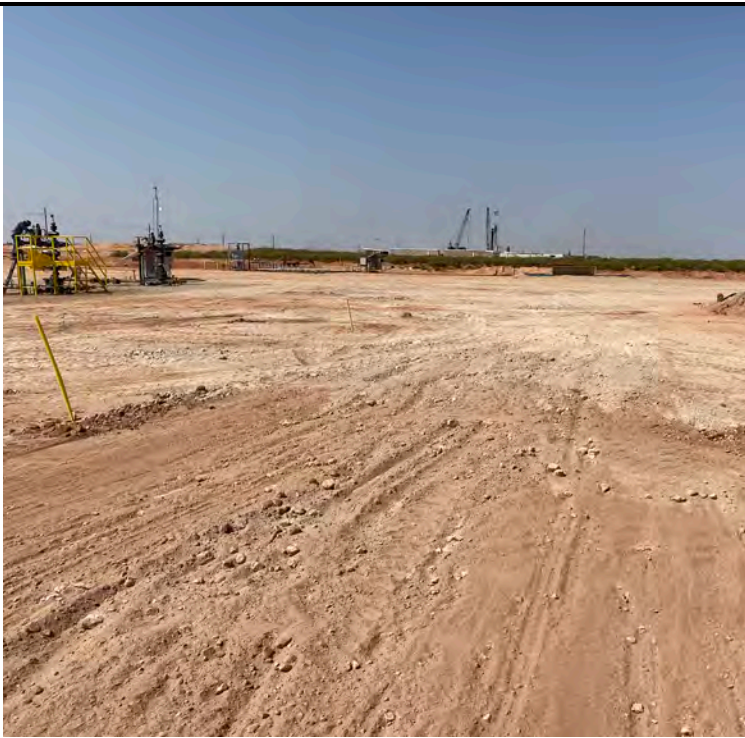
<b>Photo No.</b>	<b>Date</b>	
4	September 22, 2020	
View of backfill on pad.

A photograph showing a wide, flat area of reddish-brown soil, likely a backfill pad. In the background, there are some industrial structures, including a yellow crane and a blue crane, under a clear blue sky. A yellow survey pole is visible on the left side of the pad.
