Incident ID	NRM2030035945
District RP	
Facility ID	
Application ID

Release Notification

Site Name	JRU 36 Rambler	Site Type	SWD
Date Release Discovered	10/07/2020	API#	(if applicable)

Following the failed liner integrity inspection at the Site, WSP personnel advanced one borehole (BH01) at the location of the tear in the liner to assess for the presence or absence of soil impacts resulting from the October 7, 2020 produced water release within lined containment. Two delineation soil samples were collected from borehole BH01 at depths of approximately 0.5 feet and 1 foot bgs. Laboratory analytical results indicated that benzene, BTEX, TPH, and chloride concentrations were compliant with the Closure Criteria. Additionally, field screening of soil from the borehole indicated no elevated volatile aromatic hydrocarbons or chloride concentrations beneath the tear in the liner. The release was contained laterally by the lined containment and all released fluids were recovered during initial response activities. The tear in the liner was subsequently repaired.

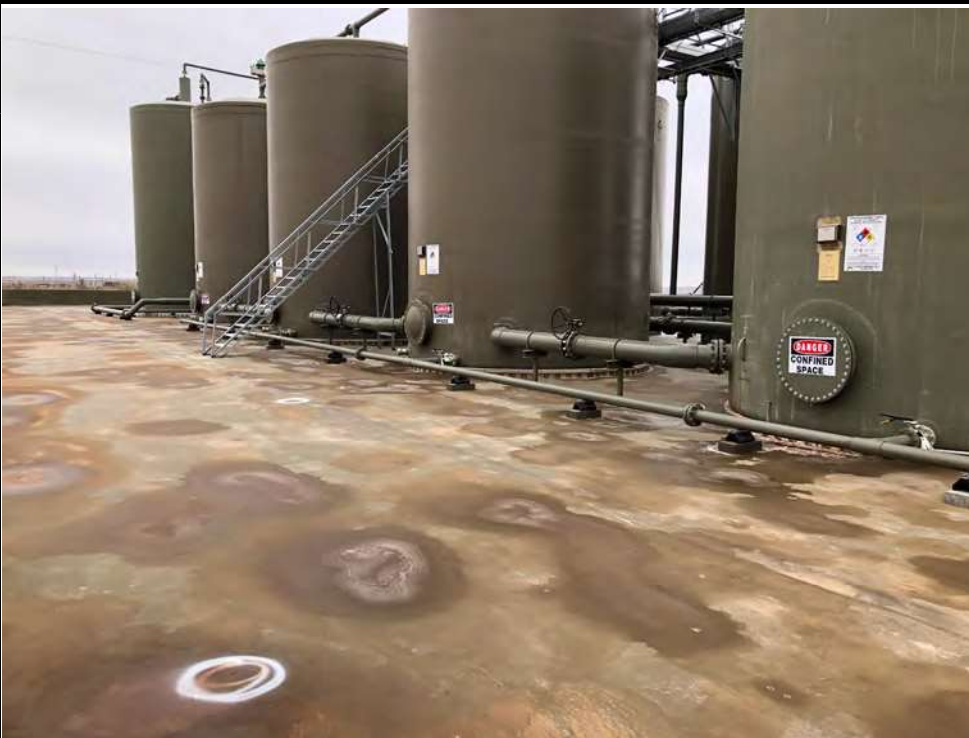
Photo No.	Date	
1	November 13, 2020	
View of puncture in liner within containment.

A photograph showing a large, cylindrical industrial storage tank. The ground in the foreground is a flat, brownish surface with several circular stains. A white circle is drawn on the ground, highlighting a puncture in the liner. The tank has a metal staircase leading up to it. A warning sign is visible on the tank's side.

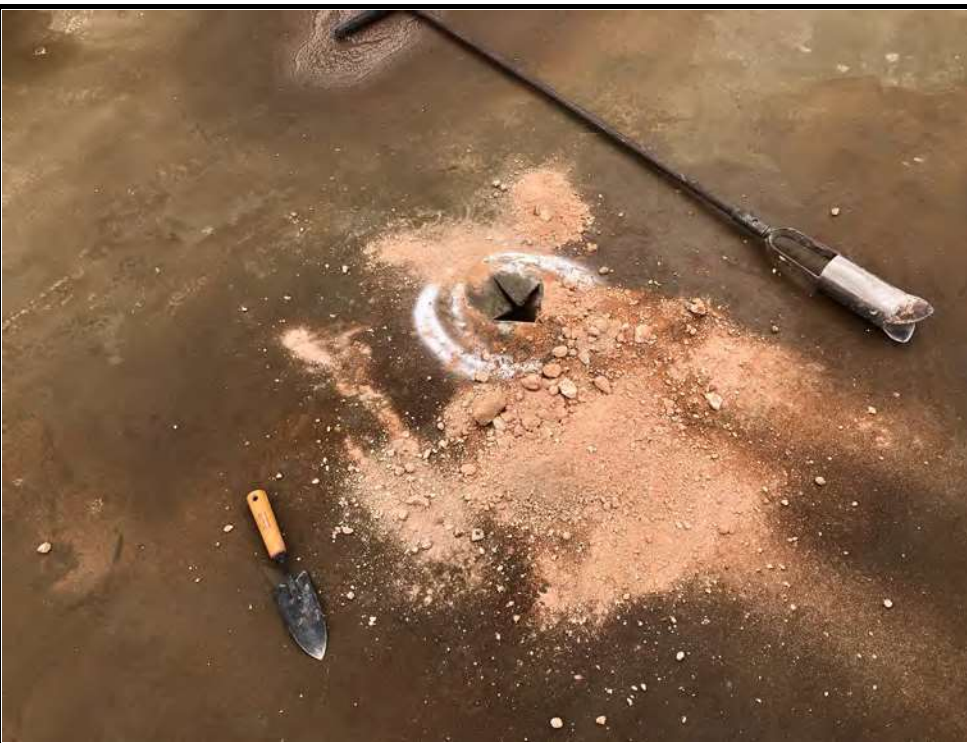
Photo No.	Date	
3	November 13, 2020	
Image of delineation sampling within containment.

A photograph showing a delineation sampling site. A circular area of reddish-brown soil is visible, with a small black object (possibly a marker or tool) in the center. A shovel with a yellow handle and a black handle are lying on the ground next to the sampling area.
