Release Notification

Site Name	Poker Lake Unit 21 Brushy Draw 903H	Site Type	Production Well
Date Release Discovered	02/05/2020	API# (if applicable)	30-015-45703 Poker Lake Unit 21 Brushy Draw 903H

Cause of Release: A valve on the manifold was left opened to prevent freezing during the night. The following day, while transferring fluid from the frac tanks to the drilling rig mud system, 128 barrels were spilled onto the drilling pad. 127.5 barrels were recovered. A third party contractor has been retained to complete remediation activities.

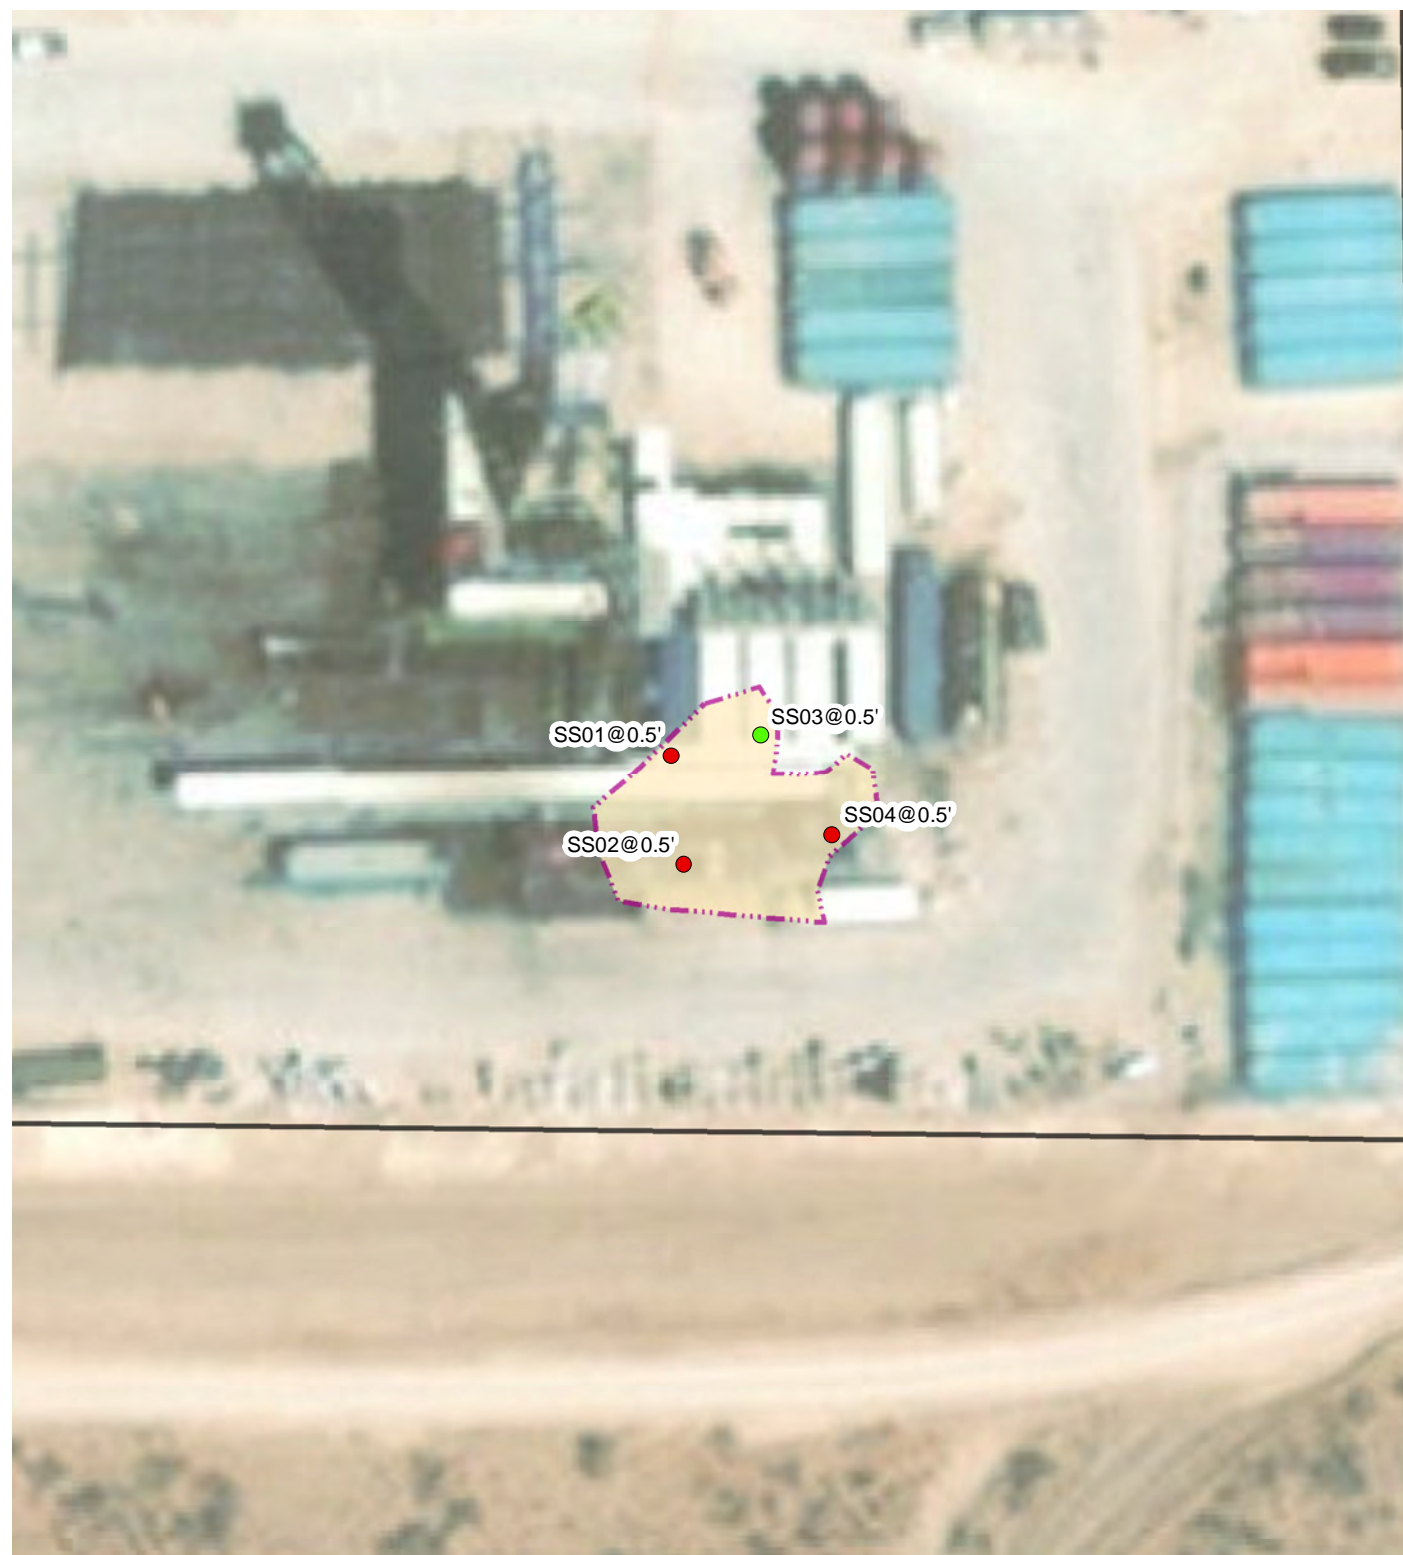
FIGURE 2
PRELIMINARY SOIL SAMPLE LOCATIONS
POKER LAKE UNIT 21 BRUSHY DRAW 903H
UNIT N SEC 21 T25S R30E
EDDY COUNTY, NEW MEXICO
XTO ENERGY, INC.

Once hydraulic fracturing and flowback operations were complete, WSP personnel visited the Site to evaluate the release extent on October 15, 2020. The release extent and preliminary soil sample locations were mapped utilizing a handheld Global Positioning System (GPS). WSP personnel collected and field screened four preliminary soil assessment samples at three locations (SS01 through SS04) within the release extent. Locations of soil samples are presented on Figure 2.

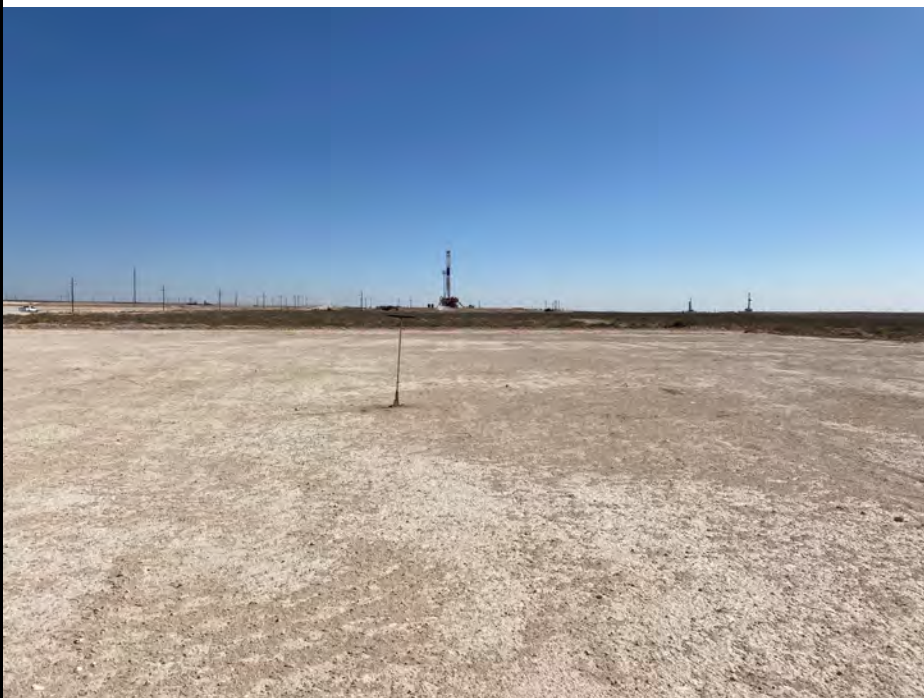
Photo No.	Date	
1	October 15, 2020	
View of SS01 sample location facing East.

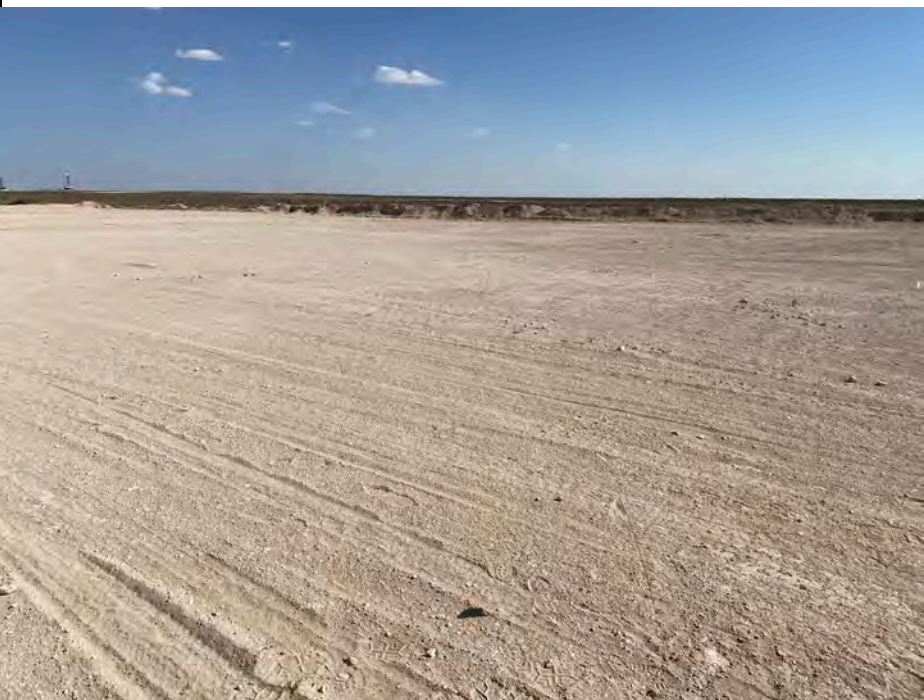
Photo No.	Date	
2	October 22, 2020	
View of area impacted by release facing Southeast.
