CLOSURE REPORT

Line 1002

**Eddy County, New Mexico
32.108608 N, 104.044301 W
NMOCD Incident No. NAPP2102646604
Incident ID No. 15683
Enterprise ECIRT No. 93359**

April 12, 2021
Ensolum Project No. 03B1226042

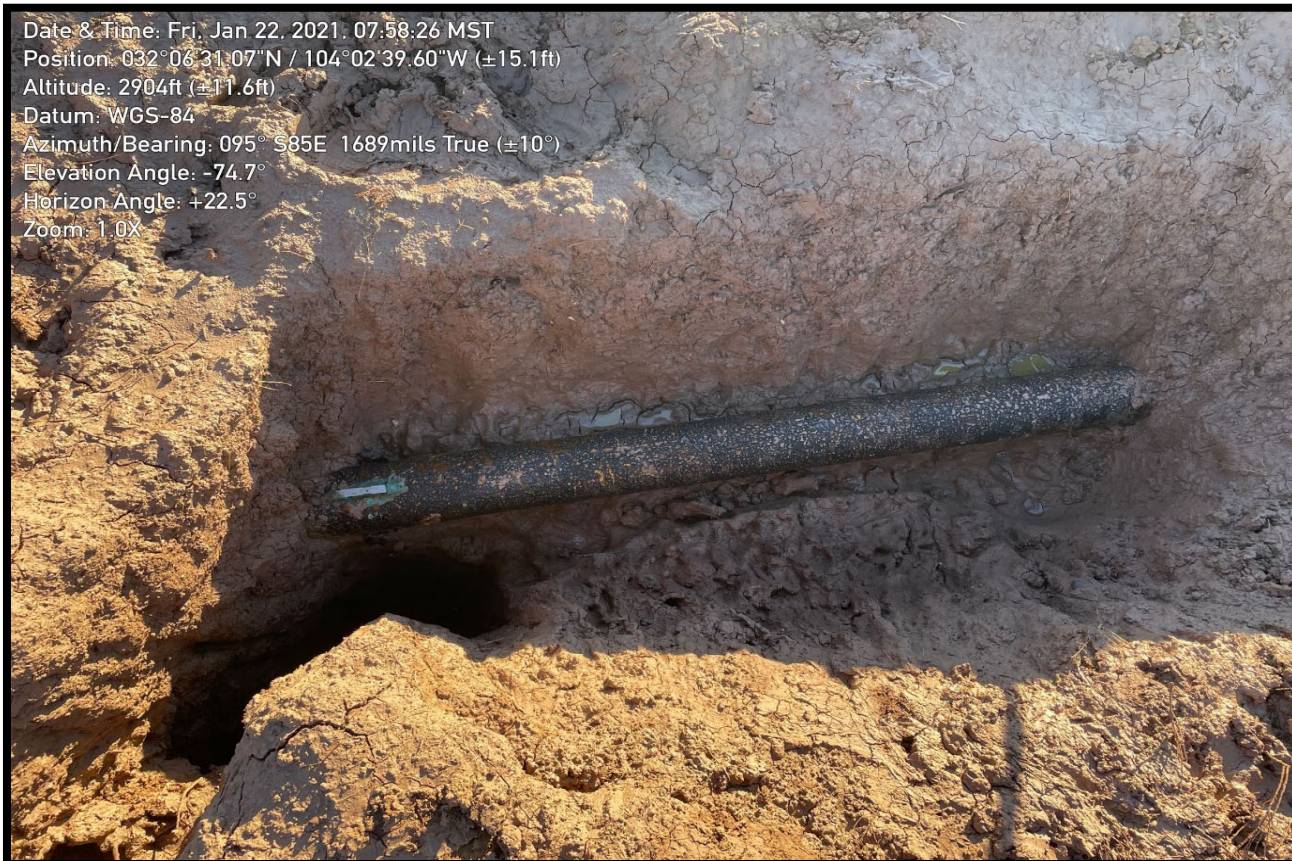
View of the release source during remediation activities, facing southeast.

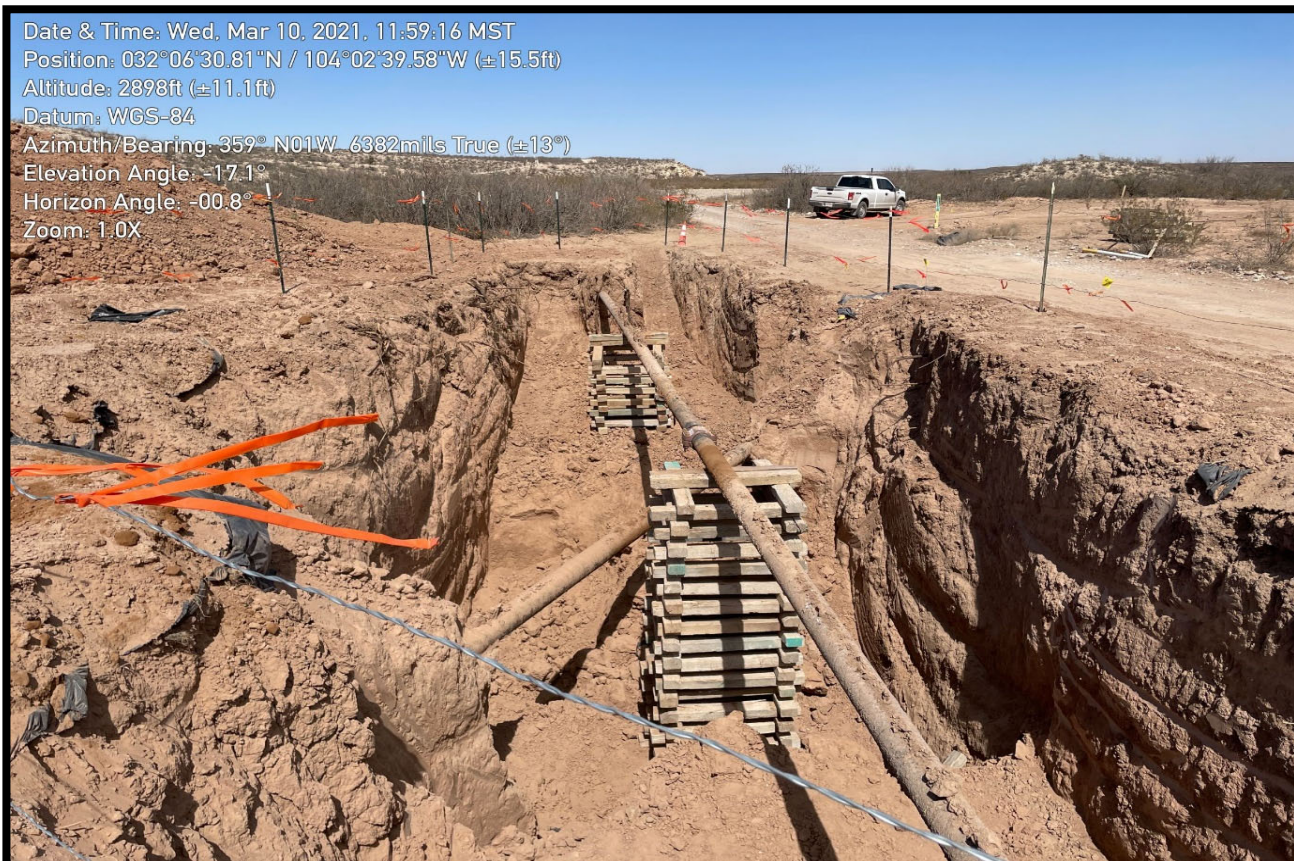
View of release area during remediation activities, facing north.

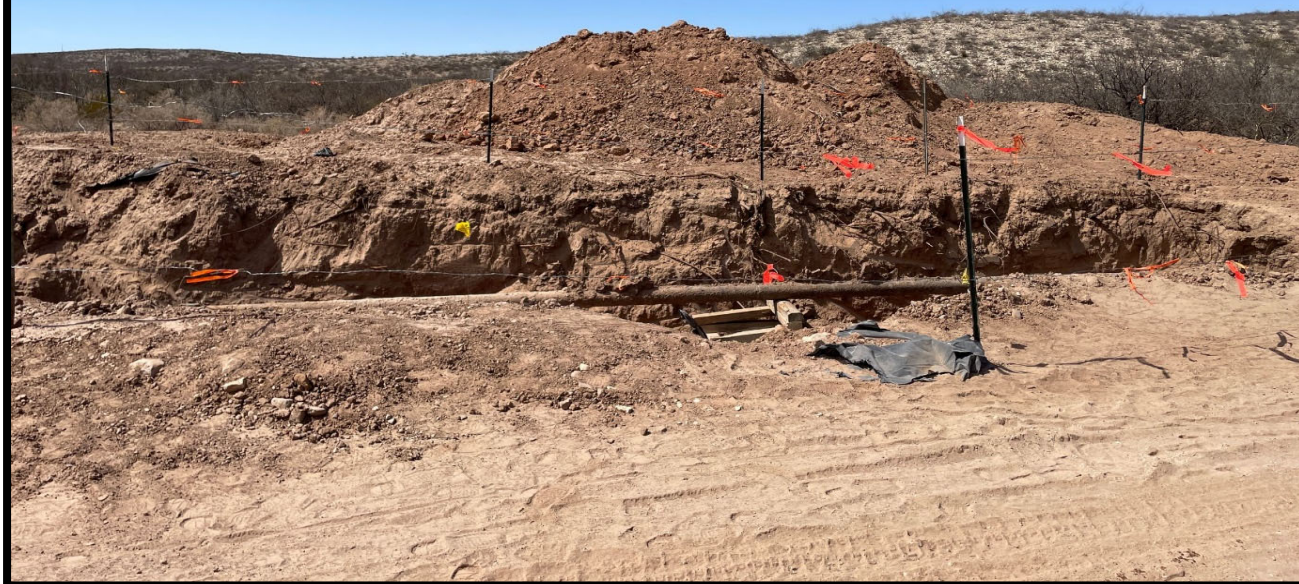
View of impacted area and soil stockpile during remediation activities, facing northwest.

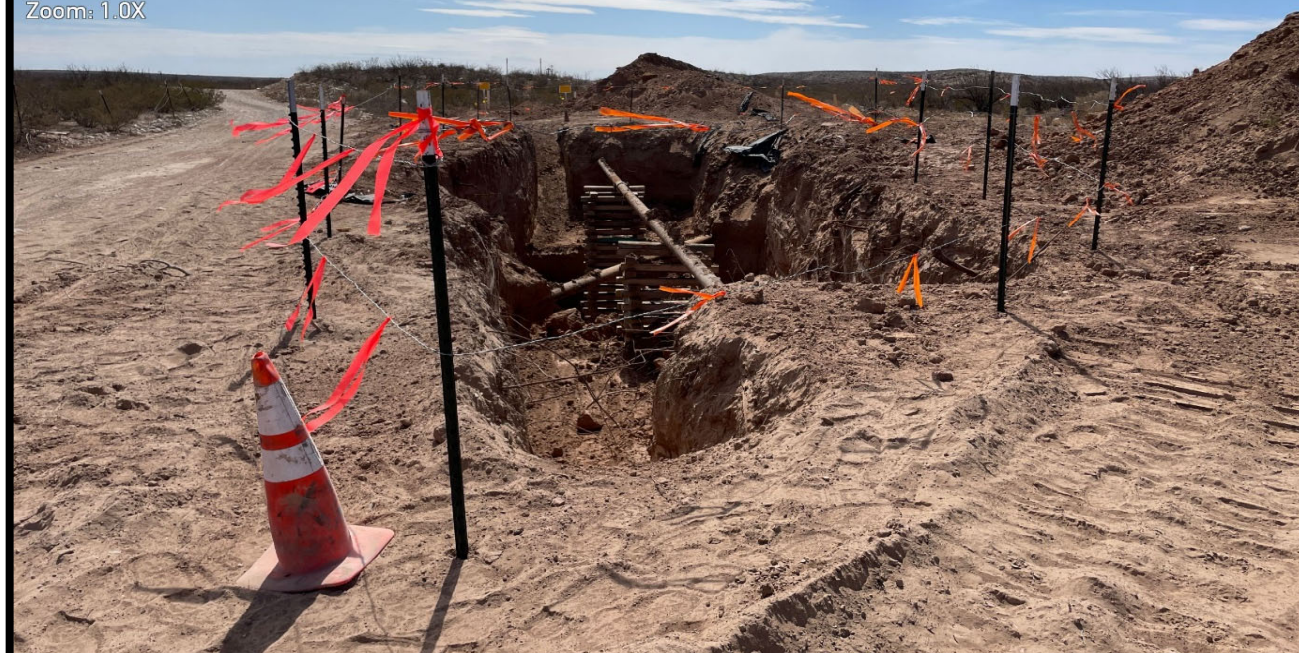
View of impacted area and soil stockpile during remediation activities, facing south.
