SUBJECT: Remediation Closure Report for the Todd 15 – 7 Battery Release (NRM2014568830), Eddy County, New Mexico

On behalf of Devon Energy Production Company, Souder, Miller & Associates (SMA) has prepared this Remediation Closure Report that describes the remediation of a release of liquids related to oil and gas production activities at Todd 15 – 7 Battery site. The site is in Unit G, Section 15, Township 23S, Range 31E, Eddy County, New Mexico, on Federal land. Figure 1 illustrates the vicinity and site location on an USGS 7.5-minute quadrangle map.

Todd 15 – 7 Battery Remediation Closure Report  
December 10, 2020

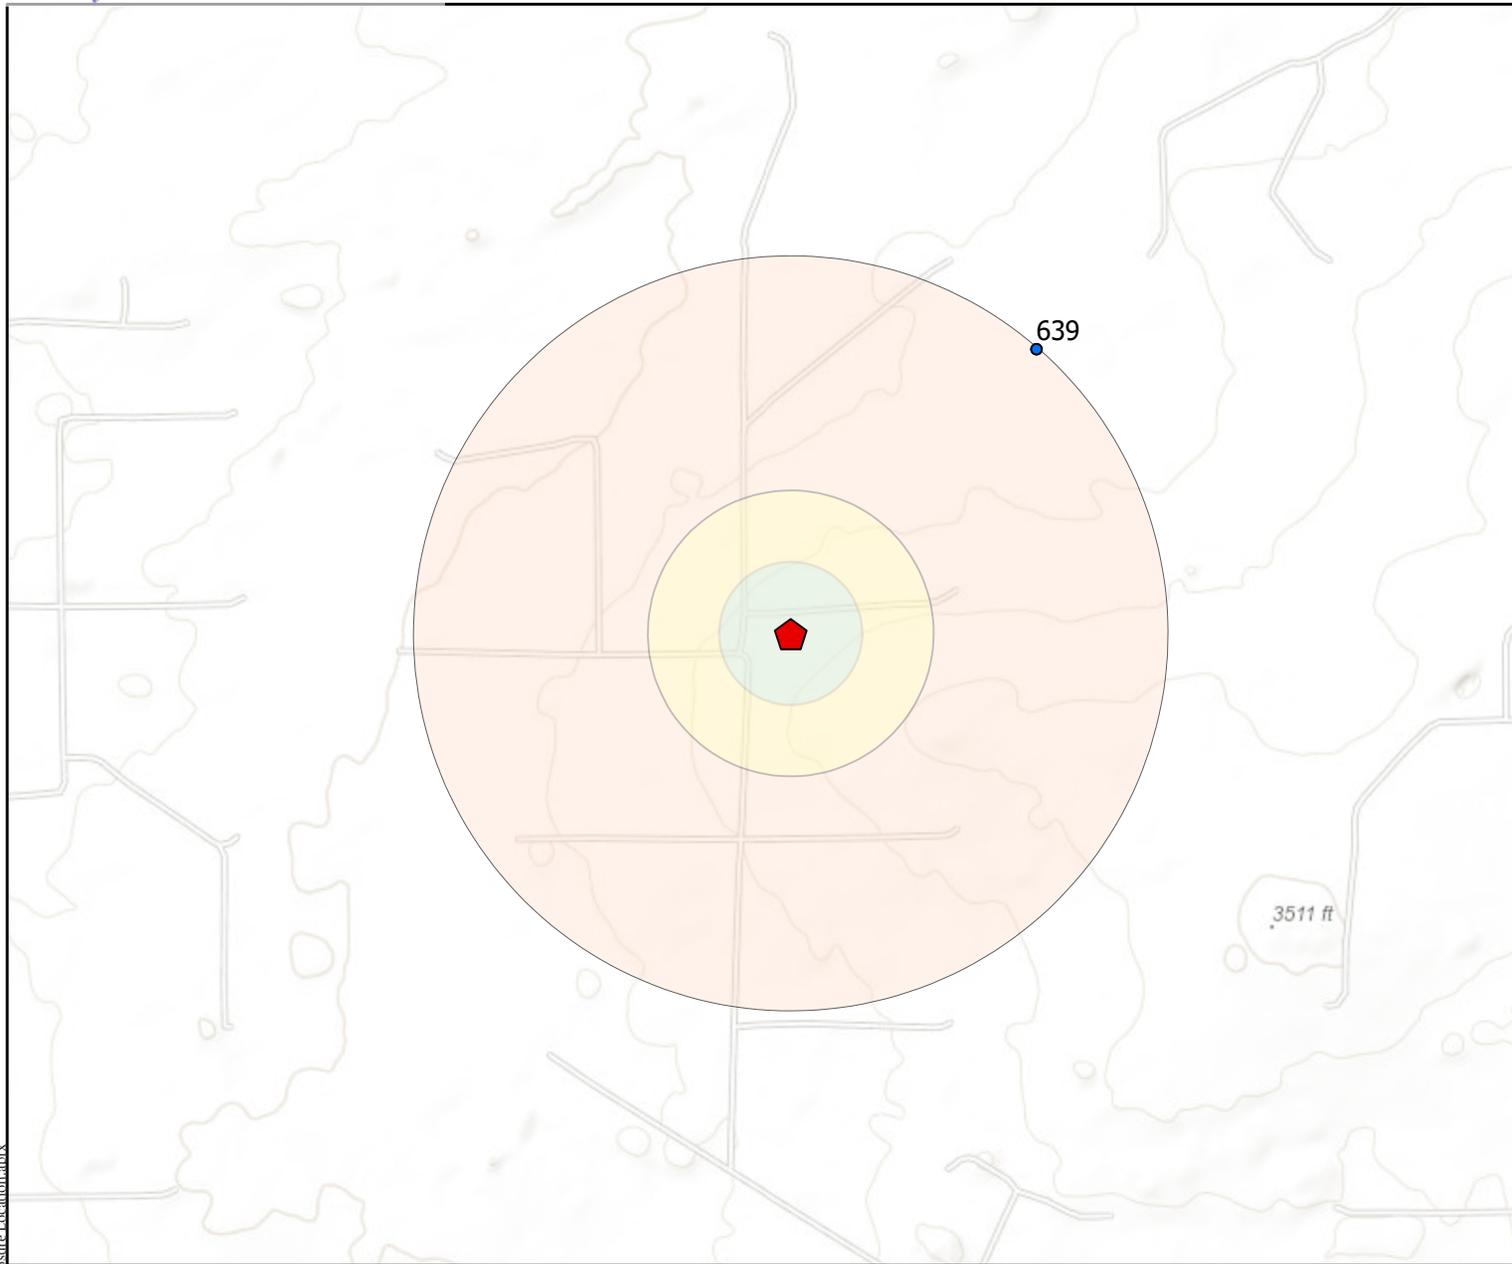
Figure 1

Vicinity and Well Head Protection Map  
 Todd 15 - 7 Battery - Devon Energy Production Company  
 UL: G S: 15 T: 23S R: 31E, Eddy County, New Mexico

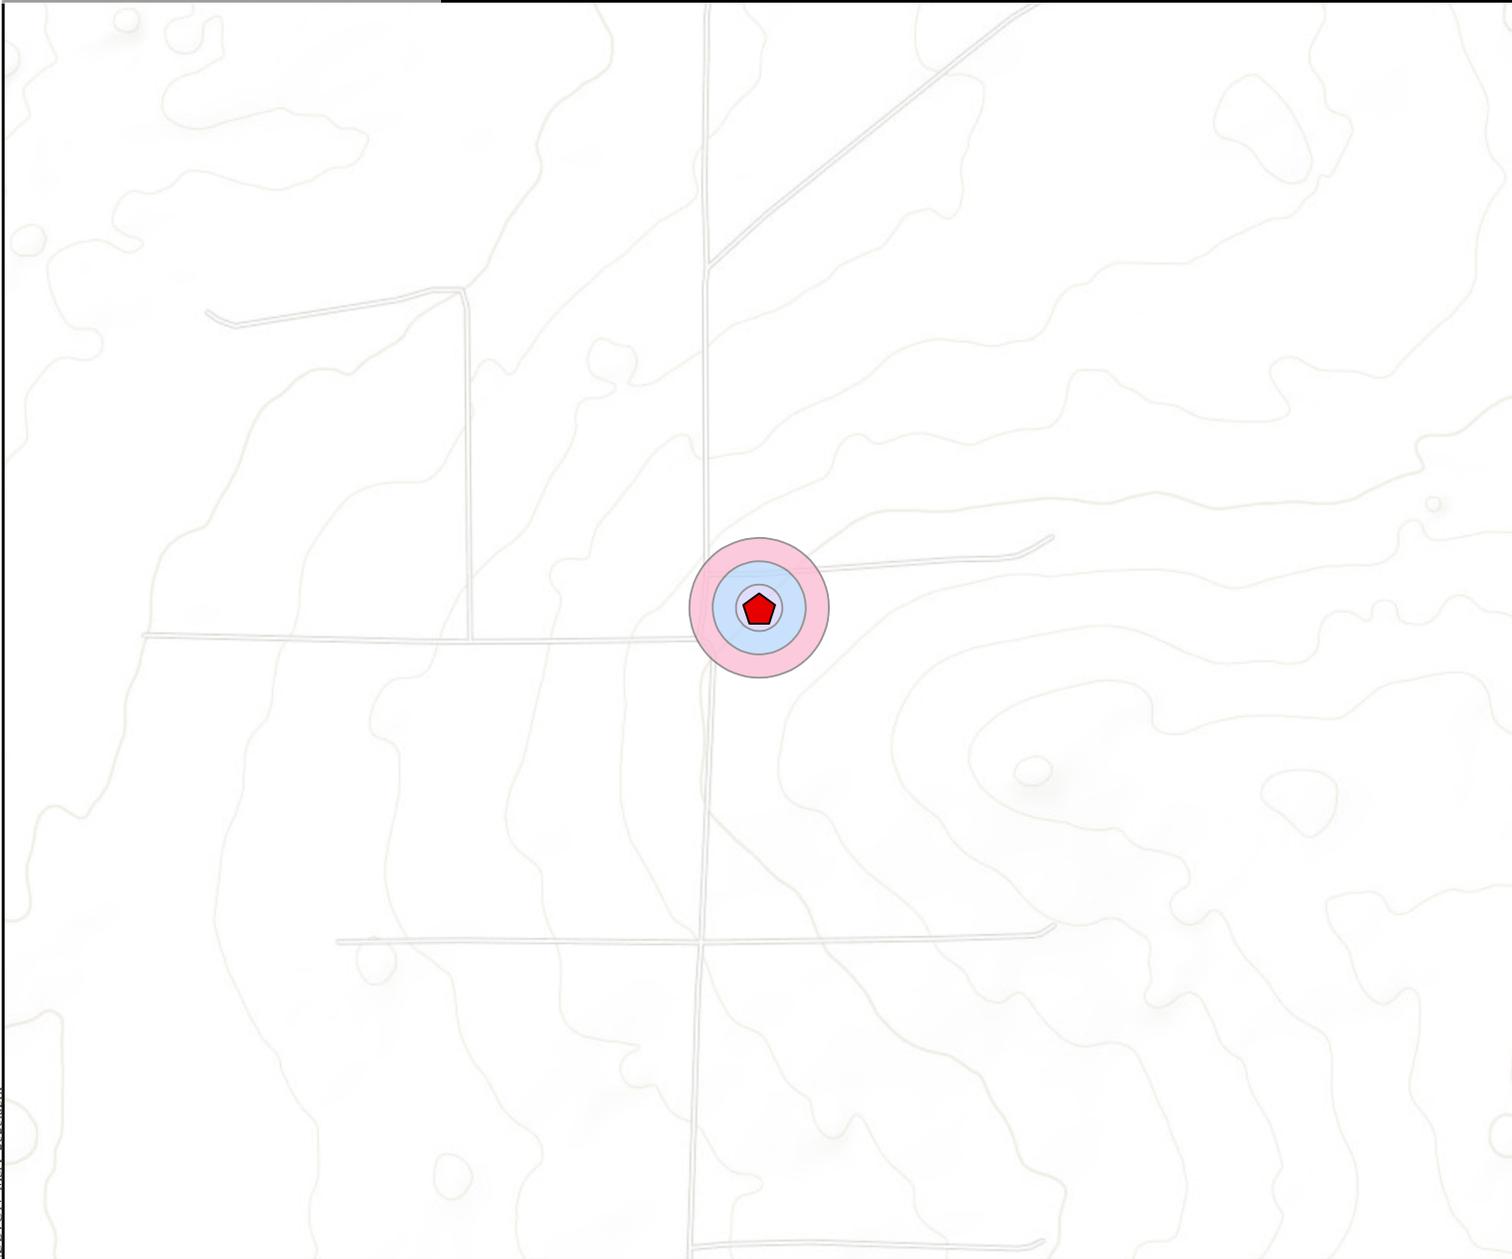
Table 2 demonstrates the Closure Criteria applicable to this location. Figure 2 illustrates the site with 200 and 300-foot radii to indicate that it does not lie within a sensitive area as described in 19.15.29.12.C(4) NMAC.

*Surface Water Protection Map*  
 Todd 15 - 7 Battery - Devon Energy Production Company  
 UL: G S: 15 T: 23S R: 31E, Eddy County, New Mexico

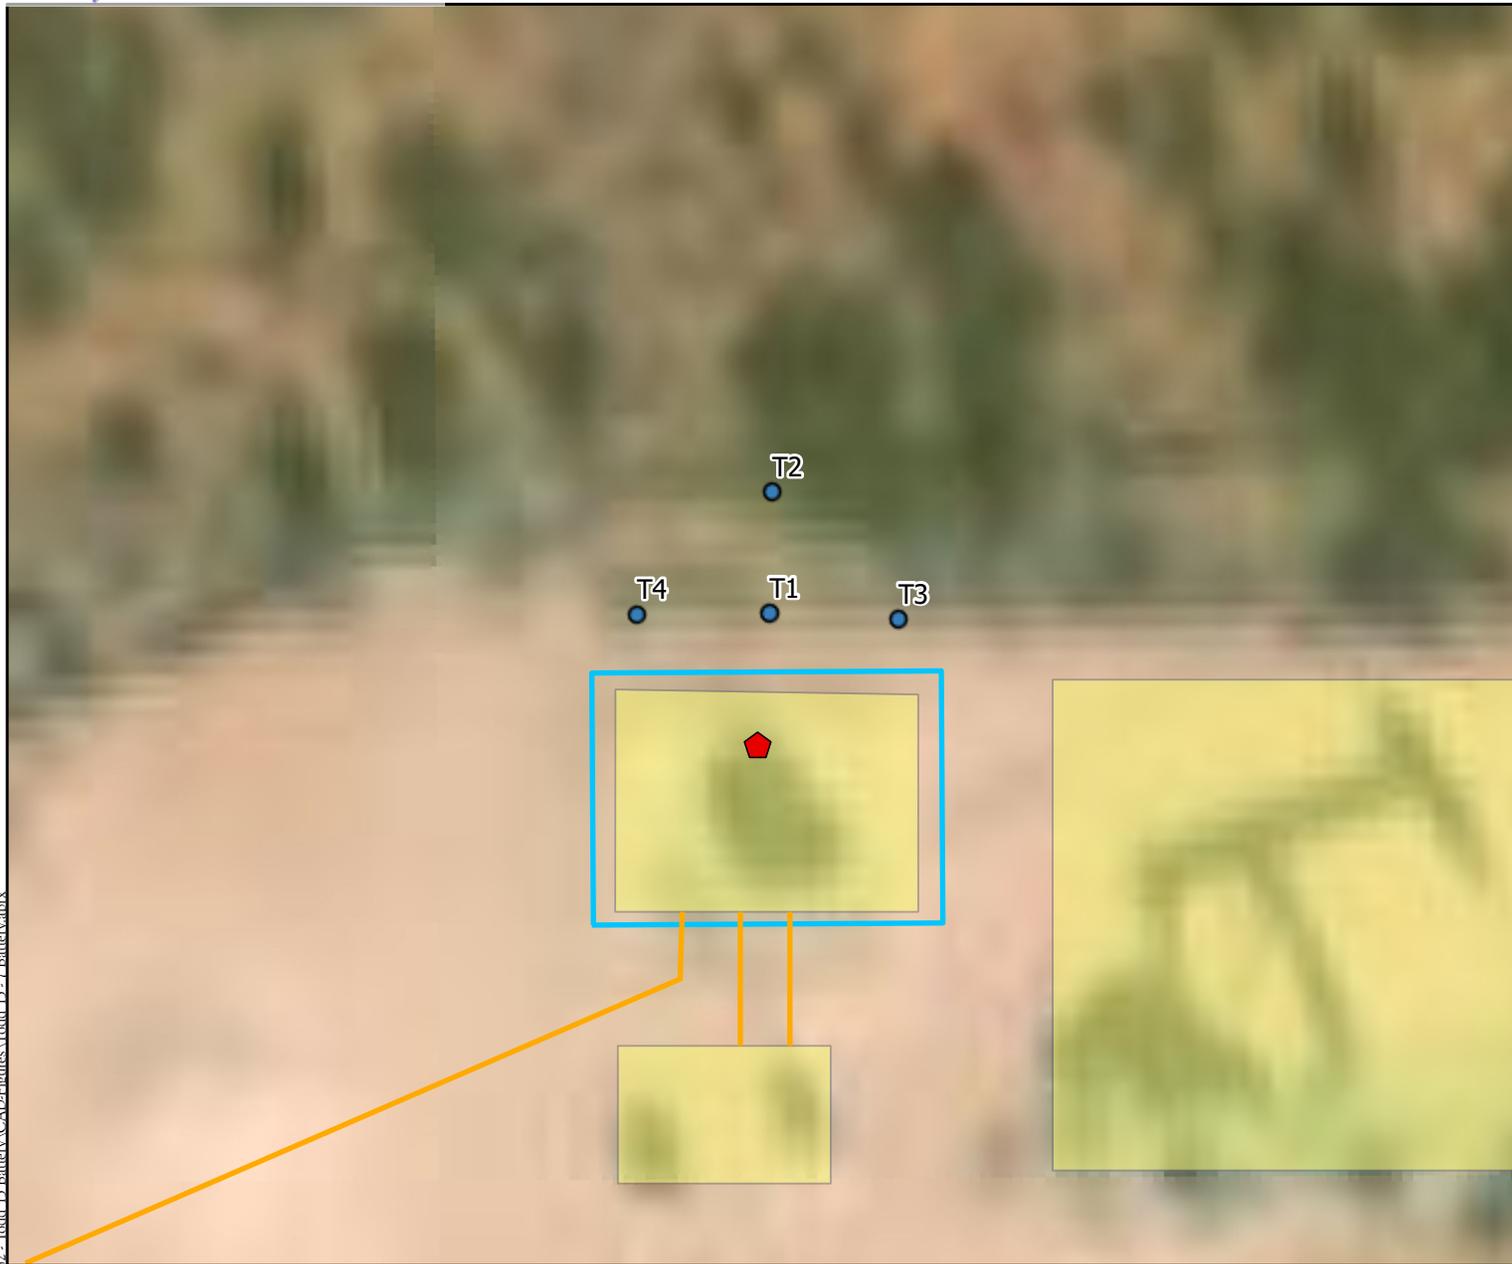
A total of four sample locations (T1 – T4) were investigated using a hand-auger to depths of up to 2 feet bgs. A minimum of two samples were collected at each sampling location and field-screened using the methods above. A total of nine samples were collected for laboratory analysis for total chloride using EPA Method 300.0; benzene, toluene, ethylbenzene and total xylenes (BTEX) using EPA Method 8021B; and motor, diesel and gasoline range organics (MRO, DRO, and GRO) by EPA Method 8015D.

Figure 3 shows the site and initial sample locations, Figure 3A shows the extent of the final excavation and closure sample locations. All field screening and laboratory results are summarized in Table 3. Laboratory reports are included in Appendix D.

Site and Initial Sample Location Map  
 Todd 15 - 7 Battery- Devon Energy Production Company  
 UL: G S: 15 T: 23S R: 31E - Eddy County, New Mexico

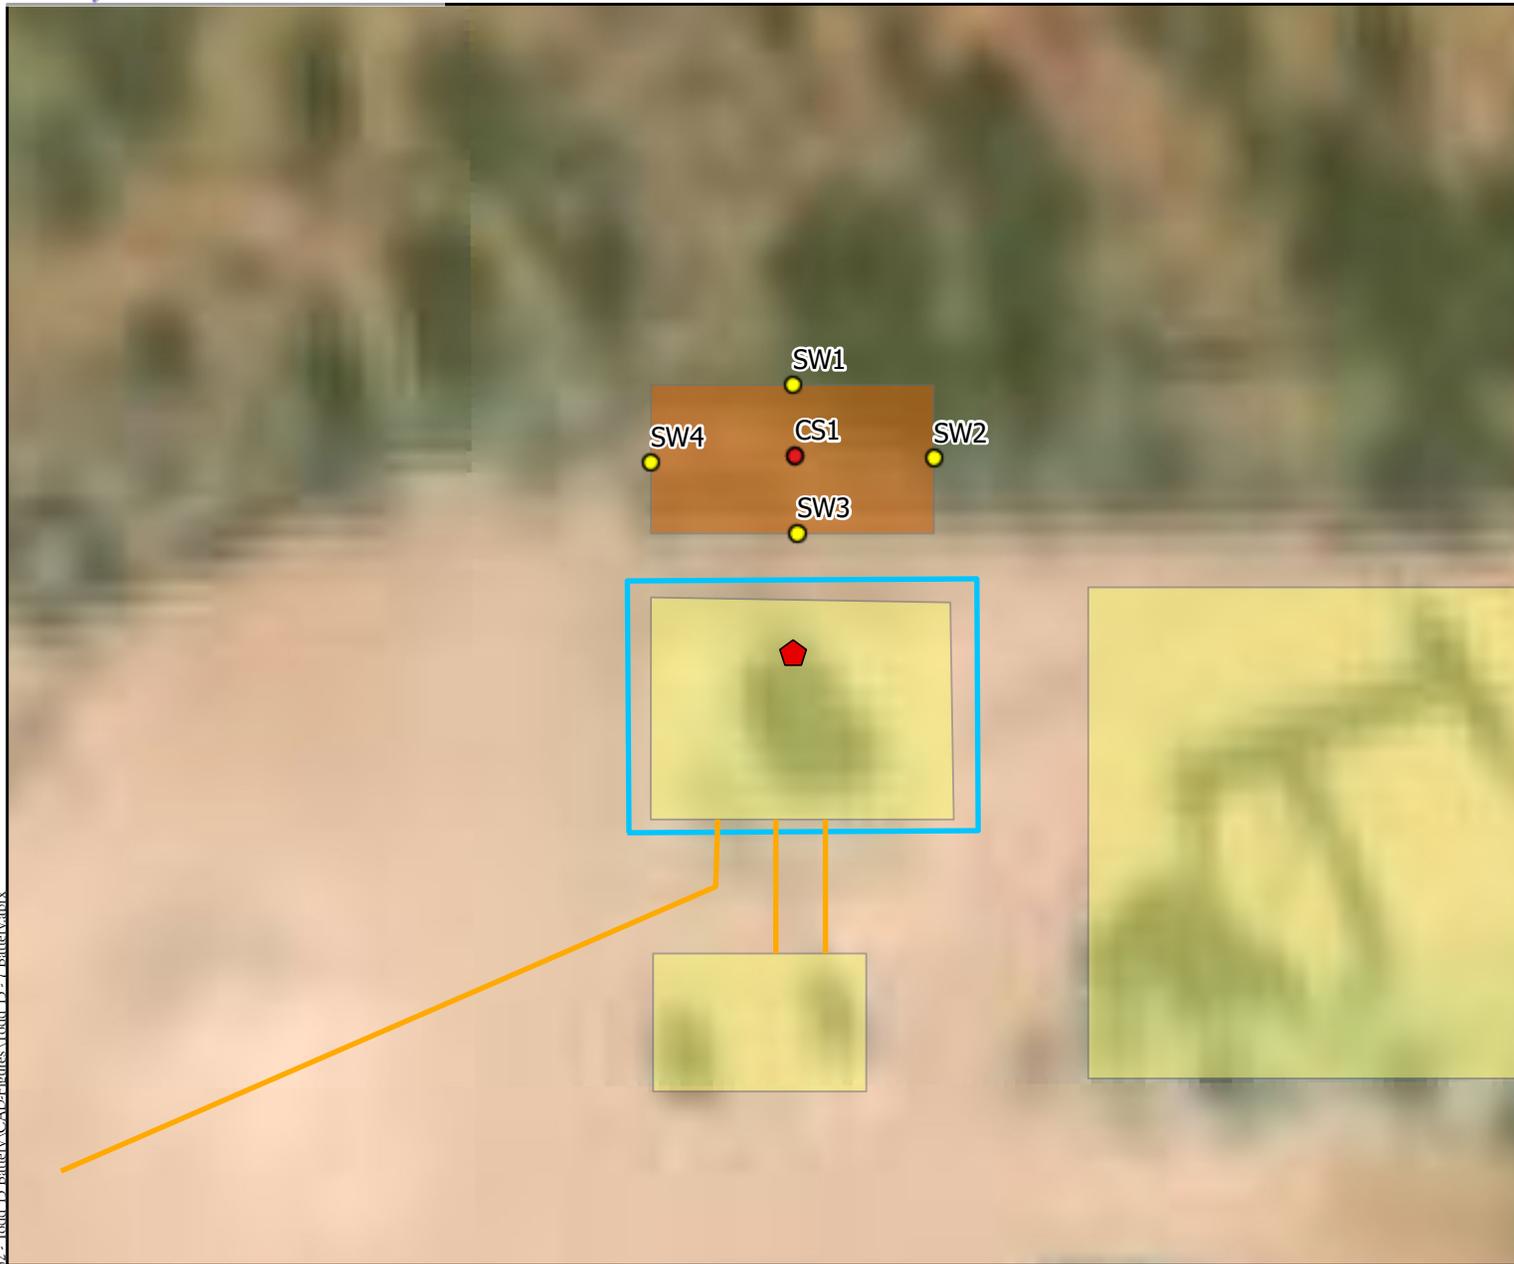
Figure 3A

On November 16, 2020, SMA collected confirmation samples from the walls and base of the excavation, which measured approximately 12.5 by 21 by 1.5 feet, representing all initial sample locations (T1 – T4). Confirmation samples were comprised of five-point composites of the base (CS1) and walls (SW1 – SW4).

Site and Confirmation Sample Location Map  
 Todd 15 - 7 Battery - Devon Energy Production Company  
 UL: G S: 15 T: 23S R: 31E - Eddy County, New Mexico

Contaminated soils were removed and replaced with clean backfill material to return the surface to previous contours. The contaminated soil was transported and disposed of at Northern Delaware Basin Landfill near Jal, NM, an NMOCD-permitted disposal facility.
