## Site Characterization and Work Plan

Chisholm Energy Operating, LLC  
COTTONWOOD 29-32 FED COM  
Eddy County, New Mexico  
Unit Letter "A", Section 29, Township 26 South, Range 26 East  
Latitude 32.001087° North, Longitude 104.307703° West  
NMOCD Reference #2RP-4768; 2RP-4986; 2RP- 5560

July 2019

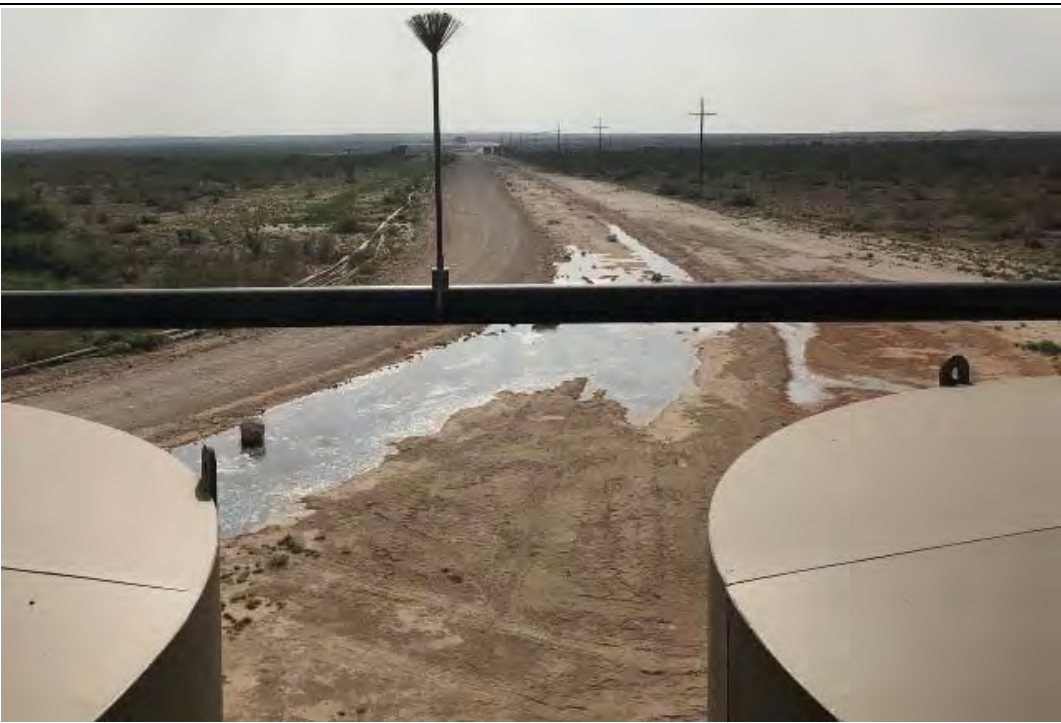
| <b>Photo No:</b><br><b>1.</b> | |

| <b>Description:</b><br>View across release area to the east | |

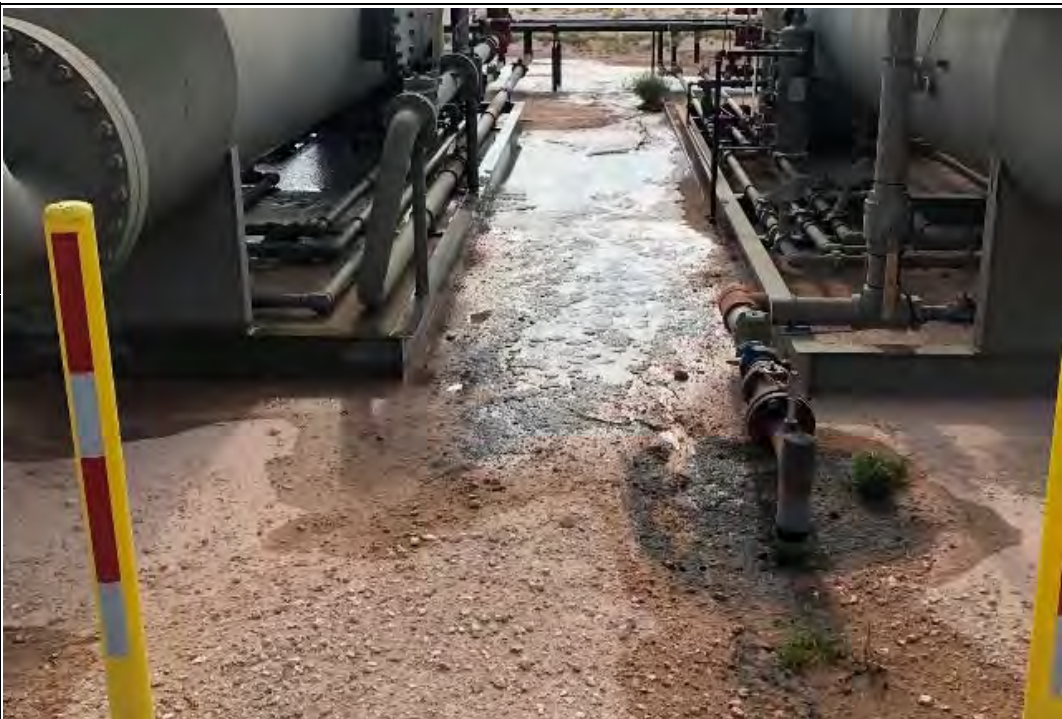
| <b>Photo No:</b><br><b>3.</b> | |

| <b>Description:</b><br>Release area on well pad between to separators and off pad to the east | |

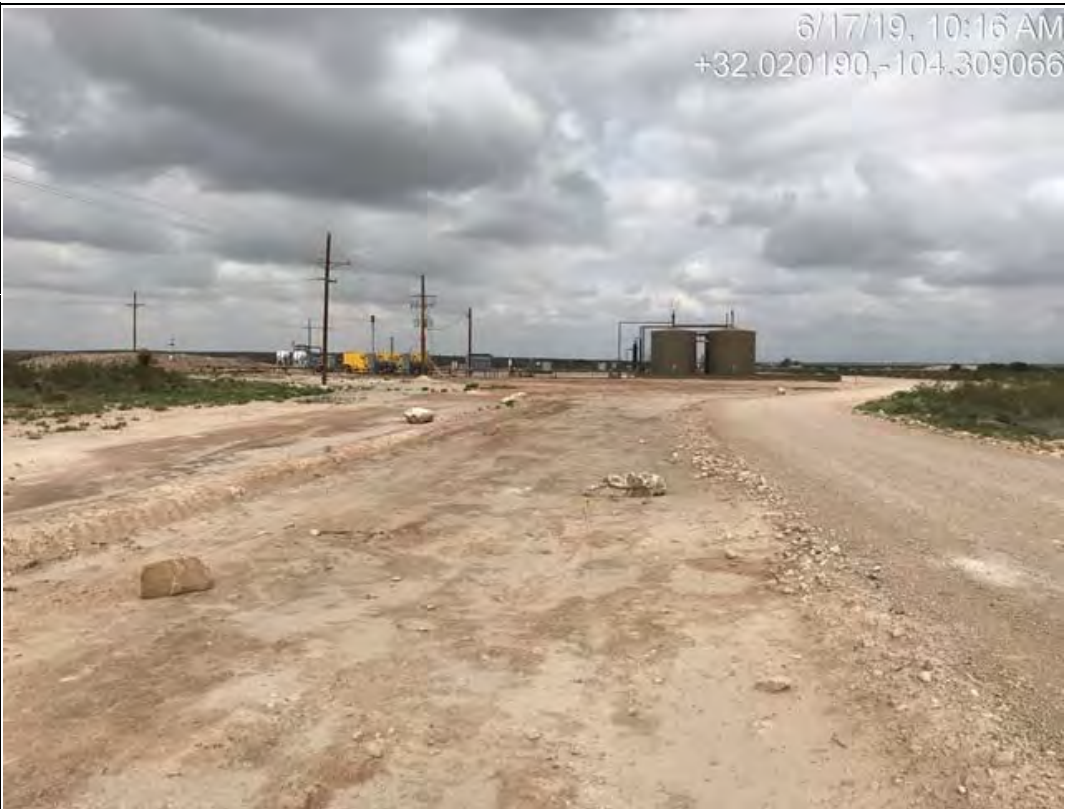
| <b>Photo No:</b><br><b>5.</b> | A wide-angle photograph showing a dirt road or pad area. In the background, there are several large cylindrical storage tanks and some industrial structures under a cloudy sky. The ground is sandy and uneven. |

| <b>Description:</b><br>Western view across release area off pad along lease road | |

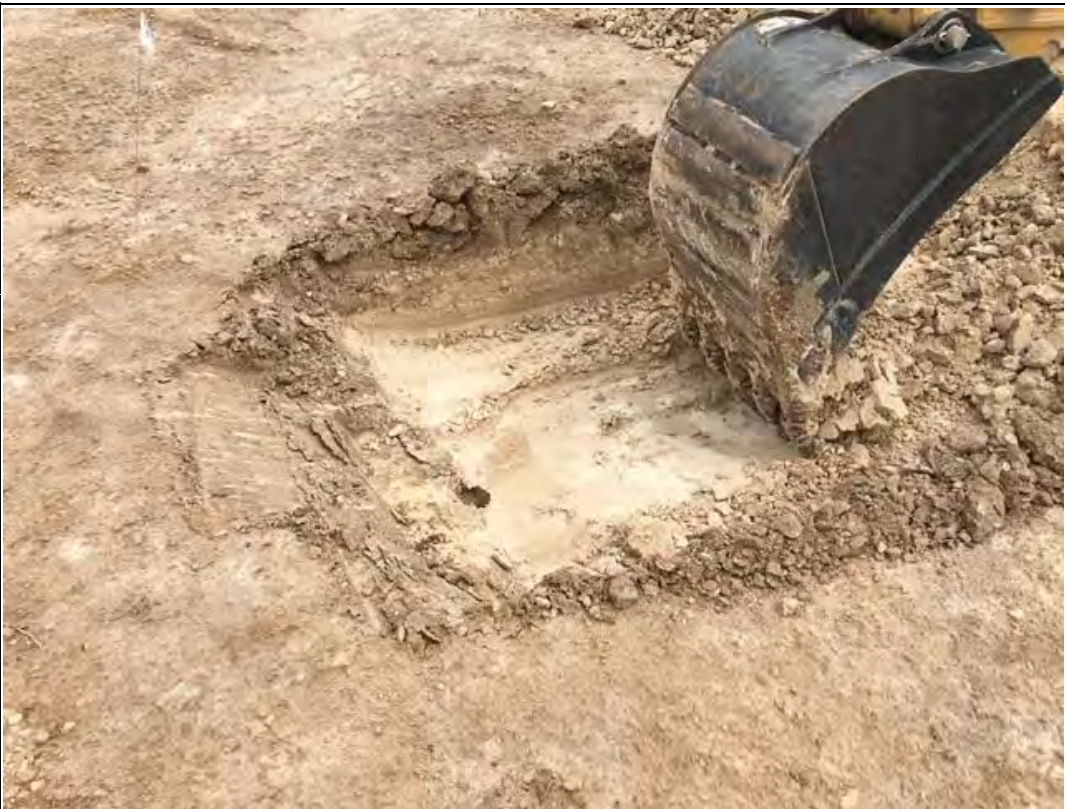
| <b>Photo No:</b><br><b>11.</b> | |

| <b>Description:</b><br>Attempted delineation at SP15 | |
