CLOSURE REPORT

BRUNSON ARGO TANK BATTERY #5

NMOCD REF. #1RP1780

RE: **Closure Report**
Chevron USA
Brunson Argo Tank Battery #5
UL-D (NW¼ of the NW¼) of Section 10, T22S, R37E
Latitude: N32° 24' 33.64"; Longitude: W103° 09' 18.70"
Lea County, New Mexico
NMOCD Ref. #1RP 1780; EPI Ref. #200130

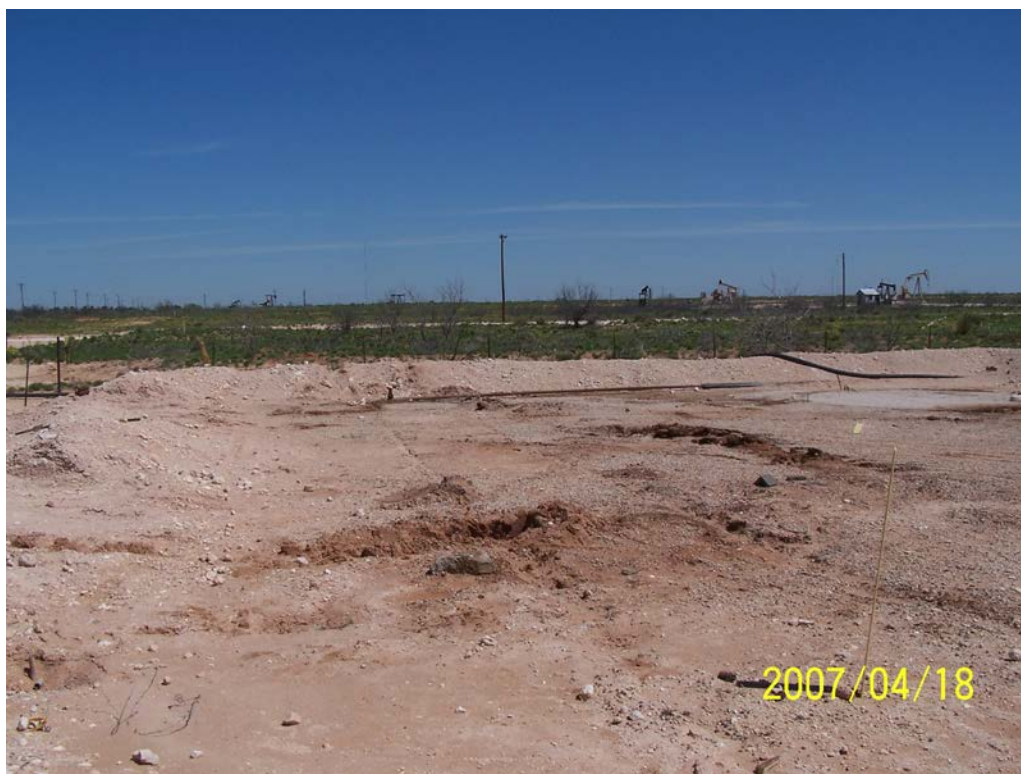
Photograph No. 1 – Looking northerly across interior of bermed area.

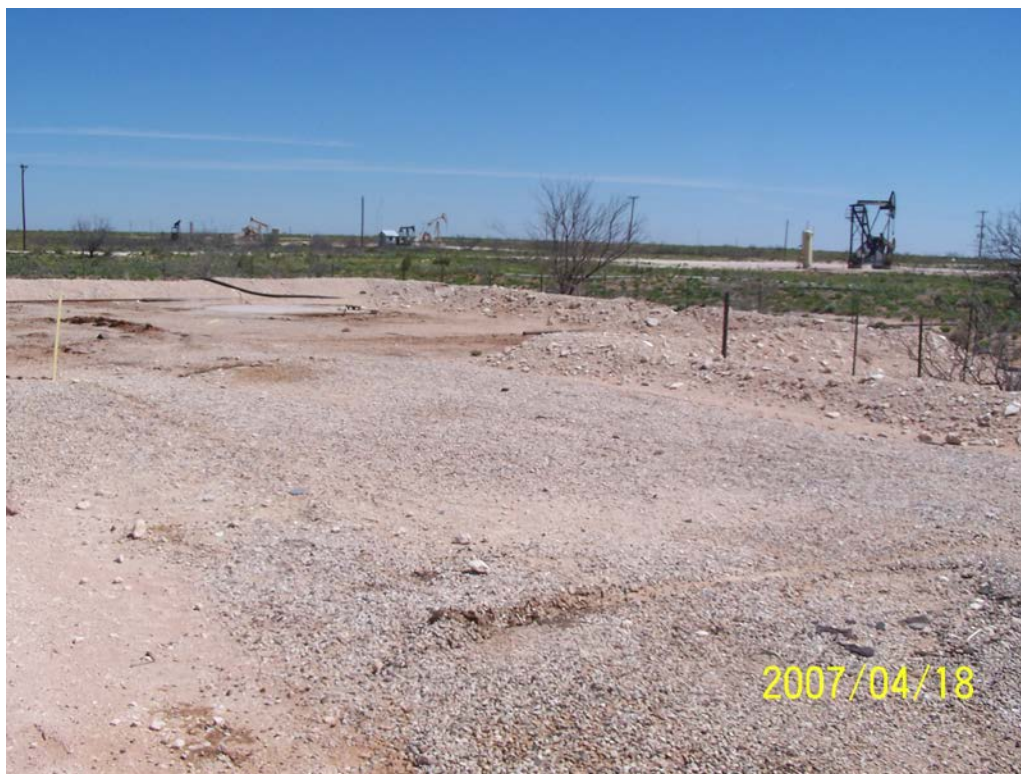
Photograph No. 2 – Looking northwesterly across interior of bermed area.

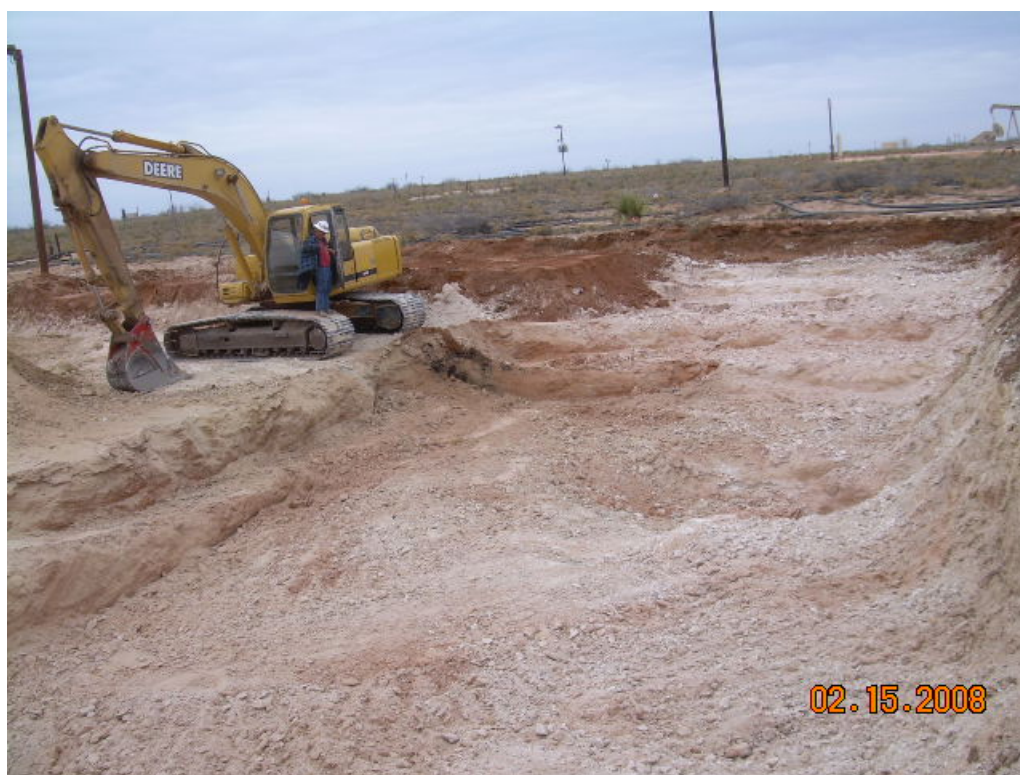
Photograph No. 3 – Looking across excavation area.

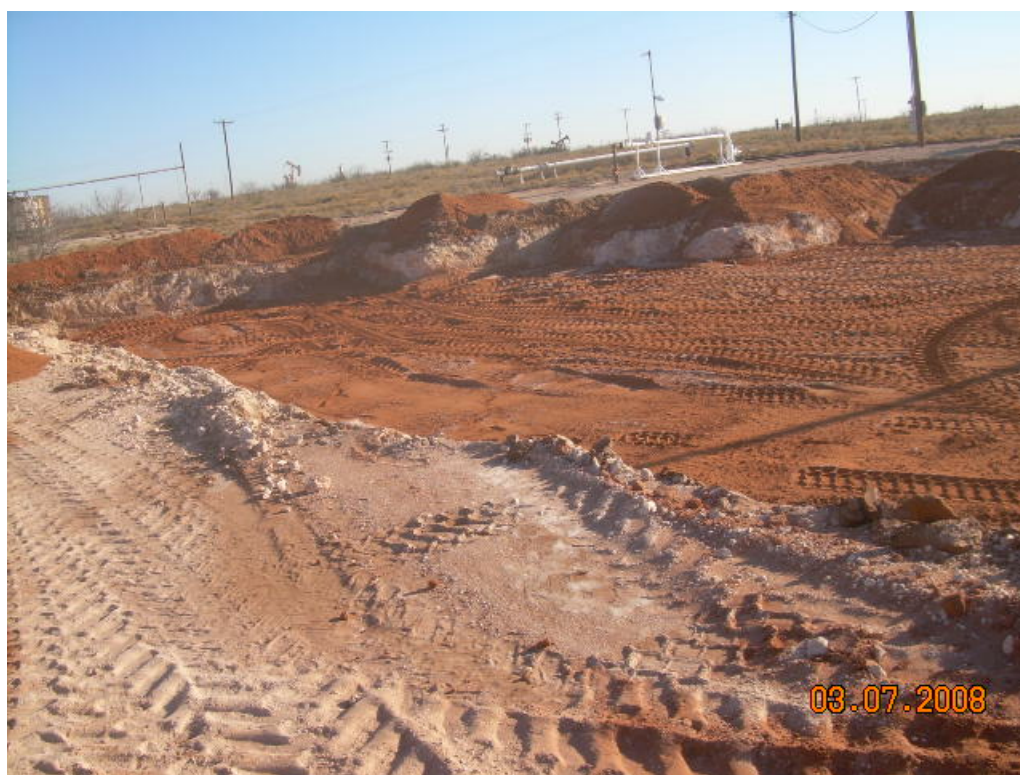
Photograph No. 4 – Looking northeasterly across excavation area.

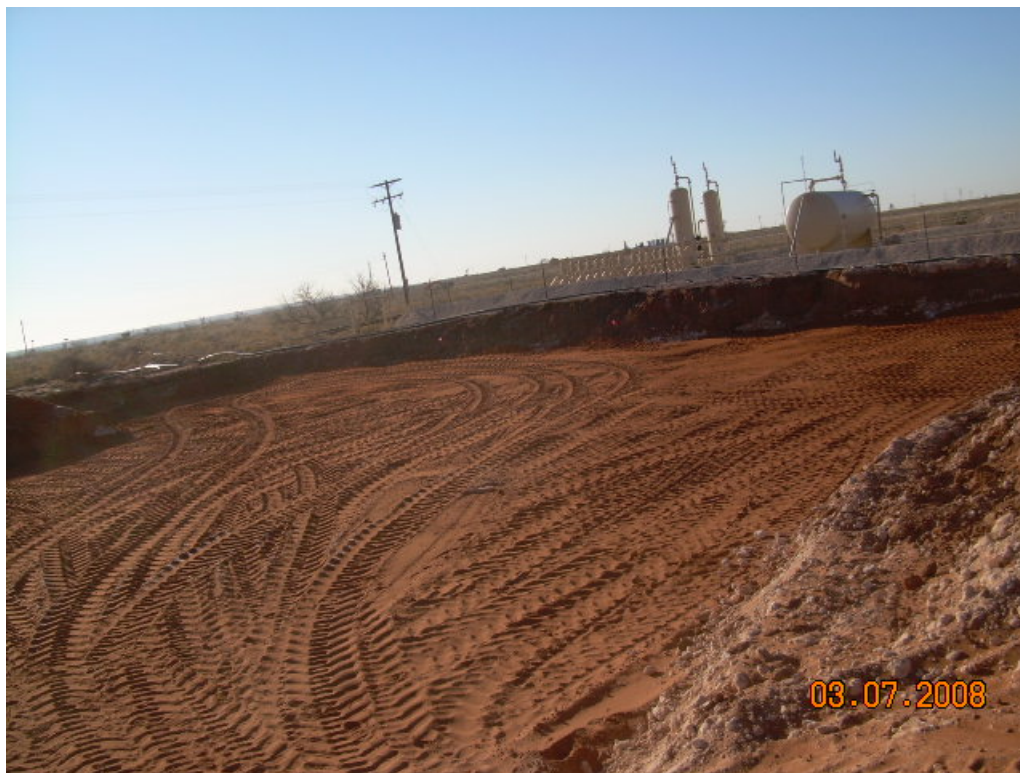
Photograph No. 5 – Looking southerly across excavation area.

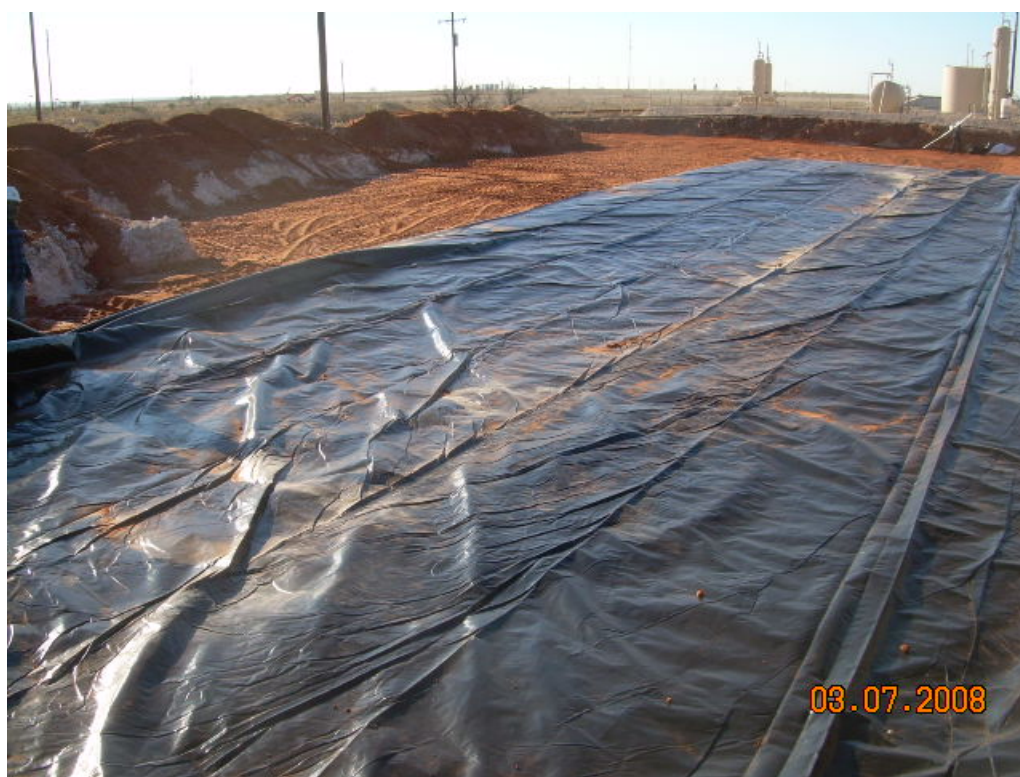
Photograph No. 6 – Looking southerly across installation of liner.

- B. **Remedial Activities** - From February 7, 2008 through March 5, 2008, approximately 5,190 yds³ of impacted material were excavated from a combined surface area of $\pm 10,400\text{-ft}^2$ at depths ranging from 1- to 17-feet bgs. Impacted soil was transported to Sundance Services, Inc. for disposal. Caliche from the production pad was excavated to $\pm 14\text{-ft}$ bgs in the northern sector, $\pm 17\text{-ft}$ bgs in the southern sector and $\pm 8\text{-ft}$ bgs in the center sector of excavation. Vertical excavation of impacted material finalized upon reported analytical results within NMOCD acceptable parameters. Lateral excavation activities continued until physical constraints impeded further delineation in the south, west and north sidewalls. The entire excavation bottom was backfilled with approximately 1,366 yds³ of clean caliche to within 5-ft of original ground surface. A 40-mil polyethylene liner was installed on bottom and vertically up the north, south and west sidewalls of the excavation as to deter lateral and vertical migration of contaminants. The polyethylene liner was sandwiched between one (1) foot layers of cushion material. Entire excavation was backfilled with approximately 3,564 yds³ of clean topsoil from top of cushion material to original ground elevation. The disturbed area was contoured to allow natural drainage and seeded with an approved Blue Grama grass blend.

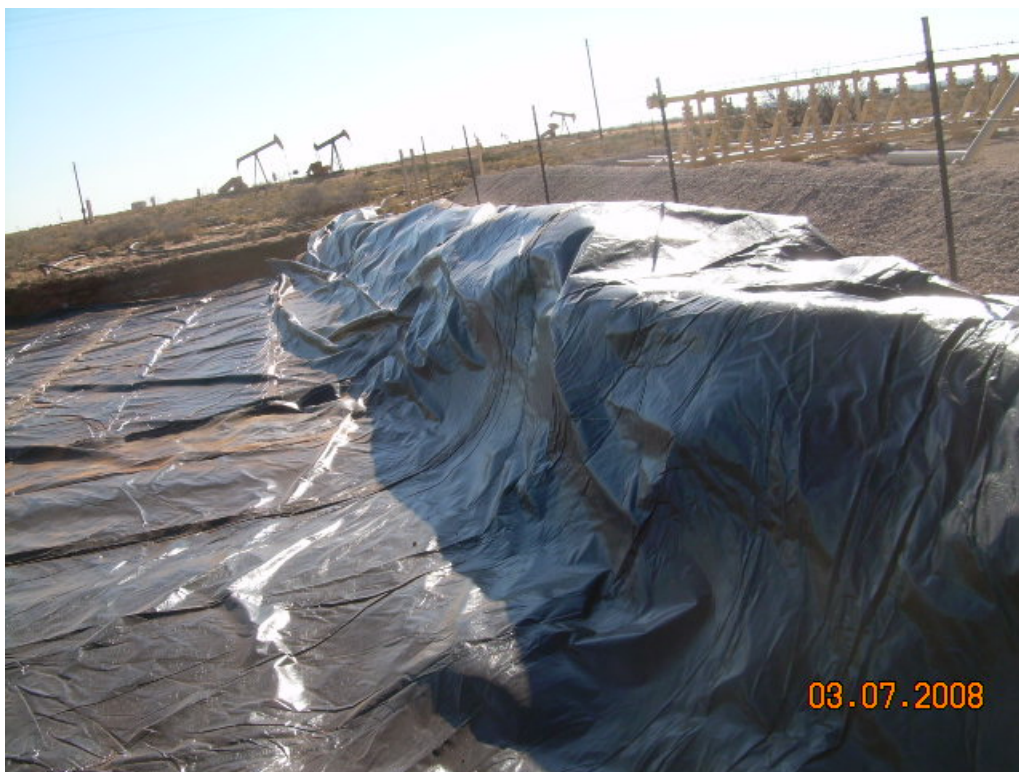
Photograph No. 7 – Looking across excavation area.

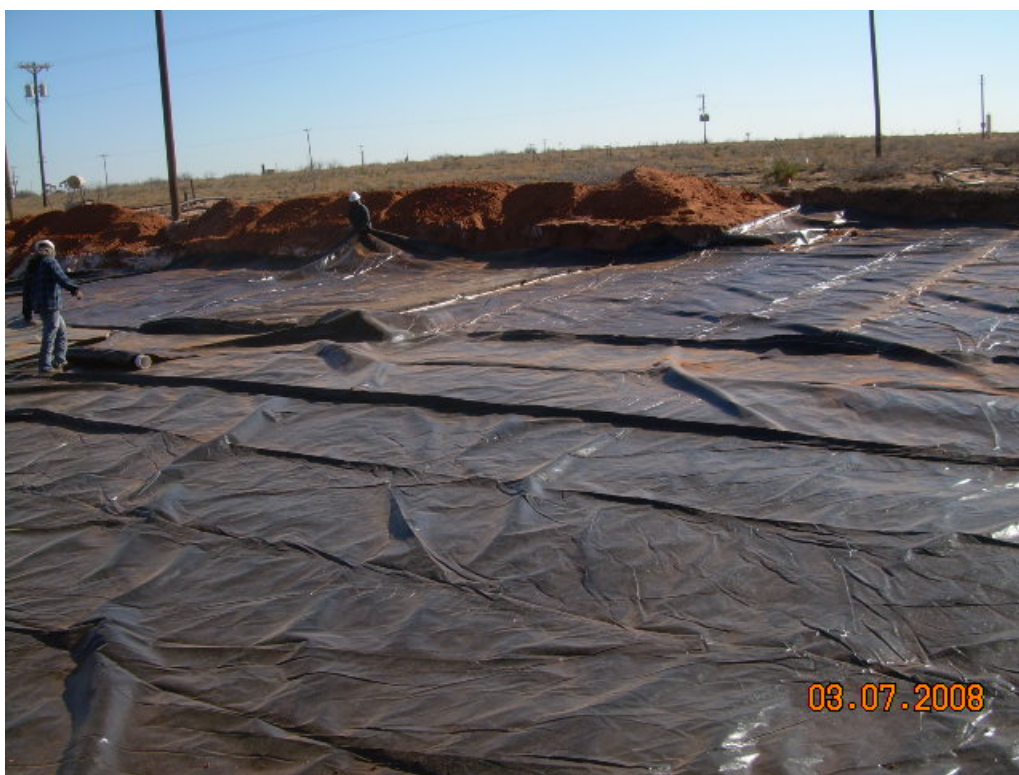
Photograph No. 8 – Looking across installation of liner.

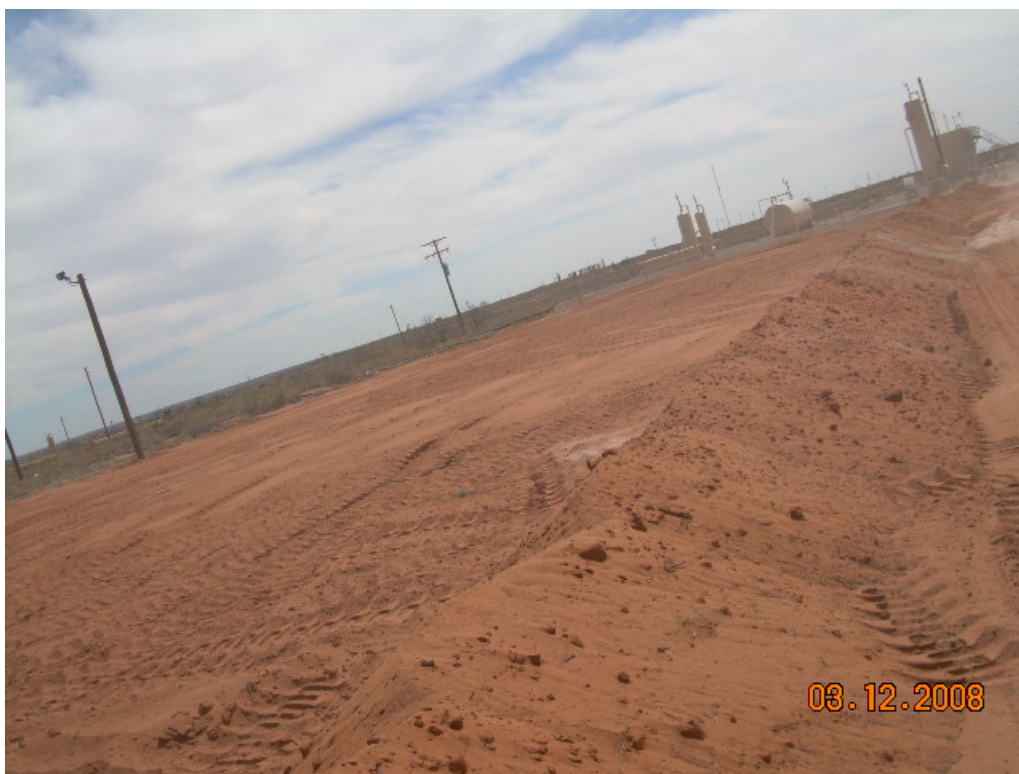
Photograph No. 9 – Remediated site.

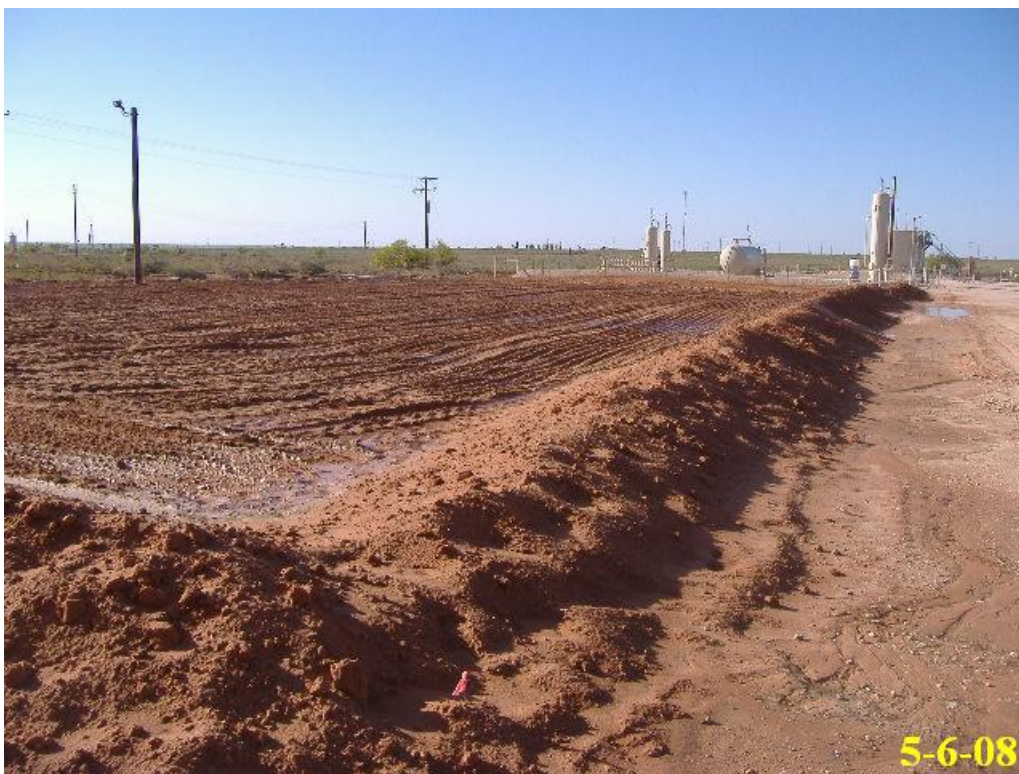
Photograph No. 10 – Remediated site.
