**SAM ADAMS 12 FEDERAL COM UBB #004H BATTERY
CLOSURE REPORT**

**API NO. 30-015-41618
U/L E, S12, T17S, R39E
EDDY COUNTY**

**RELEASE DATE: 6/18/2020
INCIDENT ID: NRM2017752399**

Subject: Closure Report for Spur Energy Partners – Sam Adams 12 Federal Com UBB #004H Battery

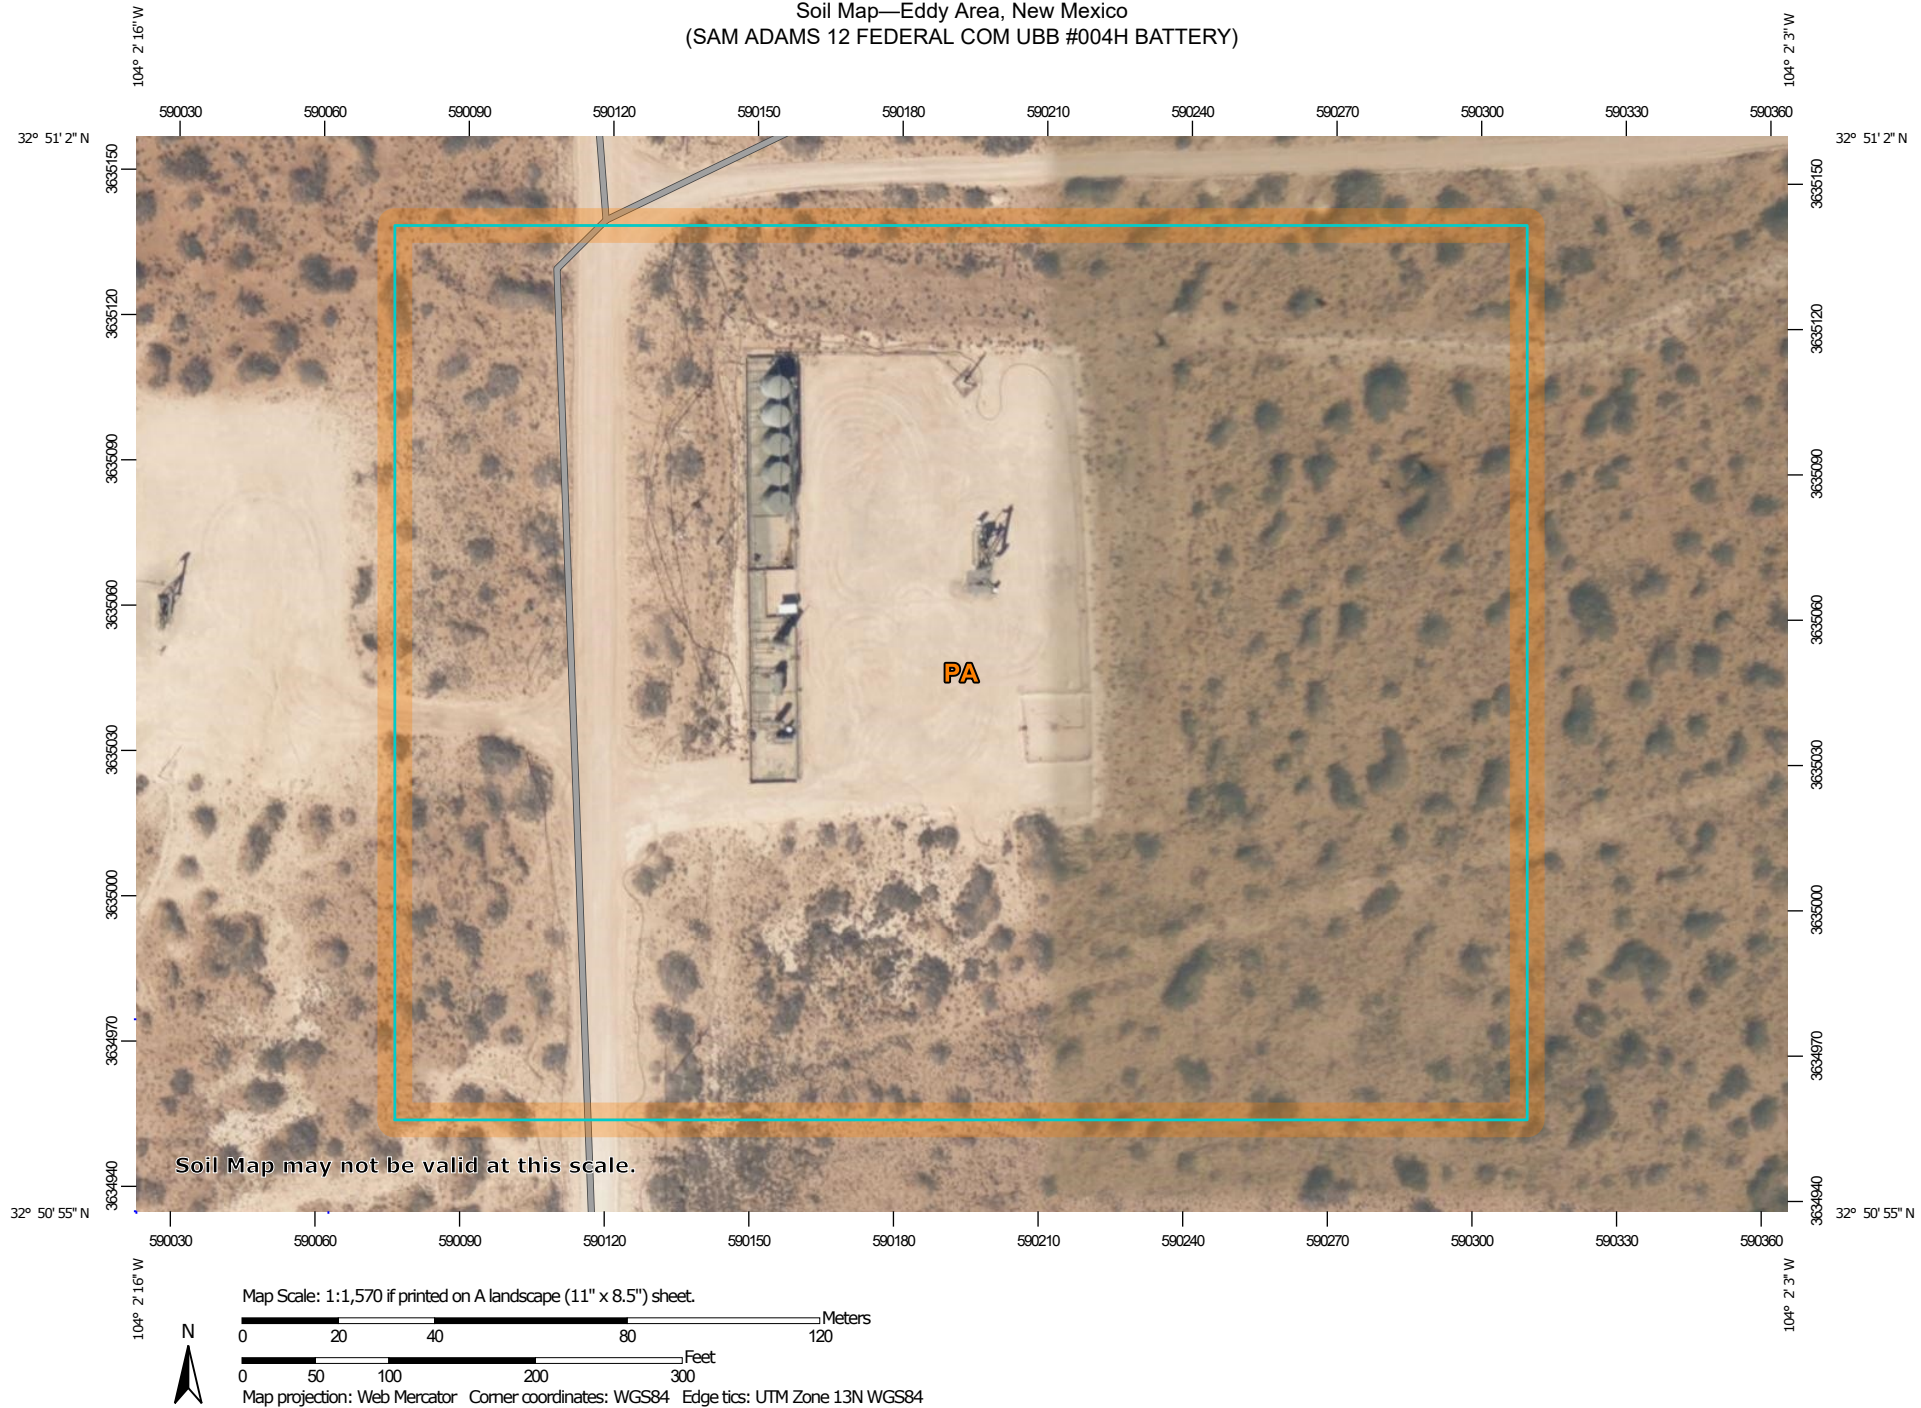
Soil Map—Eddy Area, New Mexico
(SAM ADAMS 12 FEDERAL COM UBB #004H BATTERY)

The United States Department of Agriculture Natural Resources Conservation Service indicates that the soil type found in the area consists of 100% Pajarito loamy fine sand. With a zero to three percent slope. Please find the Soil Map attached herein. This area receives an annual precipitation of 5 to 15". The surrounding landscape setting is that of dunes, interdunes and plains, with the typical profile of loamy fine sand and fine sandy loam.

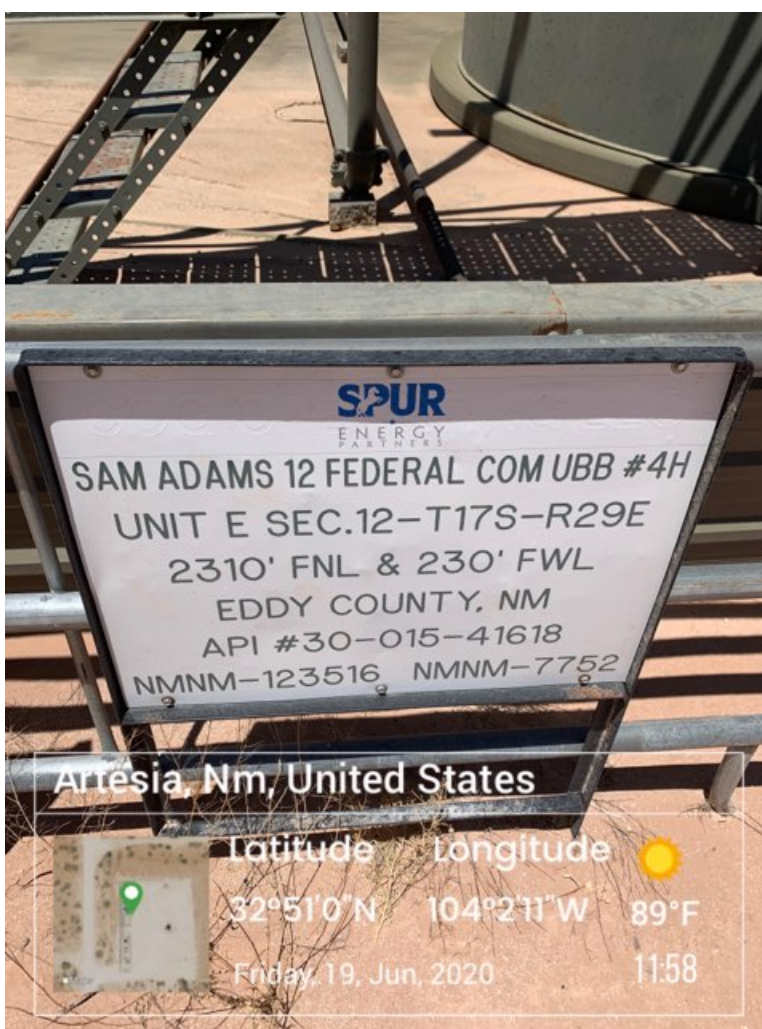
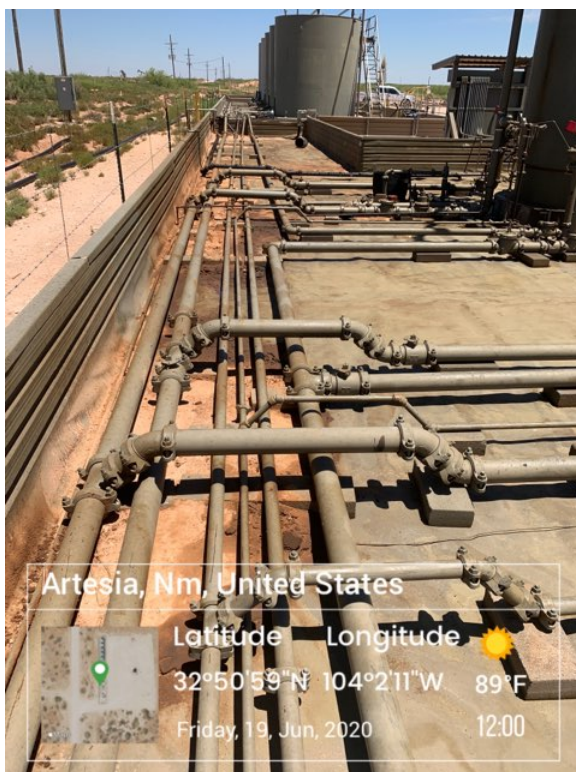
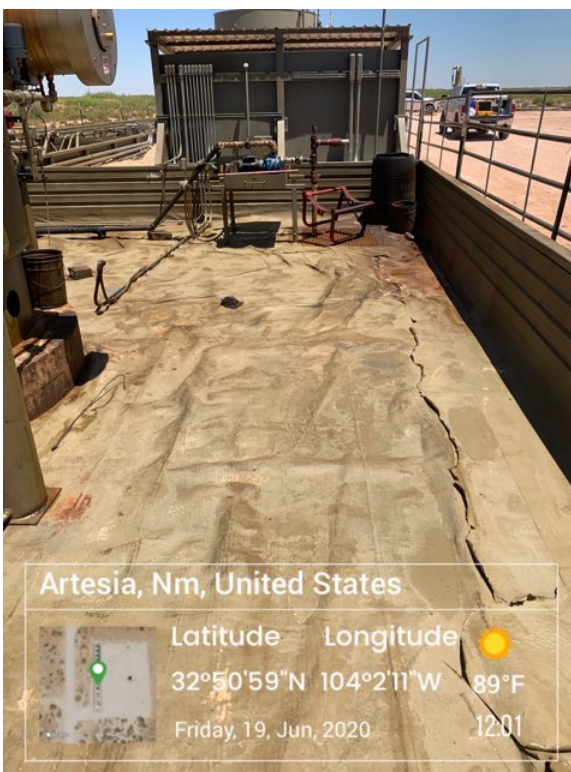
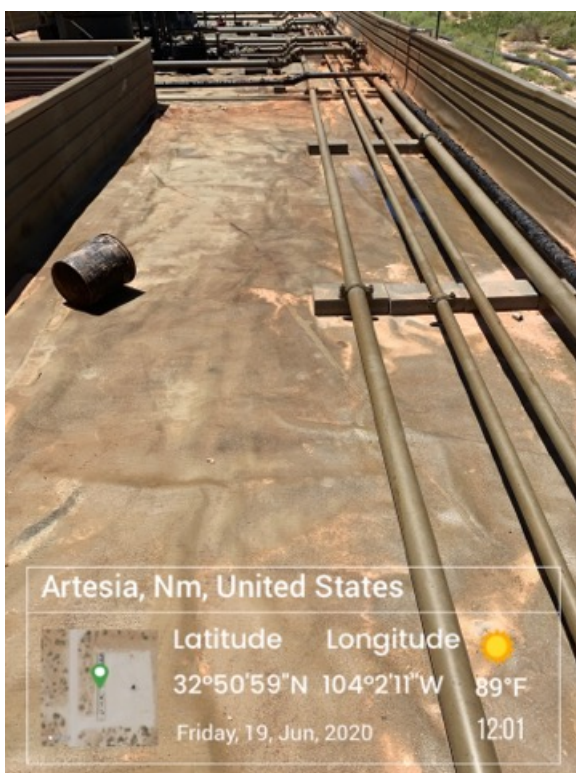
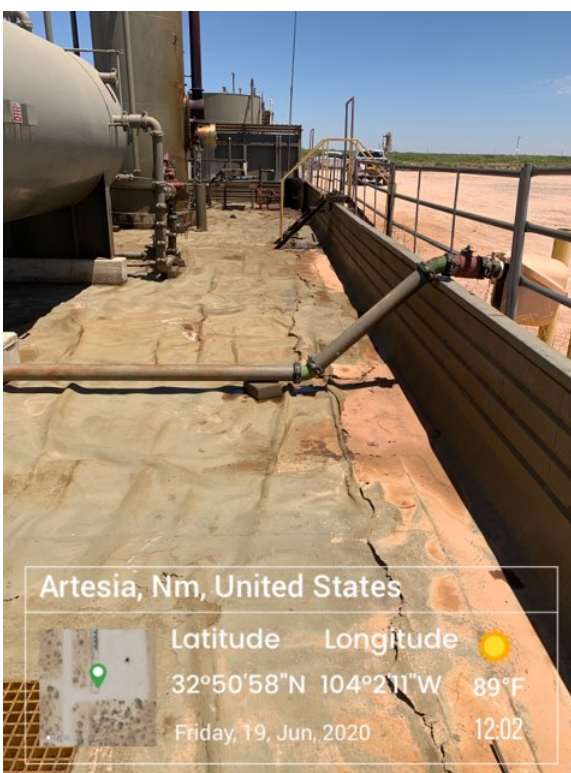
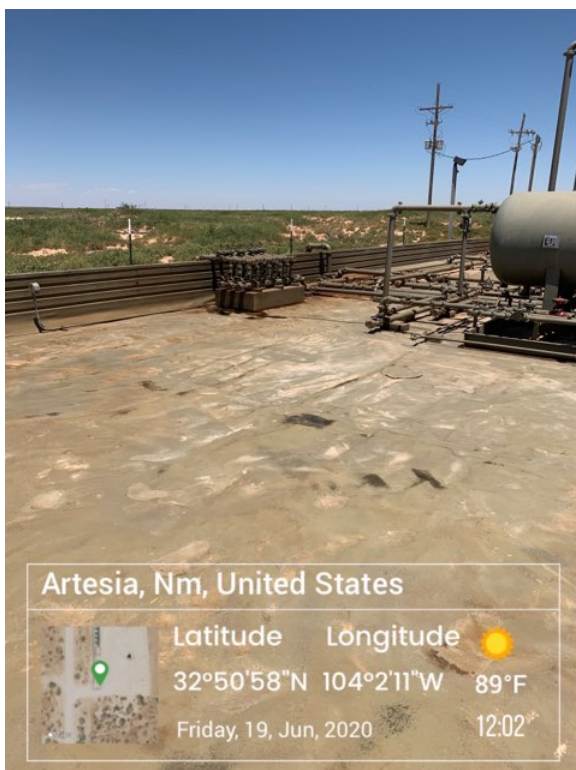
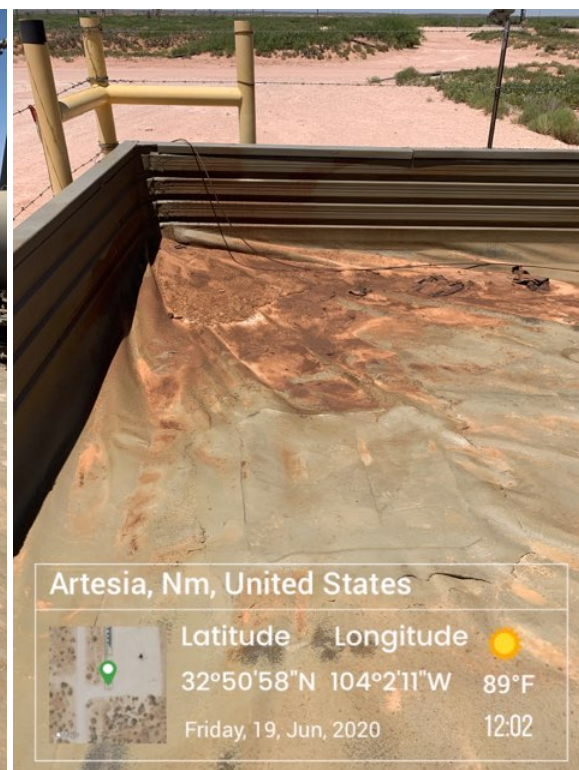
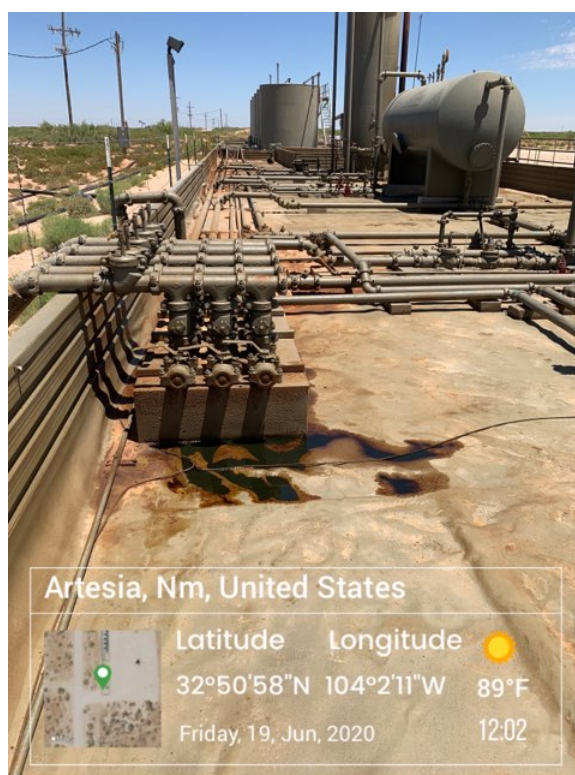
**SAM ADAMS 12 FEDERAL COM UBB #004H BATTERY
INITIAL PHOTOS**

On June 18th, 2020, a release occurred at Spur's Sam Adams site when a site glass broke on the production heater. The incident resulted in a release of 23bbls of produced water into the lined containment. A vacuum truck was dispatched to the location to recover any standing fluid; approximately 22.5bbls of produced water was recovered. The spill was contained within the boundaries of the lined containment. No produced water was released into undisturbed areas or waterways.

On June 19th, 2020, Spur Energy Partners contracted ESS to complete a full site assessment of the release that occurred on the Sam Adams and ESS responded on the same day. Initial site photos were obtained (and area attached). All of the fluid had been removed from the lined containment and no visible signs of liner breaching had occurred.

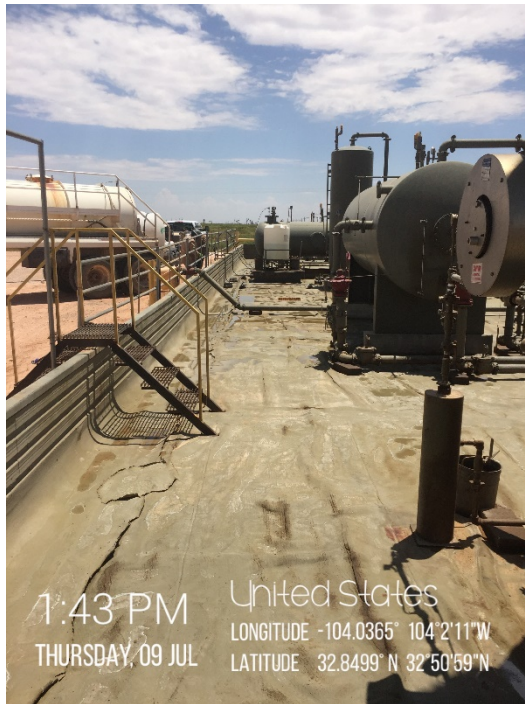
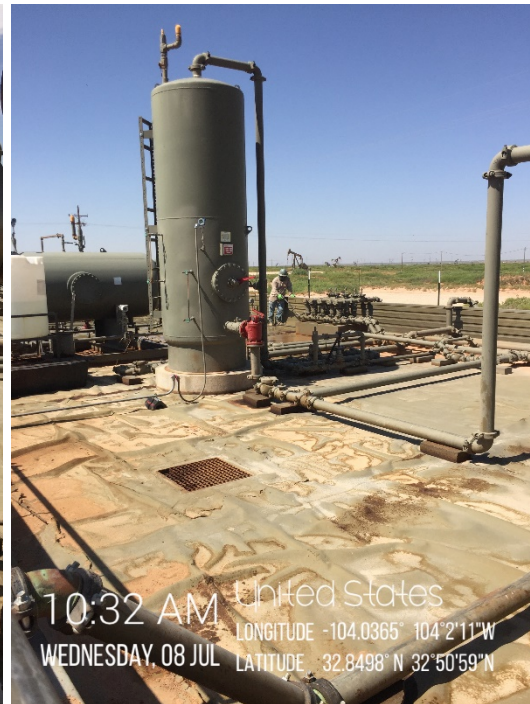
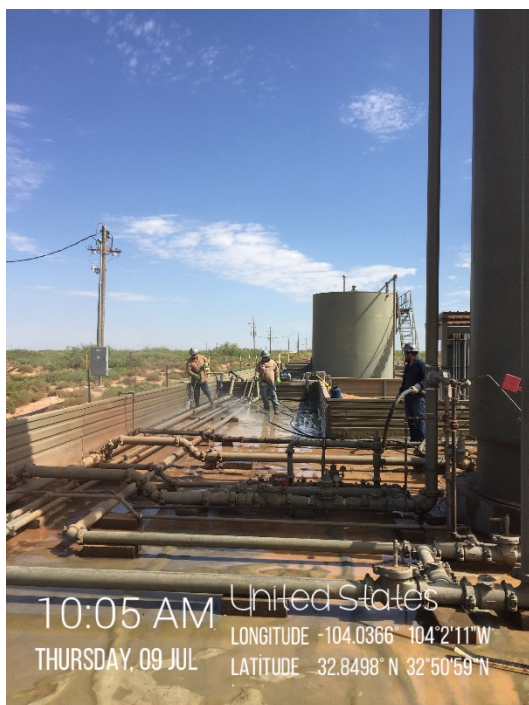
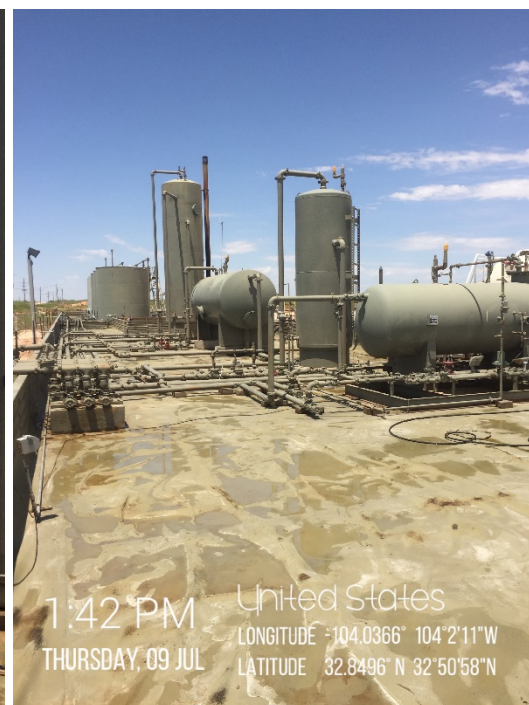
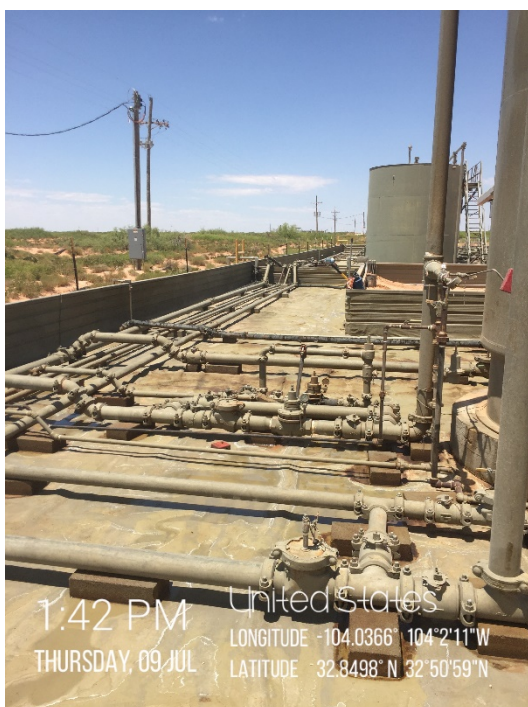
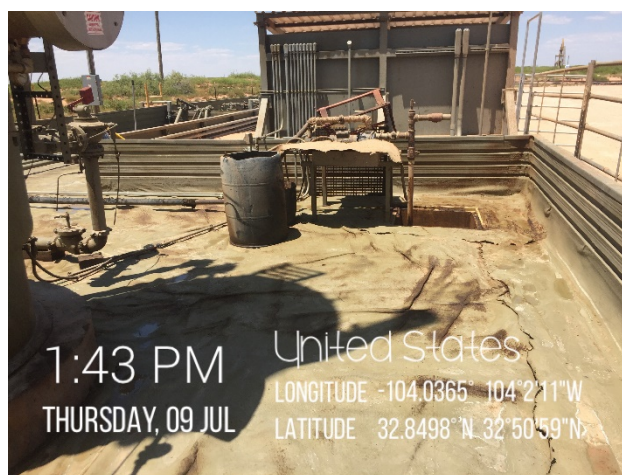
**SAM ADAMS 12 FEDERAL COM UBB #004H BATTERY
POWER WASHING PHOTOS**

On July 8th, ESS conducted a power-wash protocol of the lined containment. Due to heavy rain in the area, we were unable to wash the liner to complete the initial liner inspection. On September 9th, of 2020 an email was sent to the NMOCD to request witnessing of the liner inspection, sampling under the liner and patching the compromised liner. Please see email to the NMOCD which is attached herein, as well as the photos of the liner patching and sampling event.

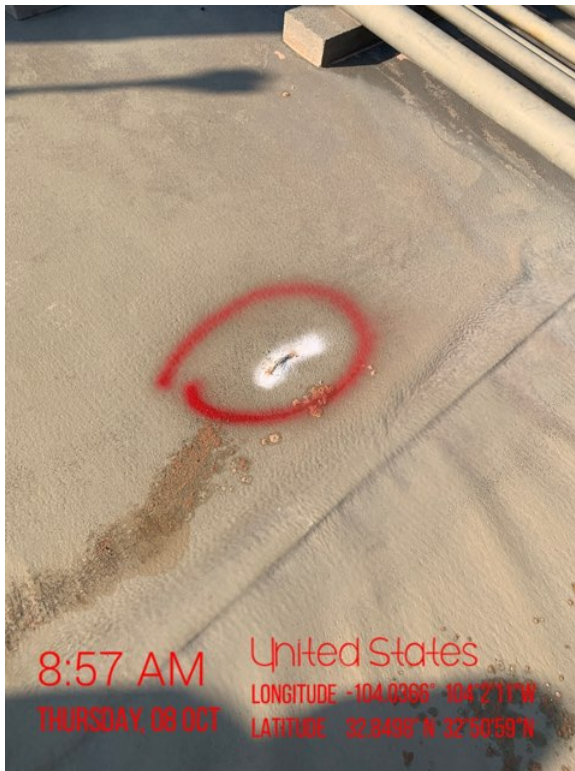
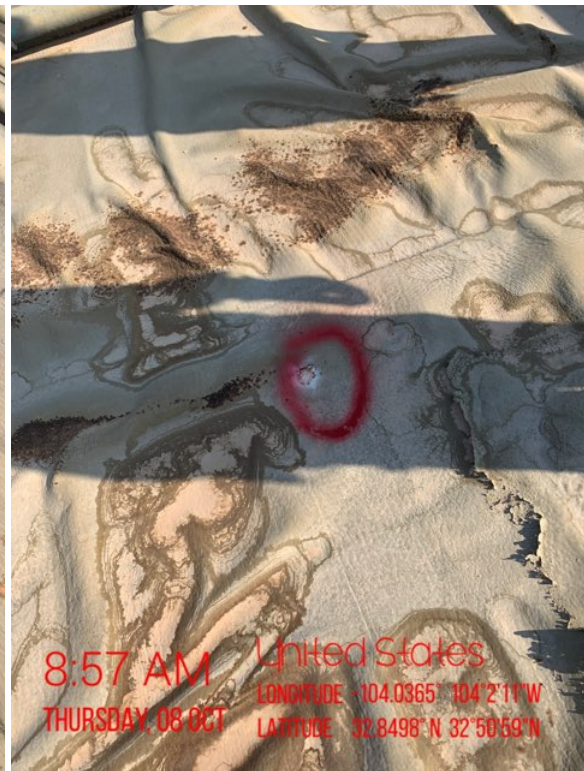
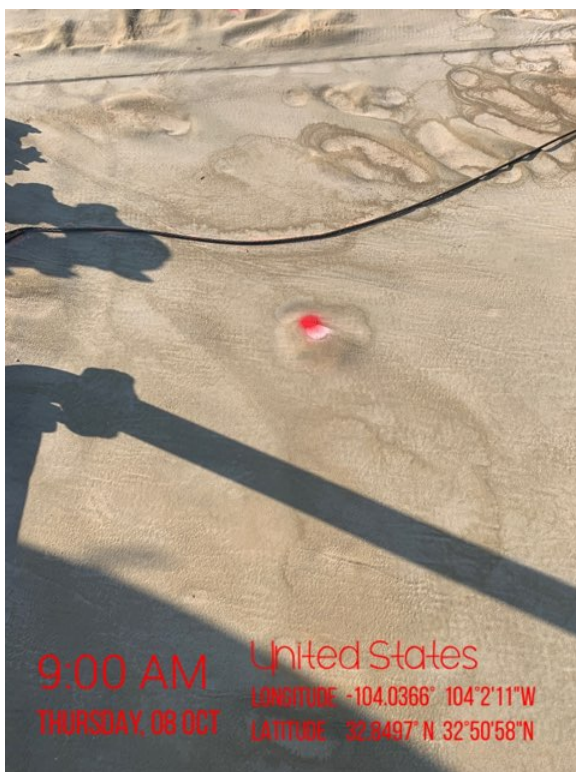
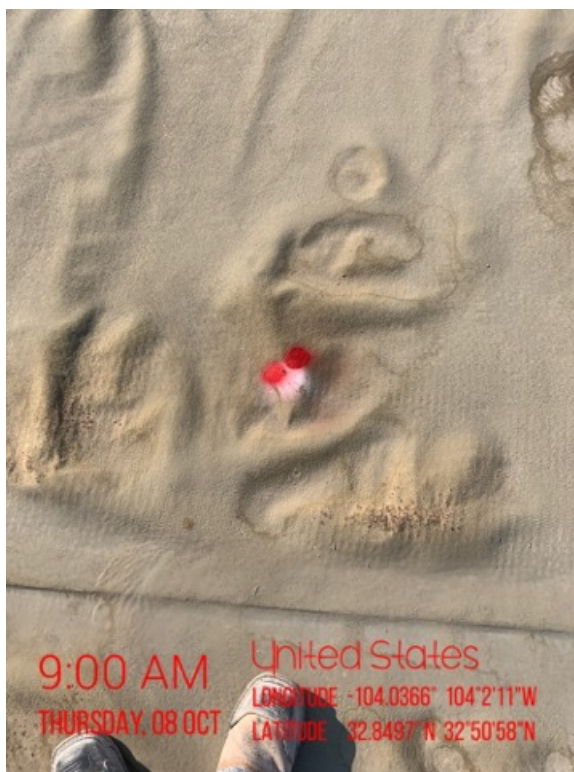
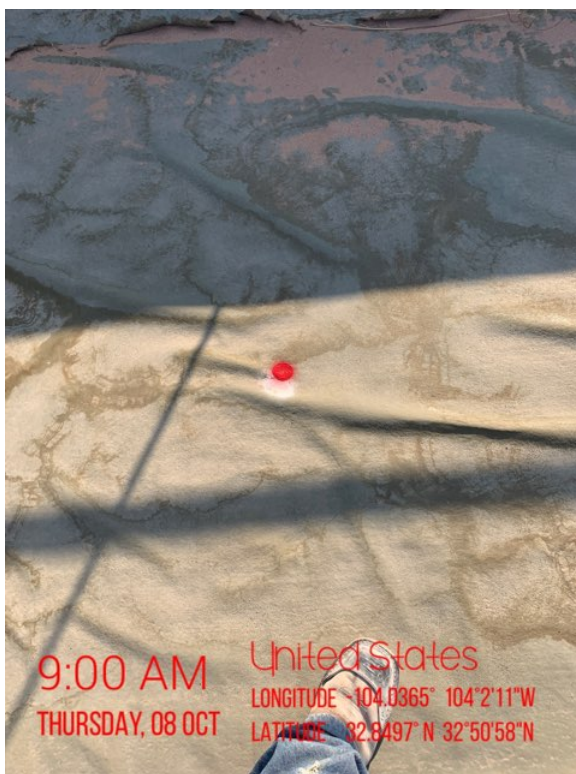
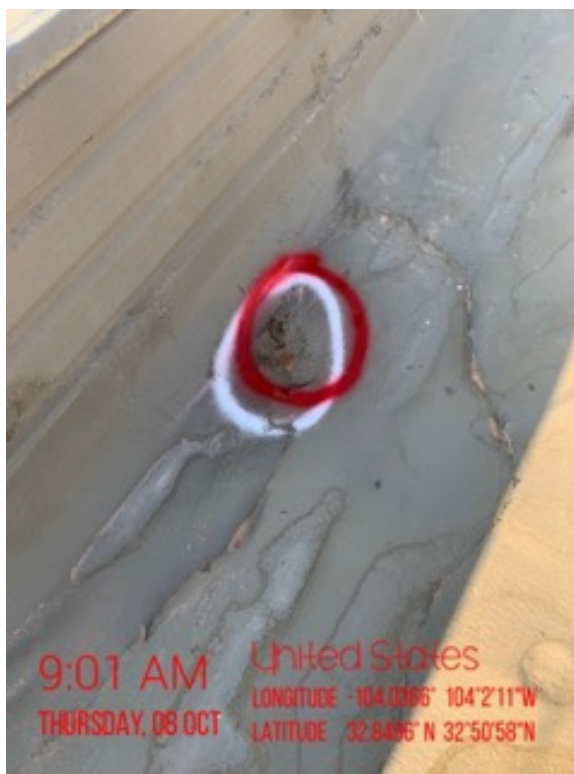
**SAM ADAMS 12 FEDERAL COM UBB #004H BATTERY
LINER PATCHING PHOTOS**

Due to conflicting scheduling events, the liner sampling and patching event did not occur until October 8th, 2020. Liner crews arrived at the site and prepped the areas where small punctures were found. A 1'x1' area was cut in three areas and delineation of the site began. The samples were gathered by use of hand auger and was sampled using 1' intervals. ESS collected a total of three vertical sample points and field tested for chlorides utilizing the titration method. Samples were placed into a laboratory-provided container, preserved on ice and submitted to Envirotech Laboratories for confirmation.

The holes in the liner that was used to sample the soil under the liner was primed, patched and sprayed with polyurethane. Any and all of the small punctures, gashes, splits or worn areas were also patched using the same method. Please see photo page attached.
