March 16, 2021

RE: Closure Request
Limestone Compressor Station Overspray
Incident Number: nRM2032830684
Lea County, New Mexico

Lucid Energy Group (Lucid) presents the following Closure Request detailing site assessment and soil sampling activities at the Limestone compressor station (Site) in Unit B, Section 35, Township 24 South, Range 34 East, in Lea County, New Mexico under surface ownership of the New Mexico State Lands (NMSLO) (Figure 1). The purpose of the site assessment and soil sampling activities was to confirm the presence or absence of impacts to soil associated with a release of natural gas and condensate at the Site and subsequent biological treatment of impacted soil. Based on field observations, field screening, and laboratory analytical results from soil sampling activities, Lucid is submitting this Closure Request. Lucid requests no further action for this site. Listed below is a brief summation of the Site details in Table 1.

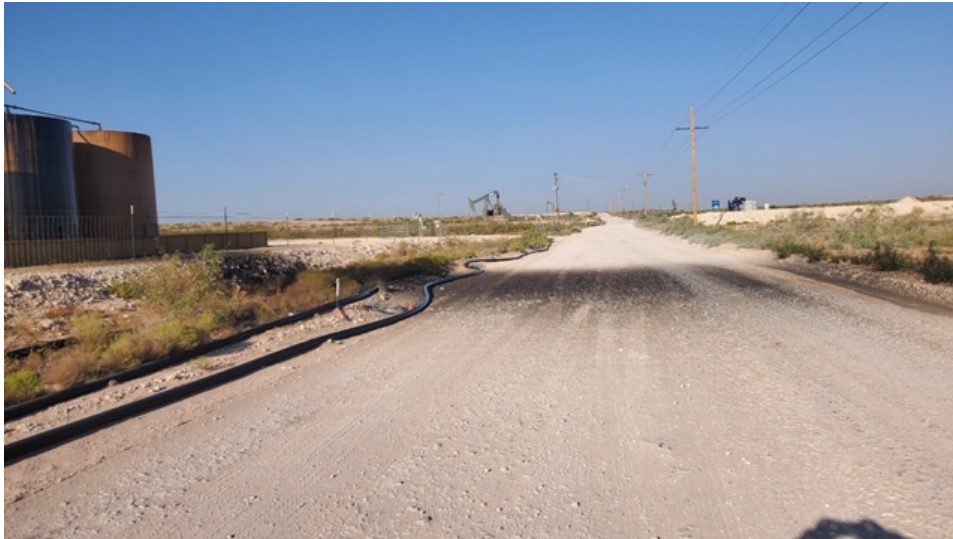
Initial Overspray Looking West (9/26/20)

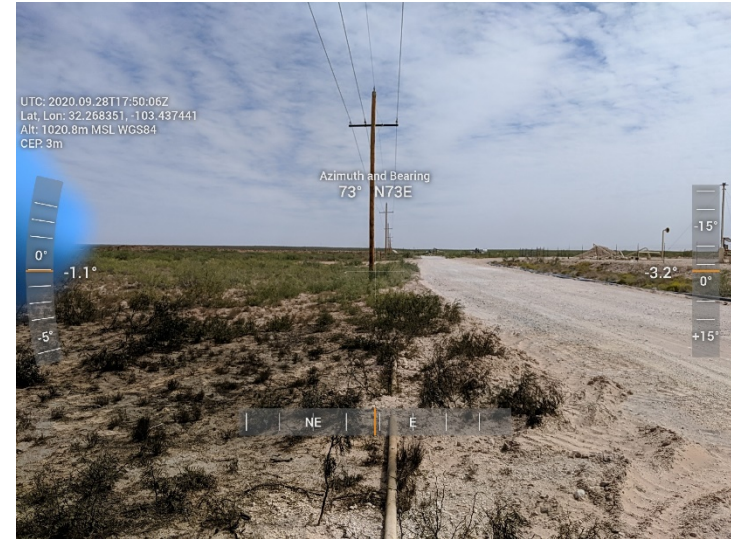
Overspray Area North of Road Looking East (9/28/20)

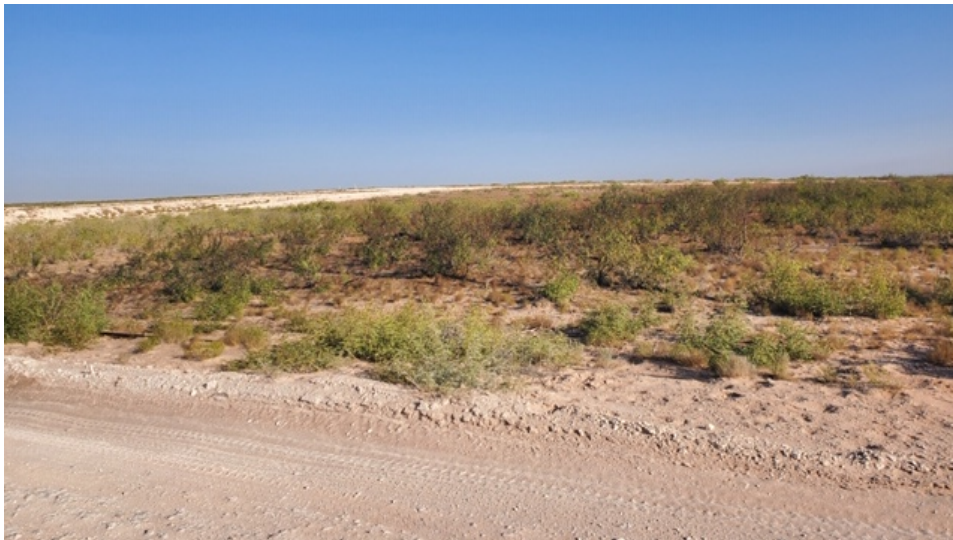
Initial Overspray Looking Northwest (9/26/20)

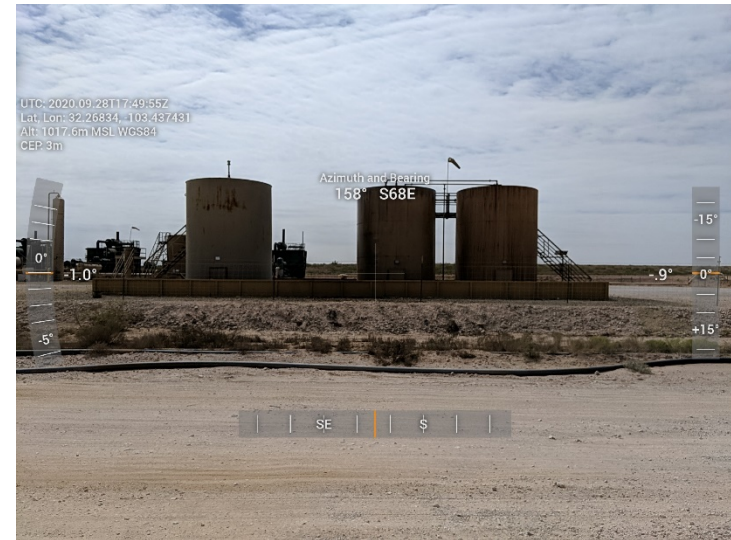
Tank Battery North of Road Looking South (9/28/20)

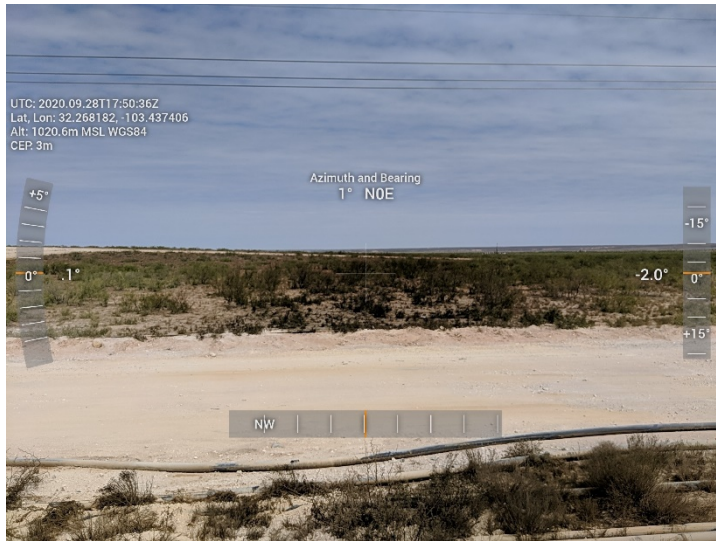
Overspray Area South of Road Looking North (9/28/20)

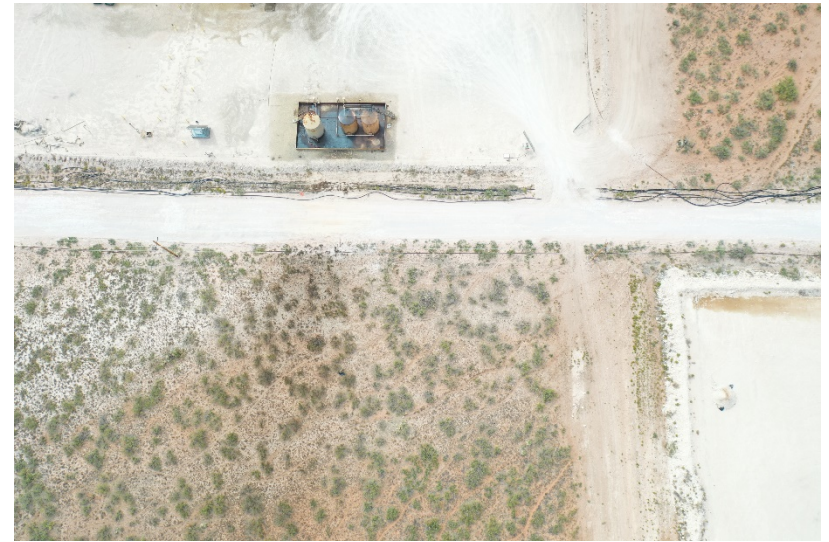
Site Aerial (9/28/20)

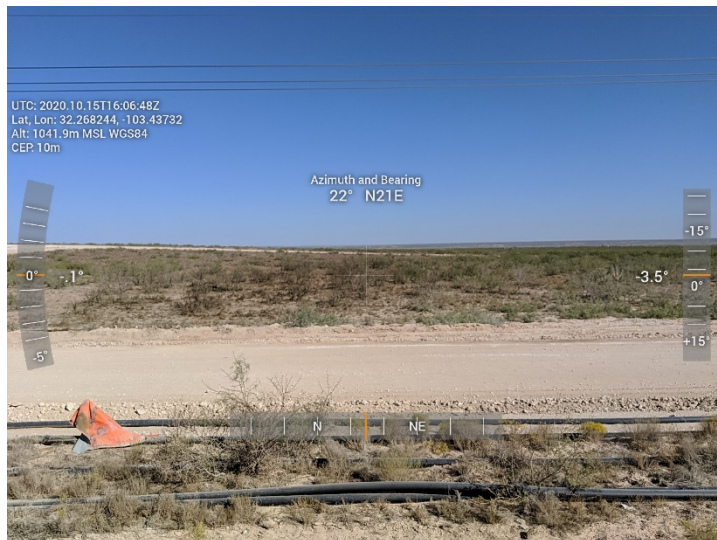
Overspray Area South of Road Looking North (10/15/20)

On September 30 and again on October 14, A2Z was onsite to apply two more in situ Micro-Blaze® bioremedial treatments to the overspray surface area and with additional attention to the vegetation. Samples were again field screened for hydrocarbon VOCs and chlorides with no impacts detected. After receipt of the analytical results from initial delineation sampling one sample, HA-1-S at 3-6 inches bgs, returned with TPH detected at 156 ppm mostly in the MRO and DRO hydrocarbon range. On October 21, a five-point composite sample HA-6-C-S, was collected relative to HA-1-S. Field screening of the sample indicated no remaining hydrocarbon nor chloride impacts. Sample HA-6-C-S was sent to Hall for further analysis.

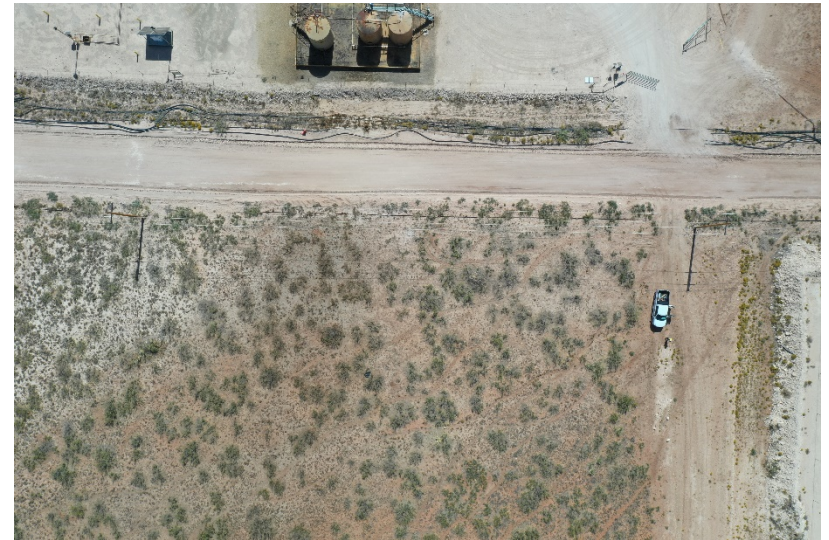
Site Aerial (10/12/20)
