RE: 1RP-4173 DC Hardy Battery

1RP-4173
DELINEATION AND DEFERRAL REPORT
DC Hardy Battery
Crude Oil Release
Lea County, New Mexico

LAI Project No. 19-0112-05

August 30, 2019

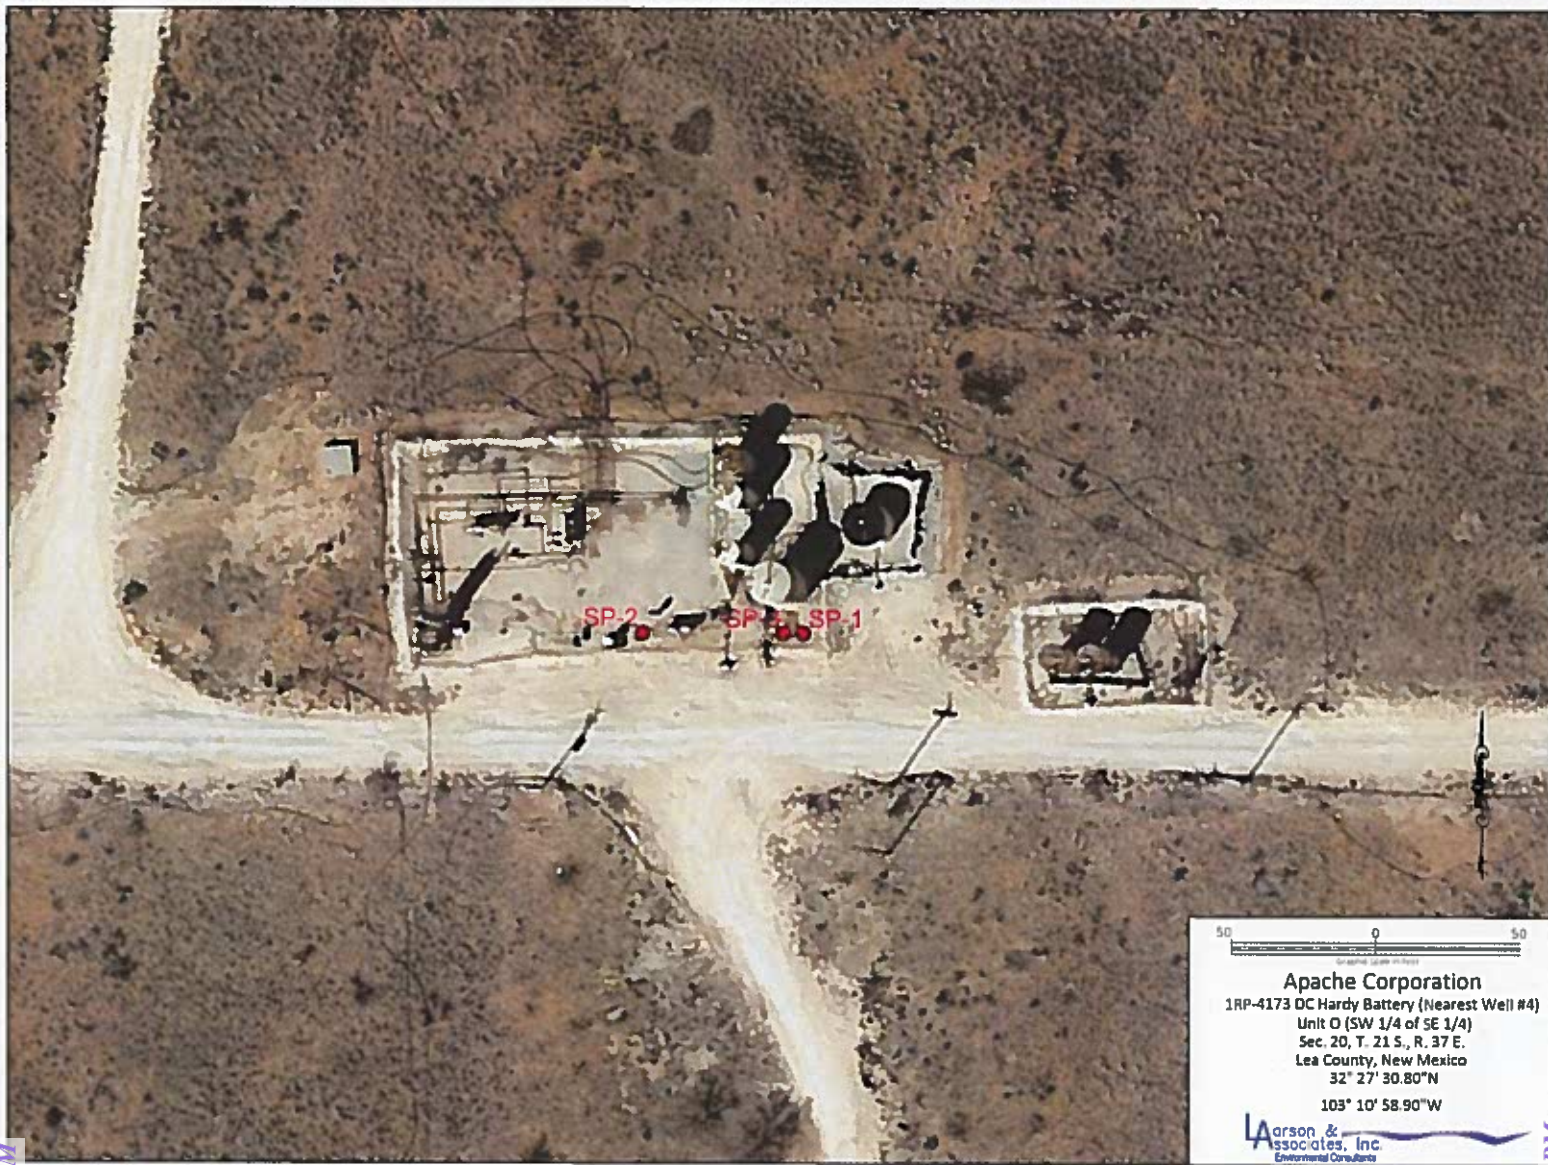
Figure 2 - Aerial Map

Figure 2 presents the soil sampling locations. Appendix C presents the laboratory report. Appendix D presents the site photographs.
