South Seven Rivers Queen Unit #426

Closure Request

1RP-2331

RE: Closure Request
Apache Corporation
South Seven Rivers Queen Unit #426
U/L A, Section 26, Township 22S, Range 36E
API No. 30-025-34651

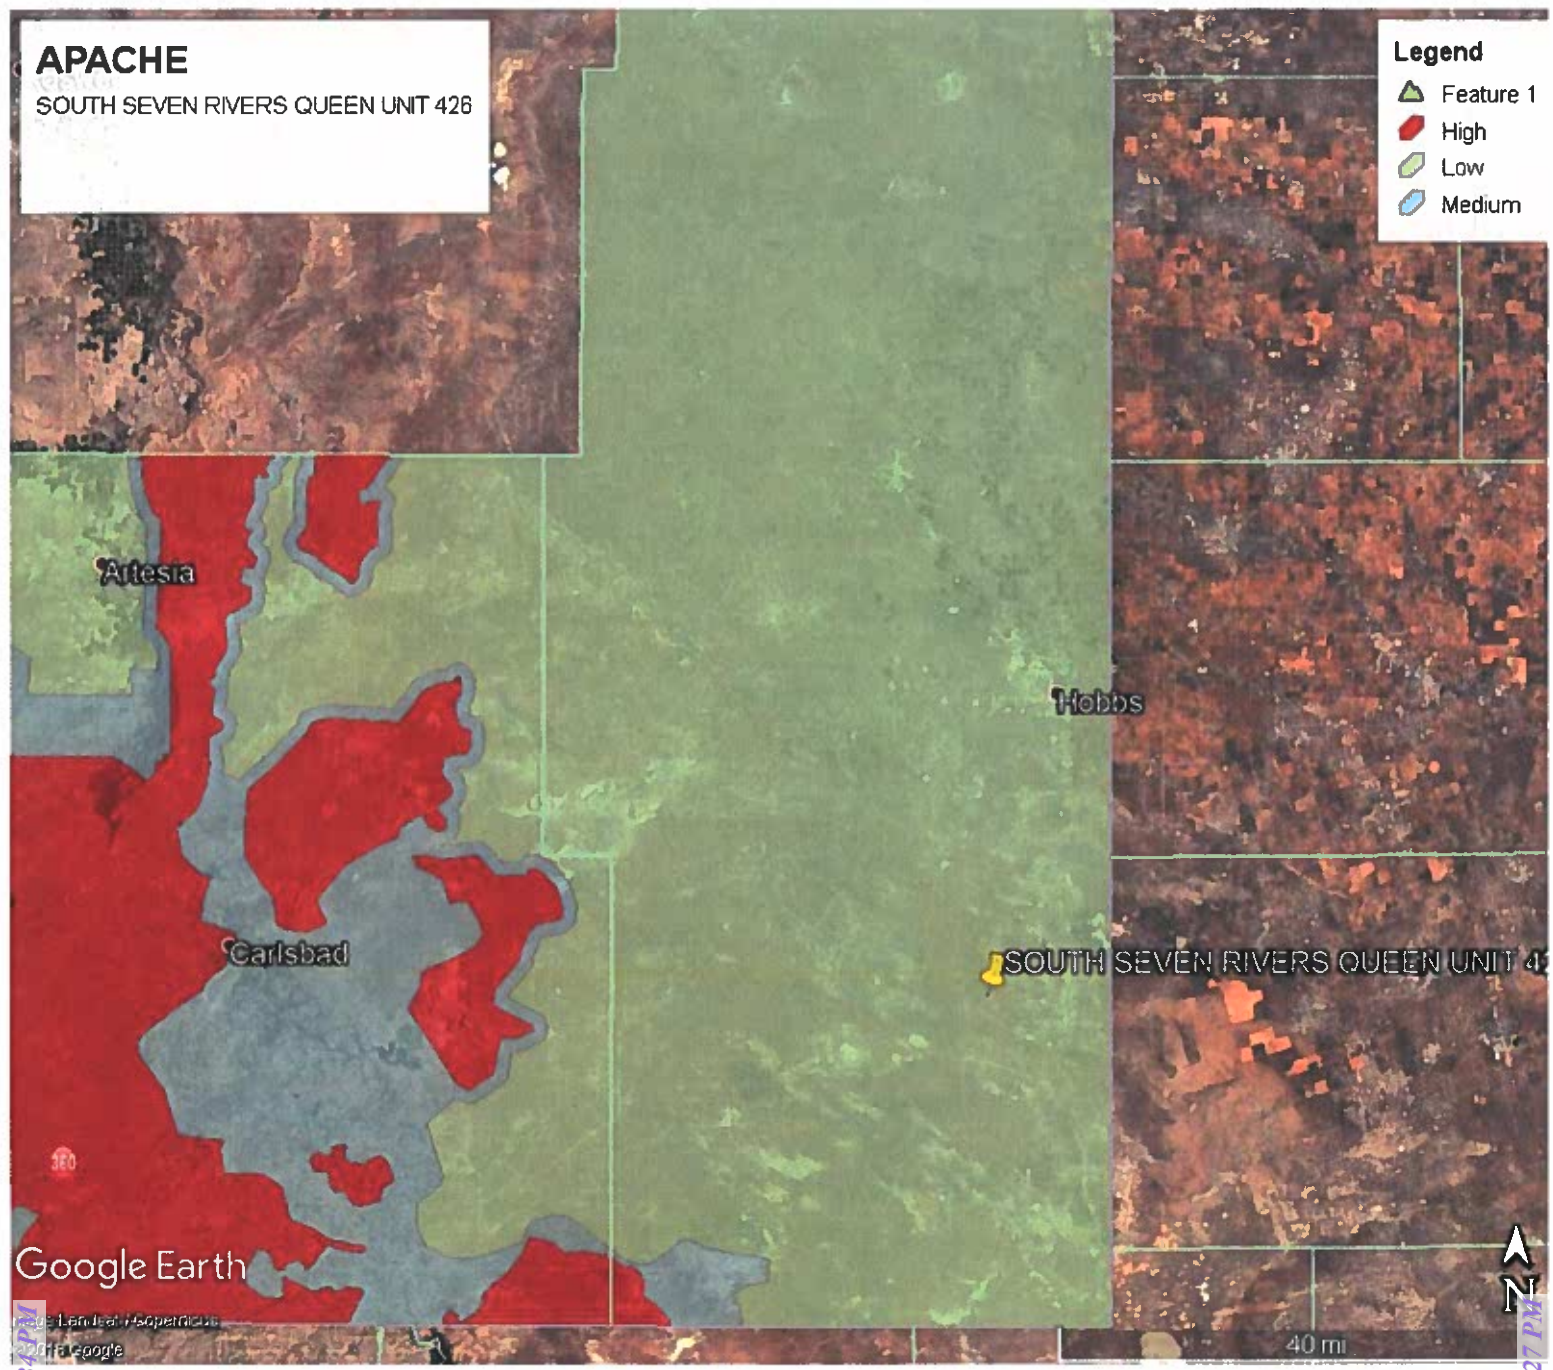
10/23/09

The saturated soil was excavated and all of the contaminated soil was hauled to Sundance Services in Eunice, New Mexico. Backfill was brought in from Strain Ranch to backfill the site. Apache personnel remediated the site in 2010 and based on site inspection the impacted area was remediated fully to closure. The site has adequate vegetation. See the attached map.
