Release Notification and Corrective Action

Name of Company BOPCO, L.P. 260731 Contact Tony Savoie
Address 522 W. Mermod, Suite 704 Carlsbad, N.M. 88220 Telephone No. 432-556-8730
Facility Name: Golden 8 Federal Battery #1 Facility Type E&P

Site Name Golden 8 Federal Battery #1	Site Type Exploration and Production
Date Release Discovered 06/14/2010	API# (if applicable) 30-015-26931

Advancing Opportunity
March 3, 2018	Photographic Log

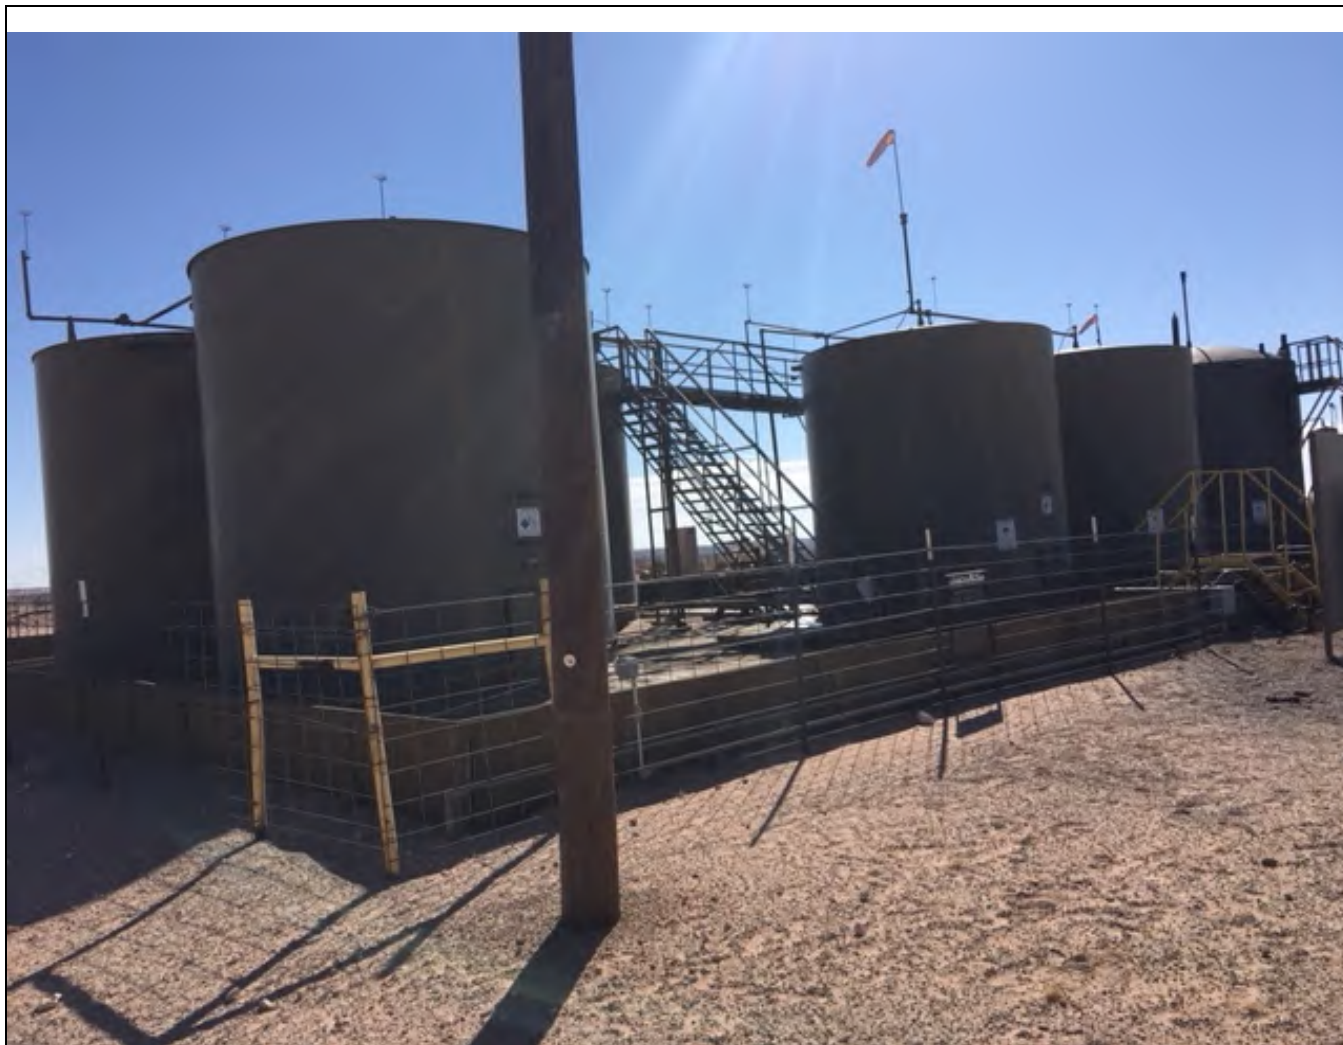
Western view of lined tank battery containment.
