LT Environmental, Inc.

January 3, 2020

**RE: Closure Request
PLU Ross Ranch 33-25-30 Battery
Remediation Permit Number 2RP-4508
Eddy County, New Mexico**

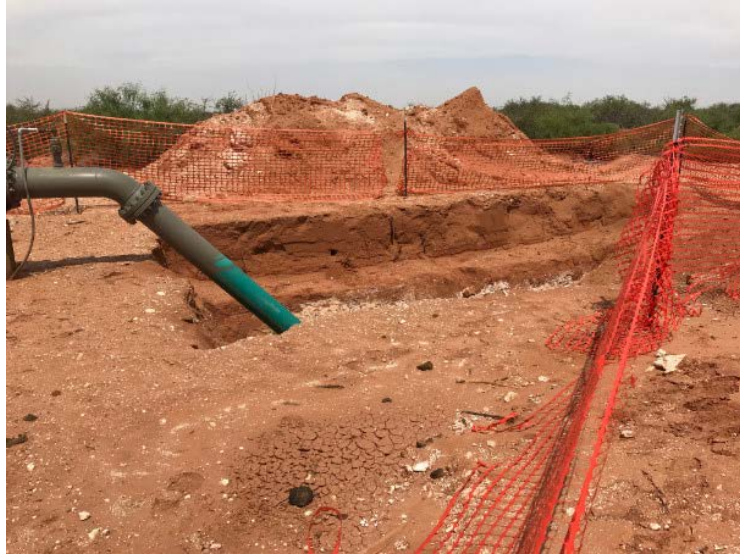
Photograph 1: West facing view of the open excavation.

The excavation measured approximately 800 square feet in area and was completed to a depth of 6 feet bgs. A total of approximately 200 cubic yards of impacted soil were removed from the excavation. The impacted soil was transported and properly disposed of at the R360 Landfill located in Hobbs, New Mexico.

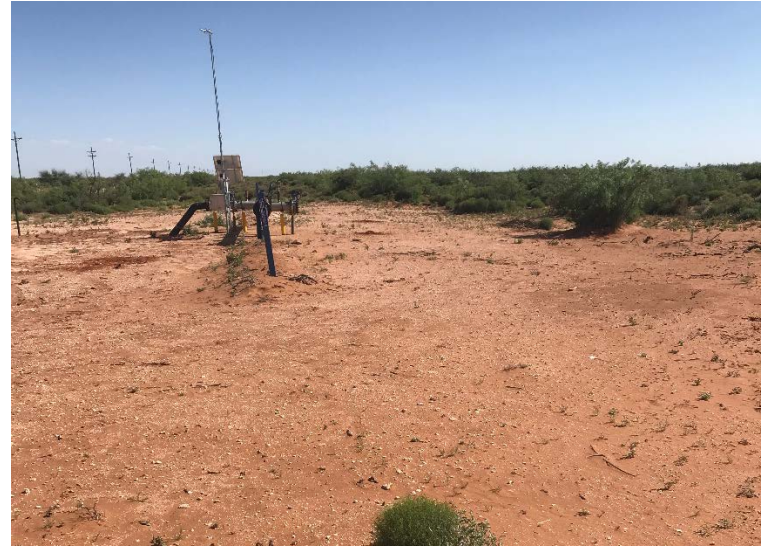
Photograph 2: View of backfilled excavation area.

Initial response efforts, natural attenuation, and excavation of impacted soil have mitigated impacts at this Site. XTO requests no further action for RP Number 2RP-4508. XTO backfilled the excavation with material purchased locally and recontoured the Site to match pre-existing site conditions. An updated NMOCD Form C-141 is included in Attachment 1.

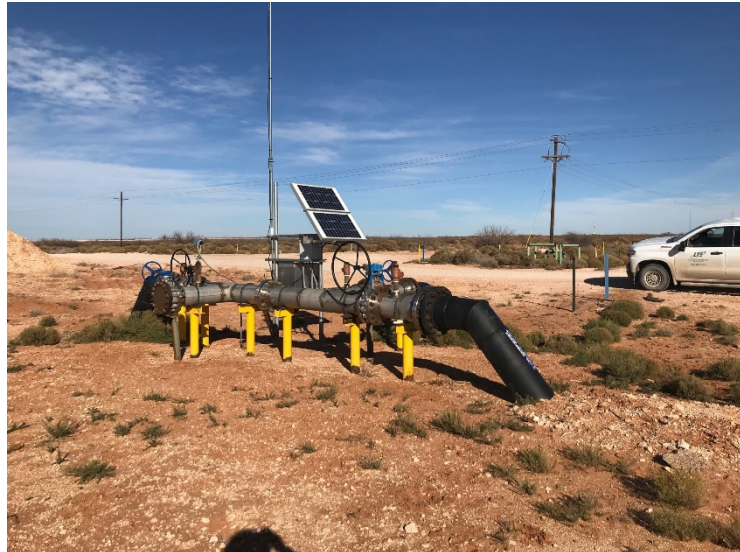
Photograph 3: Northeast facing view of former excavation area and road.

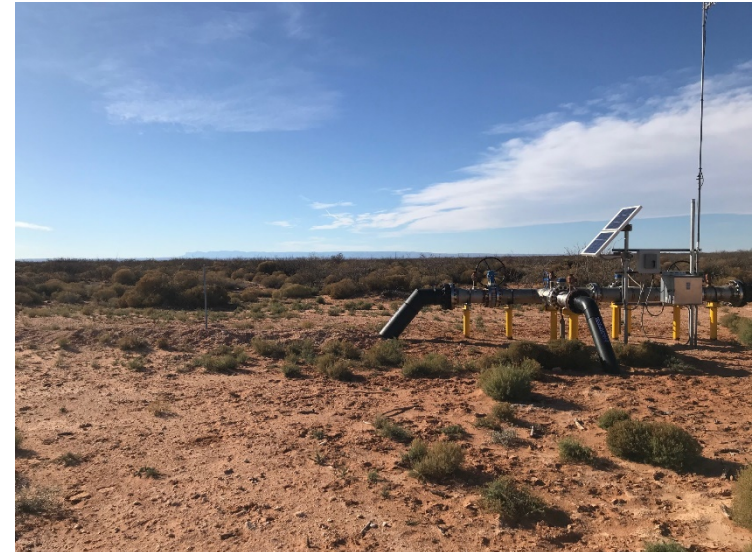
Photograph 4: West facing view of former excavation area and pasture.
