Release Notification

Site Name PLU 28 BS 907H	Site Type Well Pad
Date Release Discovered 9/23/2020	API# (if applicable)

**RE: Closure Request
Poker Lake Unit 28 BS 907H
Incident Number NRM2028239353
Eddy County, New Mexico**

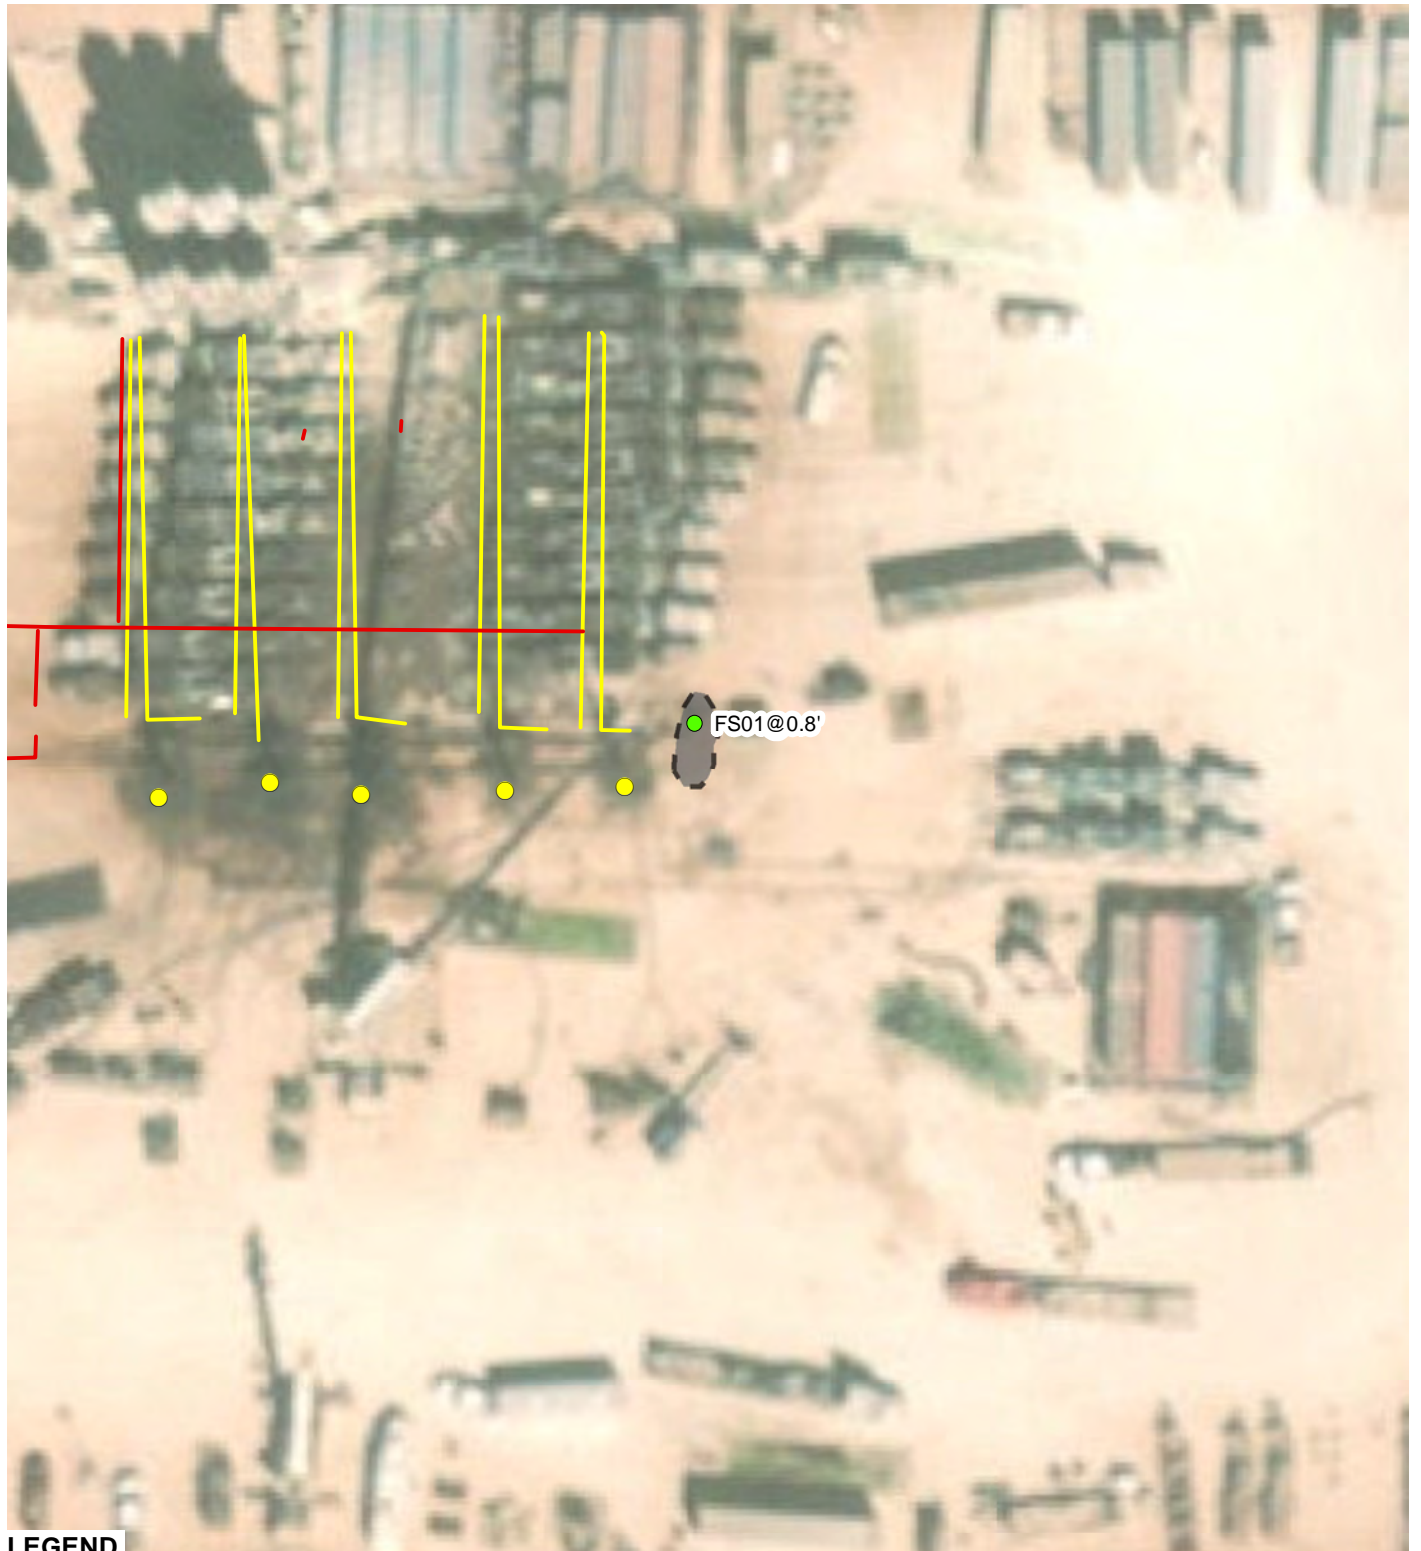
FIGURE 4
EXCAVATION SOIL SAMPLE LOCATIONS
PLU 28 BS 907H
UNIT H SEC 28 T25S R31E
EDDY COUNTY, NEW MEXICO
XTO ENERGY, INC.

The excavation measured approximately 200 square feet. A total of approximately 7 cubic yards of impacted soil were removed during the excavation activities. The impacted soil was transported and properly disposed of at the R360 Facility in Hobbs, New Mexico. After completion of confirmation sampling, the excavation was backfilled with material purchased locally and recontoured the Site to match pre-existing site conditions.

Laboratory analytical results for the delineation samples from potholes PH01 through PH03 and excavation floor soil sample FS01 indicated that benzene, BTEX, TPH-GRO/TPH-DRO, TPH, and chloride concentrations were compliant with the Closure Criteria. Laboratory analytical results are summarized in Table 1 and the complete laboratory analytical reports are included as Attachment 4.

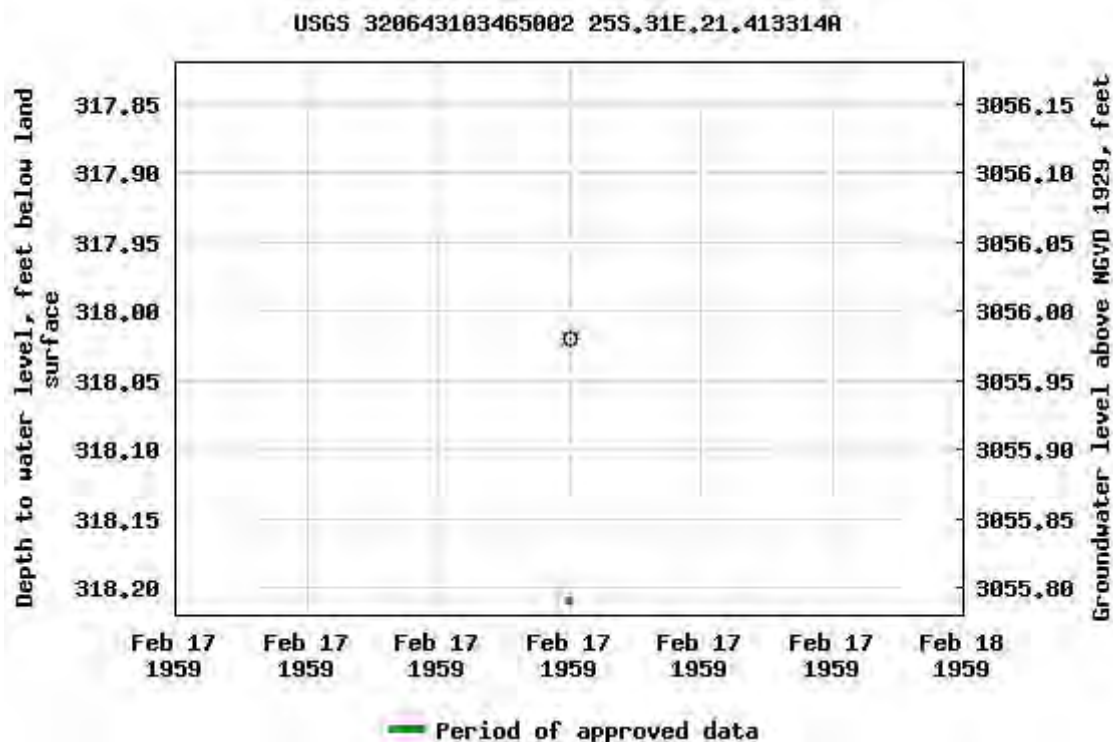
USGS 320643103465002 25S.31E.21.413314A

The depth of the well is 400 feet below land surface.

This well is completed in the Alluvium, Bolson Deposits and Other Surface Deposits (110AVMB) local aquifer.

Breaks in the plot represent a gap of at least one year between field measurements.

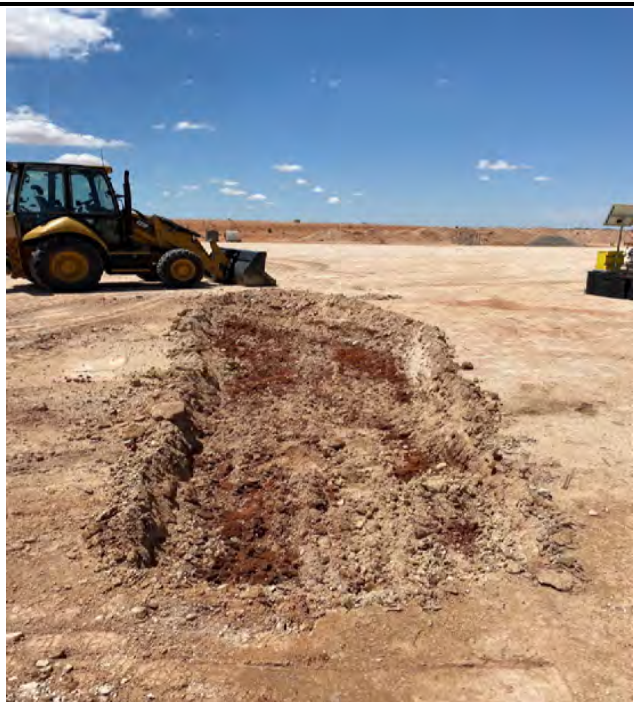
Photo No.	Date	
2	June 4, 2021	
South facing view of excavation extent.

A photograph showing a large, deep excavation pit that has been dug into the ground. The pit is filled with loose, reddish-brown soil. In the background, a yellow backhoe loader is parked on the left, and a white pickup truck is visible on the right. The sky is clear blue with a few scattered clouds.
