## Release Notification

Site Name Bell Lake Unit North #327H	Site Type Oil Production
Date Release Discovered 3/15/2021	API# (if applicable) 30-025-47853

Bell Lake North 327H  
Incident ID: NAPP2107457594

On March 15, 2021, KFOC personnel discovered a leak which was caused by a hole in a frac tank containing 20% hydrochloric acid (HCl). Of the 100 barrels (bbls) of HCl released, 95 bbls were released into a lined secondary containment and recovered. Approximately five bbls leaked onto the ground from a small hole in the lined secondary containment. The acid that leaked onto the ground was neutralized with soda ash upon discovery.

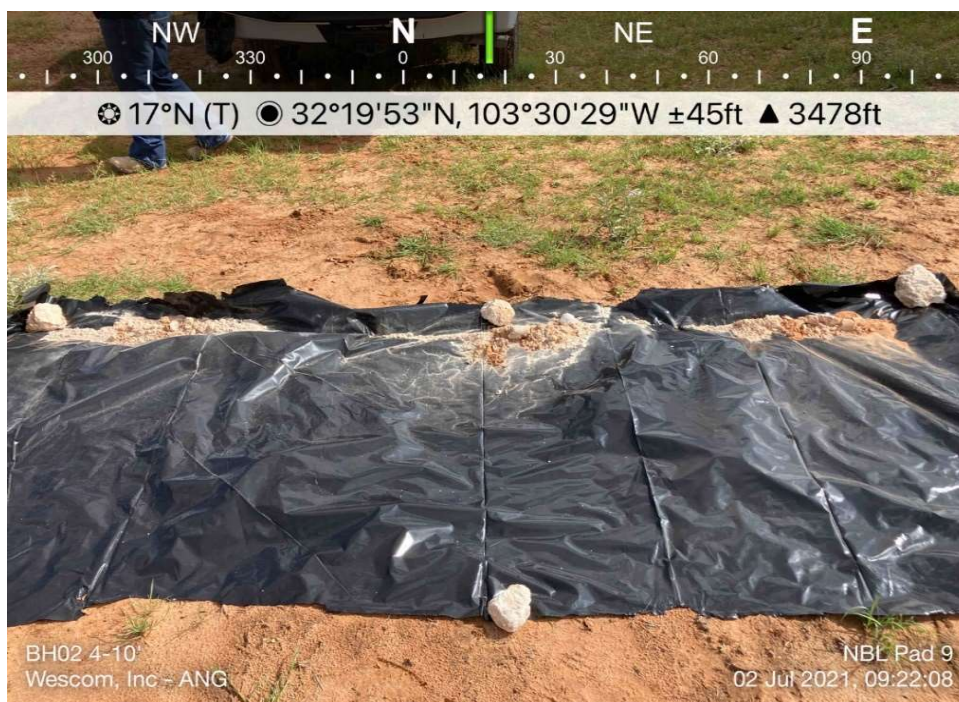
**BH02 Core Samples**

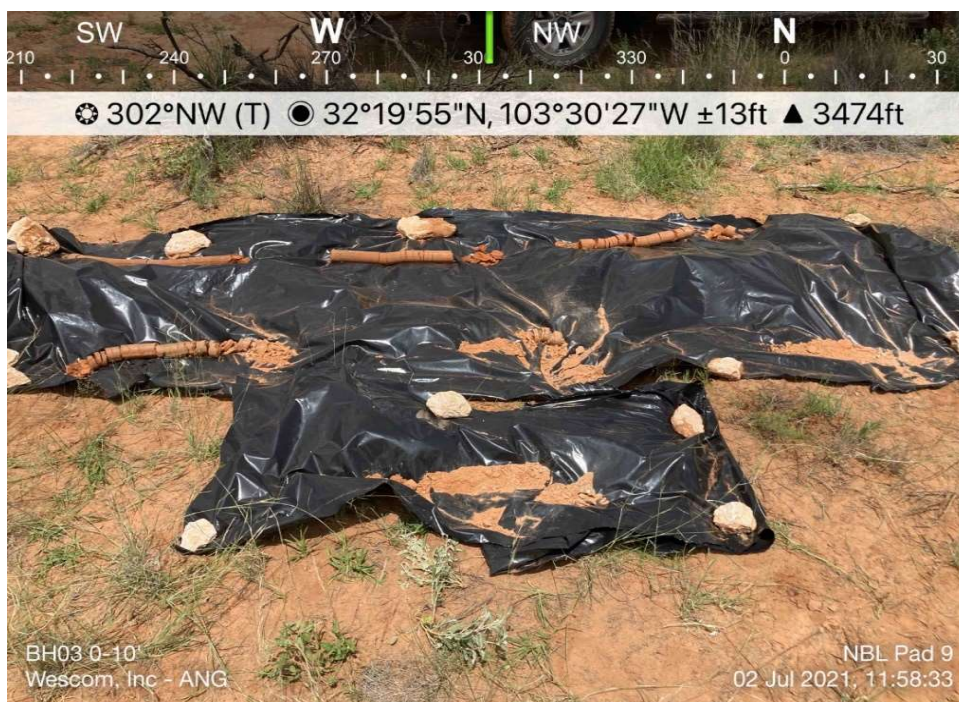
**BH03 Core Samples - (Off-Pad - East Side)**

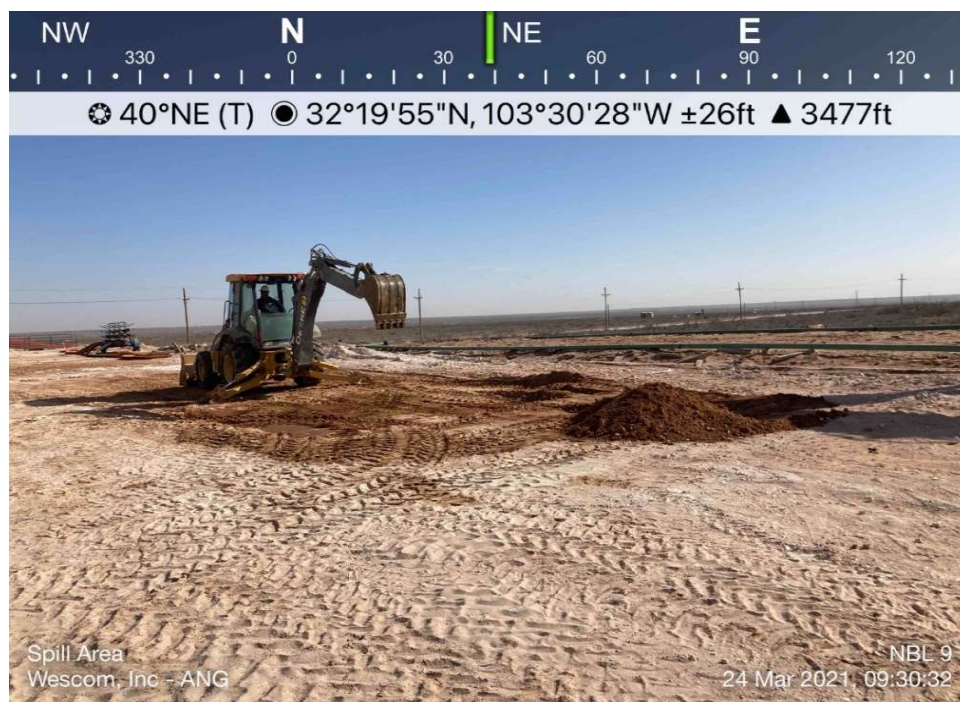
Spill Area

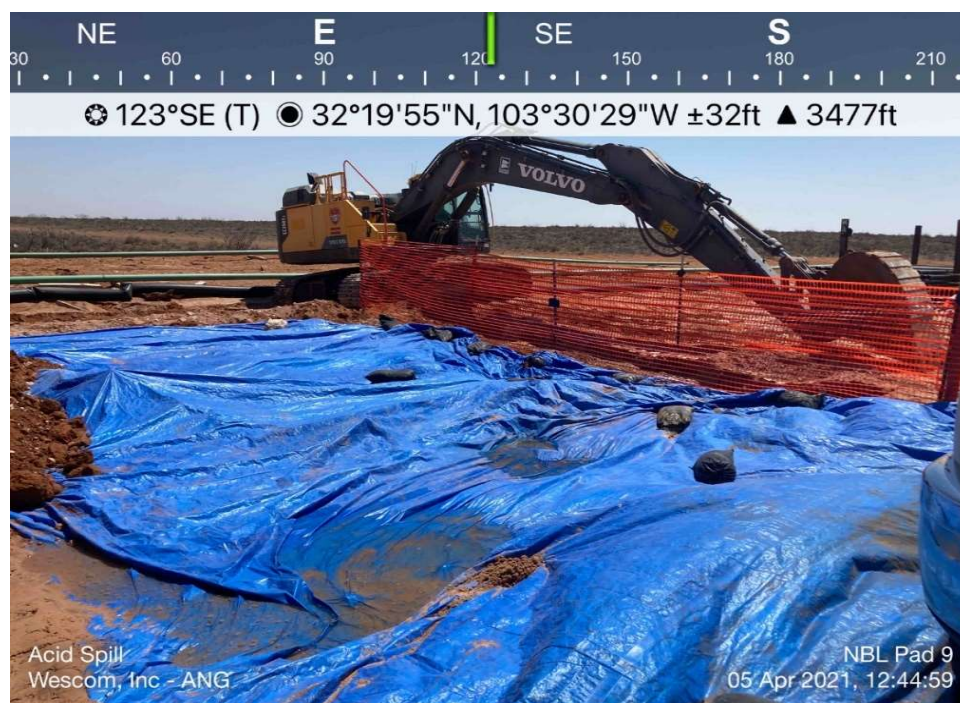
Vertical Delineation

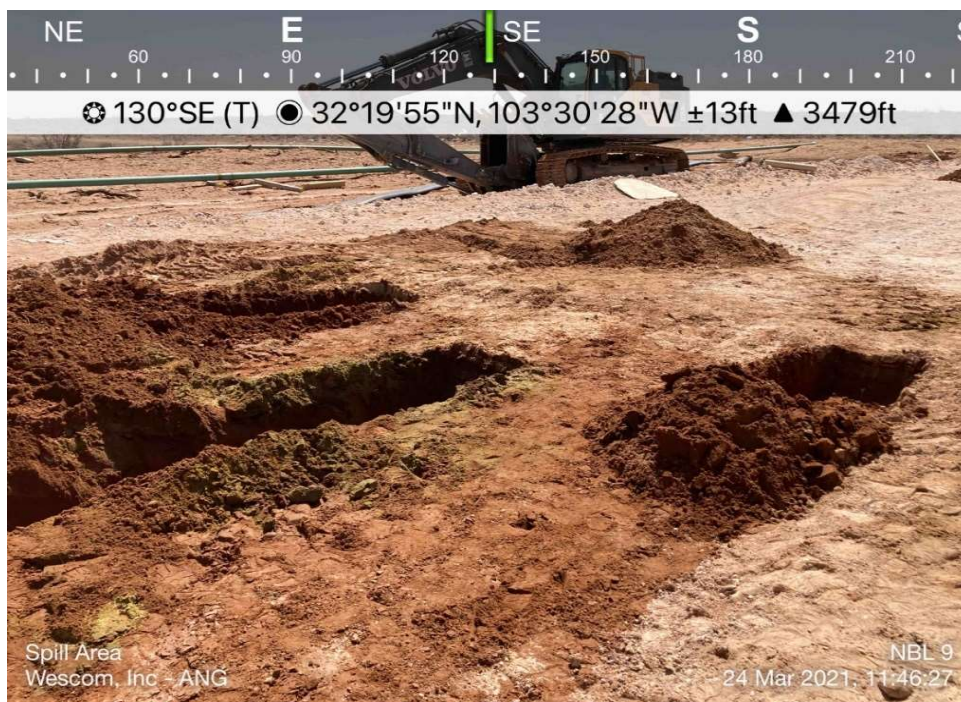
### Vertical Delineation

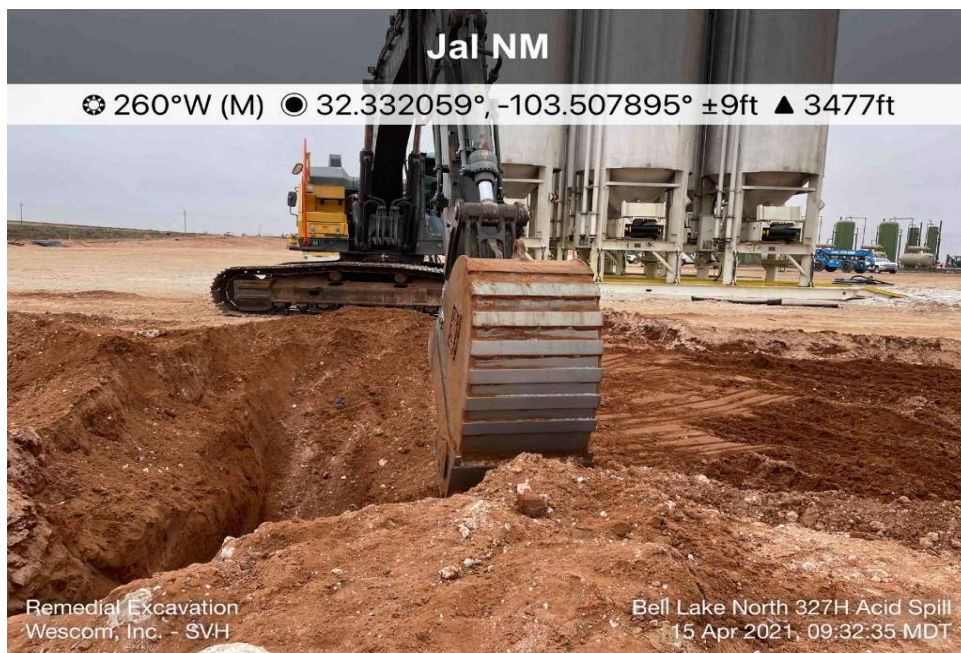
### Site Excavation

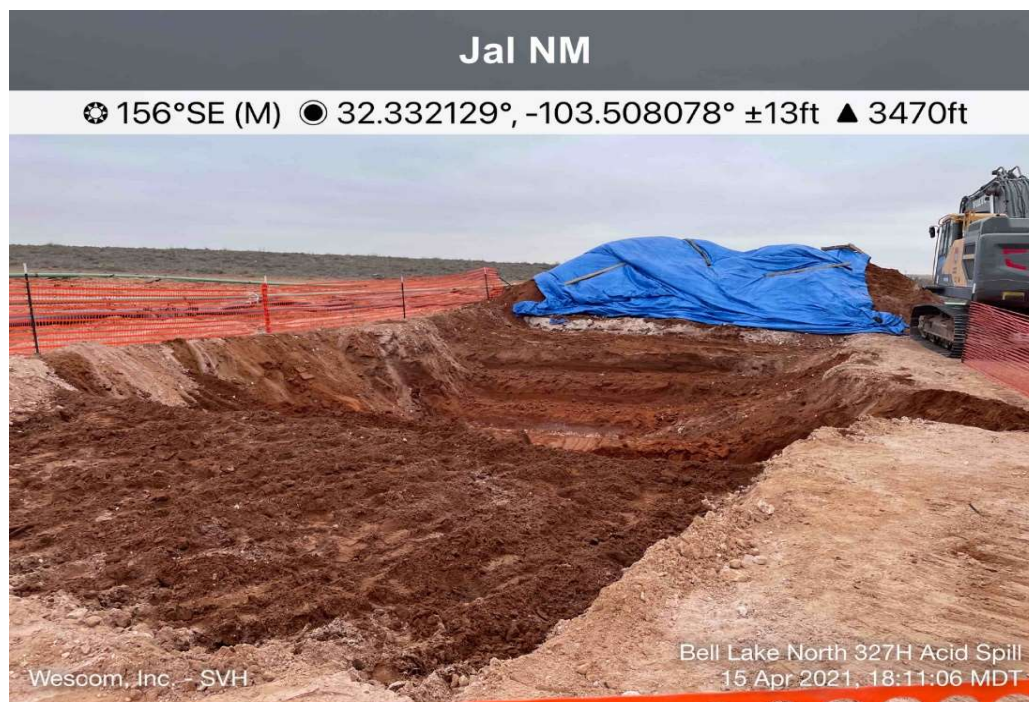
**Confirmation Sampling - North Side of Spill**

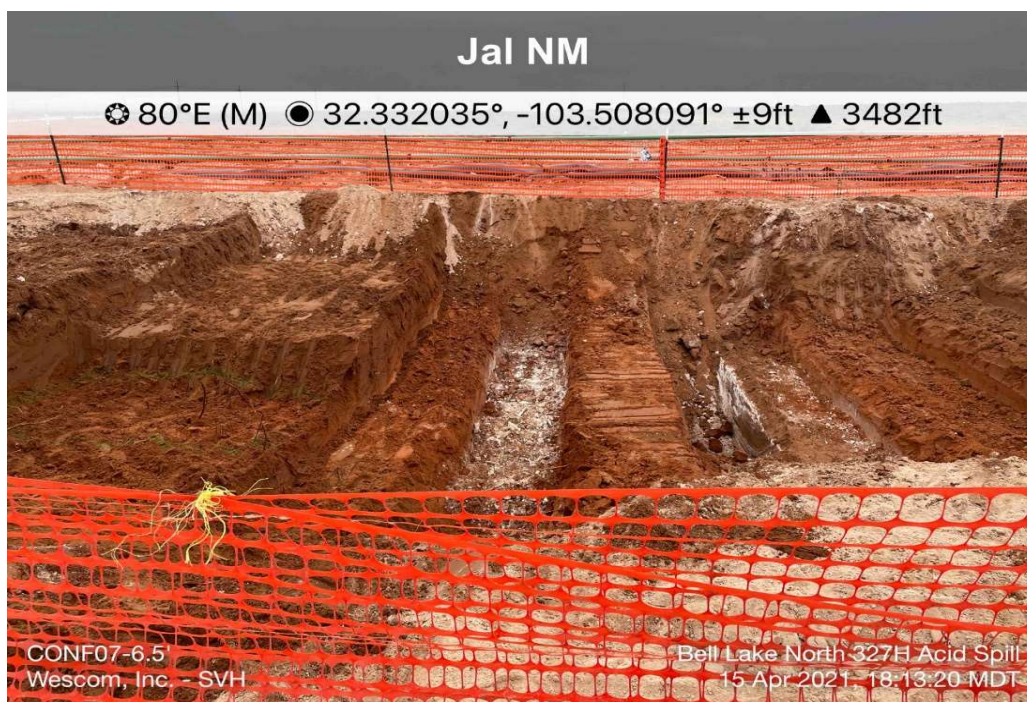
**Confirmation Sampling- West Side of Spill**

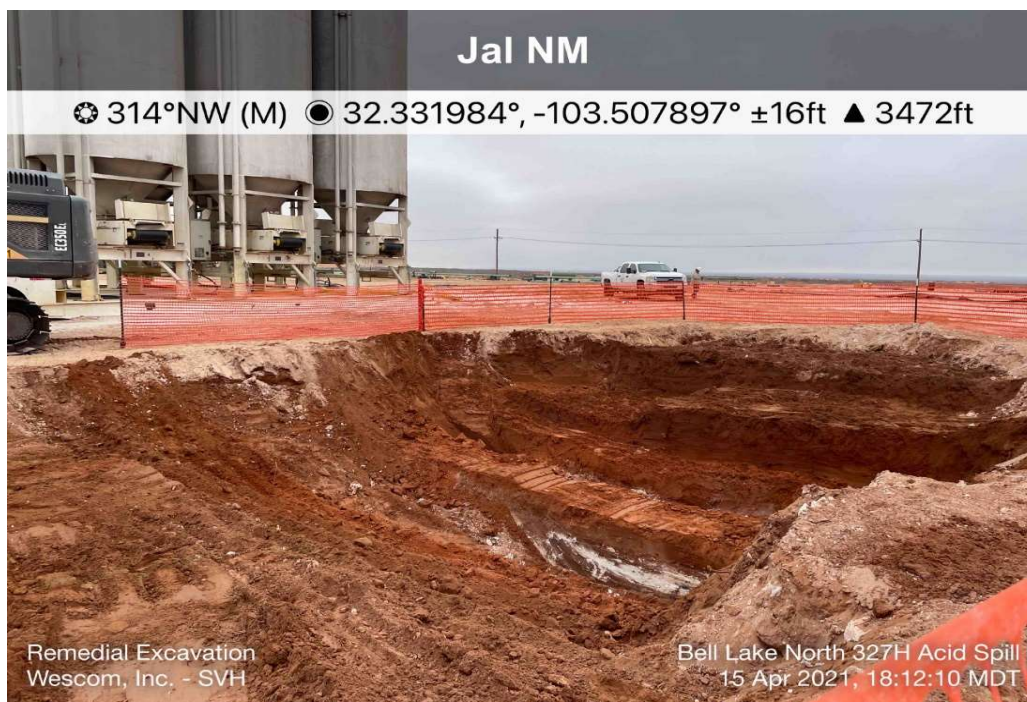
### Confirmation Sampling- East Side of Spill

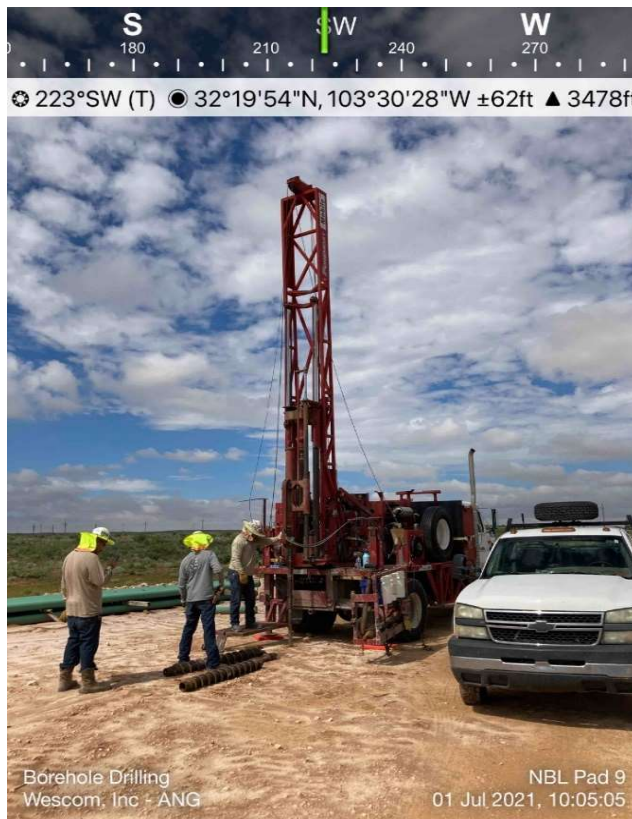
### Borehole Drilling BH01 (On-Pad)

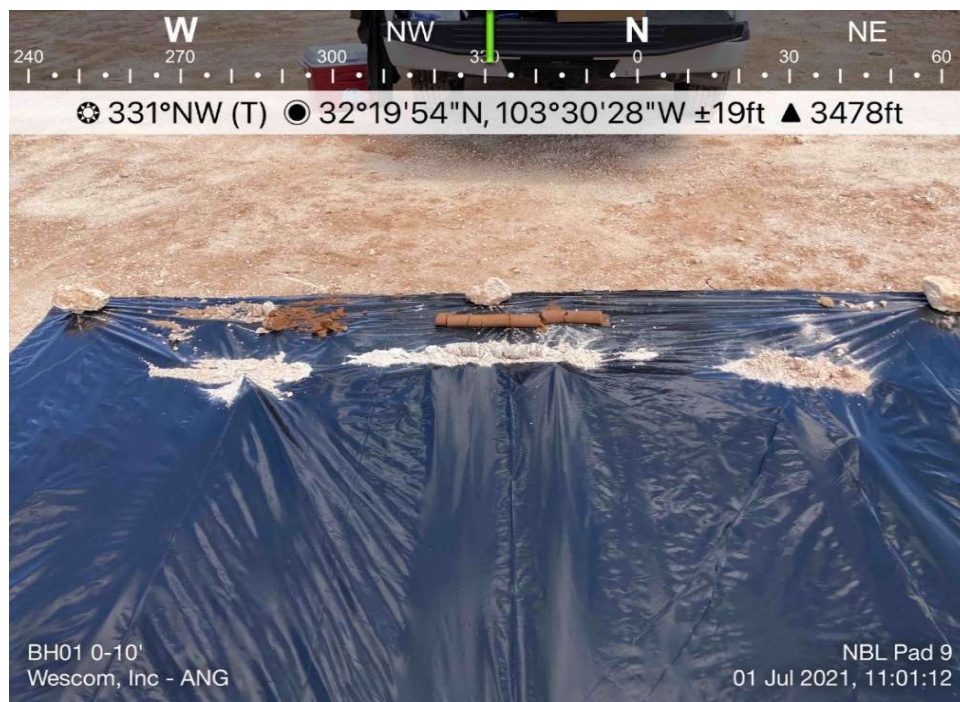
**BH01 Core Samples**

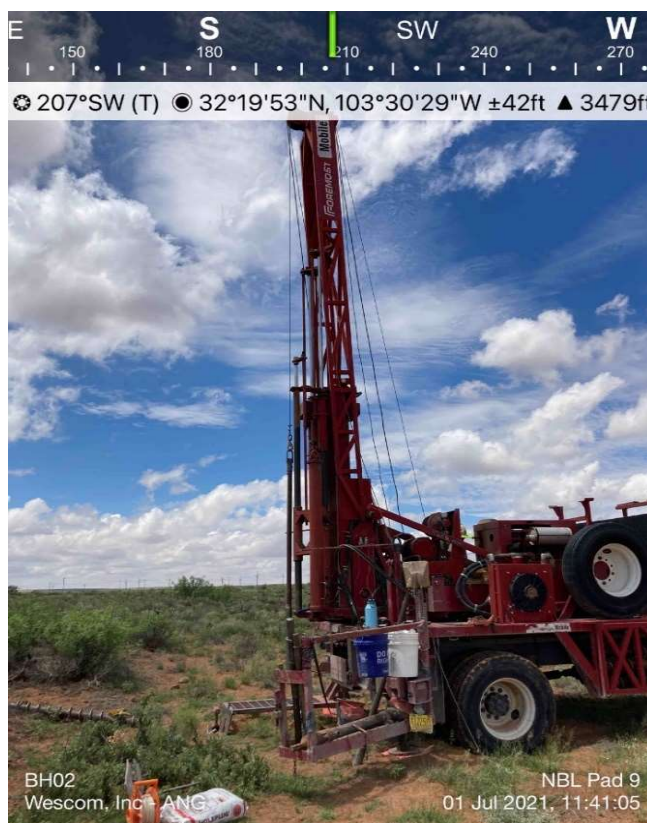
**Borehole Drilling BH02 (Off-Pad - South Side)**

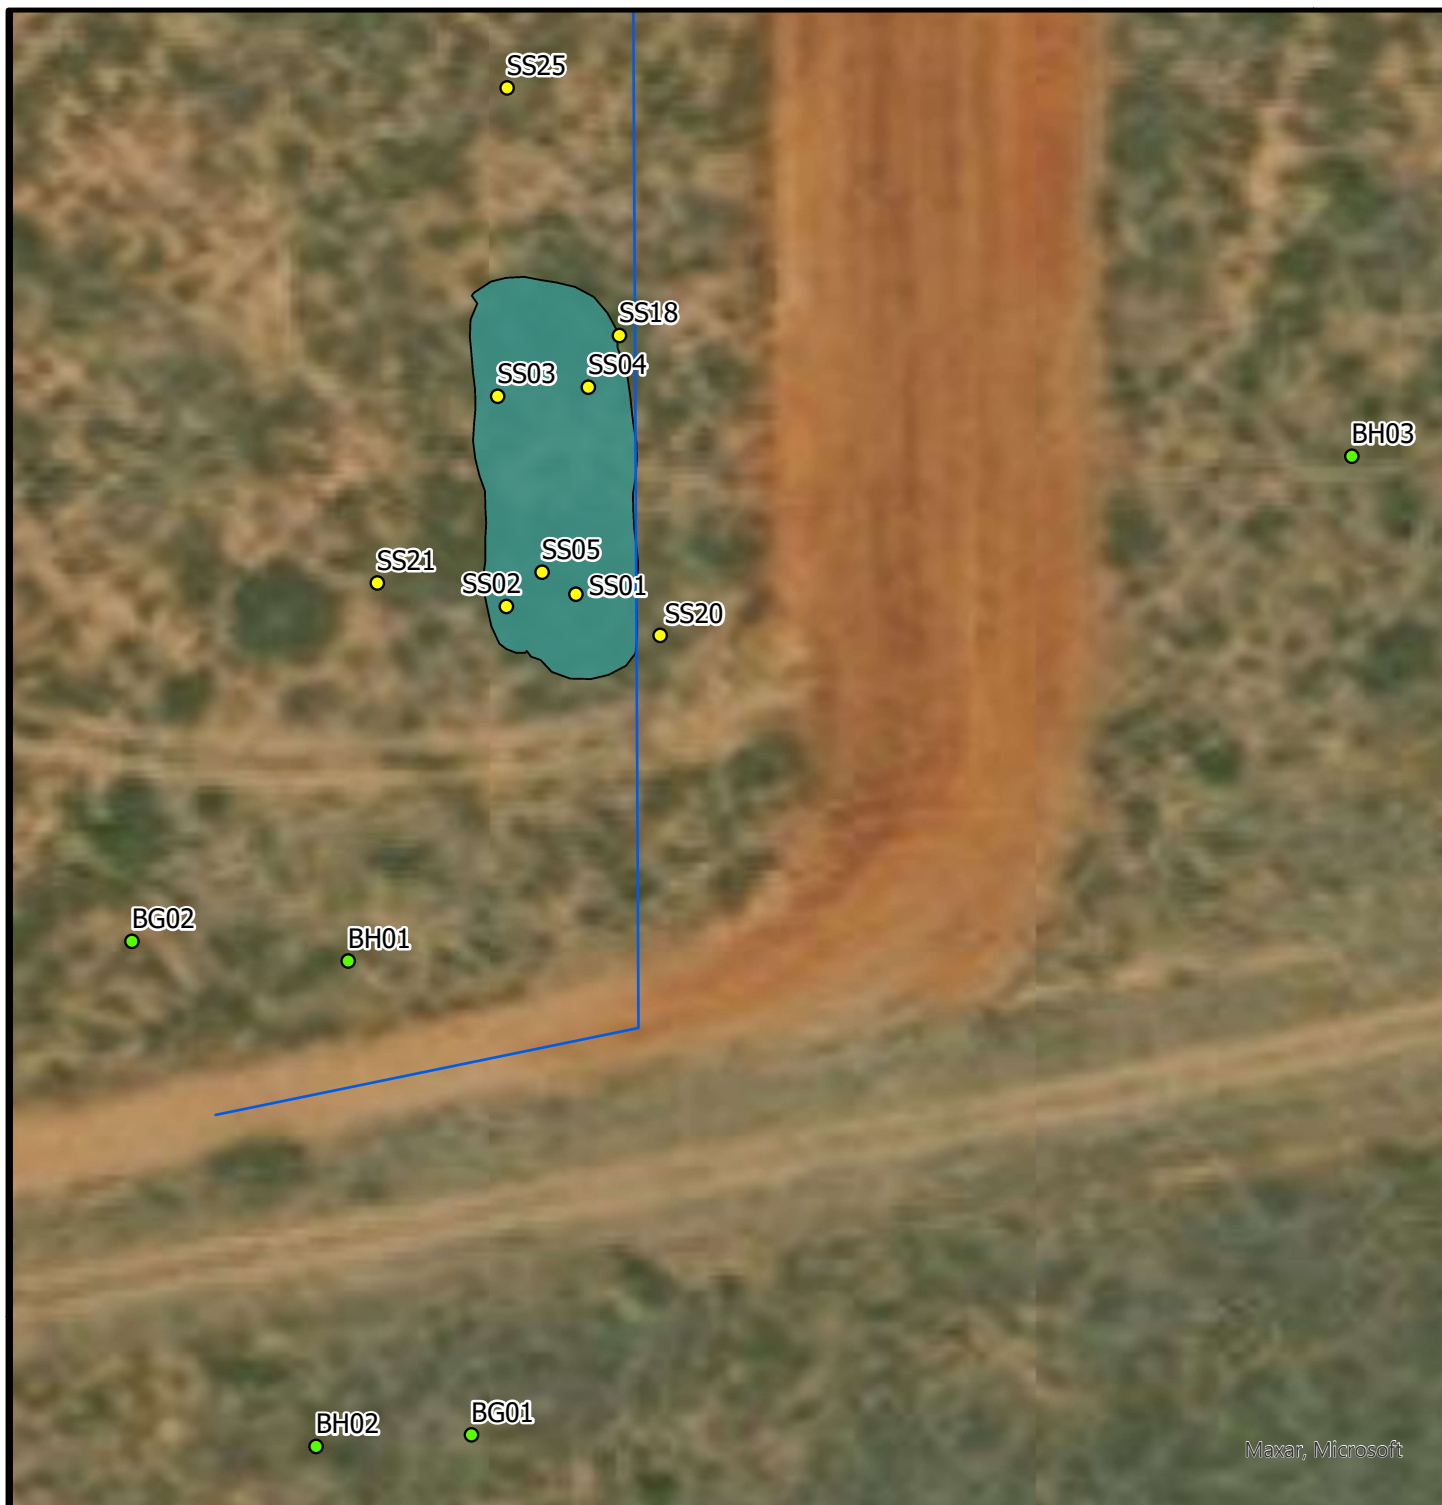
- Delineation Points
- Background Samples
- Edge of Pad
- Approx. Spill Area
