Release Notification

Site Name LaCama Com #1	Site Type Well
Date Release Discovered 03/29/2018	API# 30-015-22248

La Cama Com #1

Closure Report

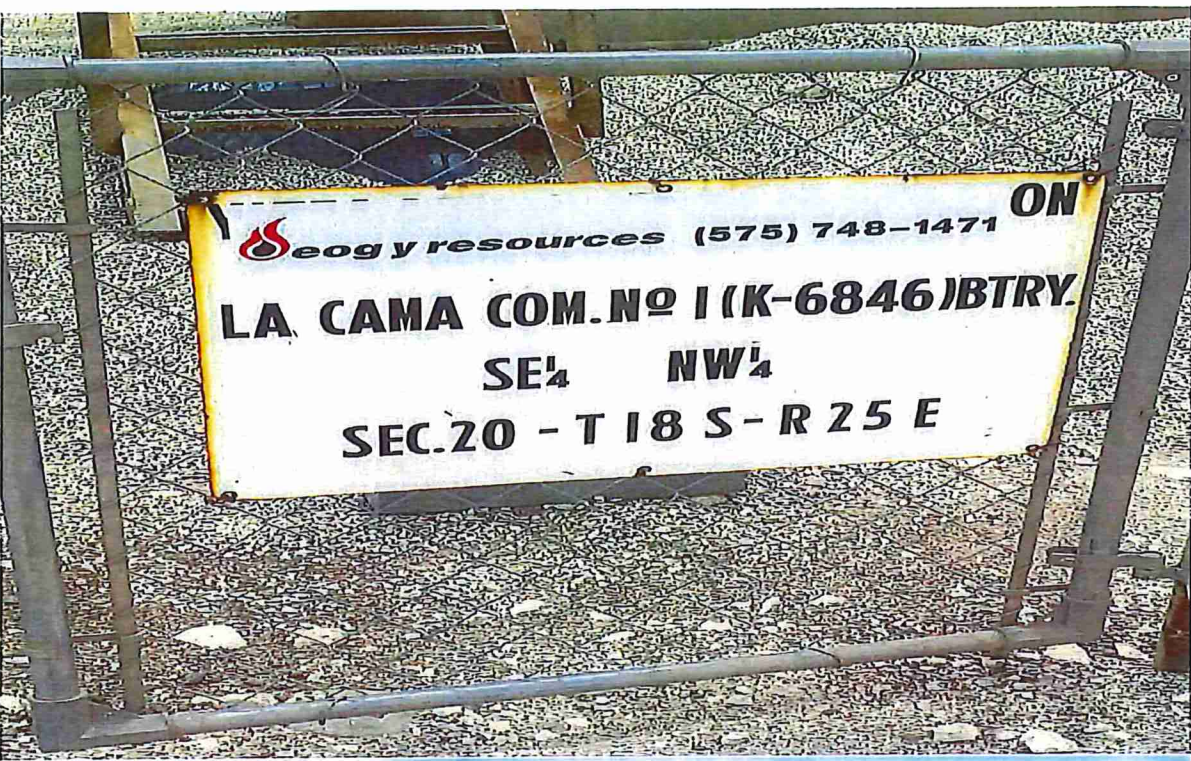
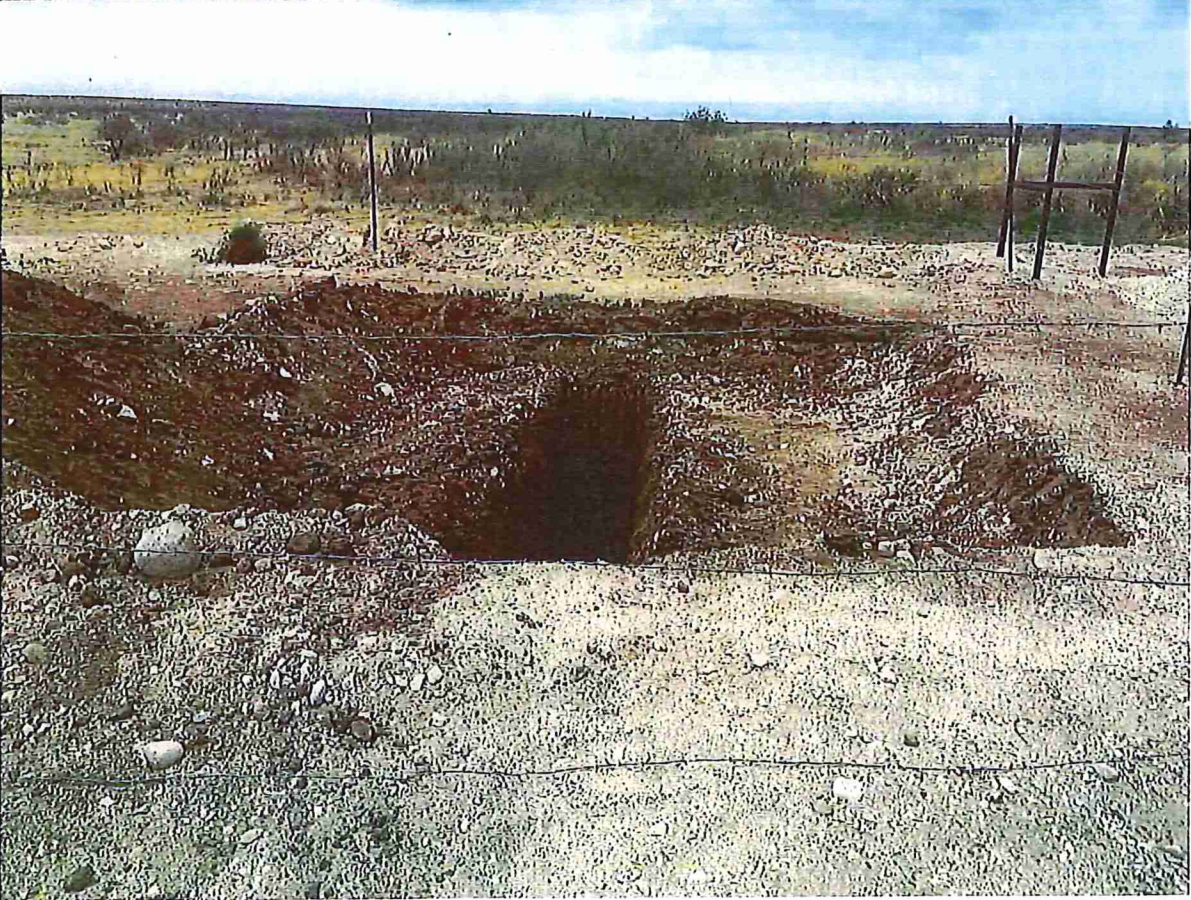
Photos

Describe Cause of Problem and Remedial Action Taken.*
There was a hole in a steel tank that allowed for the release.

The impacted area is approximately 13 feet by 13 feet within the berm of the battery. Two feet of visually impacted soil was removed after the tank was relocated.

EOG Y Resources, Inc. excavated the impacted area to two (2) feet bgs, hauling all excavated soil to a NMOCD approved facility for disposal. EOG Y Resources, Inc. Once the excavation of visually impacted soils was complete, delineation samples were collected and sent to a 3rd party laboratory for analysis. Those results indicate no further impactation with all soil samples being below RRALs for Benzene, BTEX, and TPH, as well as all samples consisting of less than 50 mg/kg chloride from two (2) feet bgs to ten (10) feet bgs.

With no further soil impactation remaining at the site after initial excavation, a C-141 Final is hereby submitted to the NMOCD requesting closure of the site.

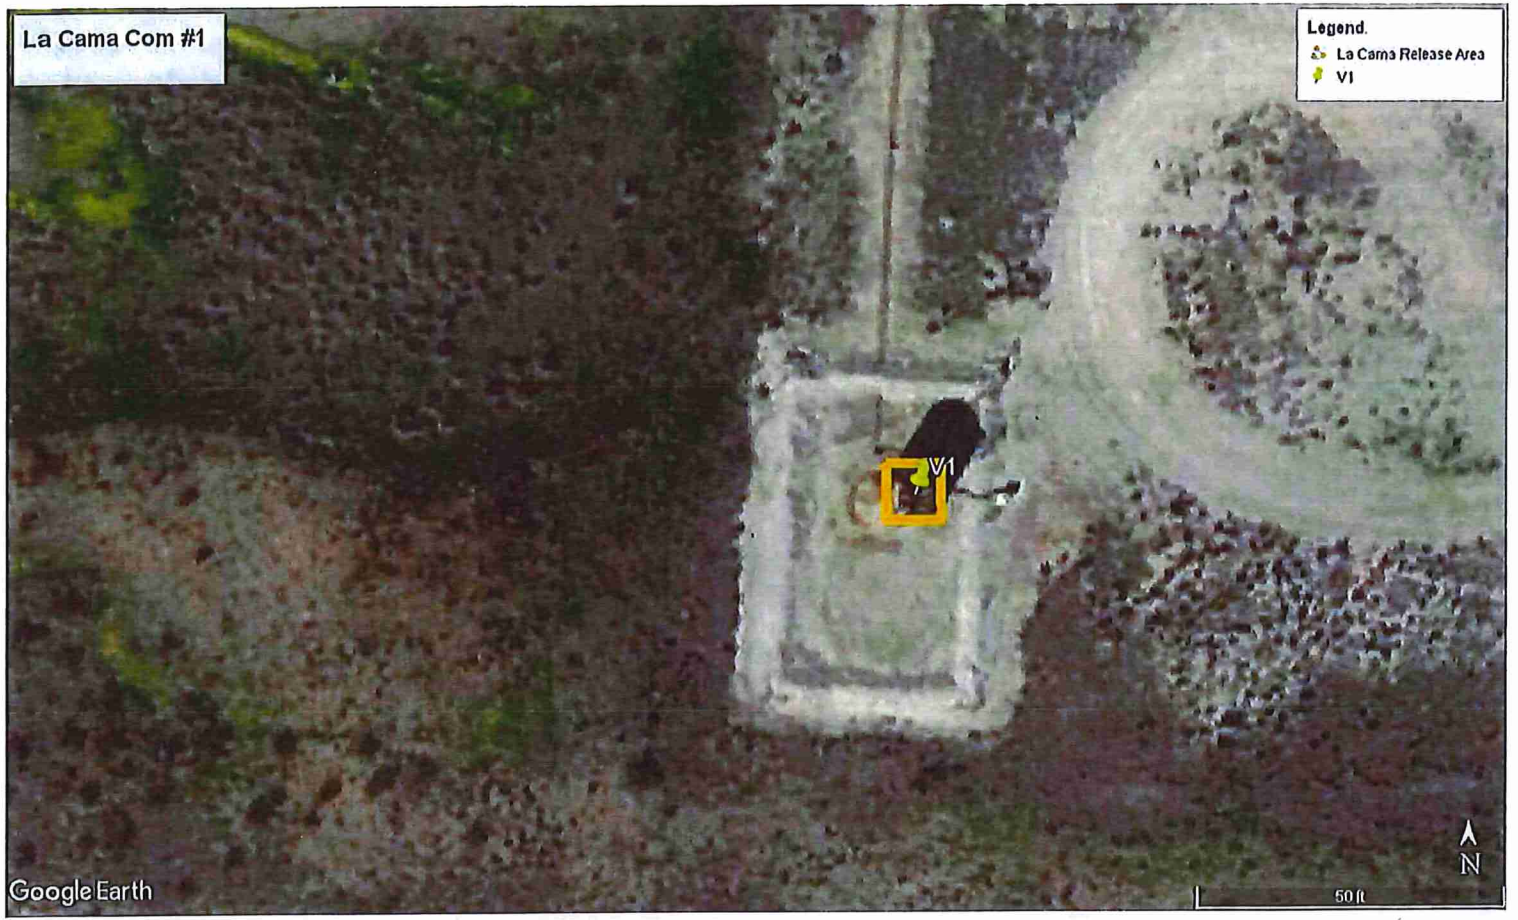
Figure 1

Site Map with Sample Point
