State of New Mexico
Oil Conservation Division

Incident ID	nAPP2113132295
District RP	
Facility ID	
Application ID

Closure

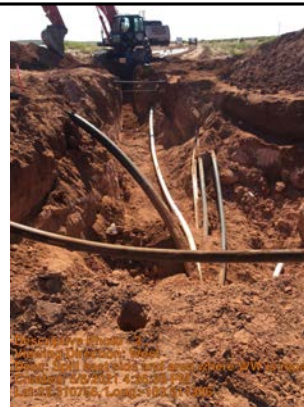
Spill east side and area where WW is repairing flow line.

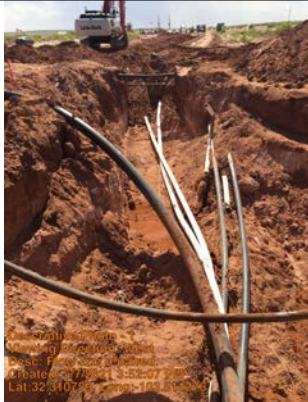
Flow line repaired.

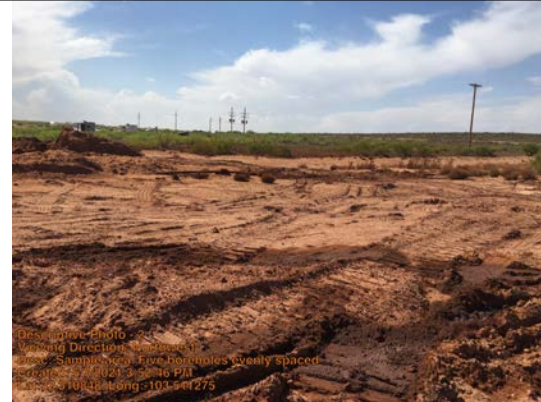
Sample area. Five boreholes evenly spaced

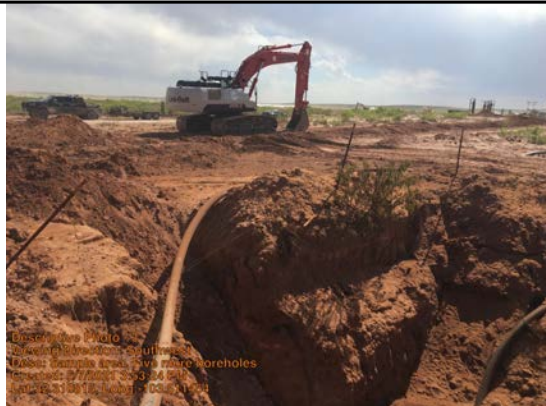
Sample area. Five more boreholes

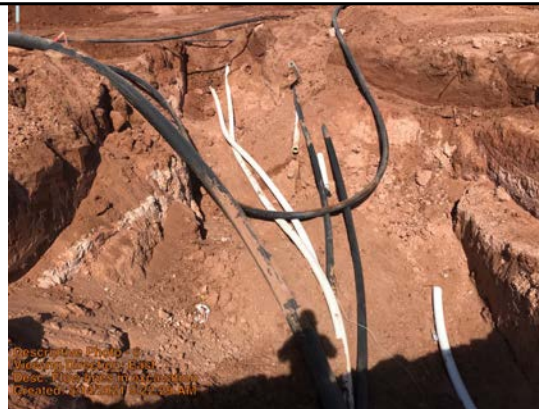
Flow lines in excavation

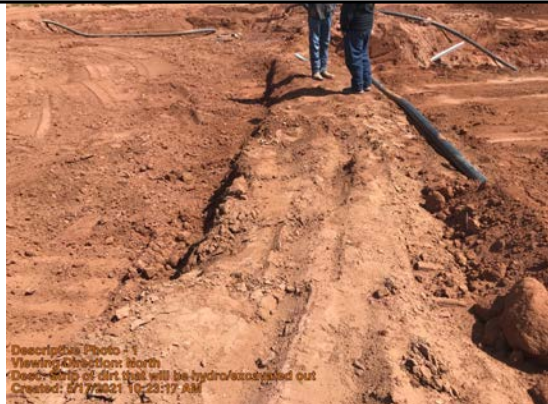
Descriptive Photo - 1
Viewing Direction: North
Describe: Strip of dirt that will be hydro/excavated out
Created: 5/17/2021 10:23:17 AM

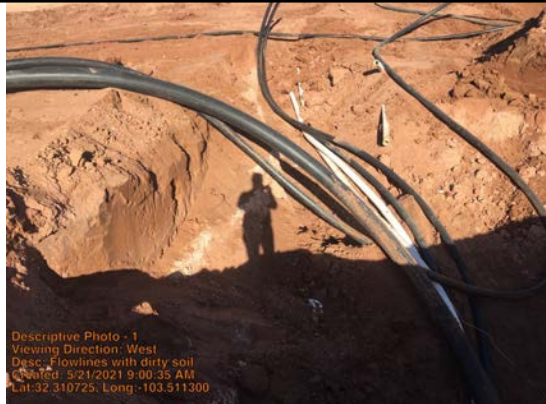
Flowlines with dirty soil

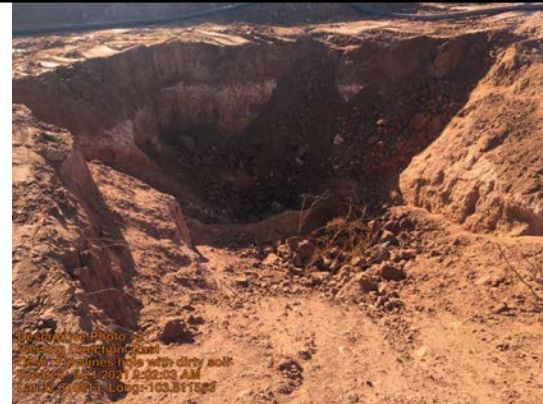
Flowlines hole with dirty soil

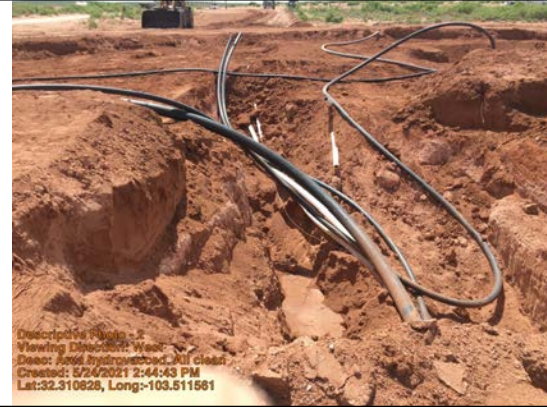
Area hydrovaccated. All clean

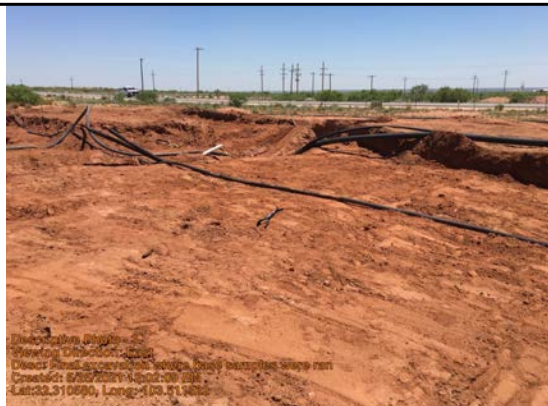
Final excavation where base samples were ran

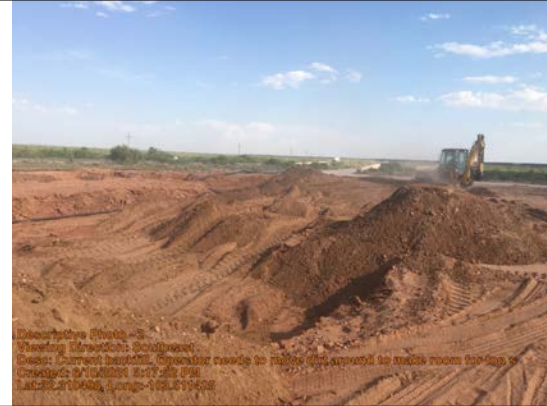
Current backfill. Operator needs to move dirt around to make room for top soil

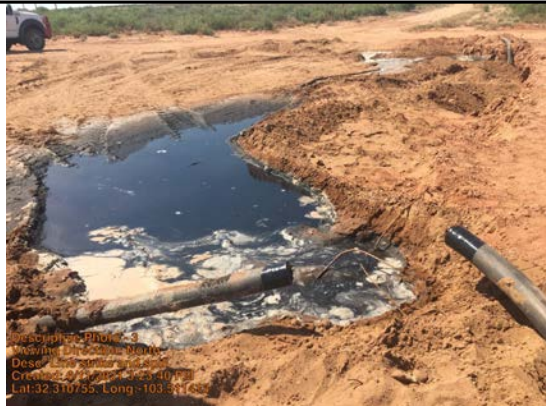
Line strike and spill

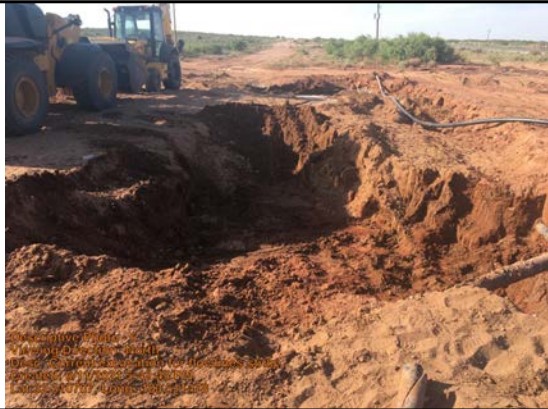
<p>Descriptive Photo of Current Excavation for Flowlines Strike Location: 17512001 3rd St NW Date: 10/15/2021 1:14 PM</p>
Second line strike. Freshwater	Current excavation for flowlines strike

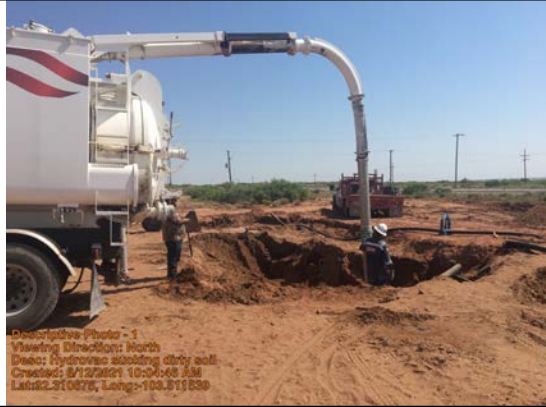
Hydrovac sucking dirty soil
