Site Name Remuda 100	Site Type Tank Battery
Date Release Discovered 7/26/2021	API# (if applicable)

**RE: Closure Request
Remuda 100
Incident Number NAPP2121445163
Eddy County, New Mexico**

WSP USA Inc. (WSP) on behalf of XTO Energy, Inc. (XTO), presents the following Closure Request detailing site assessment and soil sampling activities at the Remuda 100 (Site) in Unit E, Section 25, Township 23 South, Range 29 East, in Eddy County, New Mexico (Figure 1). The purpose of the site assessment and soil sampling activities was to assess for the presence or absence of impacts to soil following a crude oil flare fire at the Site. Based on field observations, site assessment activities, and soil sample analytical results, XTO is submitting this Closure Request, and requesting no further action (NFA) for Incident Number NAPP2121445163.

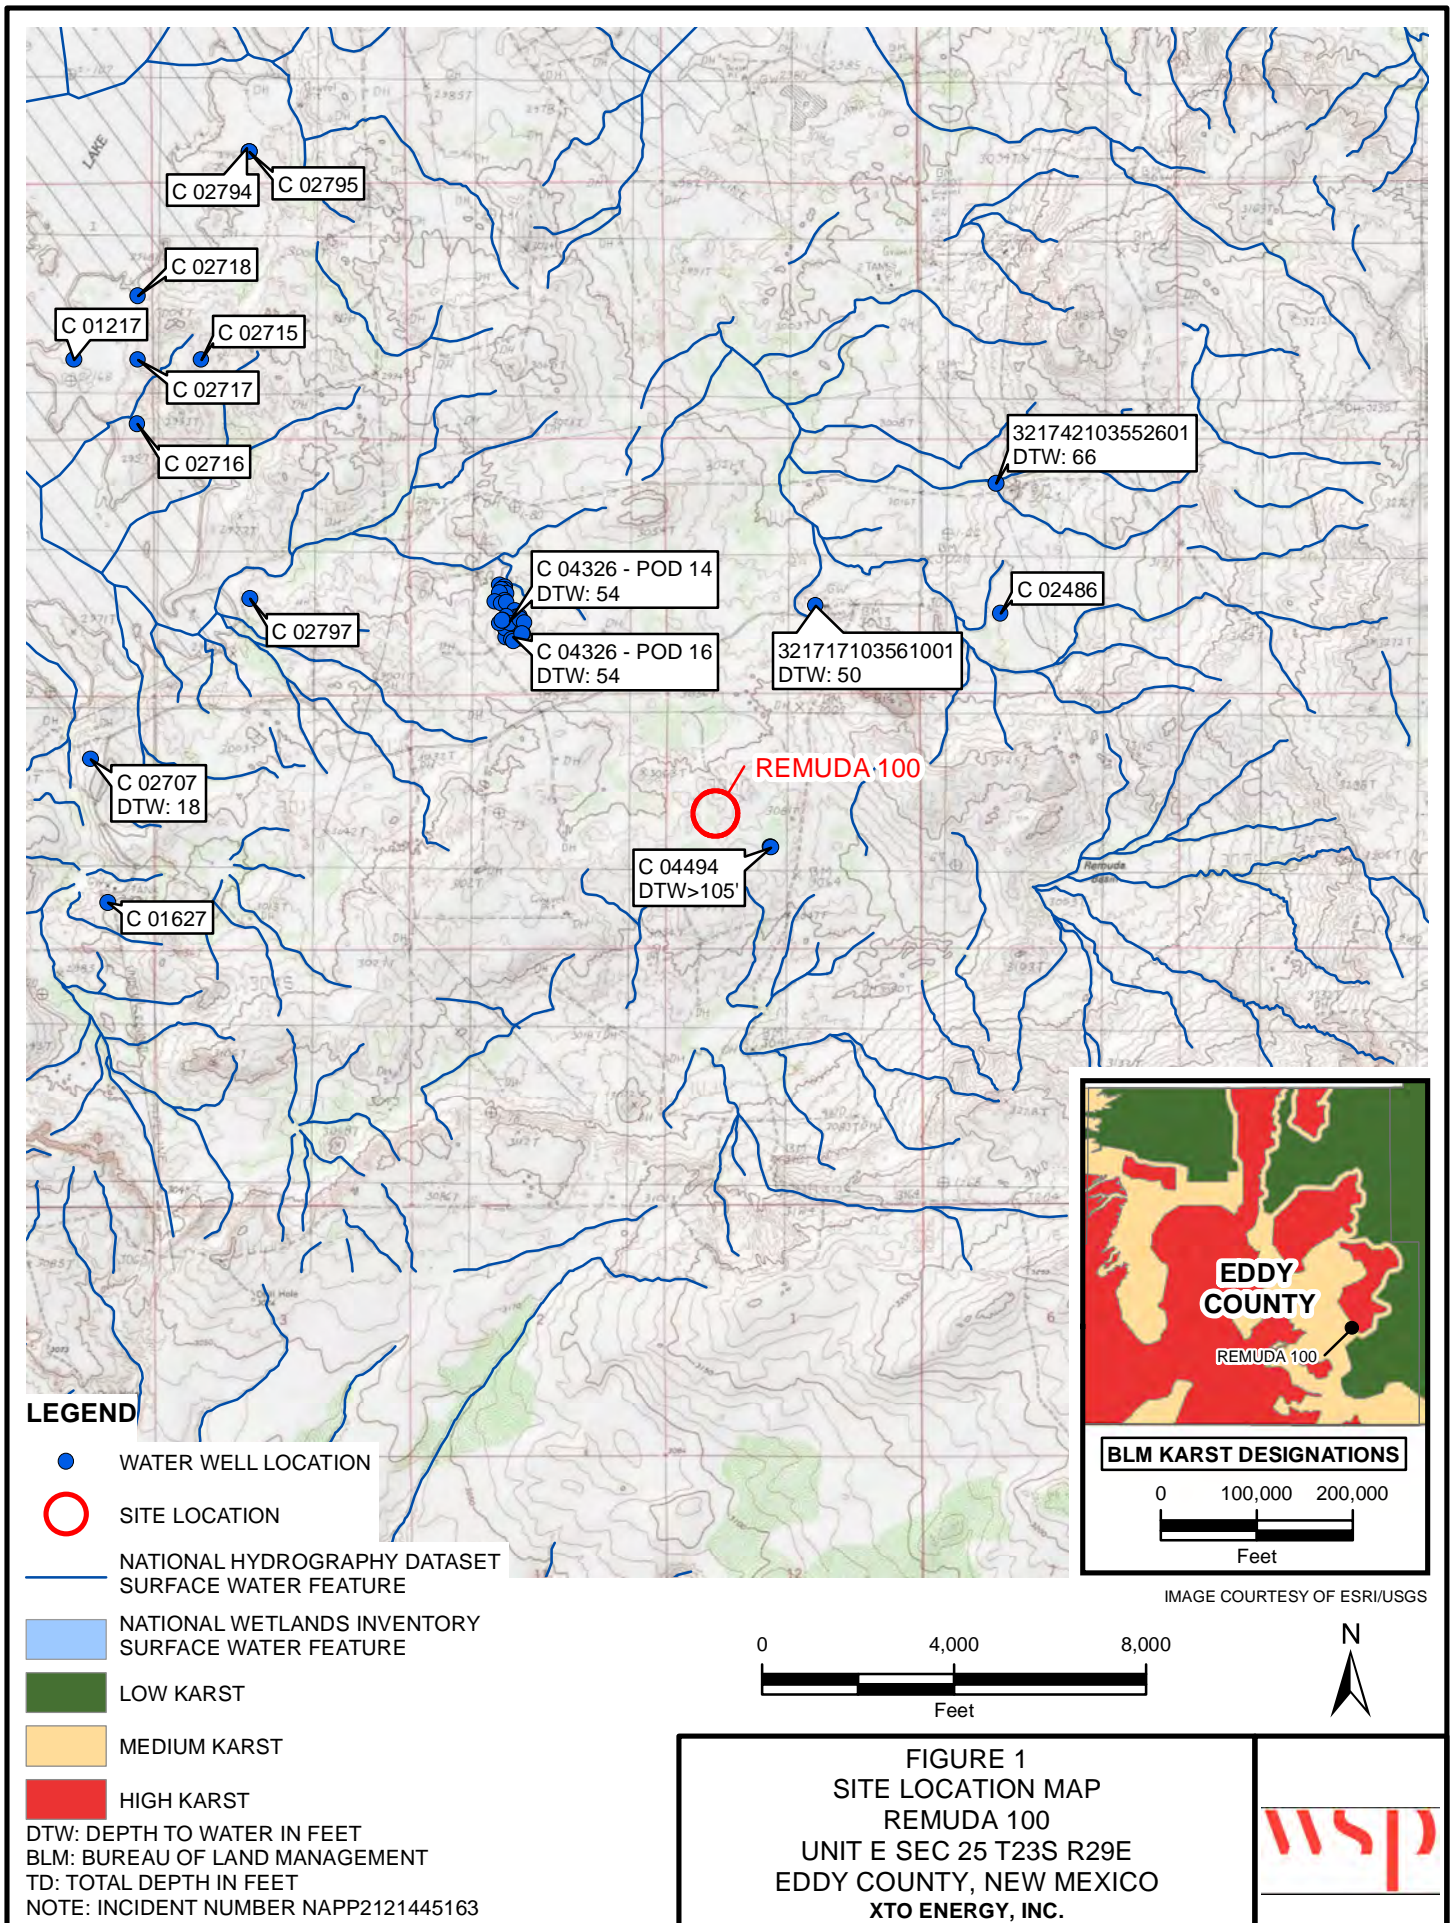
open for over 72 hours to allow for potential slow infill of groundwater. After the 72-hour waiting period without observing groundwater, it was confirmed that groundwater beneath the Site is greater than 105 feet. The borehole was properly abandoned with hydrated bentonite chips. The location of borehole C-04494 is provided on Figure 1.

The closest continuously flowing or significant watercourse to the Site is a freshwater emergent wetland, located approximately 0.58 miles southeast of the Site. The Site is greater than 200 feet from a lakebed, sinkhole, or playa lake and greater than 300 feet from an occupied residence, school, hospital, institution, church, or wetland. The Site is greater than 1,000 feet to a freshwater well or spring and is not within a 100-year floodplain or overlying a subsurface mine. The Site is not underlain by unstable geology (medium potential karst designation area). Site receptors are identified on Figure 1.

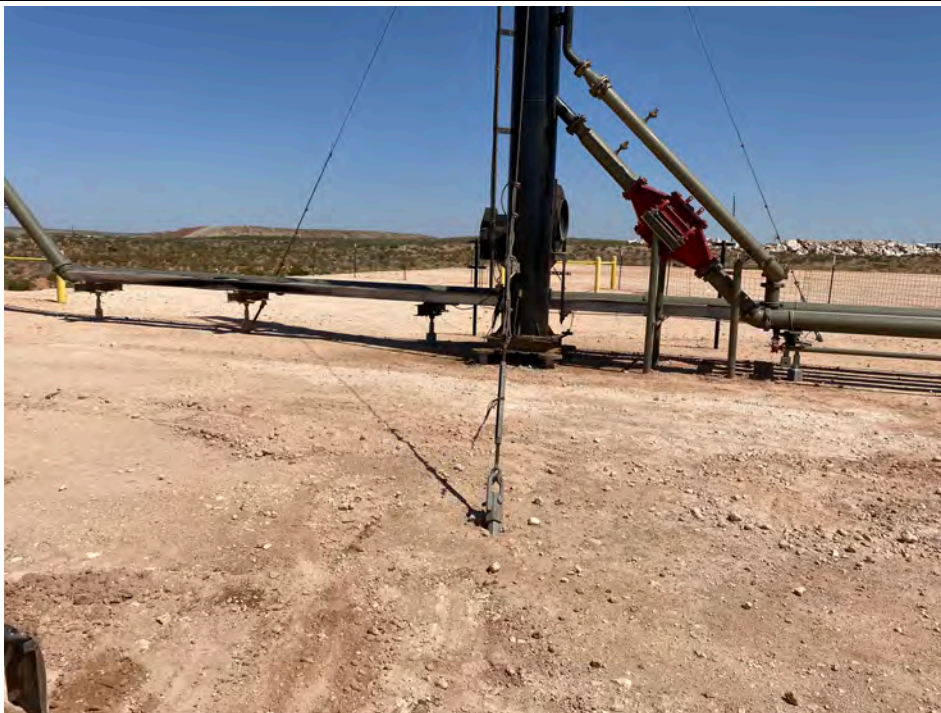
View of release extent
during the initial site
visit prior to
delineation activities.

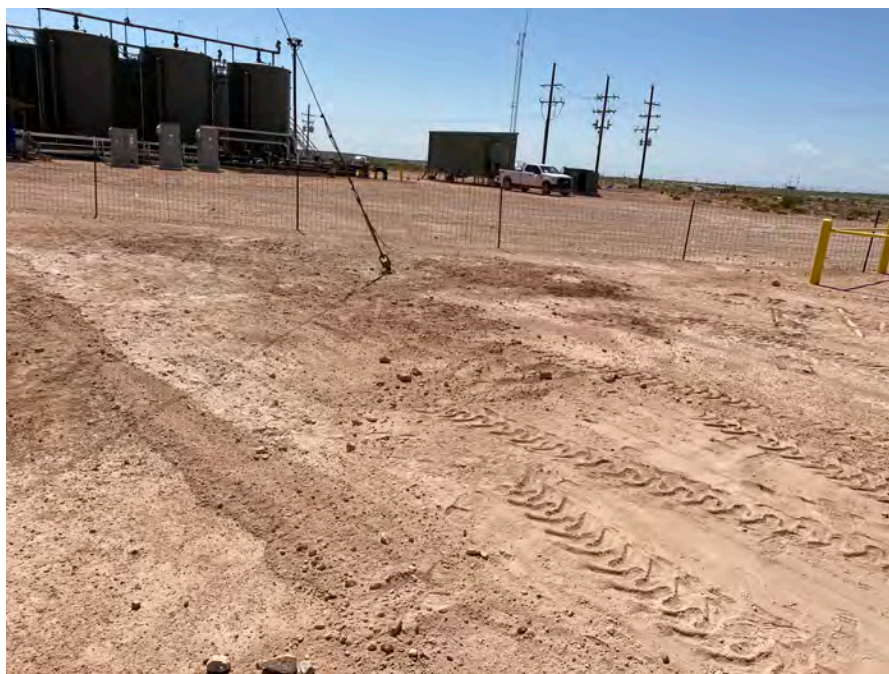
View of release extent
during the initial site
visit prior to
delineation activities.

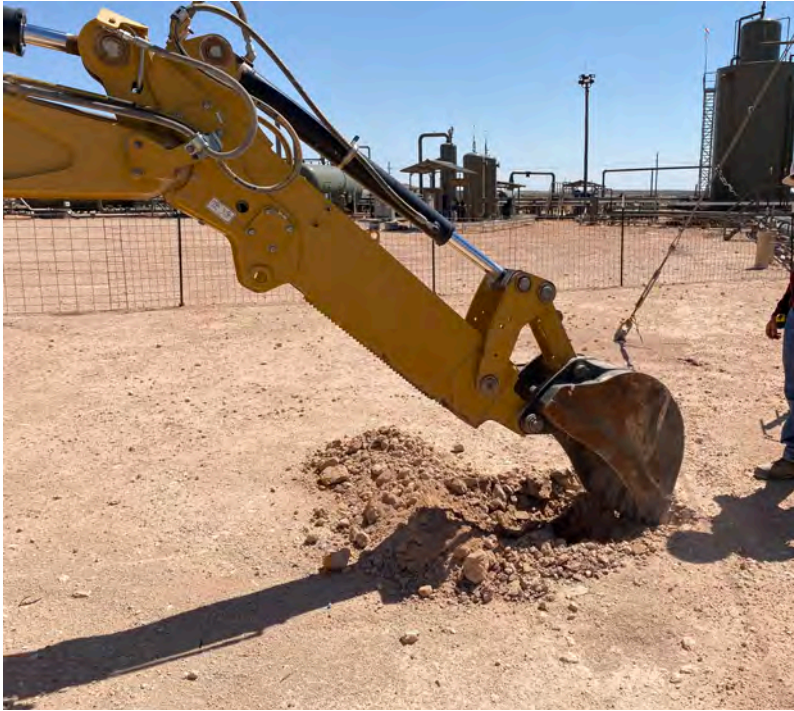
Photo No.	Date	
3	9-16-2021	
North facing view of delineation activity on PH02.

A yellow CAT excavator is shown in a north-facing view, performing delineation activity on a dirt surface. The excavator's arm and bucket are visible, with the bucket resting on the ground. In the background, there are industrial structures, including a large storage tank and various pipes and valves, under a clear blue sky.

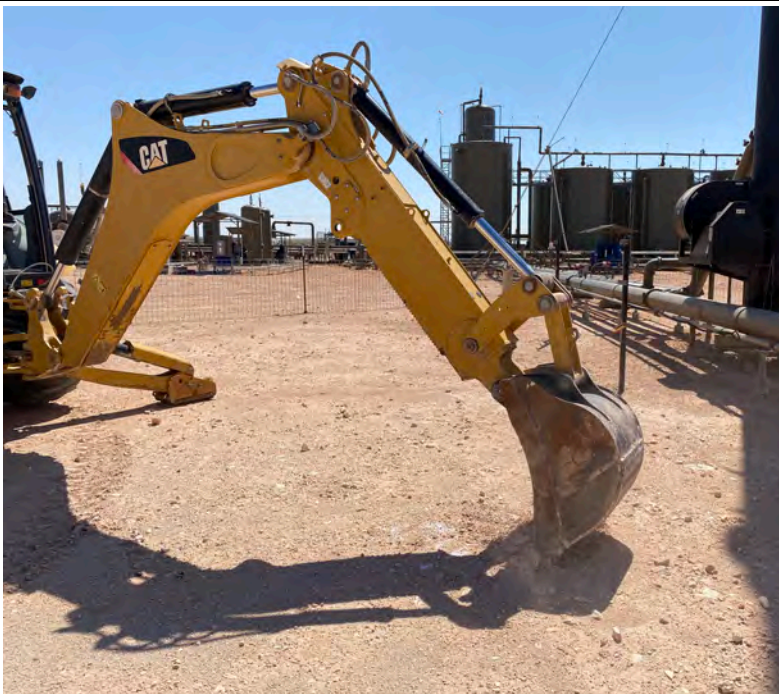
Photo No.	Date	
4	9-16-2021	
South facing view of delineation activity on PH04.

A yellow CAT excavator is shown in a south-facing view, performing delineation activity on a dirt surface. The excavator's arm and bucket are visible, with the bucket resting on the ground. In the background, there are industrial structures, including a large storage tank and various pipes and valves, under a clear blue sky.
