Release Notification

Re: Buena Suerte 32G Com 1 (30-045-28693)

Re: API# 30-045-28693 Buena Suerte 32 G COM #001 Pit Closure Notification

Closure Sampling Test Results
 October 28, 2021

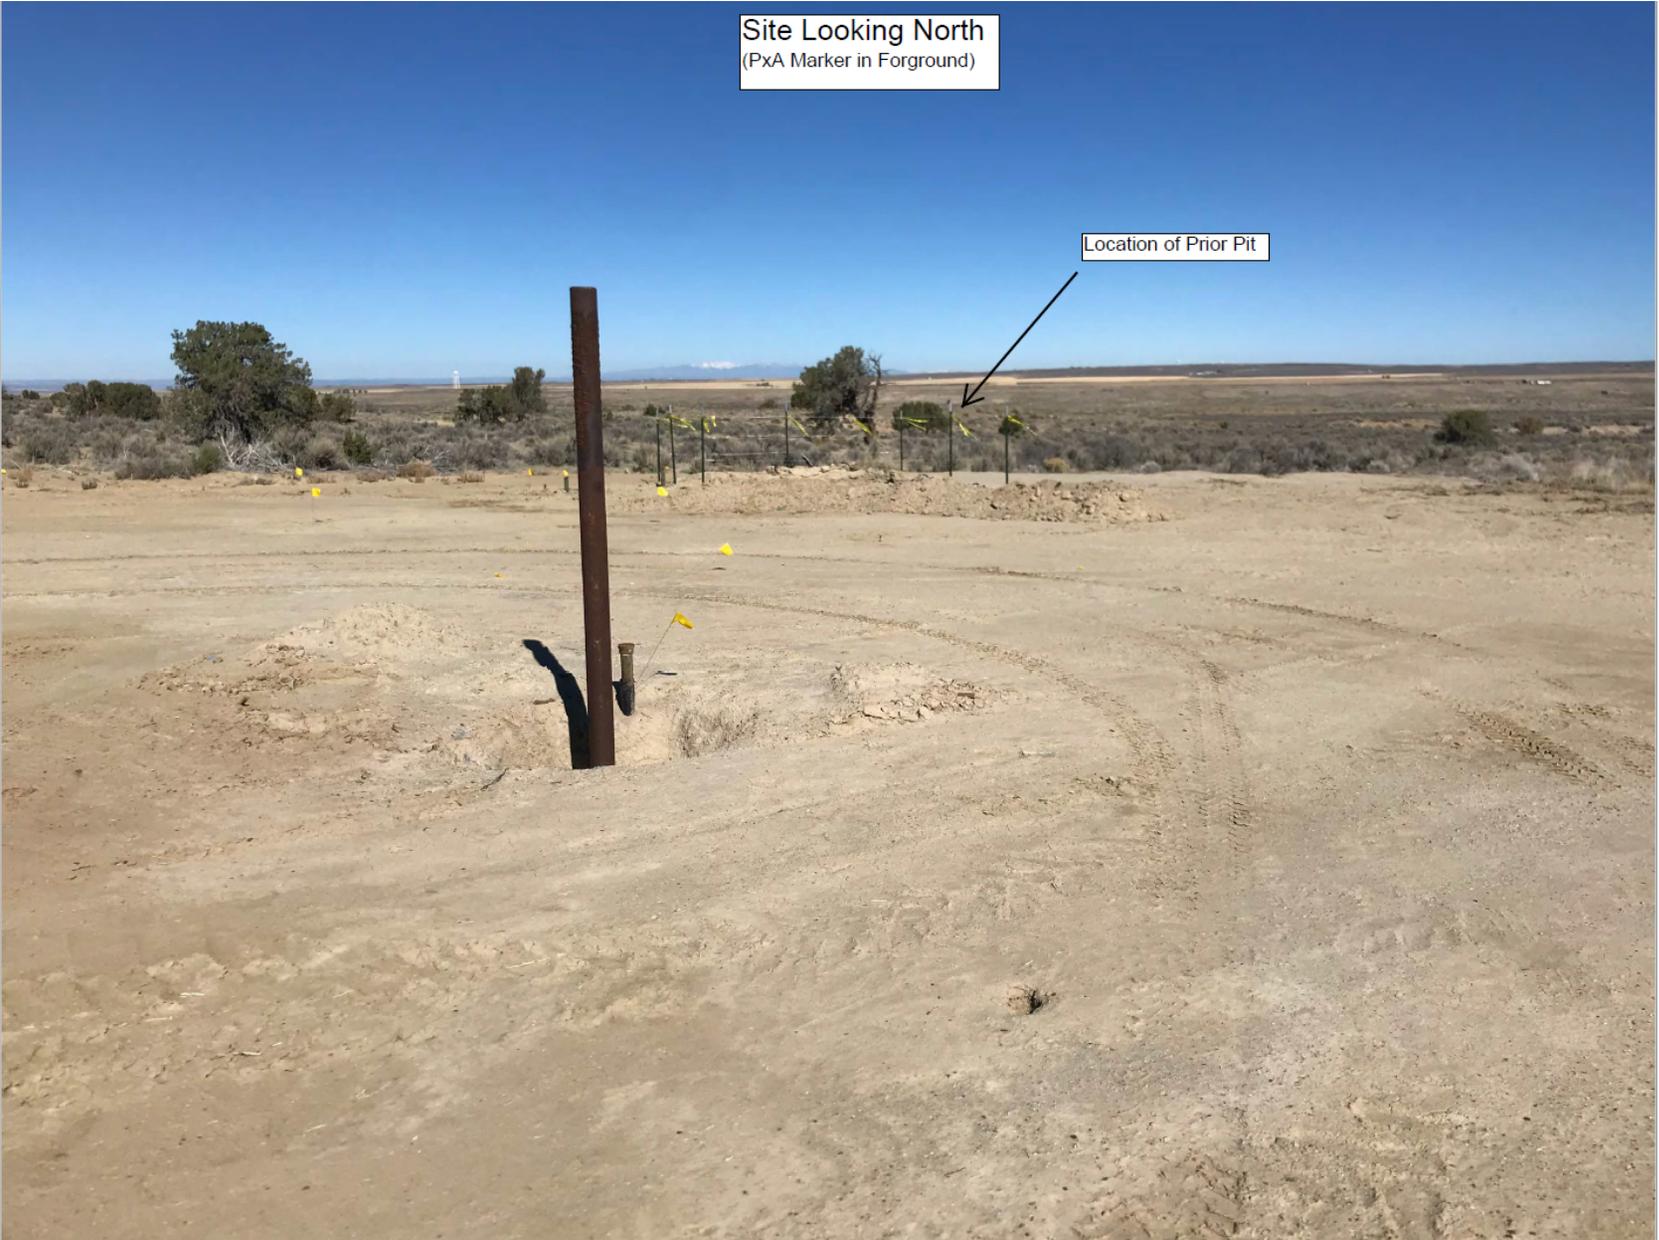
Site Looking North
(PxA Marker in Foreground)

DJR Operating, LLC excavated the pit and confirmed contamination concentrations with lab analysis. Attached to this letter are the documentation requirements per NMAC 19.15.29.

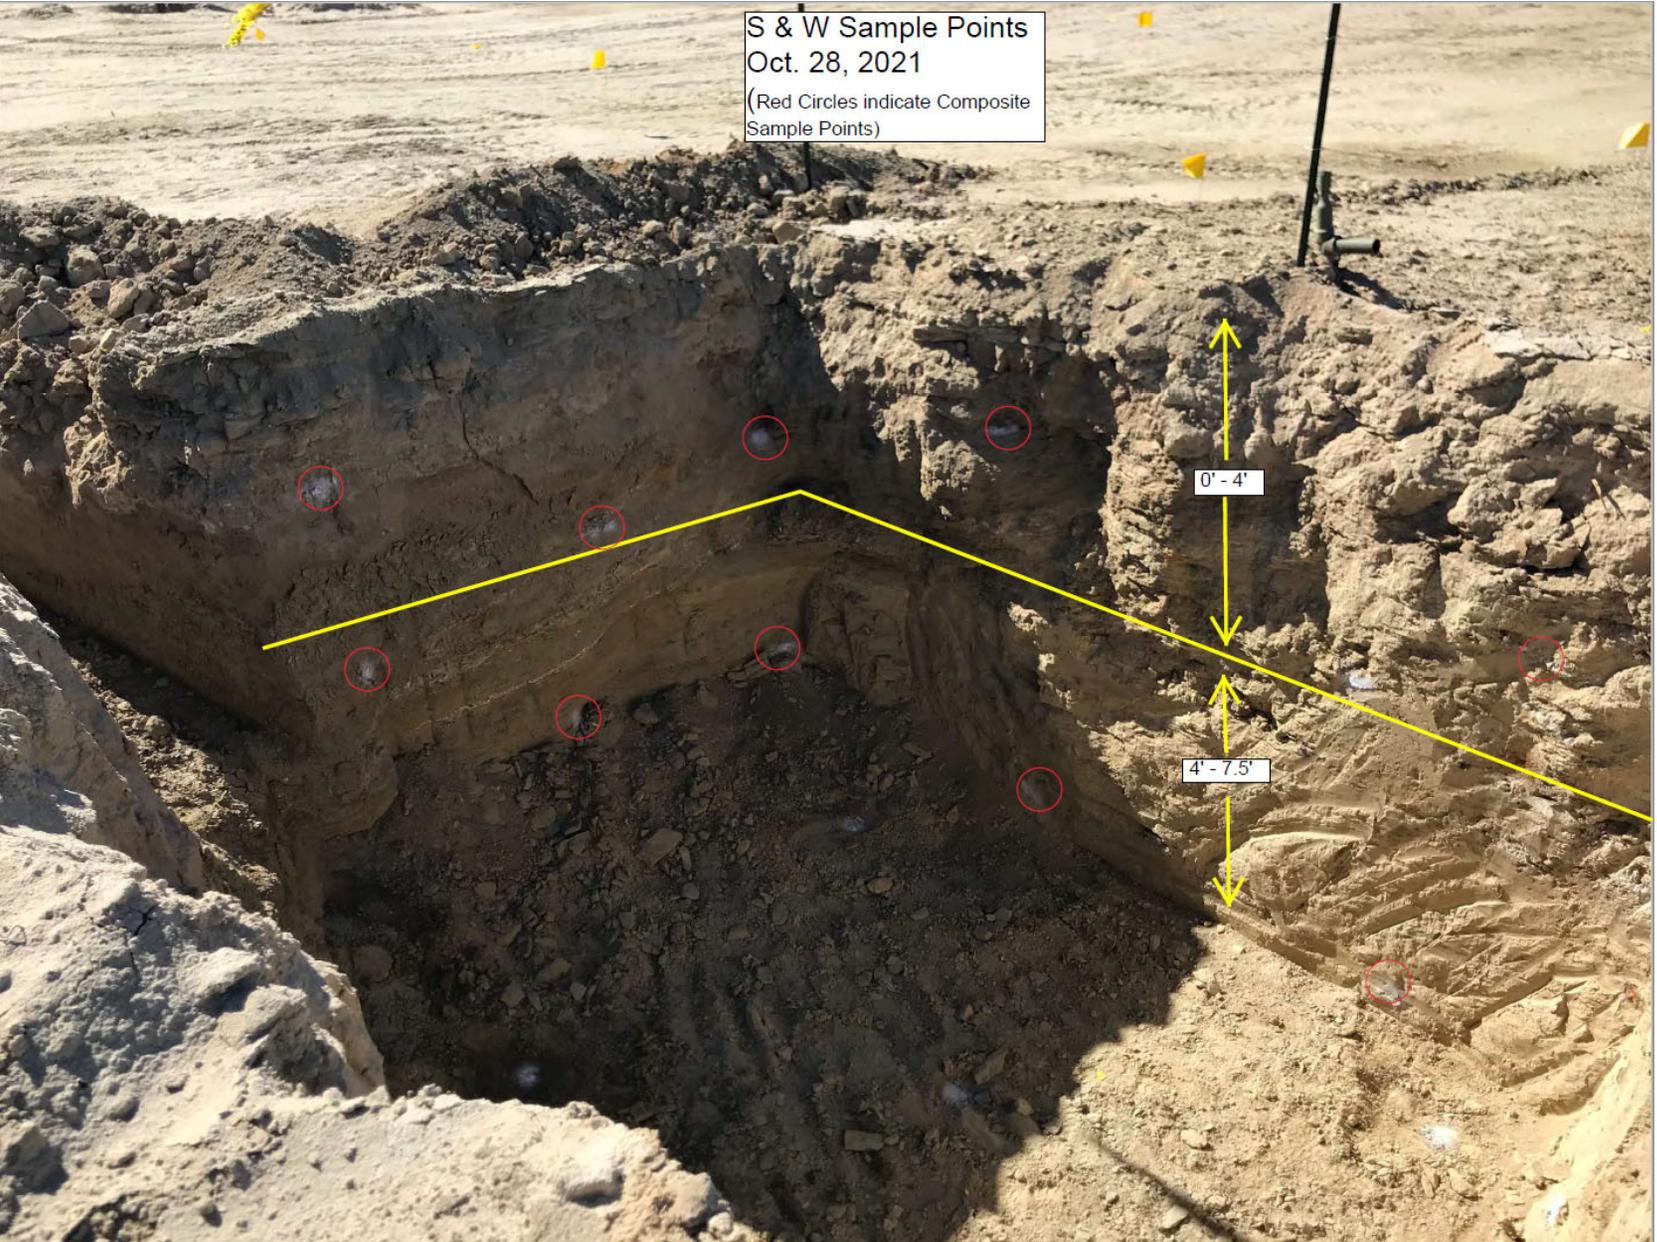
Location of Prior Pit
