Remediation Summary & Soil Closure Request

ETC Texas Pipeline, Ltd. Cal C Pipeline

Lea County, New Mexico
Unit Letter A, Section 12, Township 26 South, Range 36 East
Latitude 32.064591 North, Longitude 103.210708 West
NMOCD Reference No. nAPP2116745753

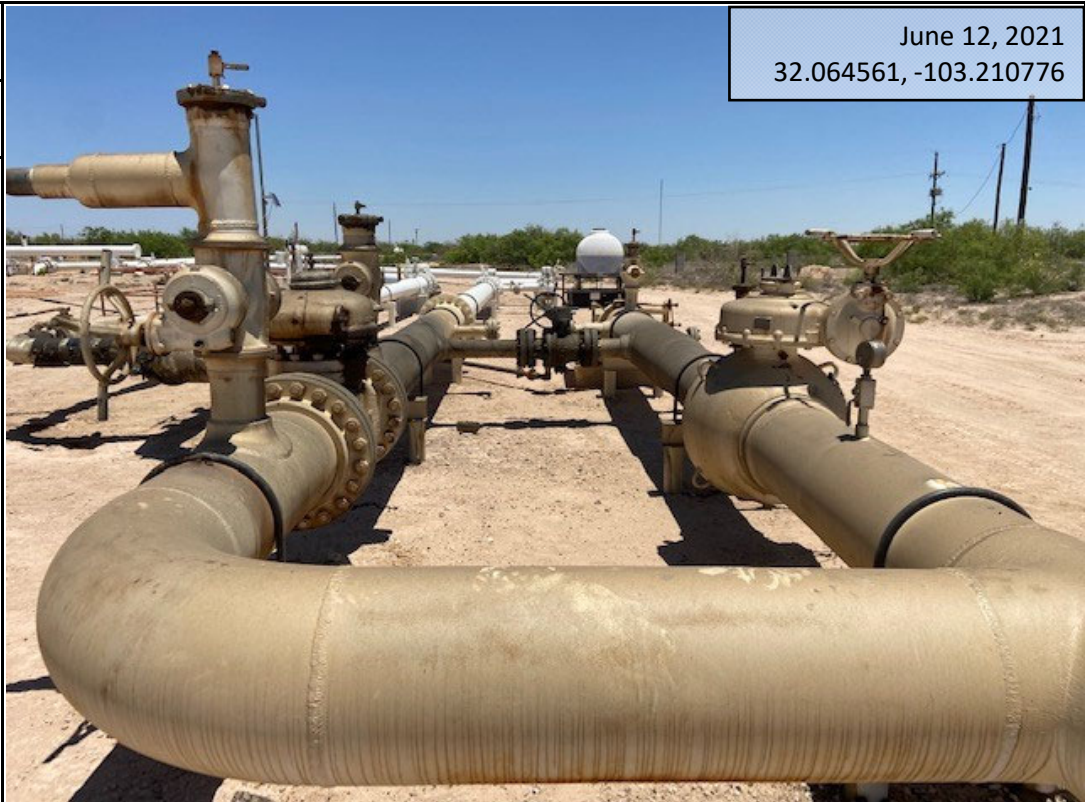
Photo Number: 2

June 12, 2021 32.064561, -103.210776
Photo Direction: East		
Photo Description: View of the affected area.

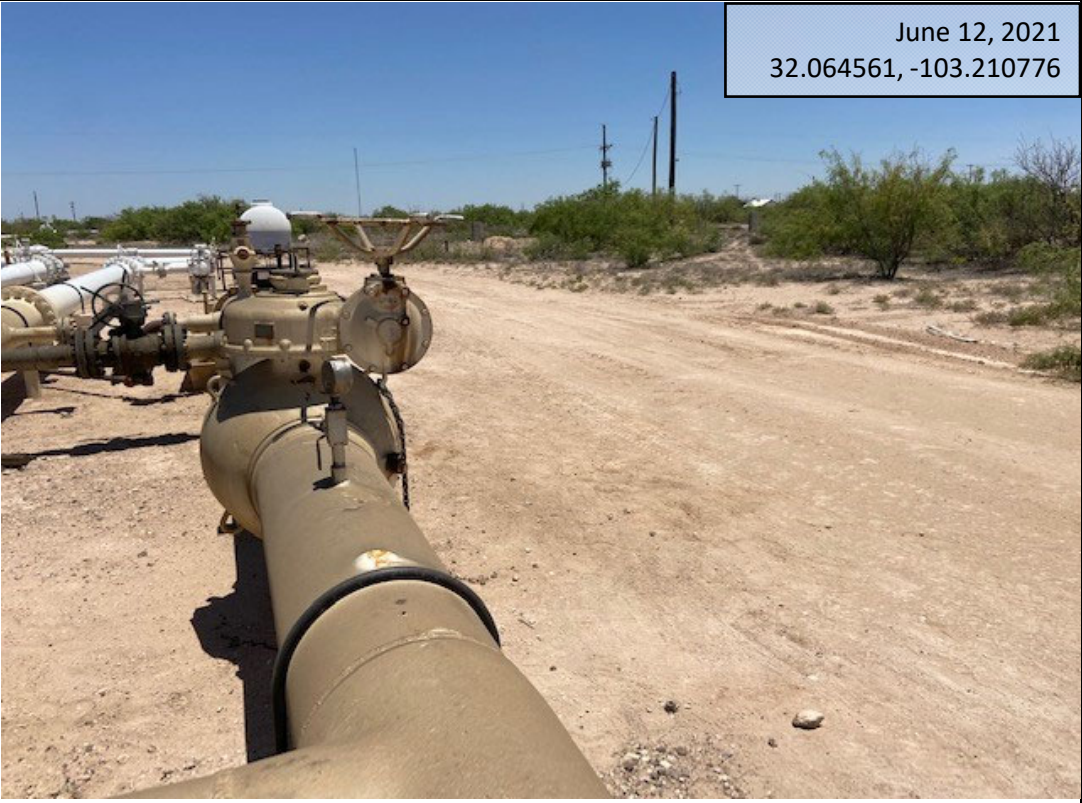
Photo Number: 3

<p>June 12, 2021 32.064561, -103.210776</p>
Photo Direction: East	
Photo Description: View of the affected area.

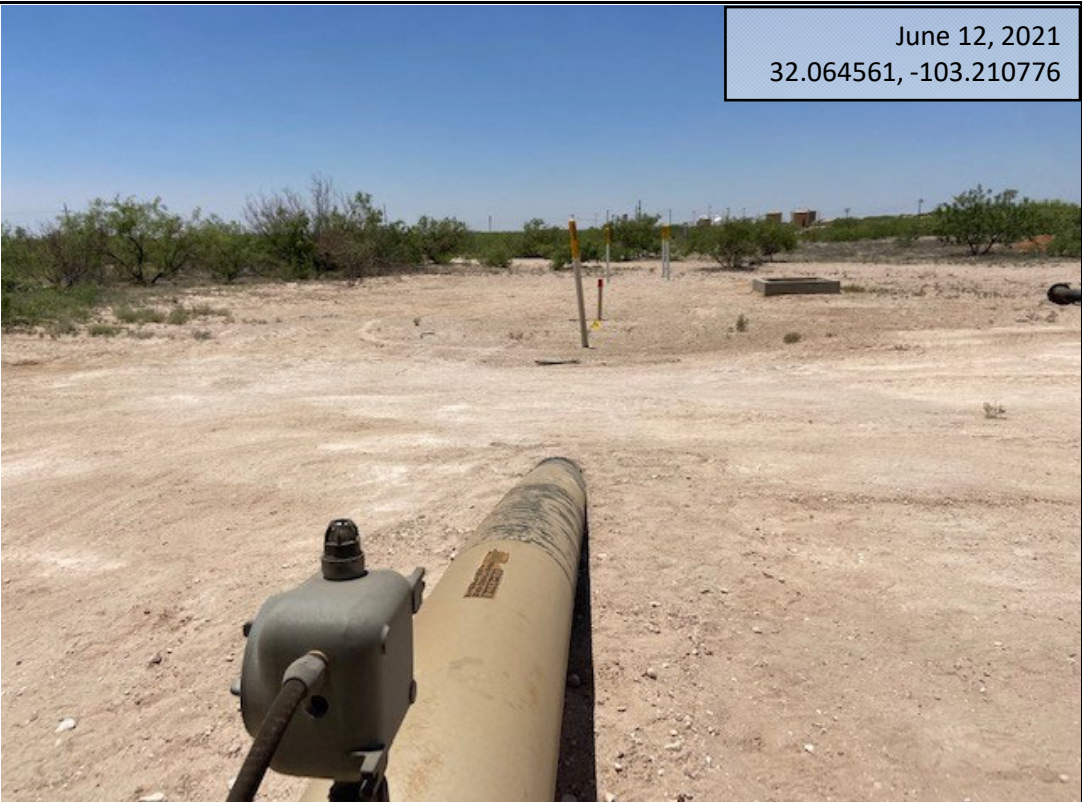
Photo Number: 4

<p>June 12, 2021 32.064561, -103.210776</p>
Photo Direction: West	
Photo Description: View of the affected area.

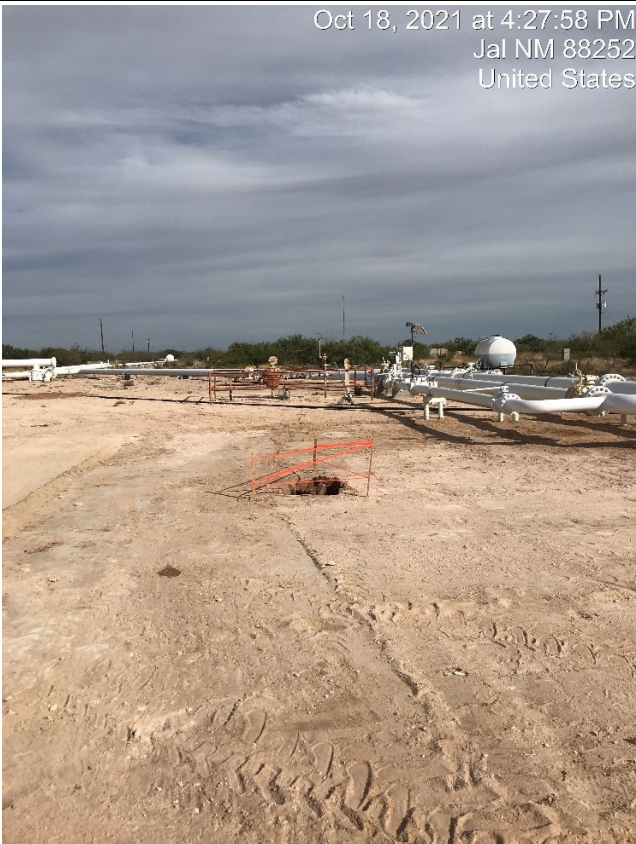
Photo Number: 7

A photograph showing a dirt area with a small excavation. In the background, there are white pipes and a cloudy sky. The photo is taken from an elevated position looking down at the excavation.
Photo Direction: East	
Photo Description: View of the excavated area.

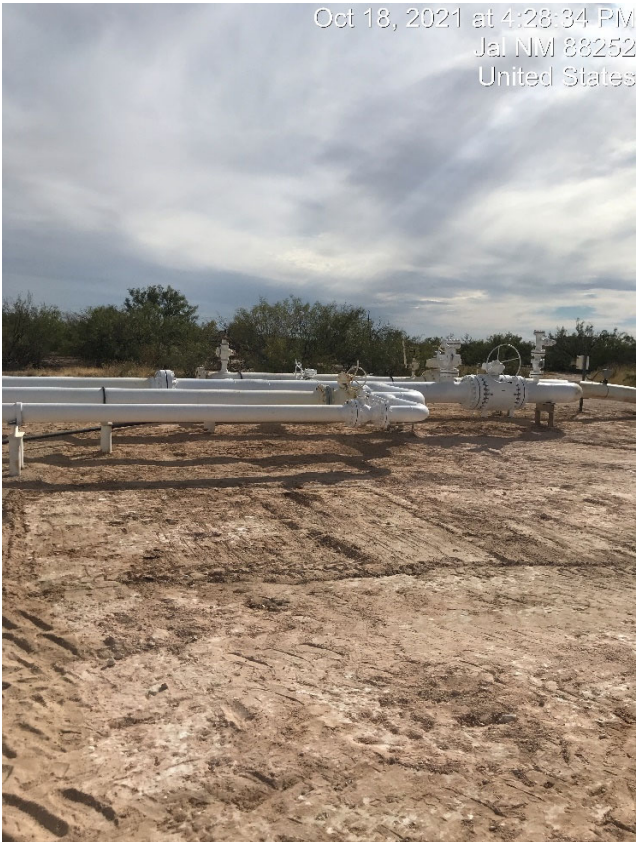
Photo Number: 8

A photograph showing a dirt area with a small excavation. In the background, there are white pipes and a cloudy sky. The photo is taken from an elevated position looking down at the excavation.
Photo Direction: Southwest	
Photo Description: View of the excavated area.

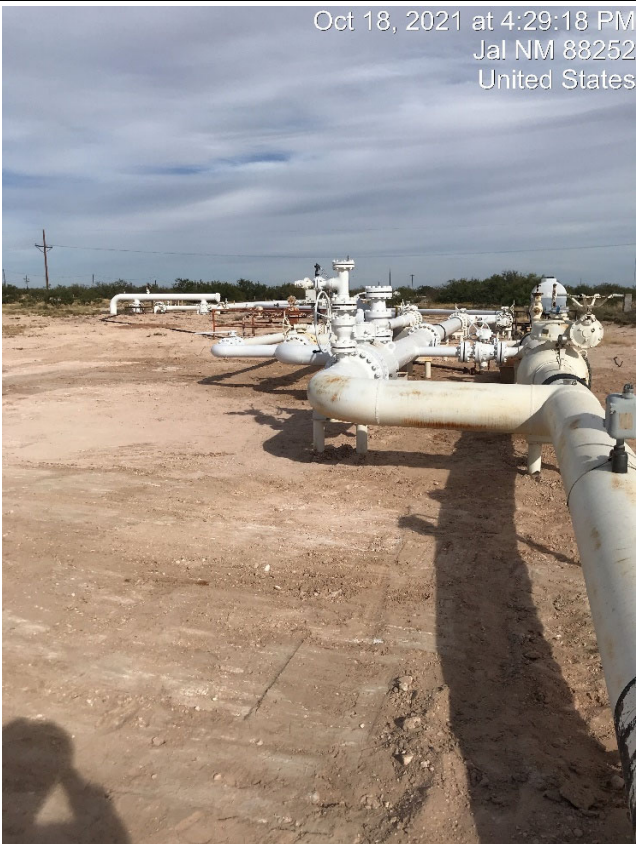
Photo Number: 9	<div>Oct 18, 2021 at 4:29:18 PM Jal NM 88252 United States</div>

Photo Direction: East	
Photo Description: View of the excavated area.
