Site Assessment/Characterization

State of New Mexico
Oil Conservation Division

Based on laboratory analytical results and field activities conducted to date, Etech recommends ETC Texas Pipeline, Ltd., provide copies of this *Remediation Summary & Soil Closure Request* to the appropriate agencies and request closure be granted to the Site.

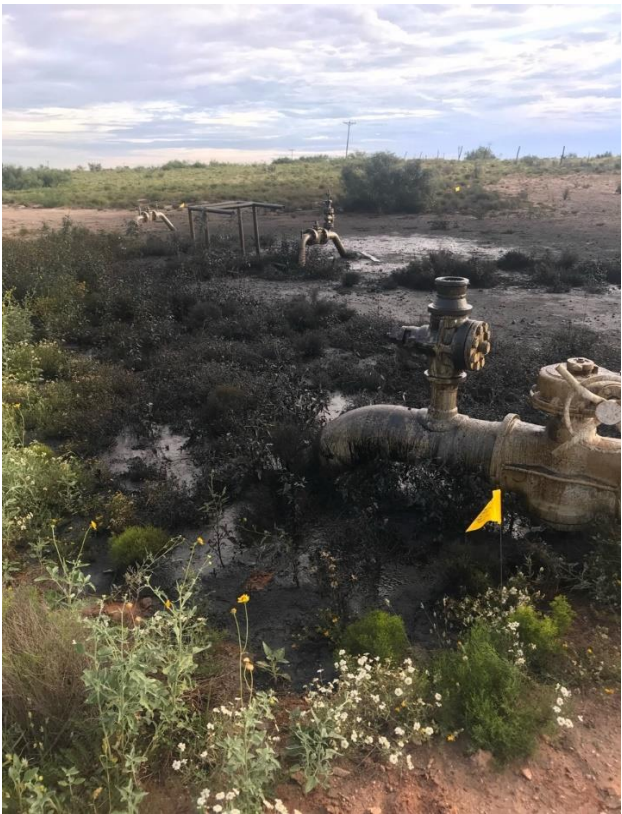
Photo Number: 1

Photo Direction: East	
Date: 8/12/2021	
Coordinates: 32.370974,-103.1256228	
Photo Description: View of the affected area.

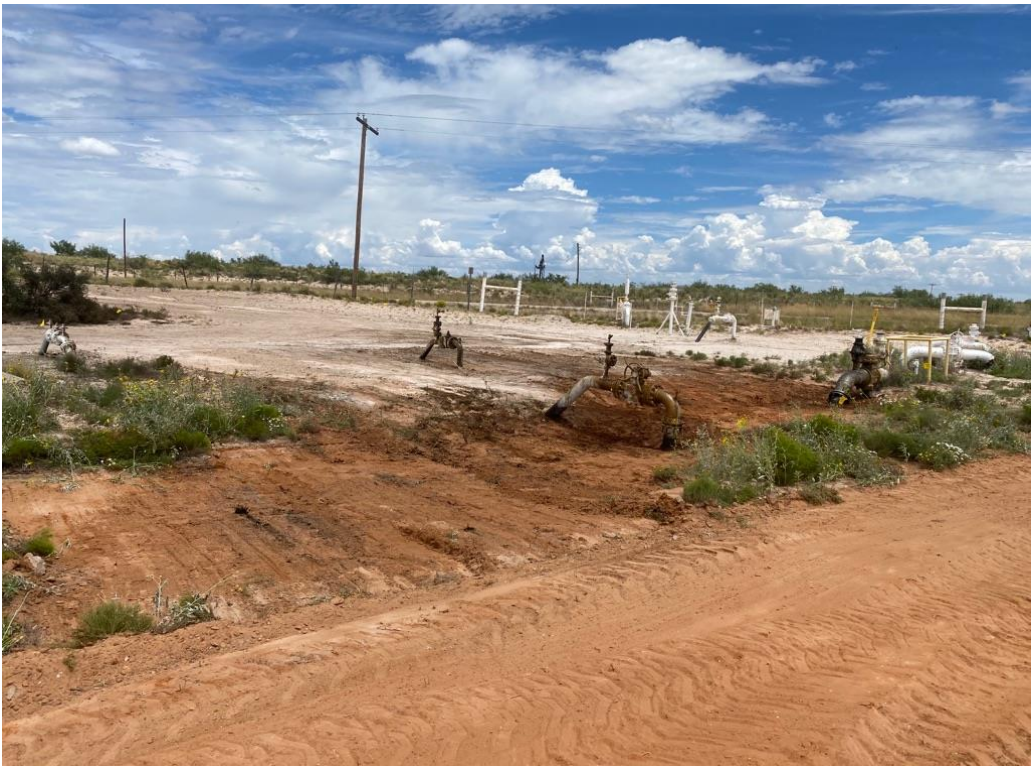
Photo Number: 2

Photo Direction: Northeast	
Date: 8/13/2021	
Coordinates: 32.370933,-103.125641	
Photo Description: View of the affected area.

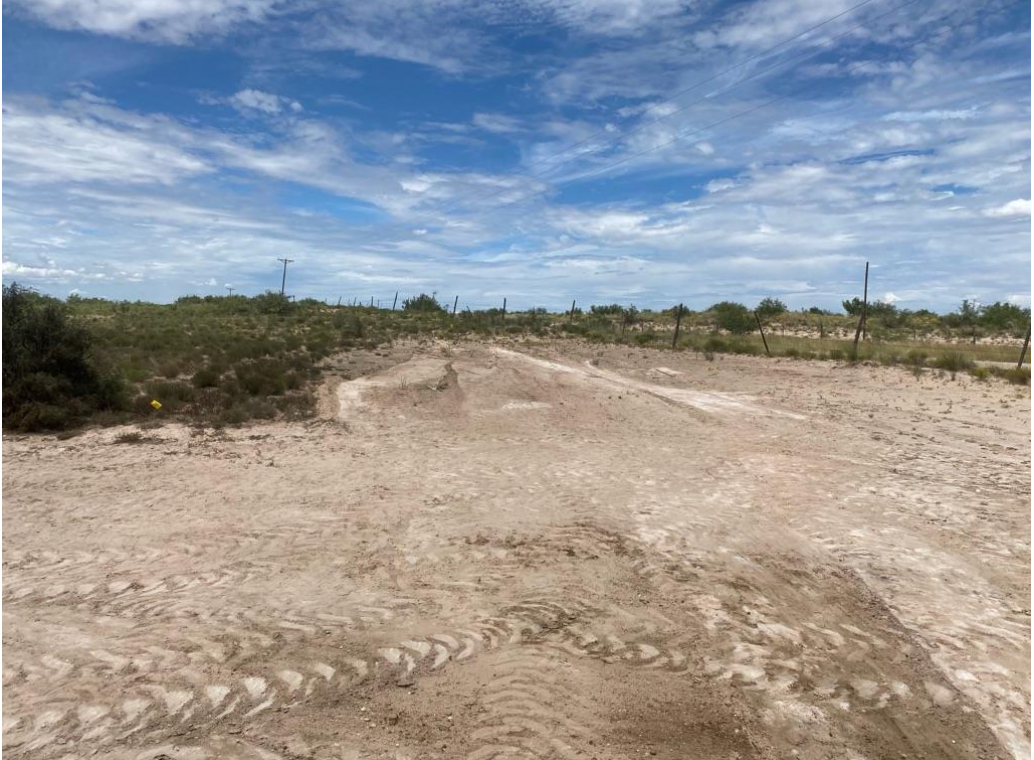
Photo Number: 3

Photo Direction: North-Northeast	
Date: 8/13/2021	
Coordinates: 32.371099,-103.125556	
Photo Description: View of the affected area.

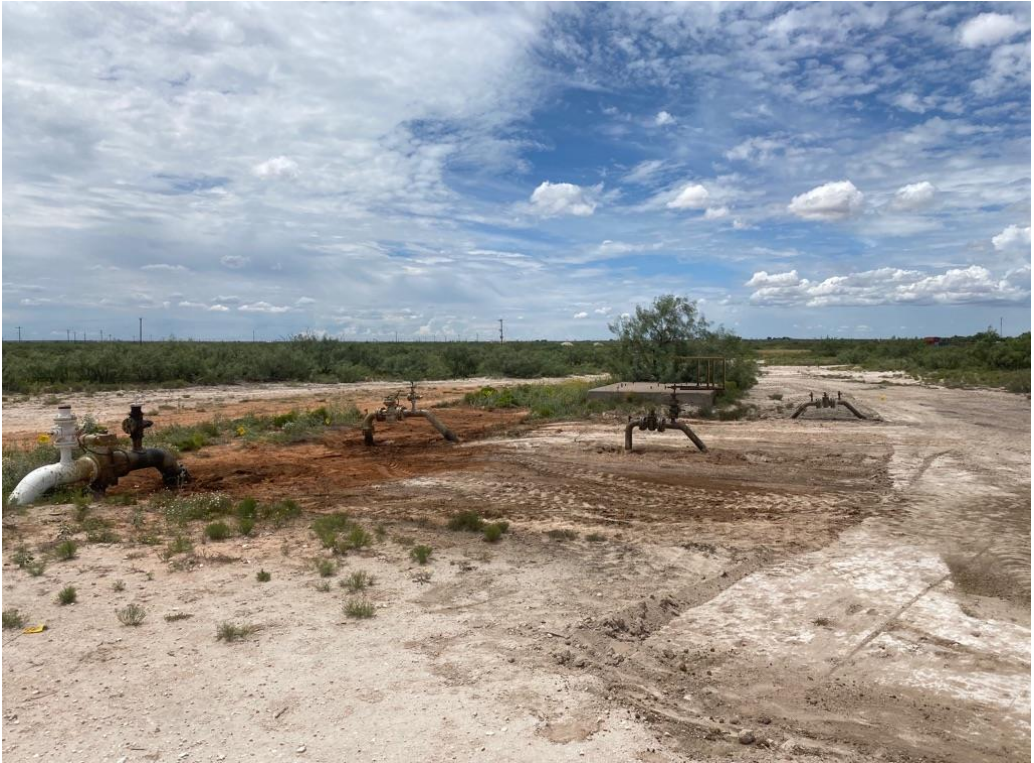
Photo Number: 4

Photo Direction: Northwest	
Date: 8/13/2021	
Coordinates: 32.371008,-103.125513	
Photo Description: View of the affected area.

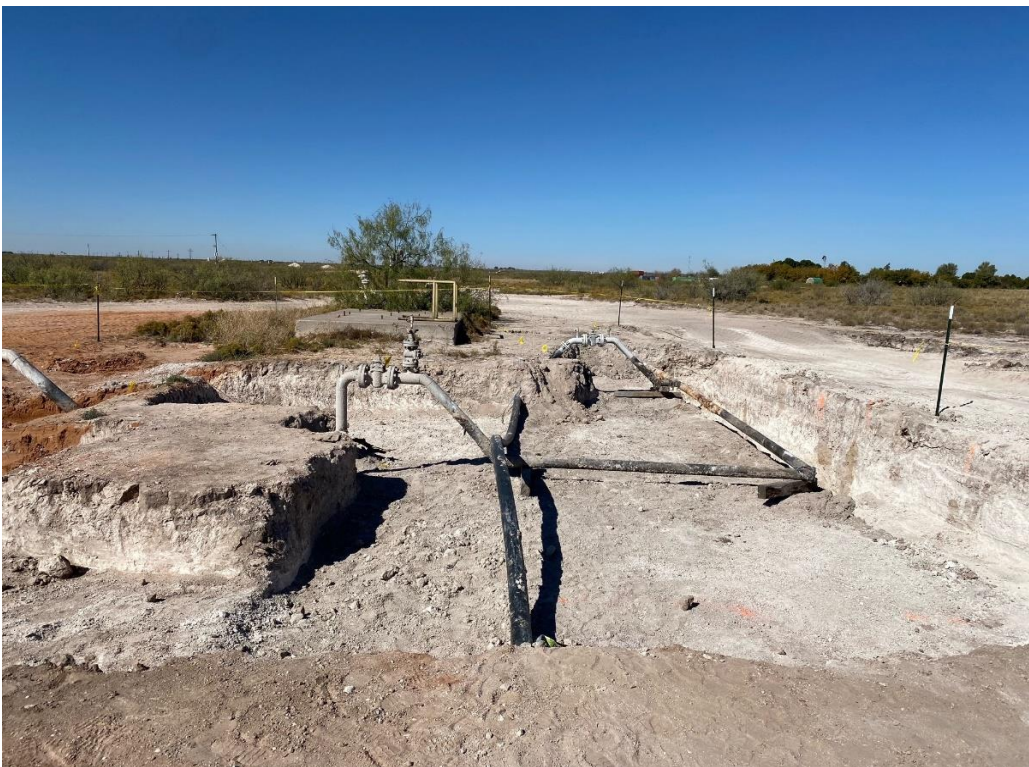
Photo Number: 5

Photo Direction: Northwest	
Date: 10/25/2021	
Coordinates: 32.371027,-103.125535	
Photo Description: View of the excavated area.

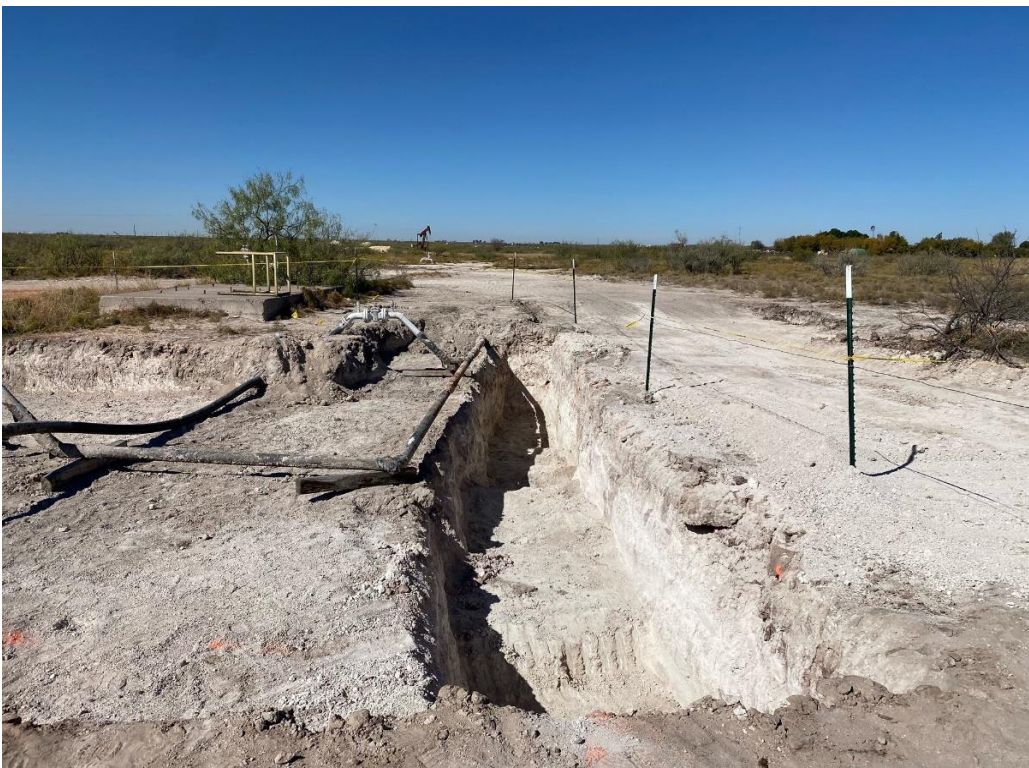
Photo Number: 6

Photo Direction: Northwest	
Date: 10/25/2021	
Coordinates: 32.371027,-103.125535	
Photo Description: View of the excavated area.

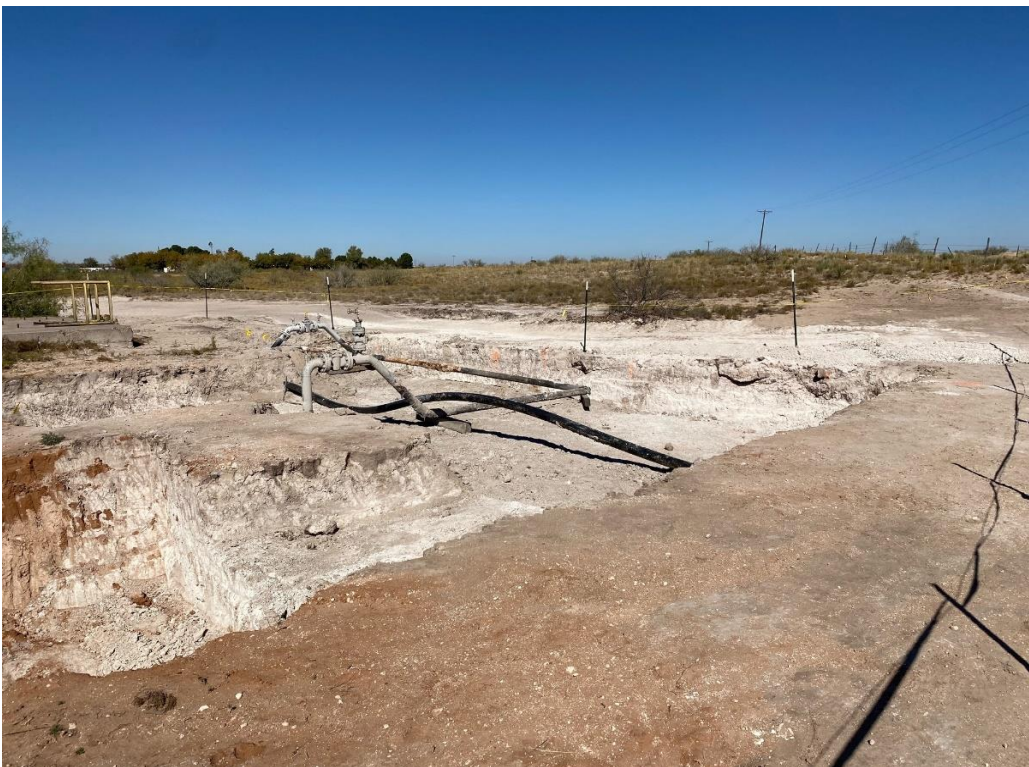
Photo Number: 7

Photo Direction: North-Northwest	
Date: 10/25/2021	
Coordinates: 32.371027,-103.125535	
Photo Description: View of the excavated area.

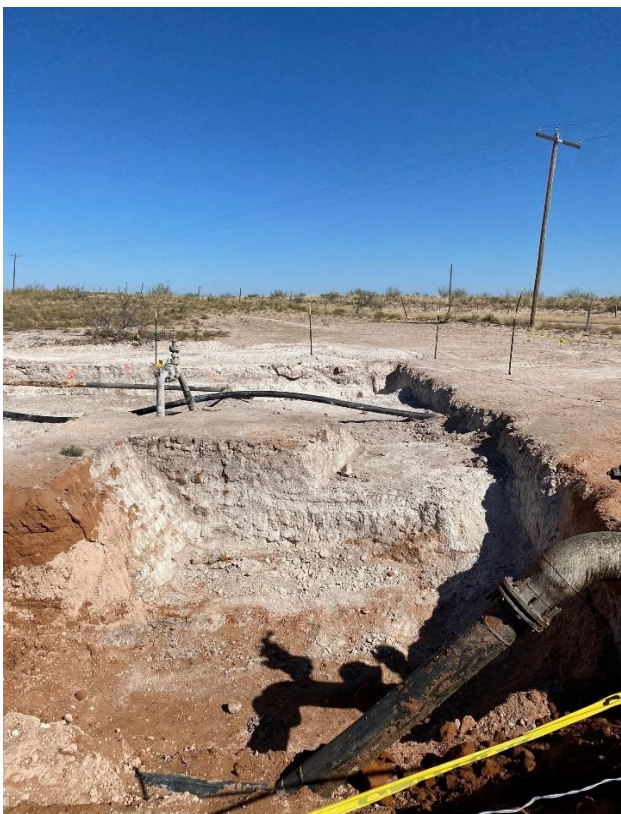
Photo Number: 8

Photo Direction: North-Northeast	
Date: 10/25/2021	
Coordinates: 32.371002,-103.125504	
Photo Description: View of the excavated area.

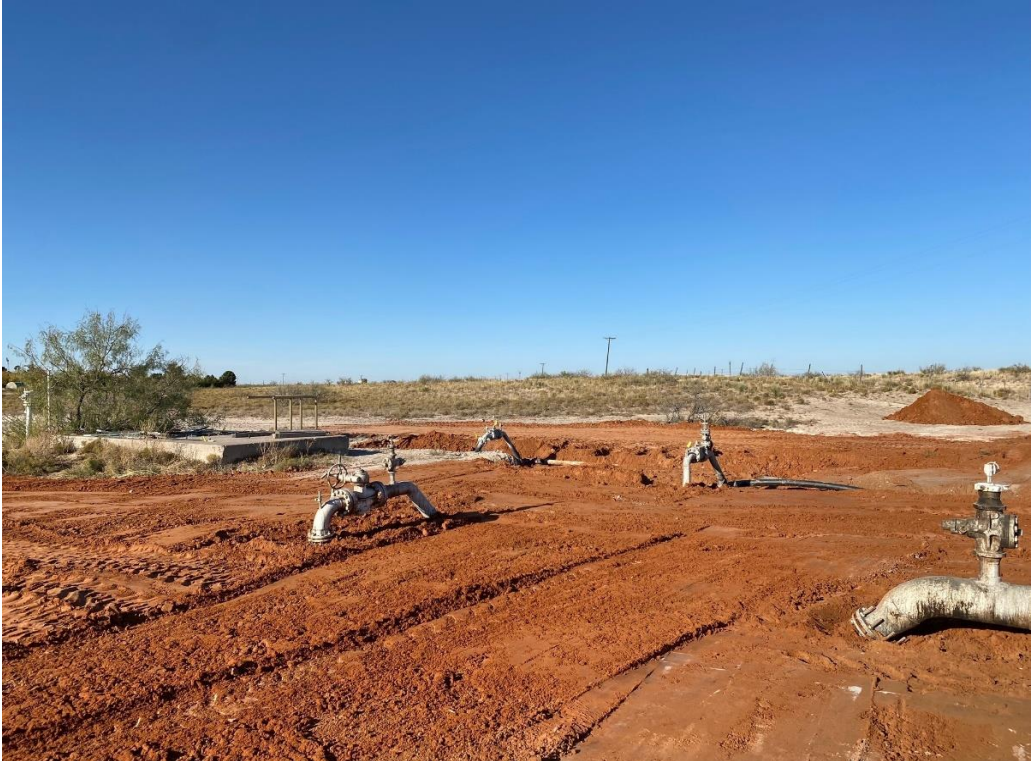
Photo Number: 9

Photo Direction: North	
Date: 11/15/2021	
Coordinates: 32.370974,-103.1256228	
Photo Description: View of the remediated area following backfill and regrading.

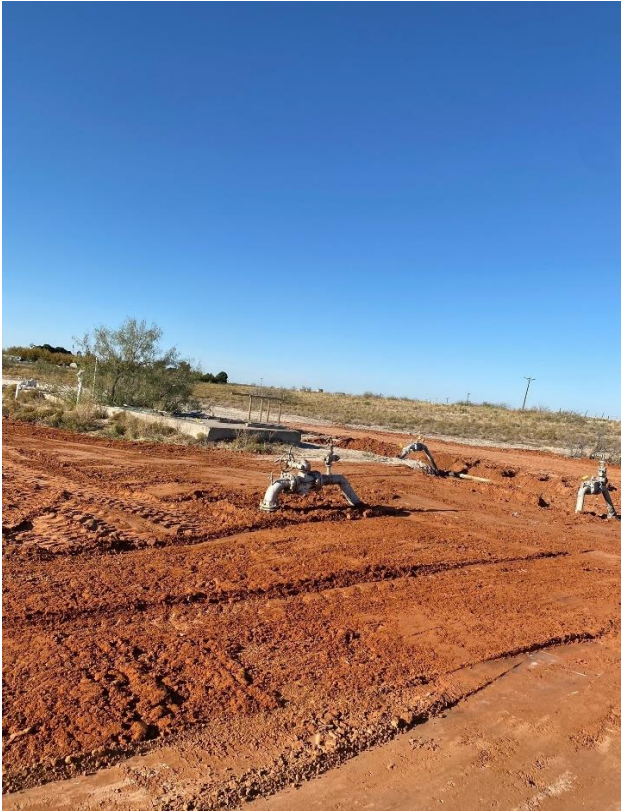
Photo Number: 10

Photo Direction: North-Northwest	
Date: 11/15/2021	
Coordinates: 32.370954,-103.125674	
Photo Description: View of the remediated area following backfill and regrading.
