Release Notification

Release Confirmation Sampling Report

Jicarilla 96-002C

Logos Operating, LLC
Jicarilla 96 002C
Release Closure Report
API #30-039-26827
Unit G, Section 2, T26N, R3W
Rio Arriba County, New Mexico

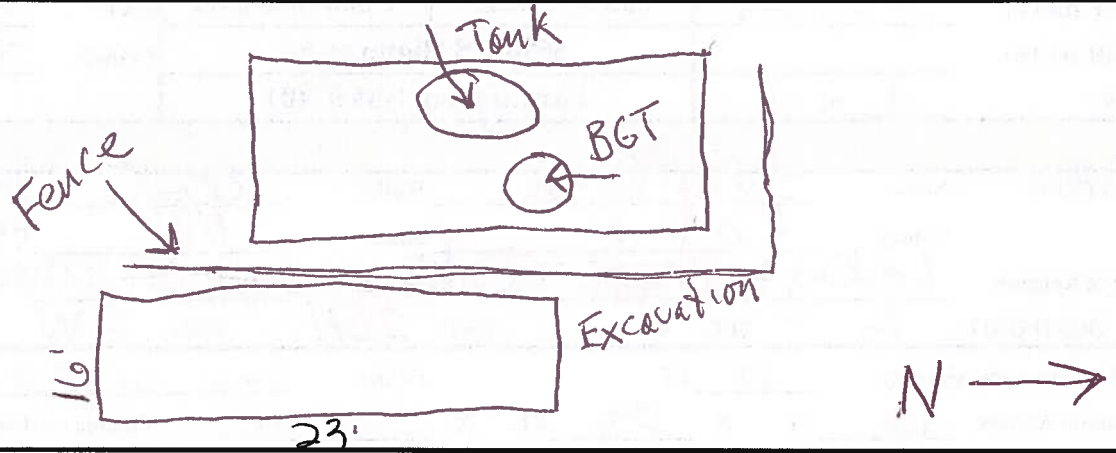
SITE PERIMETER: Draw a schematic of the spill site. Attach photos and other diagrams as needed.

Keith Maxwell w/ JOGA on site
 Jason Meechan w/ LOGOS on site
 Kelly Field Services on site as well, excavating
 Keith Maxwell w/ JOGA left site @ 1230
 base is competent sandstone couldn't excavate

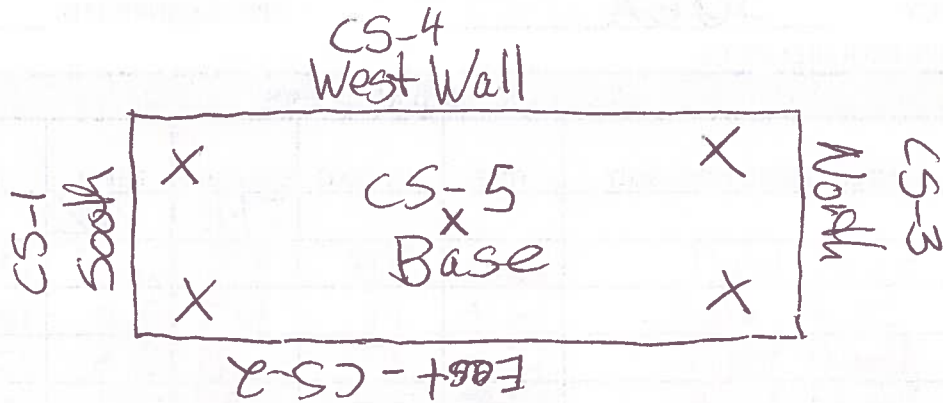
EXCAVATION OVERVIEW:

The final dimensions of the excavation measured approximately 16 feet by 23 feet by 5 feet below ground surface (bgs). Samples were collected from the four (4) walls and the base of the excavations. The soil samples were placed into individual laboratory provided 4-ounce jars, capped head space free, and transported on ice to Envirotech Analytical Laboratory. The soil sample locations are illustrated in **Figure 2, Site Map** and in **Appendix C, Field Notes with EPA 418.1 Field Screening Reports**.

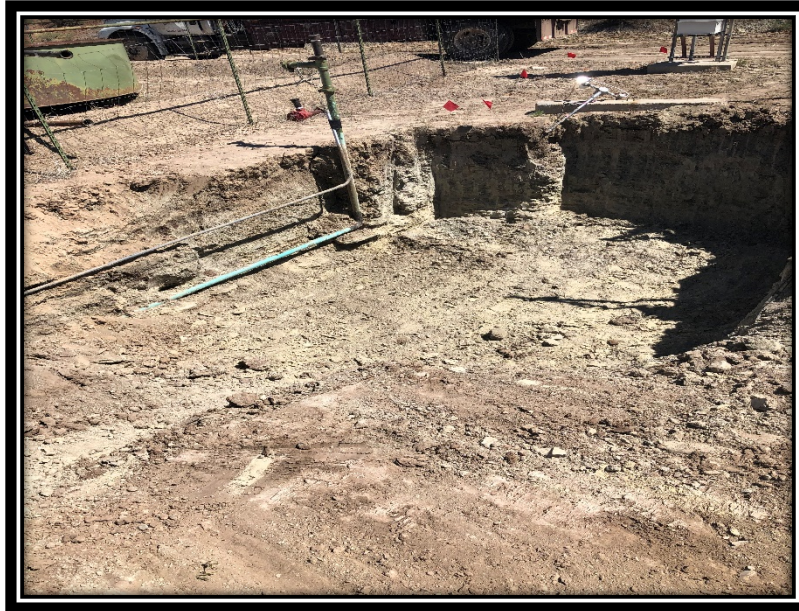
Picture 1: Excavation (View 1)

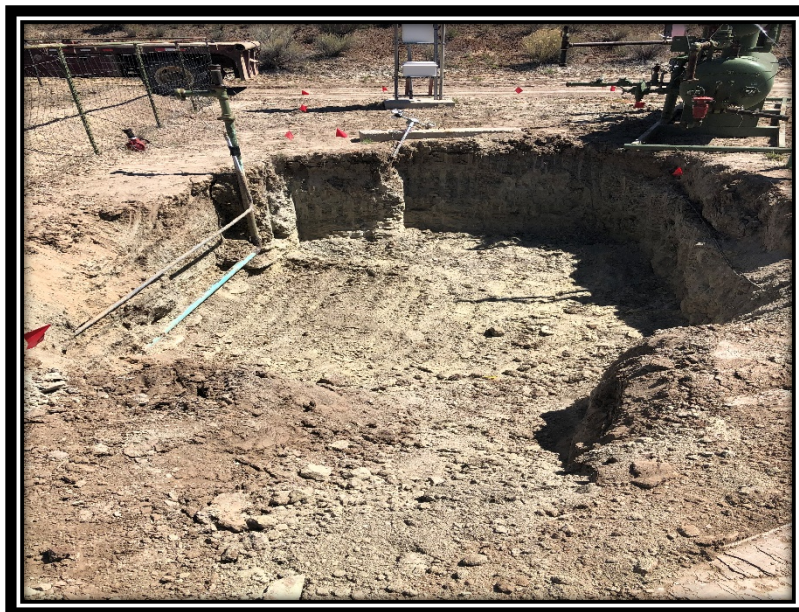
Picture 2: Excavation (View 2)

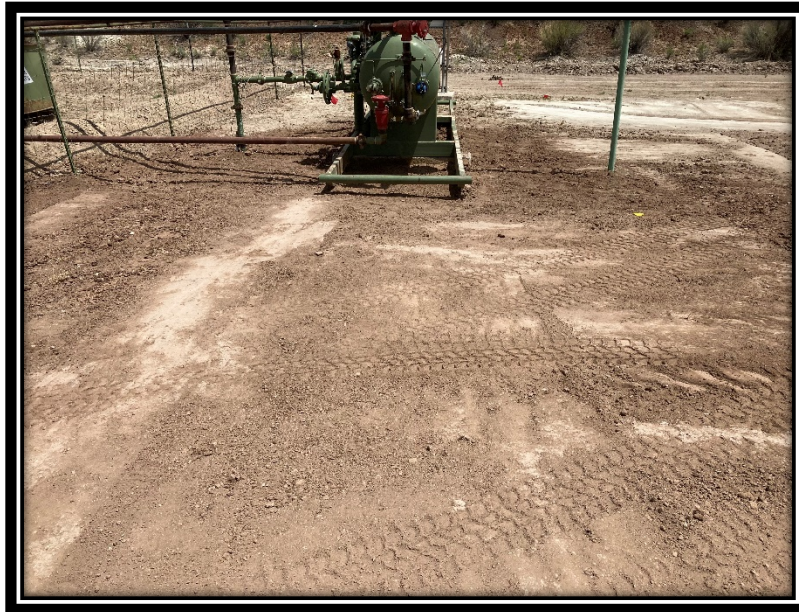
Picture 3: Backfilled Area (View 1)

Logos' contractor completed the backfill of the subject excavation on May 14, 2021. The excavation was backfilled with JOGA approved, non-waste containing, earthen material. The site was recontoured and graded to prevent ponding and erosion. The location is an active site; therefore, the area was not prepped for seeding. Backfill photos are provided in **Appendix E**.

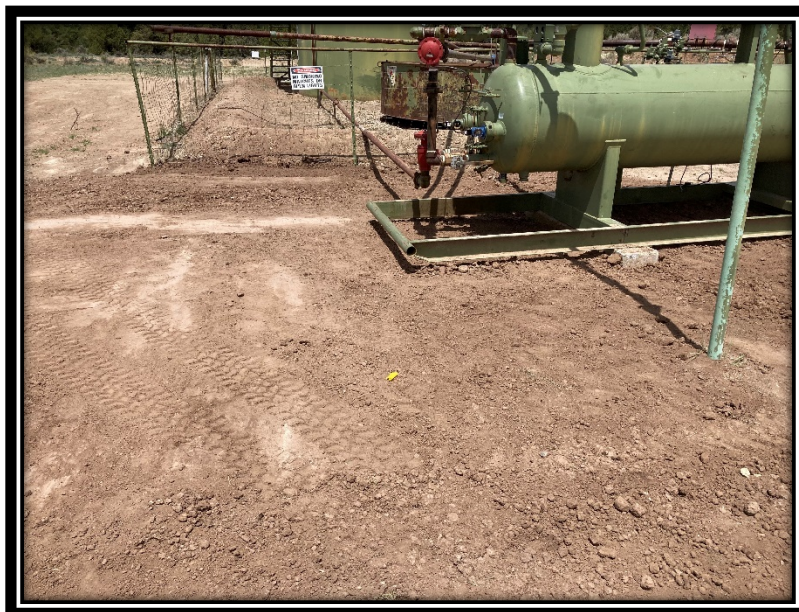
Picture 4: Backfilled Area (View 2)
