Re: Site Update
Former State G 4 Tank Battery, 1R-4863
Sec 18, T-19S, R-37E, Lea County

Photo Log

1R-4863, Former State G 4 Tank Battery

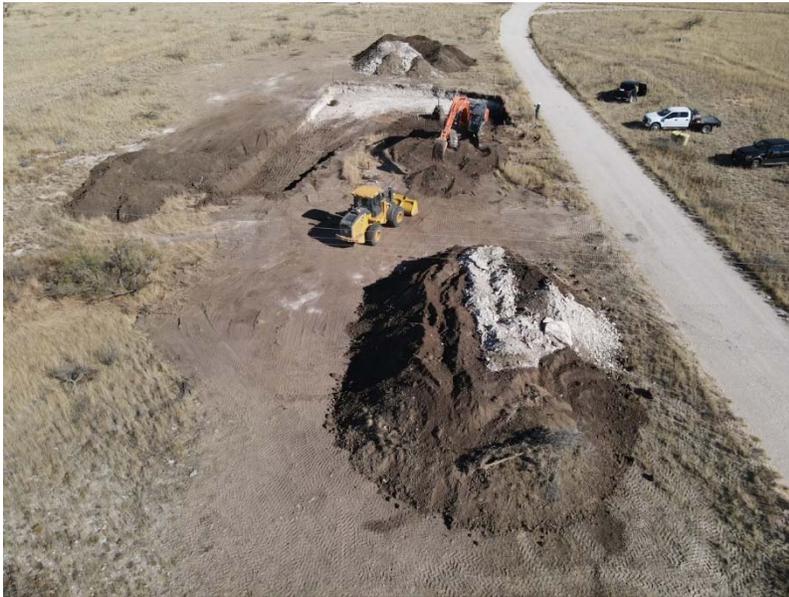
Photo 1- Aerial view of excavation facing east

Implementation of the approved scope of work began on December 2, 2021. Prior to beginning the excavation activities, the concrete pads were removed from the monitoring wells within the excavation area. Soils were then excavated and stockpiled on site until a waste characterization analysis was received and approval for disposal was received from C and C Landfarm near Monument, New Mexico. A waste characterization sample was collected and sent to Cardinal Laboratories in Hobbs, New Mexico for TPH Gasoline Range Organics (GRO), TPH Diesel Range Organics (DRO), TPH Extended DRO, Benzene, Toluene, Ethylbenzene, and Chloride. The waste characterization sample had a TPH-DRO detection of 87.8 milligrams per kilogram (mg/kg), an Extended TPH-DRO detection of 98.2 mg/kg, and a Chloride detection of 48 mg/kg. A summary of the waste characterization sample is found in **Table 1** and the laboratory report is found in **Attachment 1**. The excavation area comprised approximately 16,000 square feet to a depth of 4 feet below ground surface (bgs). The approximately 2,300 cubic yards of excavated soils were stockpiled onsite prior to being loaded into belly dump trucks for final disposal. A total of 127 truckloads of excavated soil were transported to C and C Landfarm.

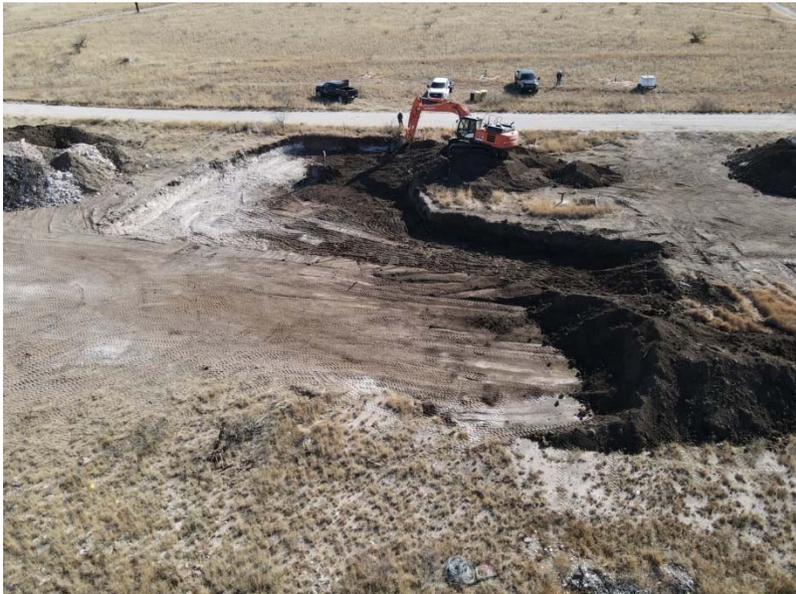
Photo 2 – Aerial view of excavation facing south

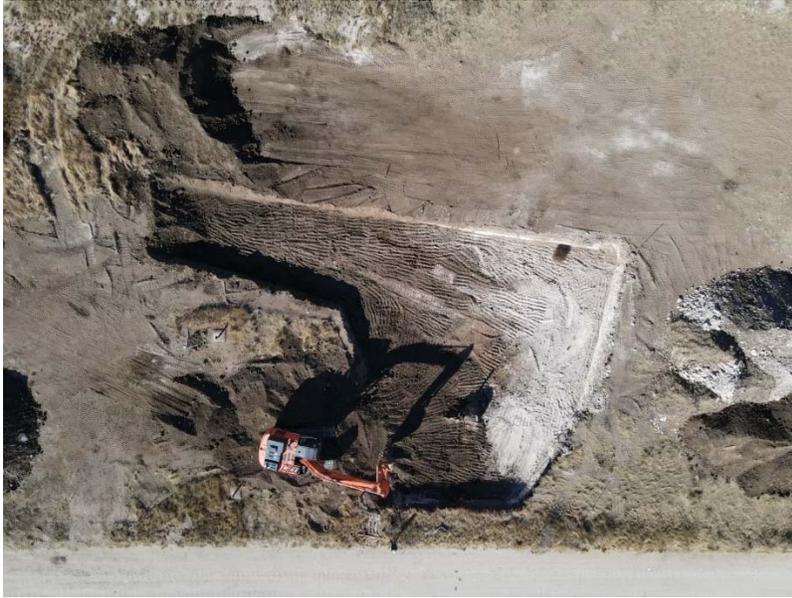
Photo 3 – Direct overhead view of excavation

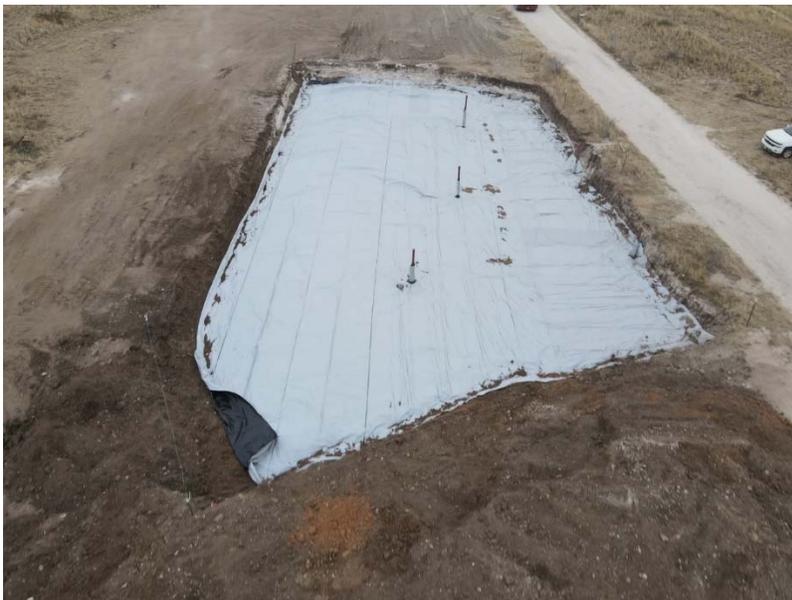
Photo 4 – Aerial view of installed liner facing east

Subsequent to excavation activities, the excavation area was fully lined with a 20-mil polyethylene liner. The 20-mil polyethylene liner was installed over the monitor well riser pipes and then sealed to the steel

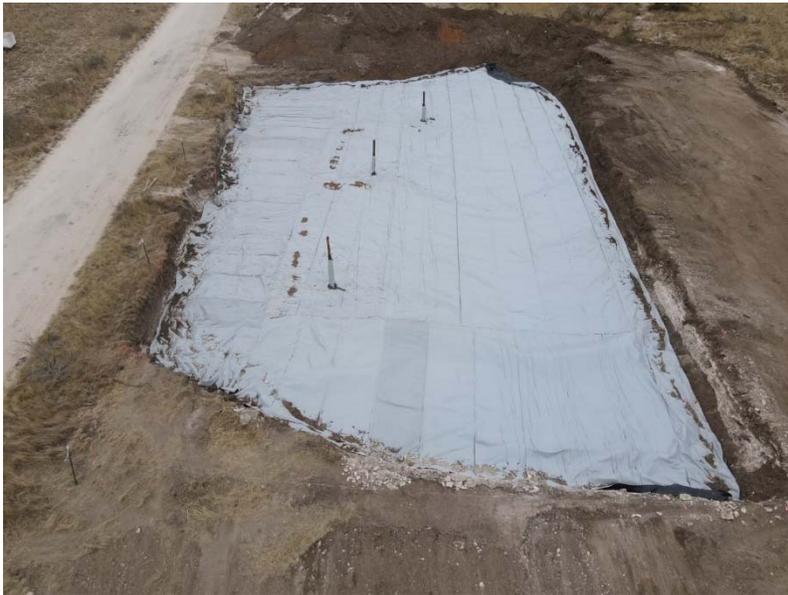
Photo 5 – Aerial view of installed liner facing west

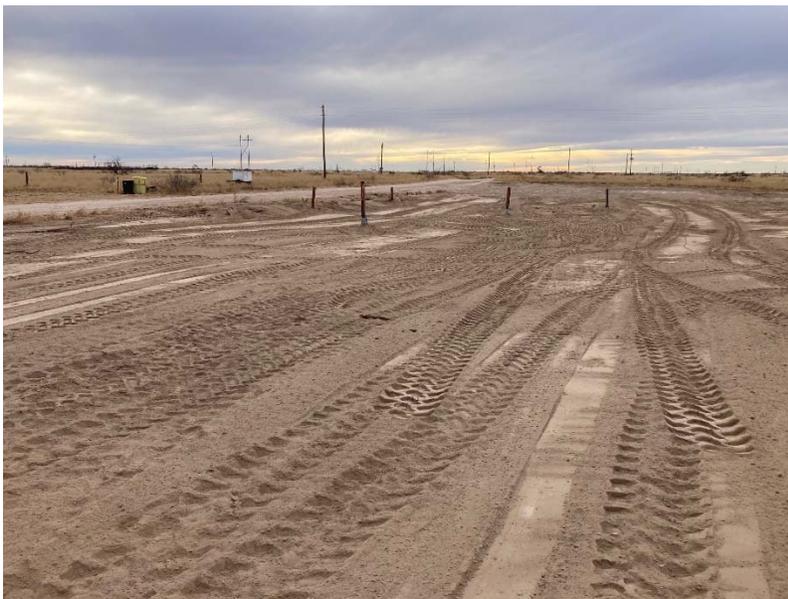
Photo 6 – View of backfilled excavation facing west

well shelter. Upon completing the liner installation, belly dump trucks began transporting approved backfill material to the site. The backfill material placed into the lined excavation was consisted of two feet of topsoil on top of two feet of caliche. The backfilled excavation was then leveled to the surrounding grade surface utilizing the loader. Native grass seed and fertilizer was subsequently applied. Photographs of the excavation, liner installation, and backfilling are found in **Attachment 2**. Subsequent to completion, the concrete pads were re-installed around the base of the monitor well shelters.

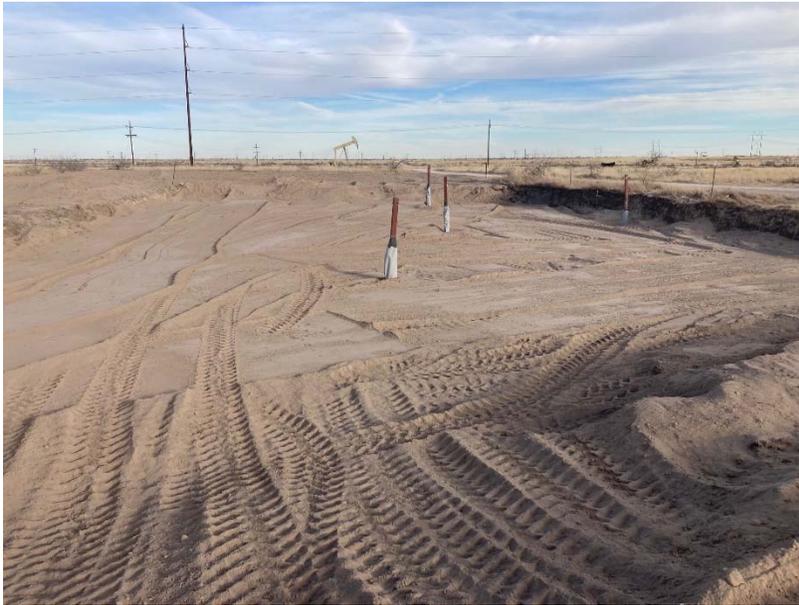
Photo 7 – View of the backfilled excavation facing east
