**Re: Release Characterization and Closure Request
ConocoPhillips
Heritage Concho
GJ West Coop Trunkline Releases
Unit Letter B, Section 28, Township 17 South, Range 29 East
Eddy County, New Mexico
Incident ID# NJMW1228952965**

TETRA TECH, INC. PROJECT NO. 212C-MD-02622	DESCRIPTION	View east of northwestern corner of inspection area.	1
	SITE NAME	ConocoPhillips: GJ West Coop 125 Site Visit	12/23/2021

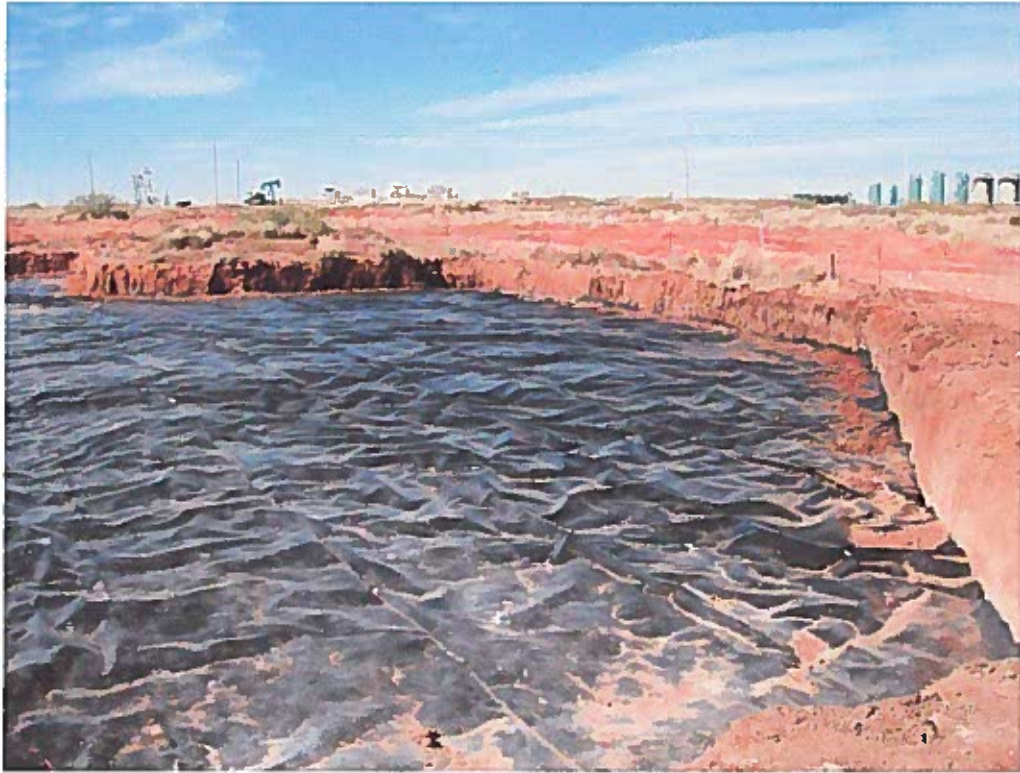
View West – Along COG buried water line at SB-1 and SB- 5

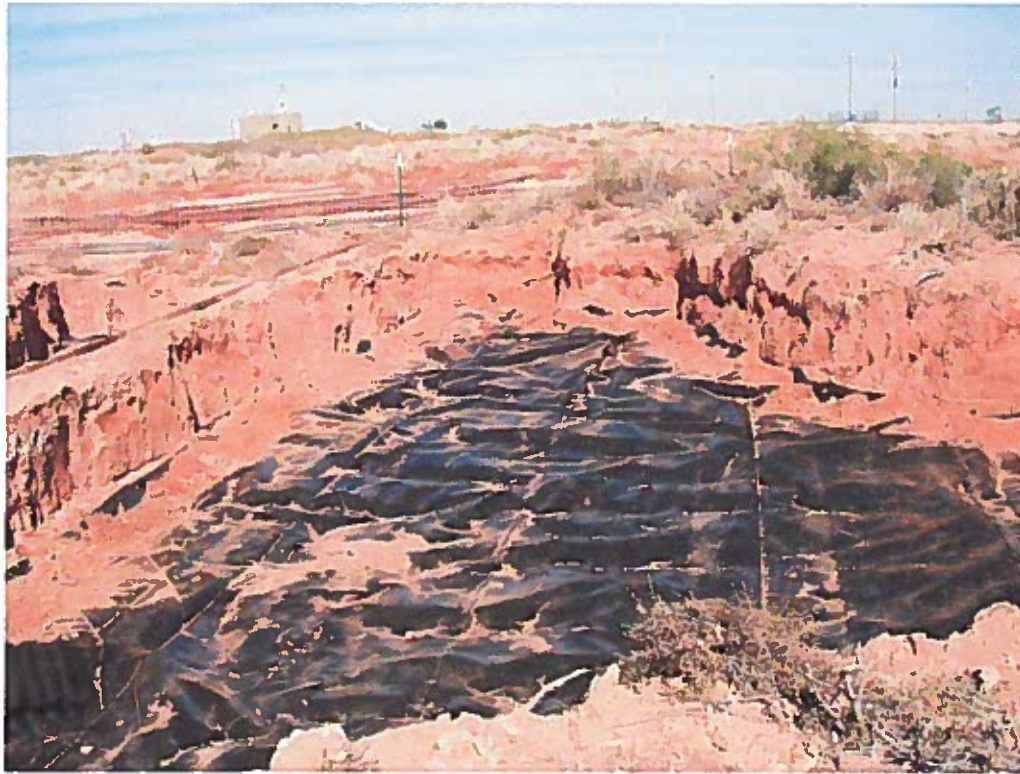
View North – Area of SB-9

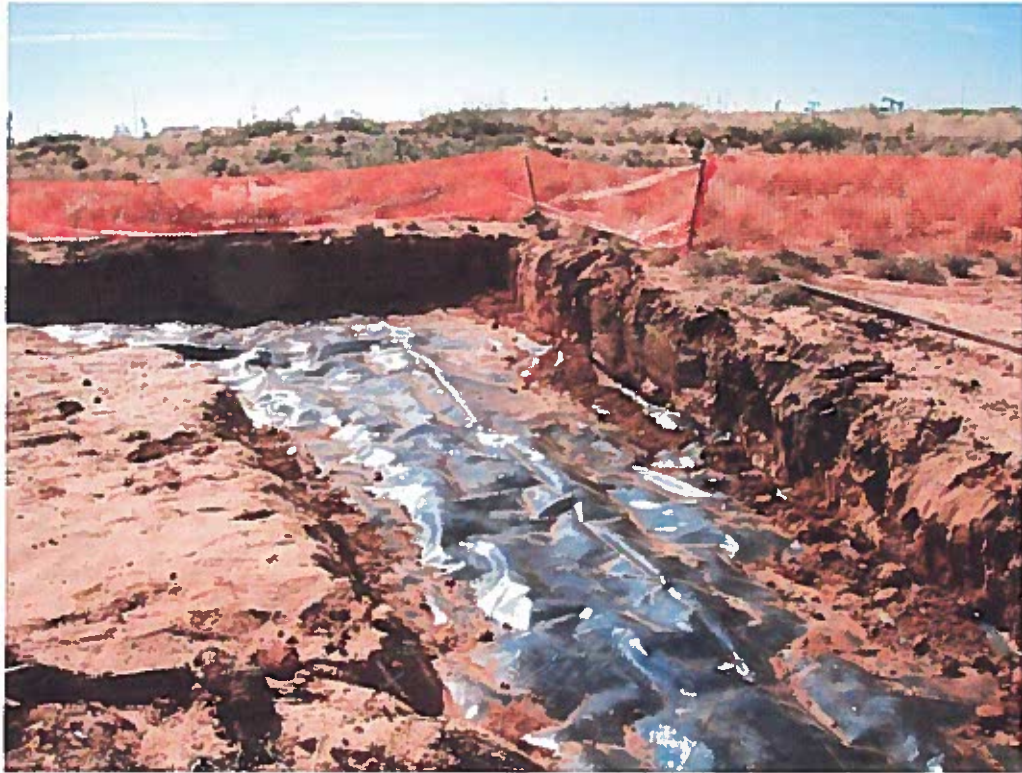
View South – SB-9 and SB-4

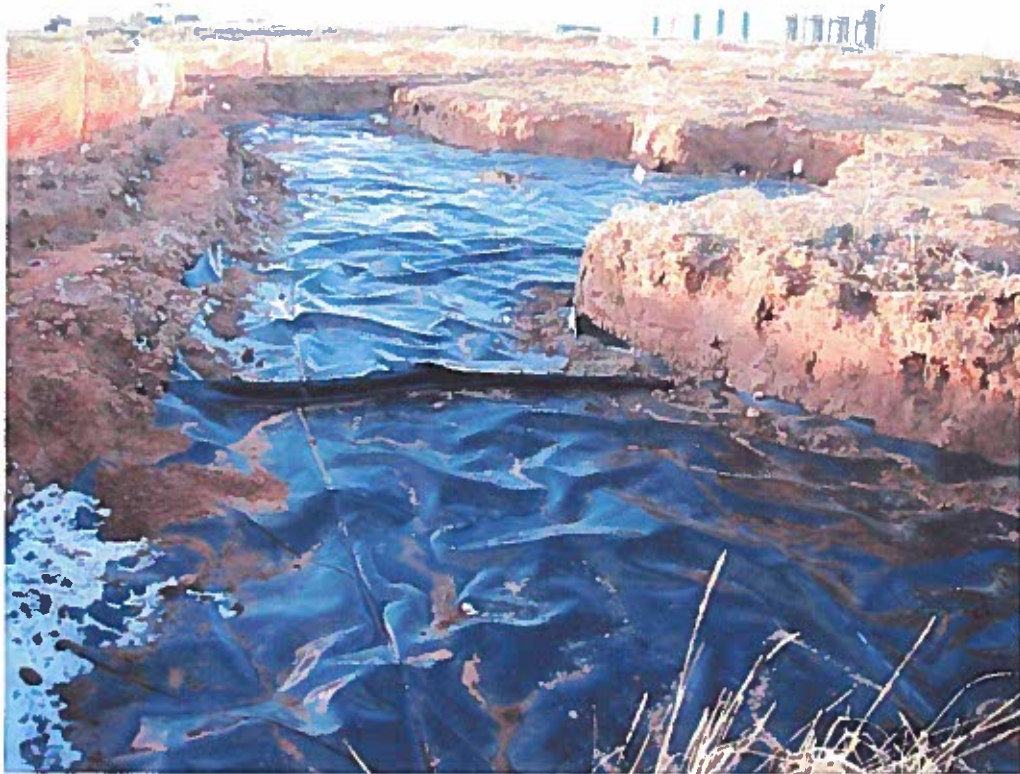
View North West – SB-4

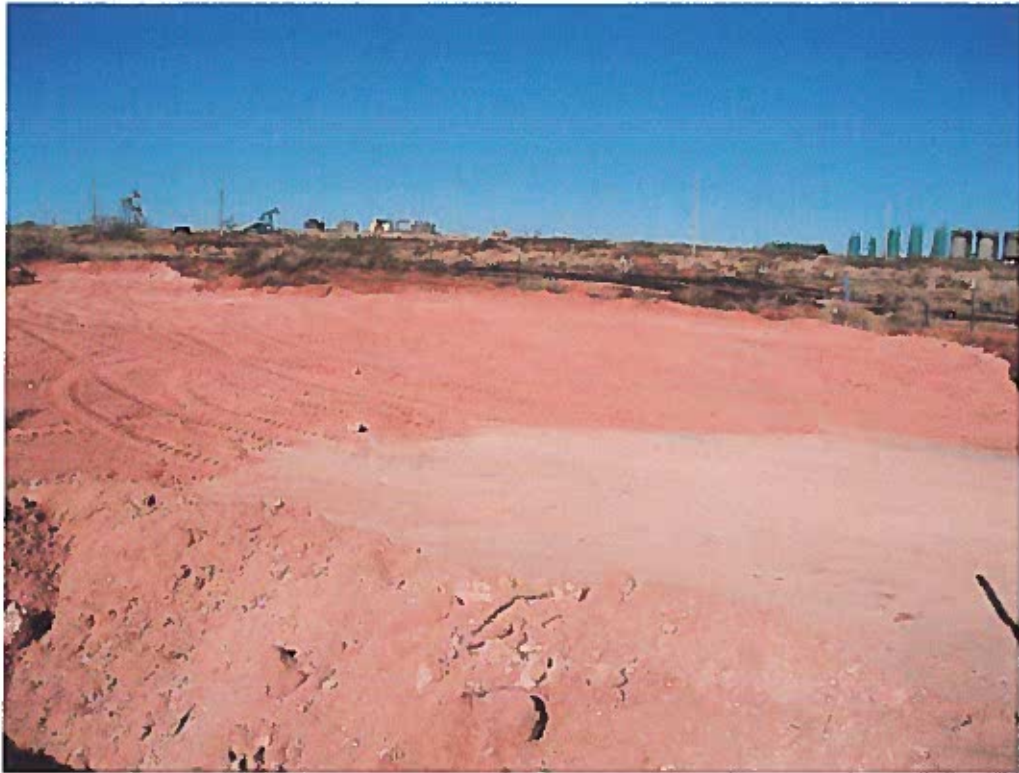
View North – Backfill area of SB-1 and SB-5

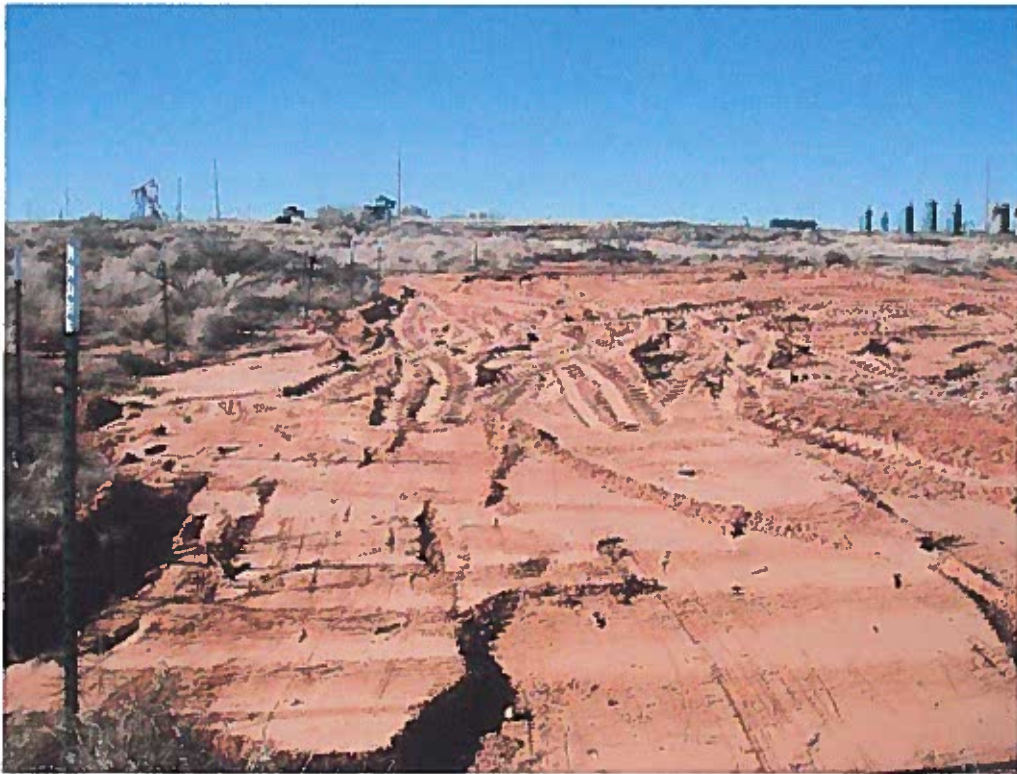
View West – Backfill area of AH-5 and SB-5

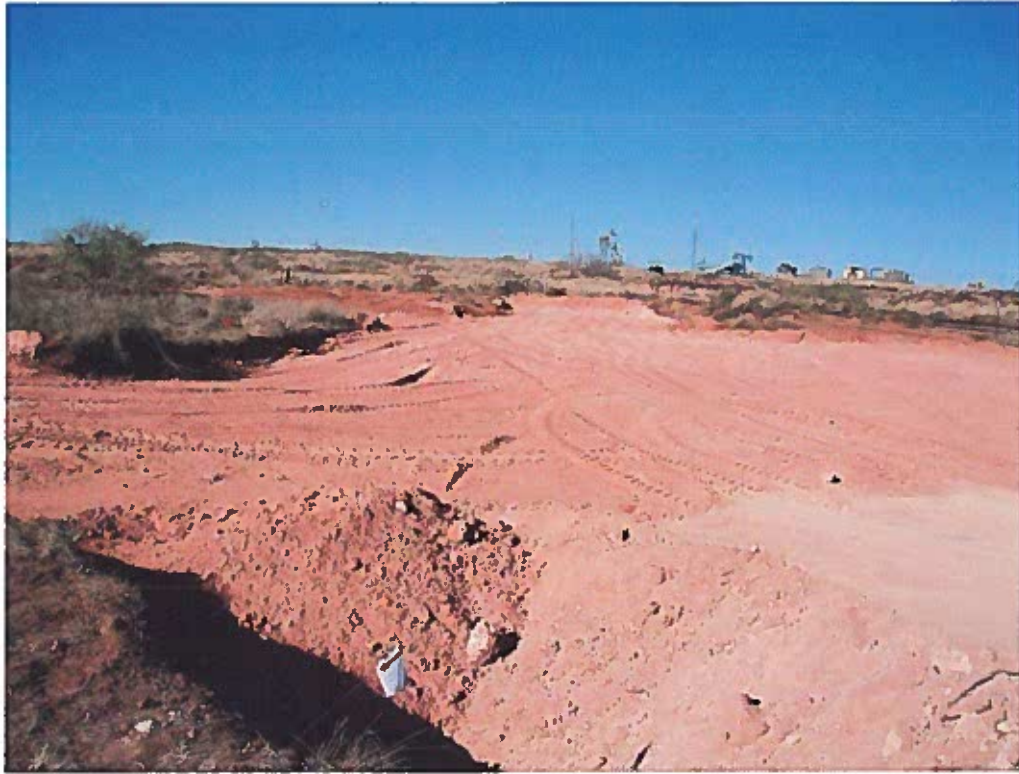
View West – Backfilled area of SB-1 and SB-5

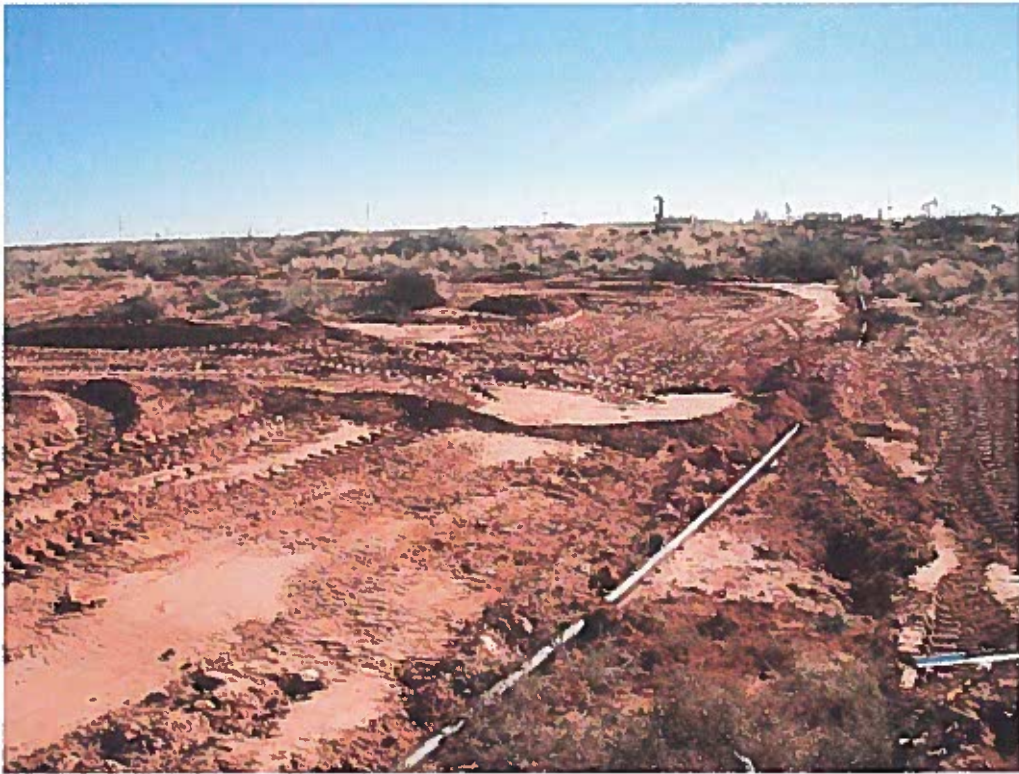
View South– Backfilled area of SB-9 and SB-4

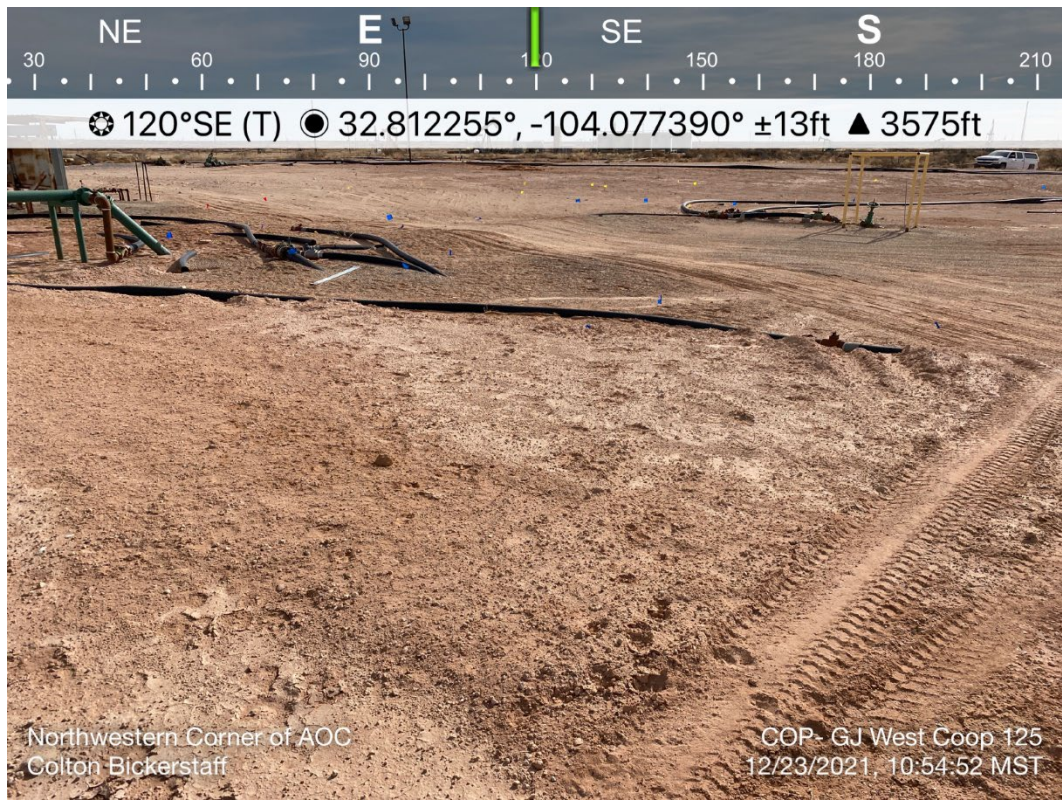
TETRA TECH, INC. PROJECT NO. 212C-MD-02622	DESCRIPTION	View east-southeast of northwestern corner of inspection area.	2
	SITE NAME	ConocoPhillips: GJ West Coop 125 Site Visit	12/23/2021

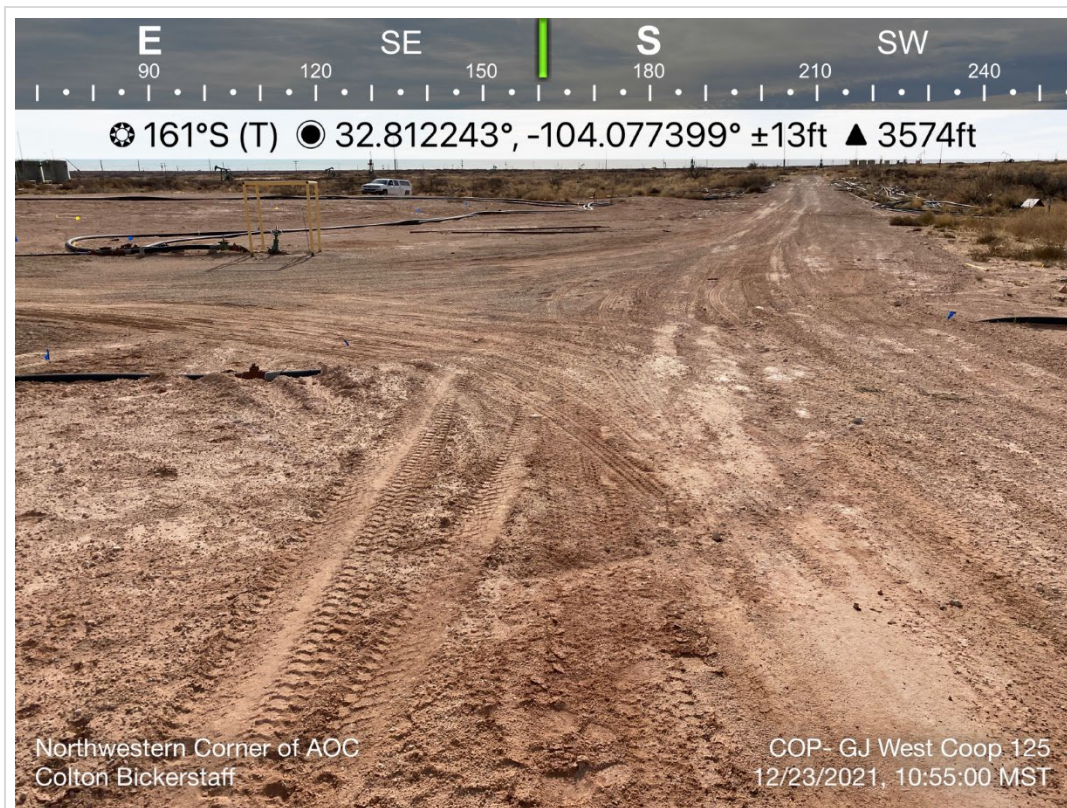
TETRA TECH, INC. PROJECT NO. 212C-MD-02622	DESCRIPTION	View southeast-south of northwestern corner of inspection area.	3
	SITE NAME	ConocoPhillips: GJ West Coop 125 Site Visit	12/23/2021

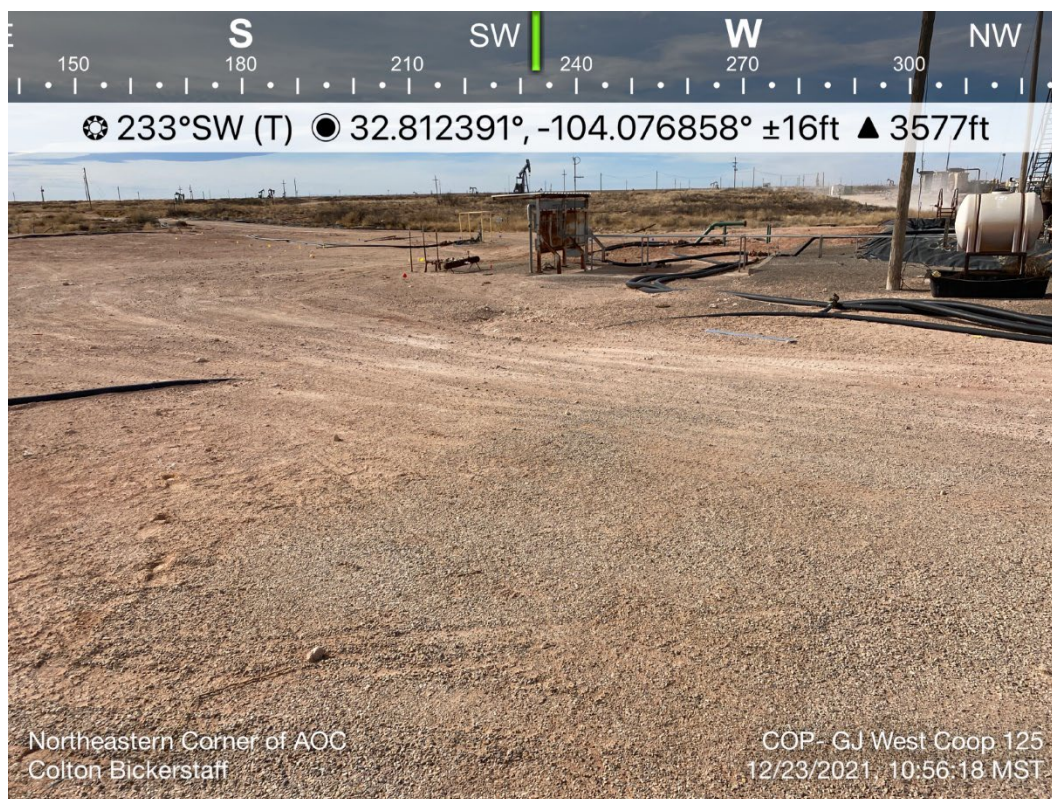
TETRA TECH, INC. PROJECT NO. 212C-MD-02622	DESCRIPTION	View southwest of northeastern corner of inspection area.	4
	SITE NAME	ConocoPhillips: GJ West Coop 125 Site Visit	12/23/2021

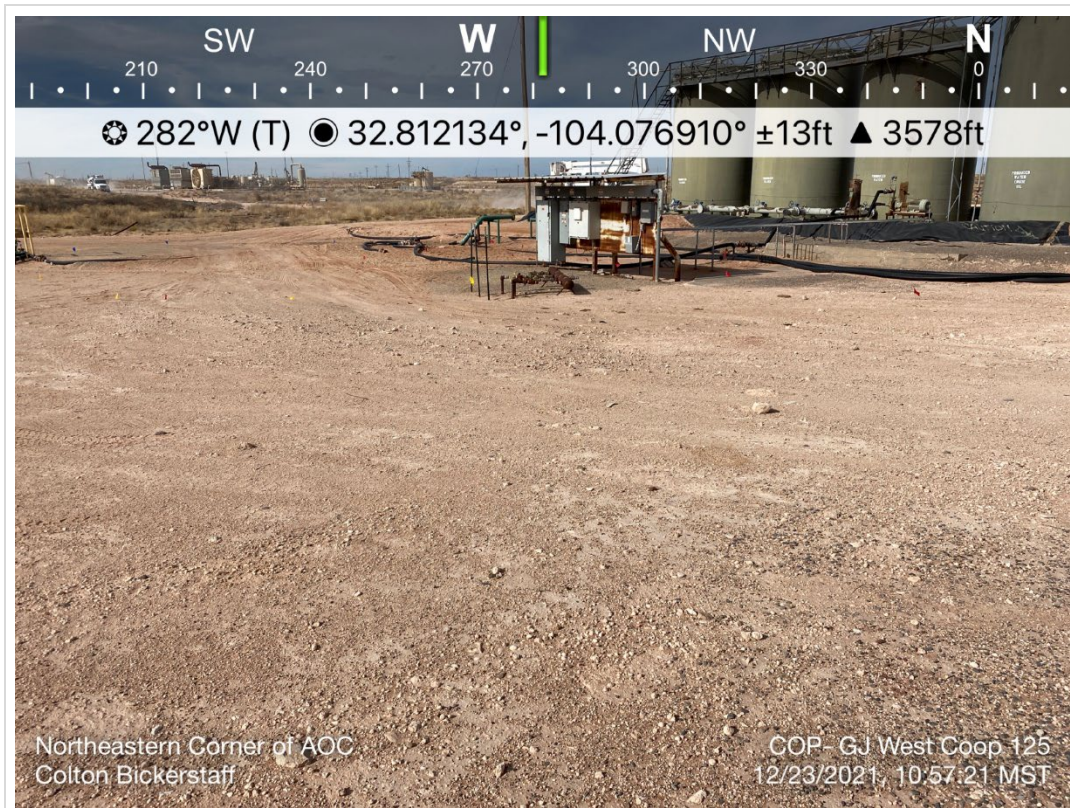
TETRA TECH, INC. PROJECT NO. 212C-MD-02622	DESCRIPTION	View west of northeastern corner of inspection area.	5
	SITE NAME	ConocoPhillips: GJ West Coop 125 Site Visit	12/23/2021

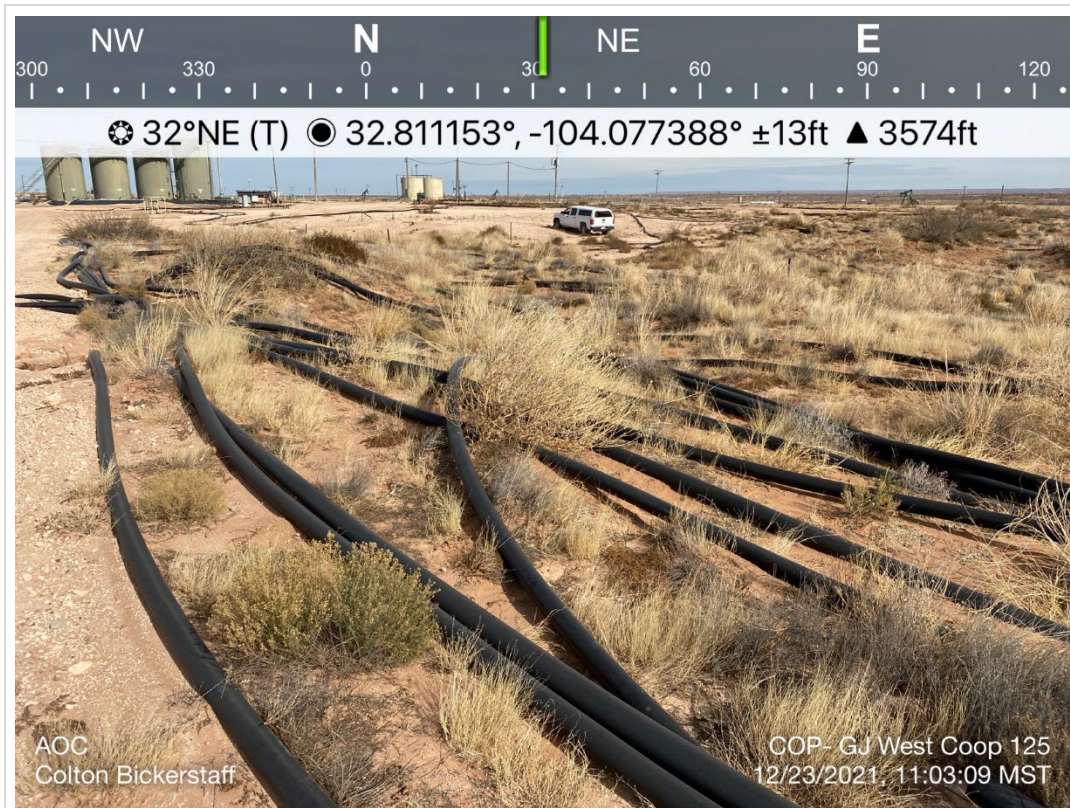
TETRA TECH, INC. PROJECT NO. 212C-MD-02622	DESCRIPTION	View north-northeast of surface flowlines in inspection area.	9
	SITE NAME	ConocoPhillips: GJ West Coop 125 Site Visit	12/23/2021

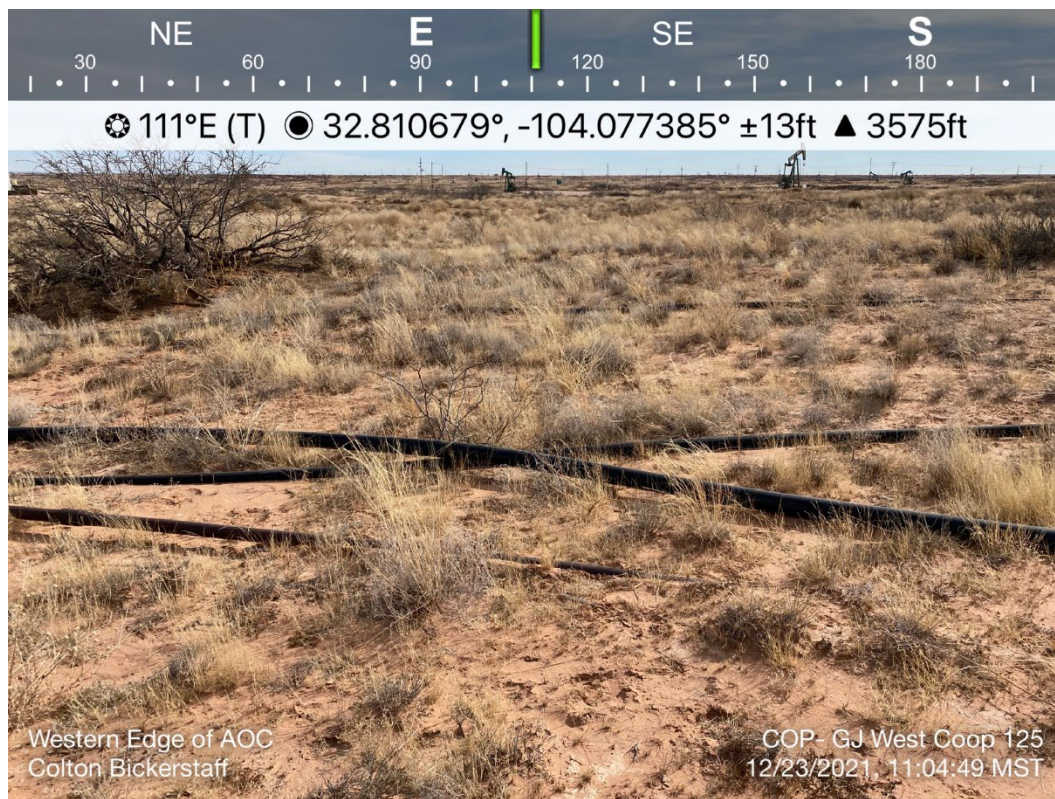
TETRA TECH, INC. PROJECT NO. 212C-MD-02622	DESCRIPTION	View east-southeast of western edge of inspection area.	10
	SITE NAME	ConocoPhillips: GJ West Coop 125 Site Visit	12/23/2021

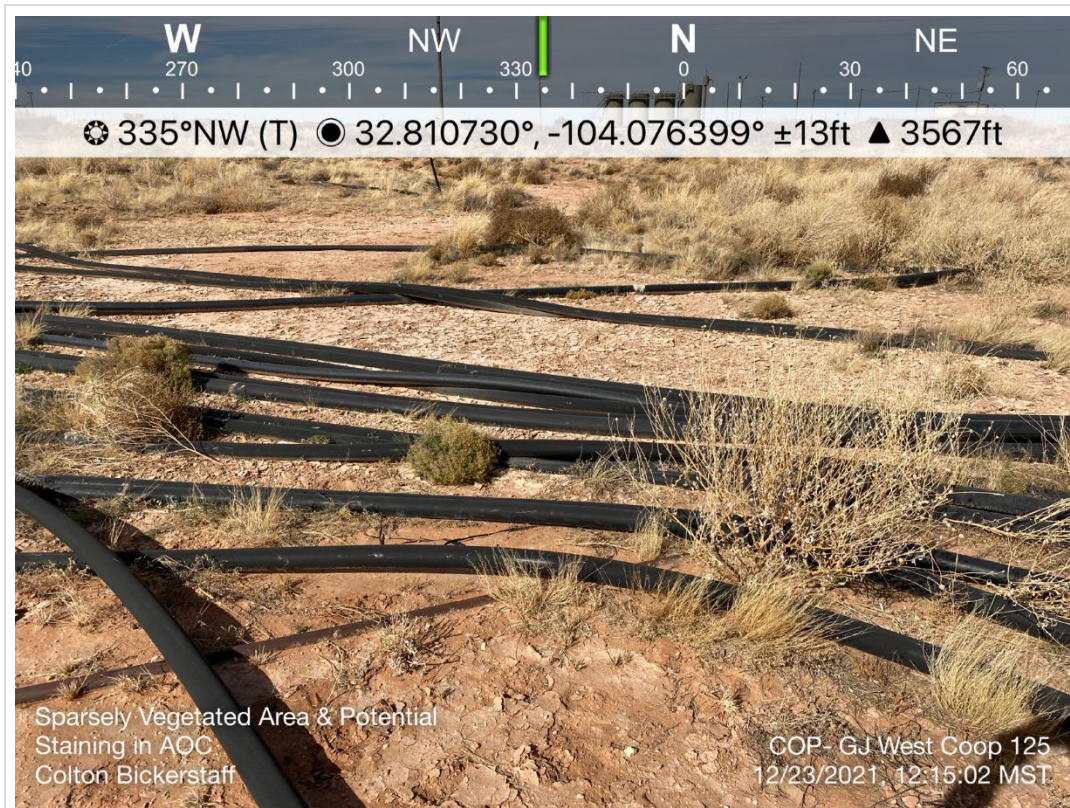
During the inspection, potential evidence of soils with minor staining were observed in areas that correspond to areas that were approved for deferral in the December 11, 2014 Closure Report. Established vegetation was observed throughout the majority of the inspection area. Photographic documentation of the Visual Site Inspection is included as Appendix D.

TETRA TECH, INC. PROJECT NO. 212C-MD-02622	DESCRIPTION	View northwest-north of sparsely vegetated area and potential staining in inspection area.	15
	SITE NAME	ConocoPhillips: GJ West Coop 125 Site Visit	12/23/2021

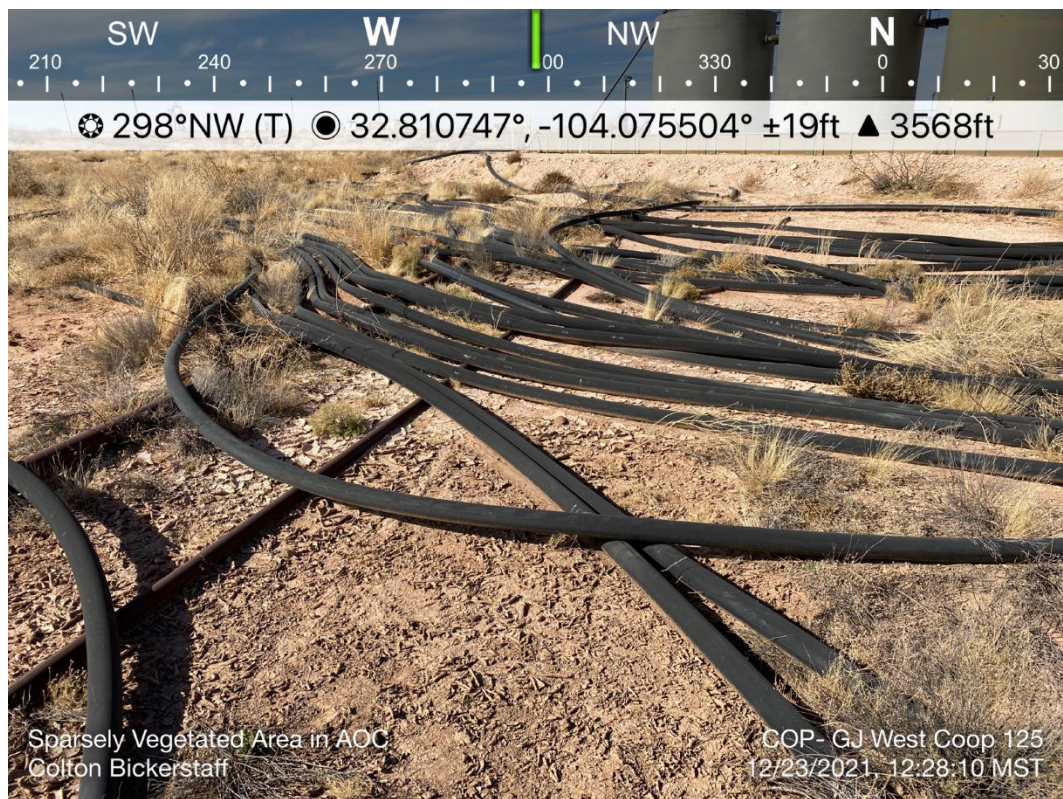
TETRA TECH, INC. PROJECT NO. 212C-MD-02622	DESCRIPTION	View west-northwest of surface flowlines in inspection area.	18
	SITE NAME	ConocoPhillips: GJ West Coop 125 Site Visit	12/23/2021
