Closure

**Re: Closure Report
ConocoPhillips
MCA 300 Flowline Line Release
Unit Letter J, Section 28, Township 17 South, Range 32 East
Lea County, New Mexico
1RP-5752
Incident ID # NRM1929049253**

According to the State of New Mexico C-141 Initial Report (Appendix A), the release was discovered on October 4, 2019. The release occurred as the result of a flowline rupture south of the MCA 2C header and encompassed an area of approximately 3,100 square feet. The leak resulted in a release of approximately 5 barrels (bbls) of crude oil and 33 bbls of produced water, of which 2 bbls of crude oil and 9 bbls of produced water were recovered during initial response activities. The NMOCD received the C-141 report form for the release on October 17, 2019 and subsequently assigned the Site the Remediation Permit (RP) number 1RP-5752 and Incident Identification (ID) NRM1929049253.

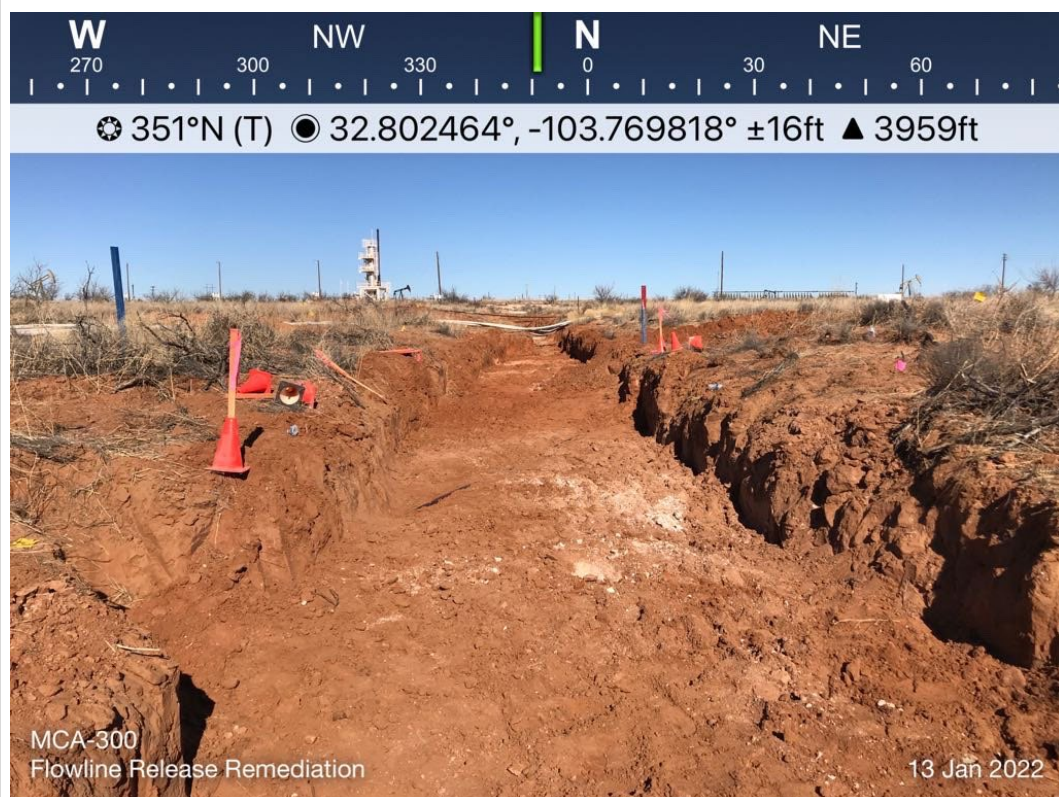
TETRA TECH, INC. PROJECT NO. 212C-MD-02599	DESCRIPTION	View north. 4-foot excavation.	2
	SITE NAME	ConocoPhillips MCA 300 Flowline Release	1/13/2022

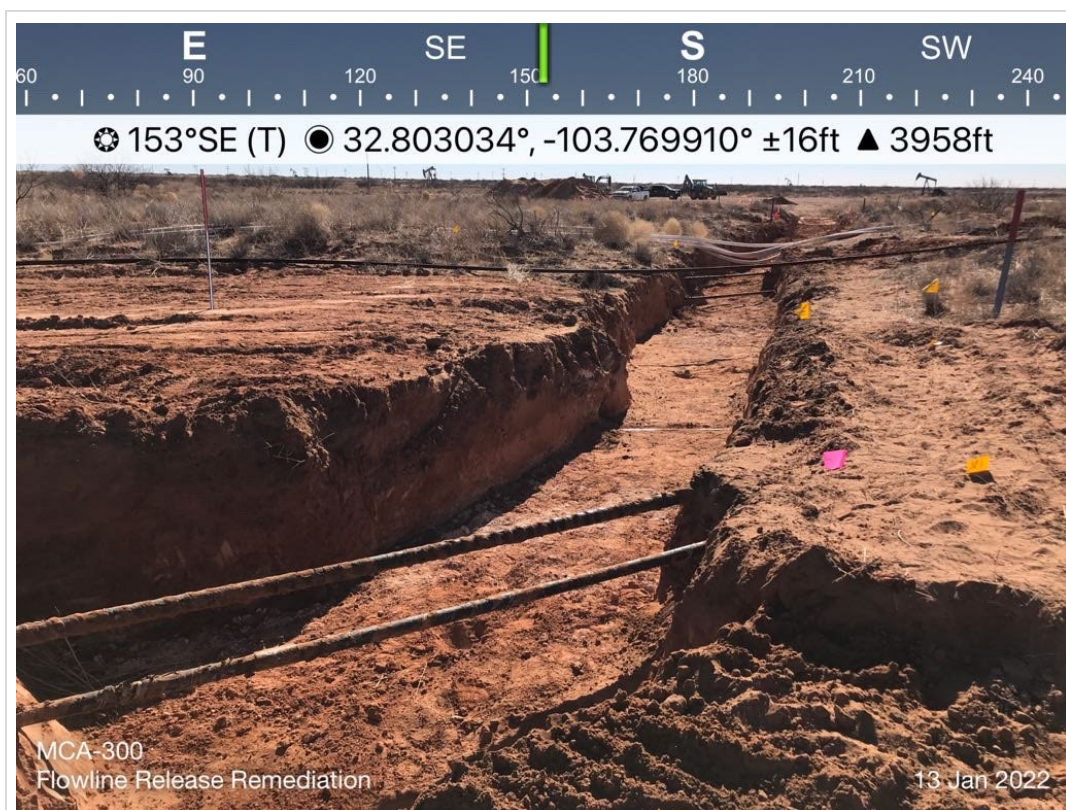
TETRA TECH, INC. PROJECT NO. 212C-MD-02599	DESCRIPTION	View south southeast. 4-foot excavation, buried steel lines, and surface flowlines.	3
	SITE NAME	ConocoPhillips MCA 300 Flowline Release	1/13/2022

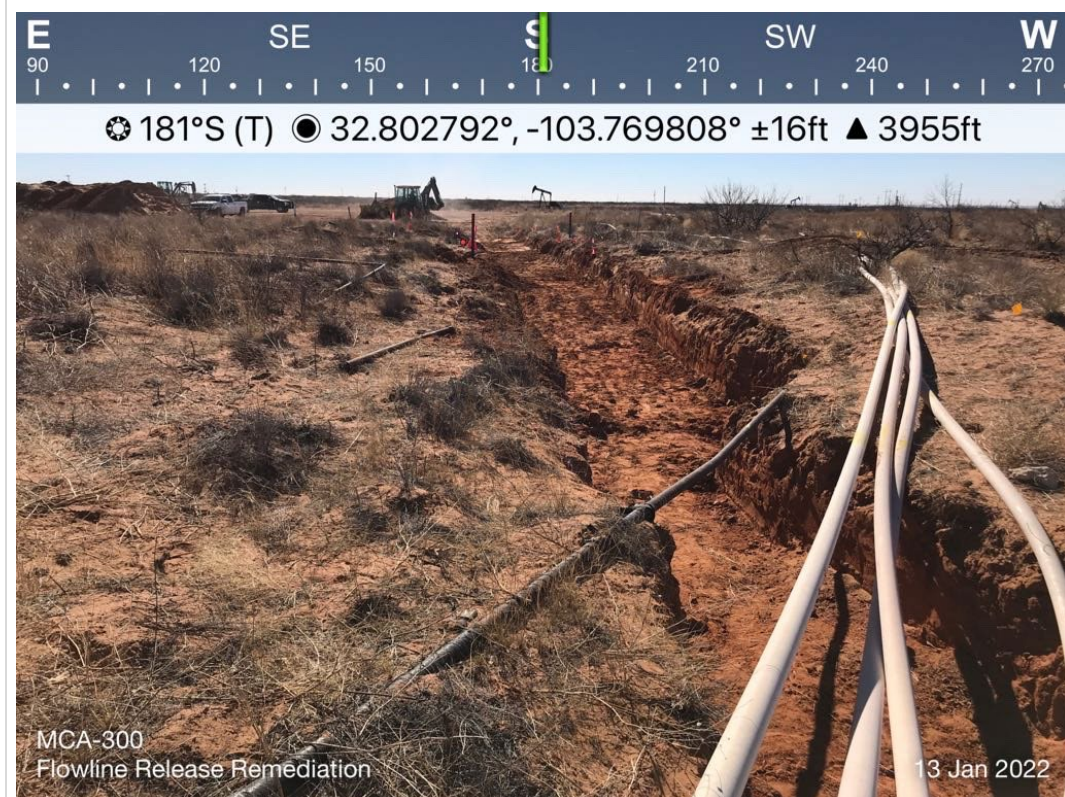
TETRA TECH, INC. PROJECT NO. 212C-MD-02599	DESCRIPTION	View south. 4-foot excavation, surface flowlines and steel lines.	6
	SITE NAME	ConocoPhillips MCA 300 Flowline Release	1/13/2022

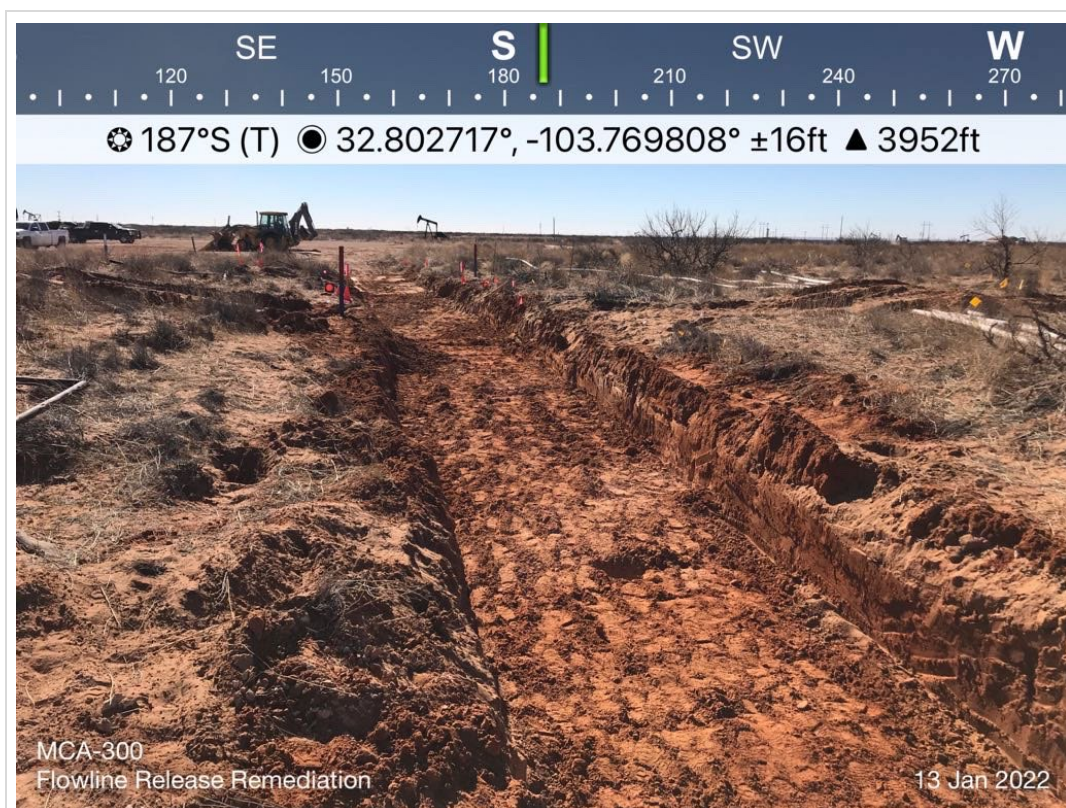
TETRA TECH, INC. PROJECT NO. 212C-MD-02599	DESCRIPTION	View south. 4-foot excavation.	7
	SITE NAME	ConocoPhillips MCA 300 Flowline Release	1/13/2022

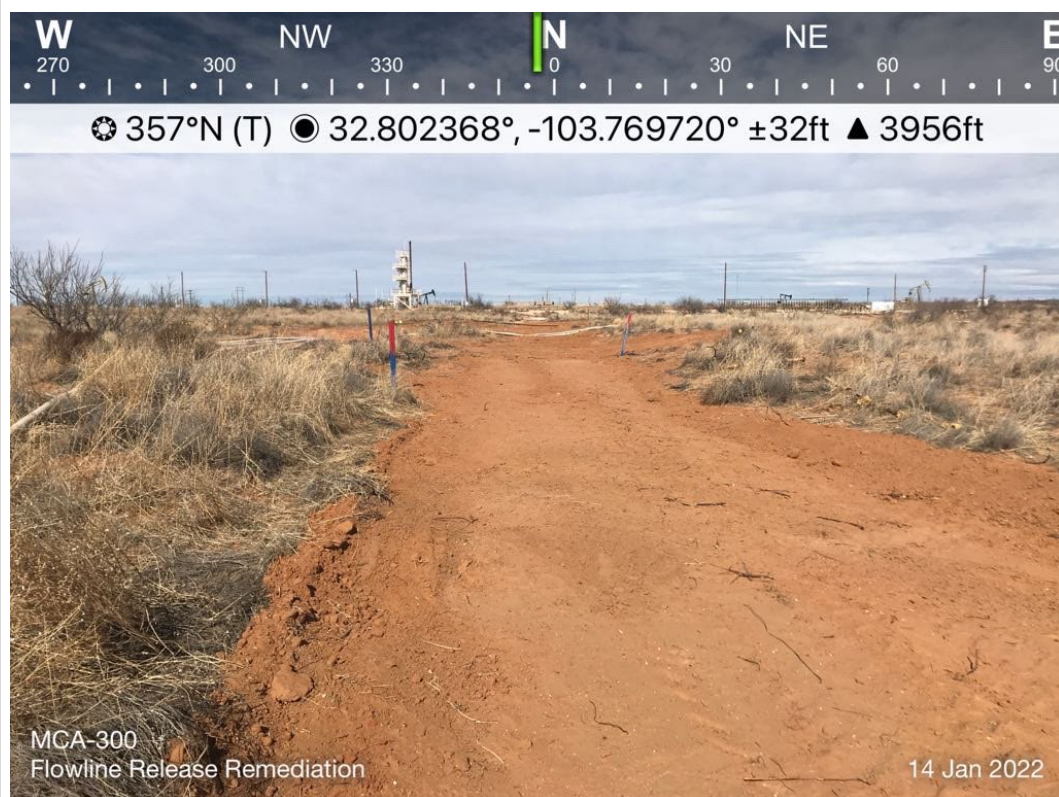
TETRA TECH, INC. PROJECT NO. 212C-MD-02599	DESCRIPTION	View north. Backfilled 4-foot excavation area.	8
	SITE NAME	ConocoPhillips MCA 300 Flowline Release	1/14/2022

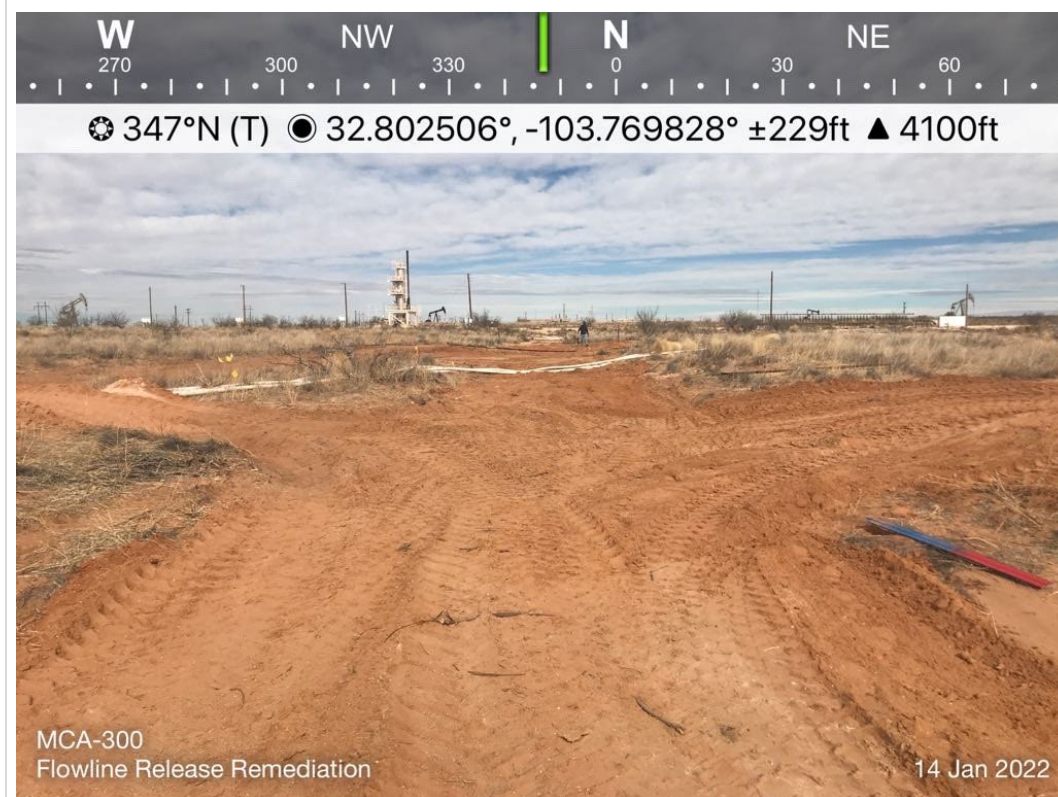
TETRA TECH, INC. PROJECT NO. 212C-MD-02599	DESCRIPTION	View north. Backfilled and seeded 4-foot excavation area.	10
	SITE NAME	ConocoPhillips MCA 300 Flowline Release	1/14/2022
