**RE: Closure Request
Ross Draw 25 North Tank Battery
Incident Number NAPP2129840452
Eddy County, New Mexico**

WSP USA Inc. (WSP), on behalf of XTO Energy, Inc. (XTO), presents the following Closure Request detailing site assessment, soil sampling, and excavation activities at the Ross Draw 25 North Tank Battery (Site) in Unit B, Section 25, Township 26 South, Range 29 East, in Eddy County, New Mexico (Figure 1). The purpose of the site assessment, soil sampling, and excavation activities was to address impacts to soil following a release of produced water at the Site. Based on the excavation activities and laboratory analytical results from the soil sampling events, XTO is submitting this Closure Request, describing remediation that has occurred and requesting no further action (NFA) for Incident Number NAPP2129840452.

FIGURE 2
 PRELIMINARY SOIL SAMPLE LOCATIONS
 ROSS DRAW 25 NORTH TANK BATTERY
 UNIT B SEC 25 T26S R29E
 EDDY COUNTY, NEW MEXICO
 XTO ENERGY, INC.

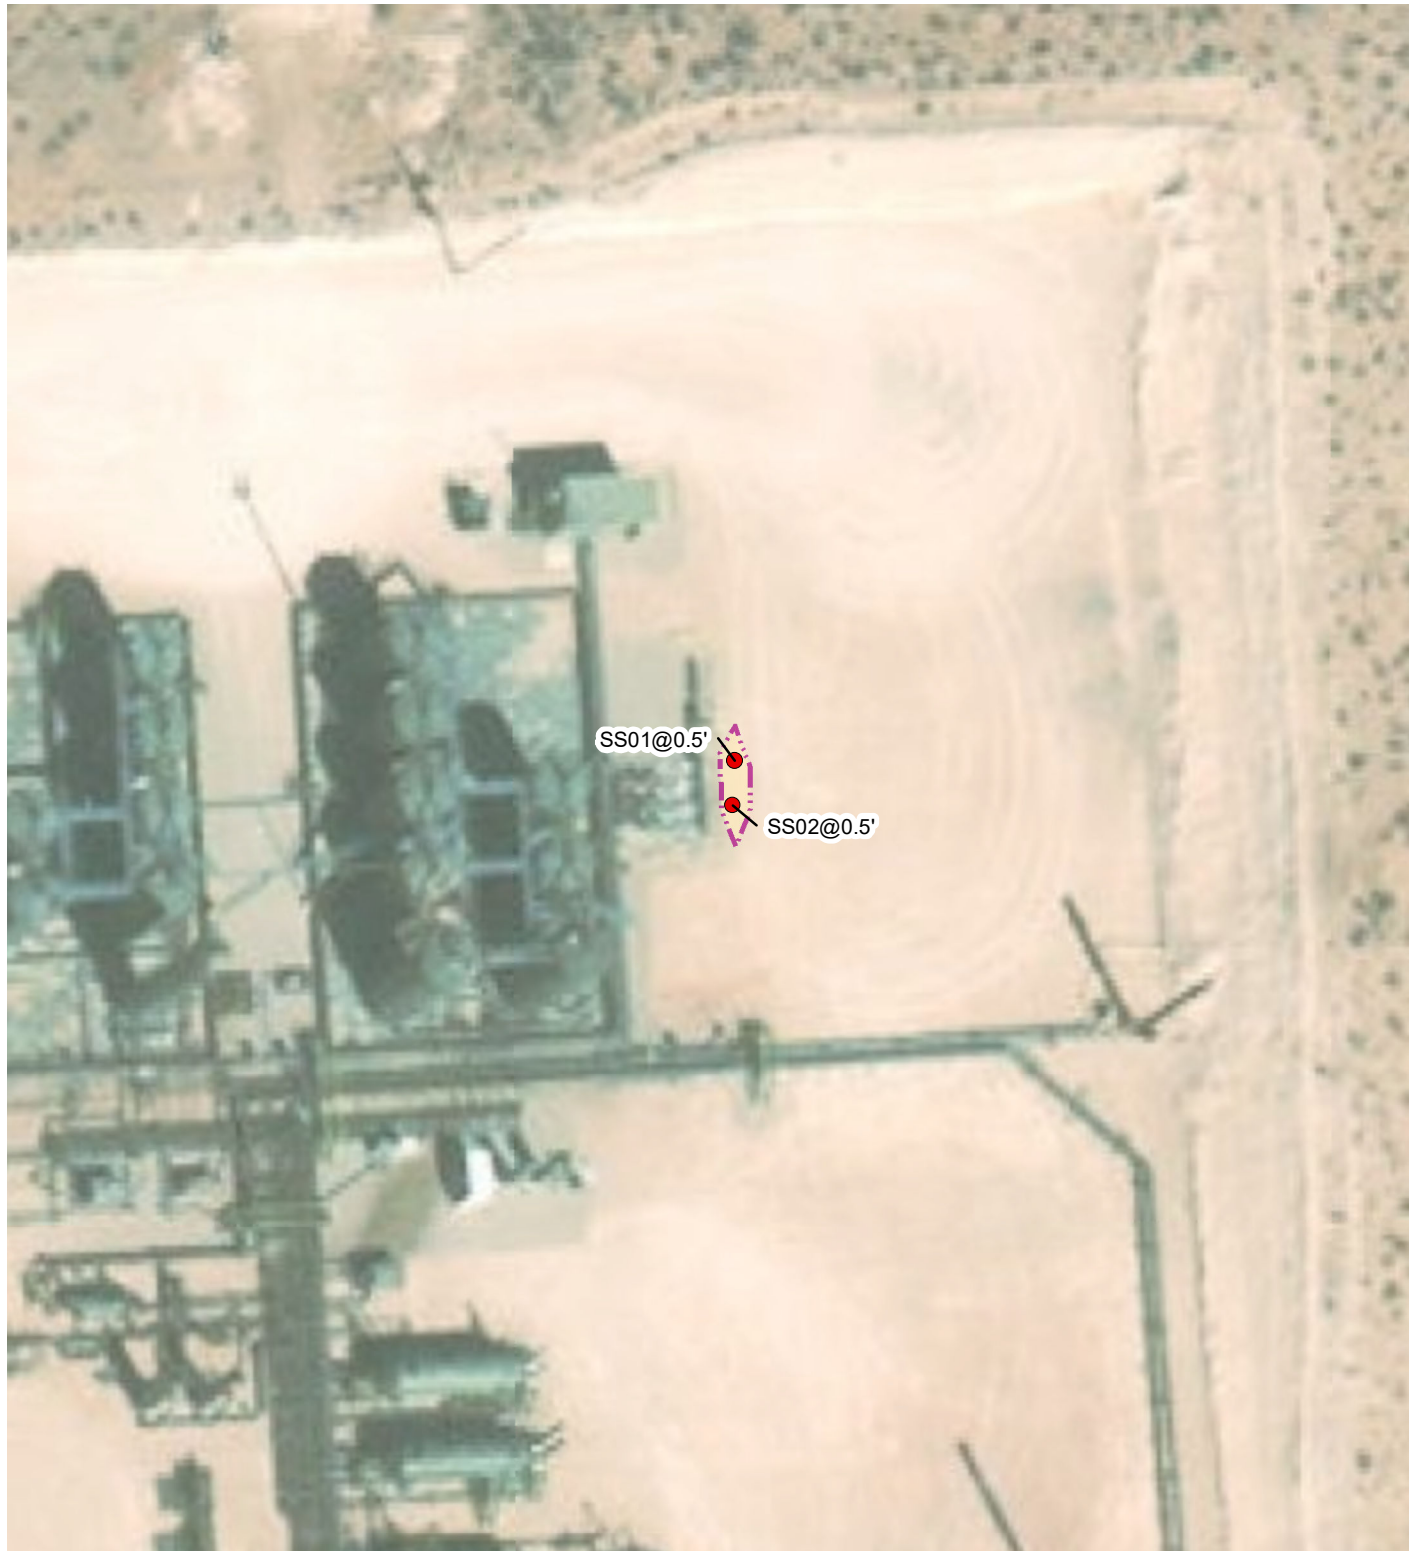
On November 1, 2021, WSP personnel visited the Site to evaluate the release extent based on information provided on the Form C-141 and visual observations. WSP personnel collected two preliminary assessment soil samples (SS01 and SS02) within the release extent, from a depth of approximately 0.5 feet bgs to assess the lateral extent of impacted soil. Soil from the preliminary soil samples was field screened for volatile aromatic hydrocarbons and chloride utilizing a calibrated photo-ionization detector (PID) and Hach® chloride QuanTab® test strips, respectively. The release extent and preliminary soil sample locations were mapped utilizing a handheld Global Positioning System (GPS) and are presented on Figure 2.

Laboratory analytical results for preliminary soil samples SS01 and SS02 indicated that chloride concentrations exceeded the Closure Criteria; benzene, BTEX, and TPH concentrations were compliant with the Closure Criteria. Based on visible staining in the release area, elevated field screening results, and laboratory analytical results for the preliminary soil samples, excavation activities were warranted.

- PRELIMINARY SOIL SAMPLE WITH CONCENTRATIONS EXCEEDING APPLICABLE CLOSURE CRITERIA
- RELEASE EXTENT

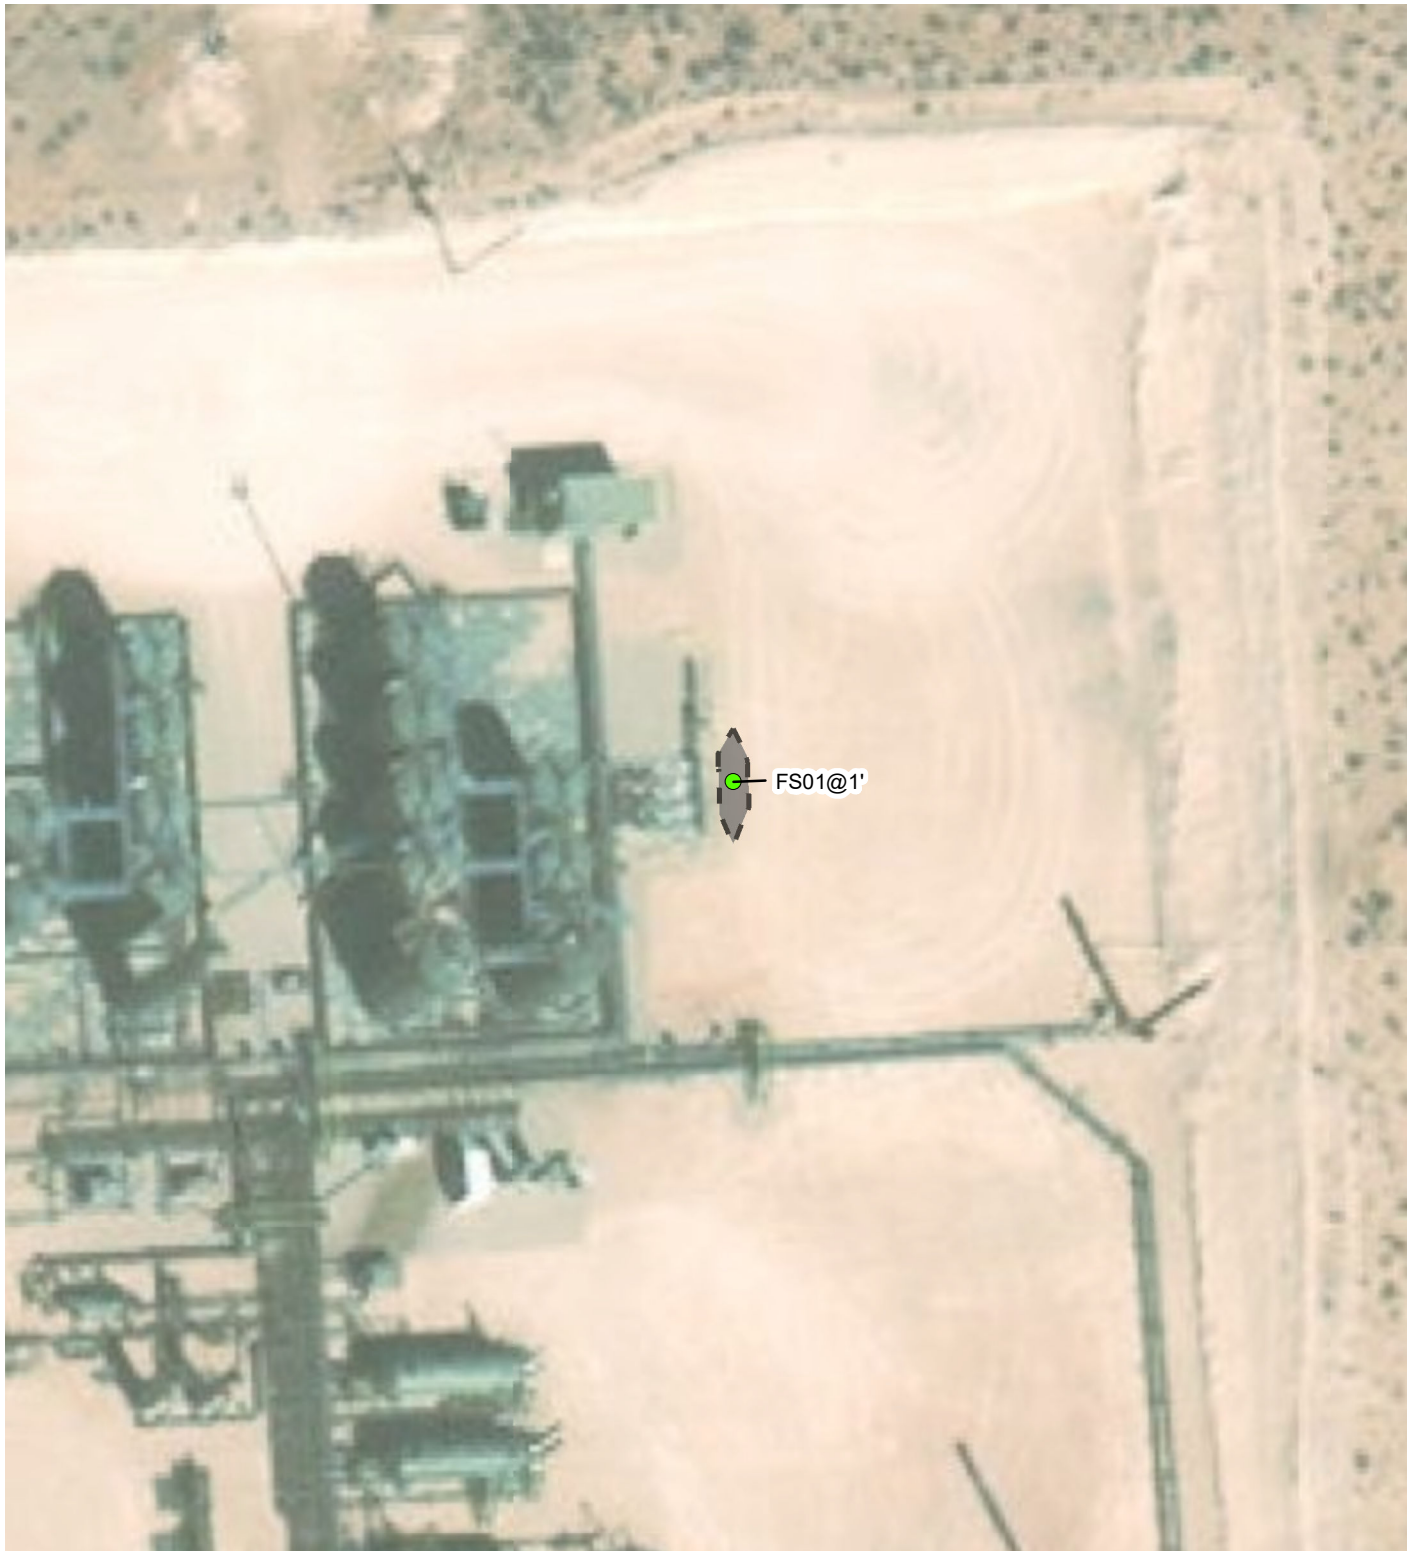
FIGURE 3
EXCAVATION SOIL SAMPLE LOCATIONS
ROSS DRAW 25 NORTH TANK BATTERY
UNIT B SEC 25 T26S R29E
EDDY COUNTY, NEW MEXICO
XTO ENERGY, INC.

The final excavation extent measured approximately 171 square feet. A total of approximately 6.3 cubic yards of impacted soil were removed during excavation activities. The impacted soil was transported and properly disposed of at the R360 facility located in Hobbs, New Mexico. After the completion of confirmation sampling, the excavation was secured with fencing.

Laboratory analytical results for excavation floor sample FS01, collected from the final excavation extent, indicated that benzene, BTEX, TPH, and chloride concentrations were compliant with the Closure Criteria. The laboratory analytical results are summarized in Table 1 and the complete laboratory analytical reports are included in Attachment 3.

FLOOR SAMPLE IN COMPLIANCE
WITH APPLICABLE CLOSURE CRITERIA

EXCAVATION EXTENT

XTO will backfill the excavation with material purchased locally and recontour the Site to match pre-existing site conditions. Initial response efforts and excavation of impacted soil have mitigated impacts at this Site. As such, XTO respectfully requests NFA for Incident Number NAPP2129840452.

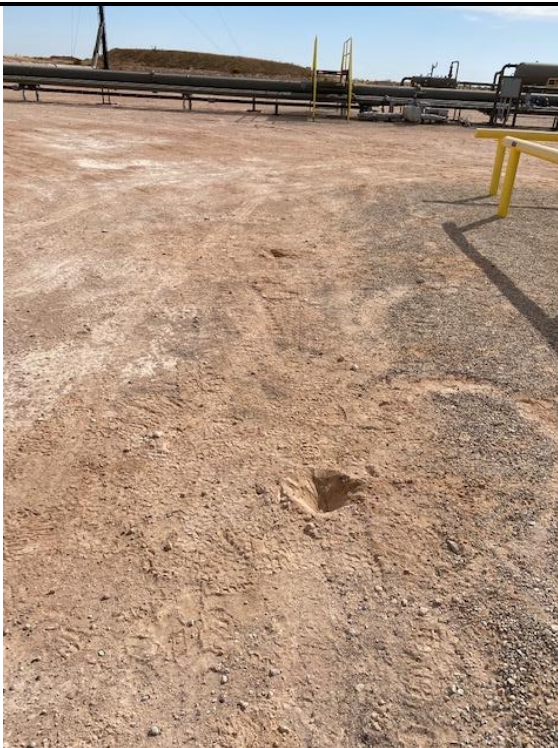
Photo No.	Date	
1	November 1, 2021	
View facing south of the release that occurred on October 12, 2021.

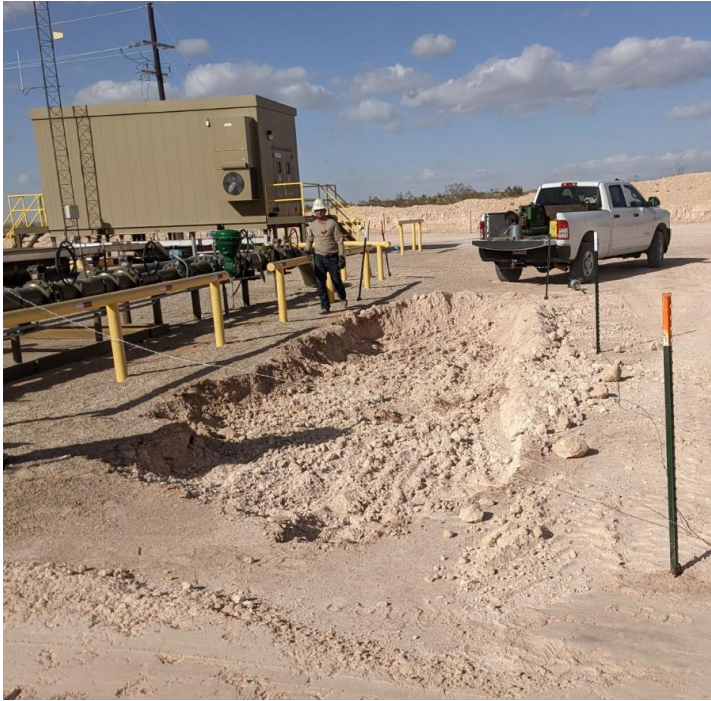
Photo No.	Date	
3	December 12, 2021	
View facing north of excavation extent.

A photograph showing a large, rectangular, tan-colored industrial building in the background. In the foreground, there is a deep, rectangular excavation pit filled with light-colored soil and debris. A white pickup truck is parked on the right side of the excavation. A person wearing a hard hat and safety vest is standing near the edge of the excavation. The ground is sandy and uneven. The sky is blue with some clouds.
