February 10, 2022

**Re: Closure Report  
ConocoPhillips  
Heritage Concho  
Big Papi Federal Com #2H Release  
Unit Letter C, Section 4, Township 26 South, Range 29 East  
Eddy County, New Mexico  
Incident # NAB1922035506  
2RP-5562**

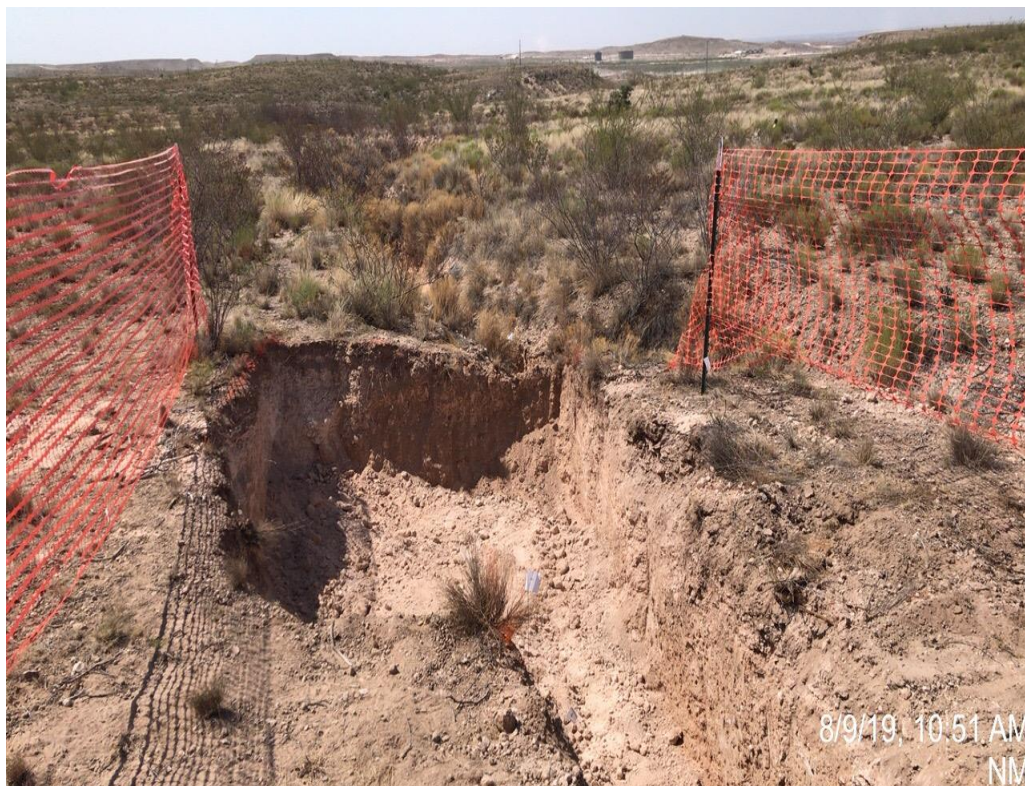
View South, area of bottomhole 1

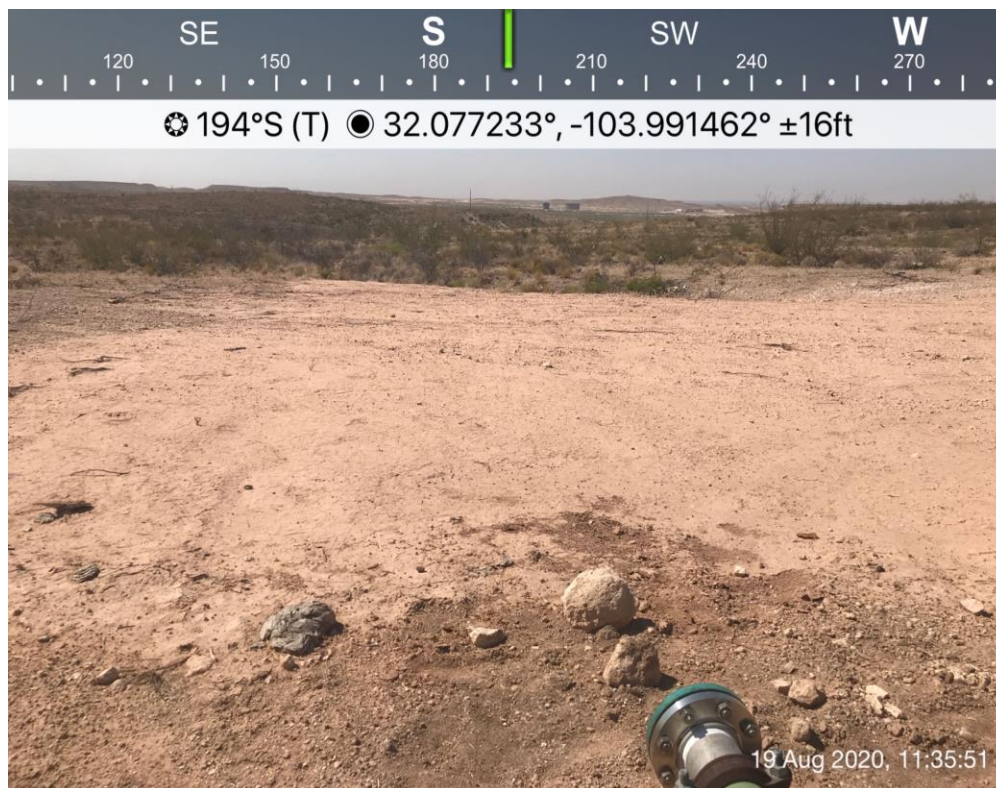
View South, area of Bottom Hole 1

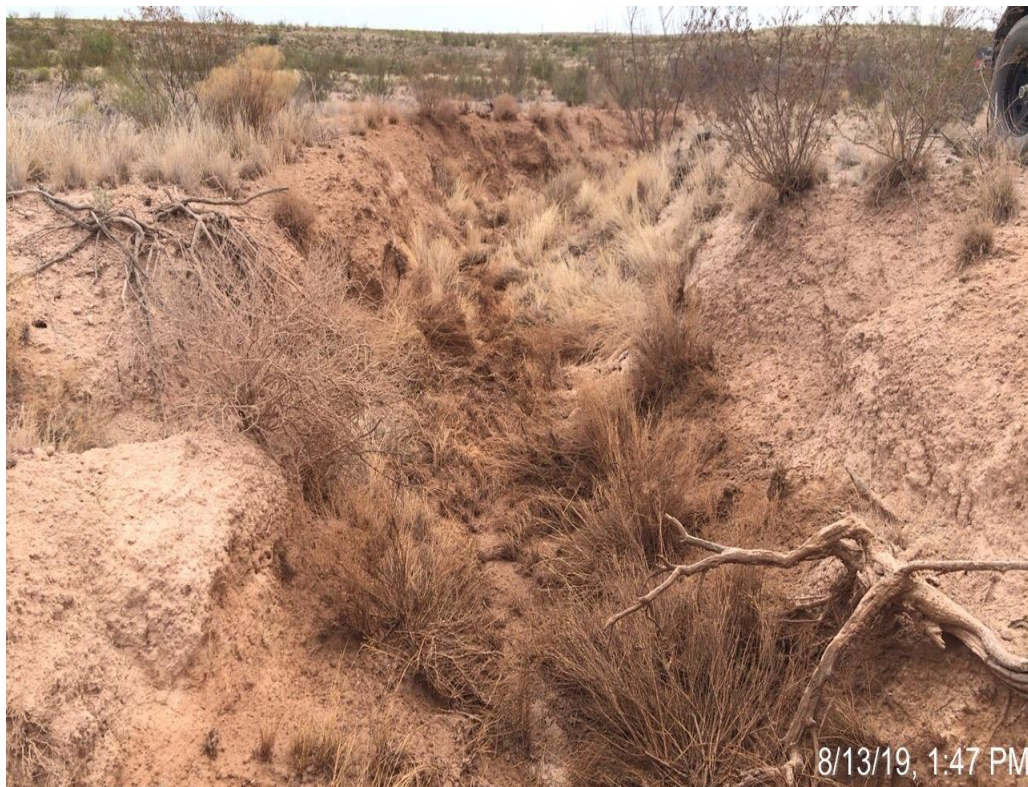
View South, AH-5 and AH-6

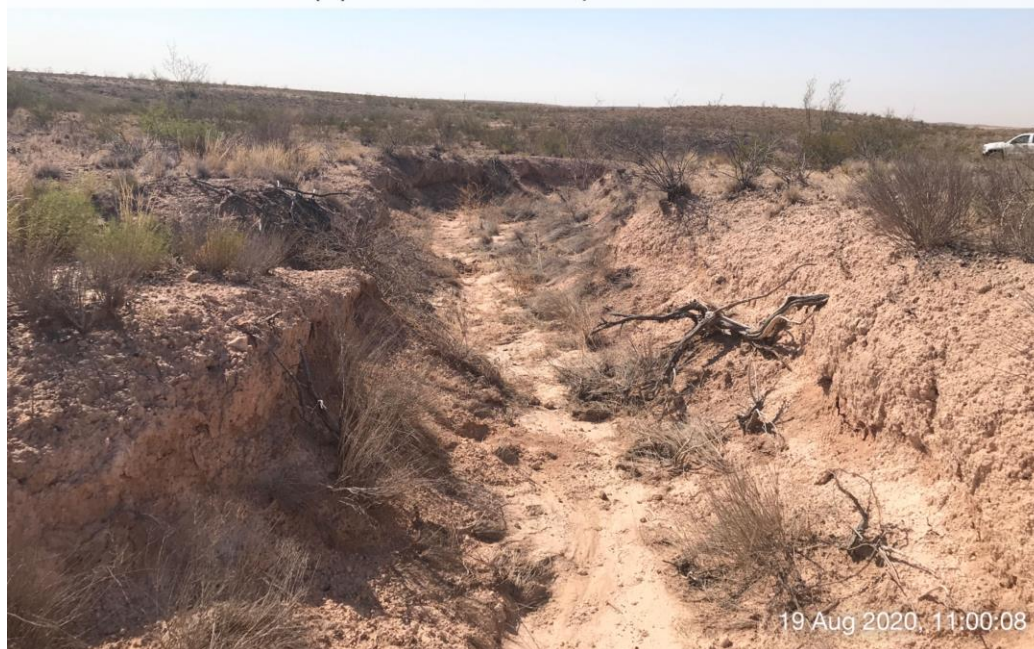
View Southeast, area of AH-3 and AH-4

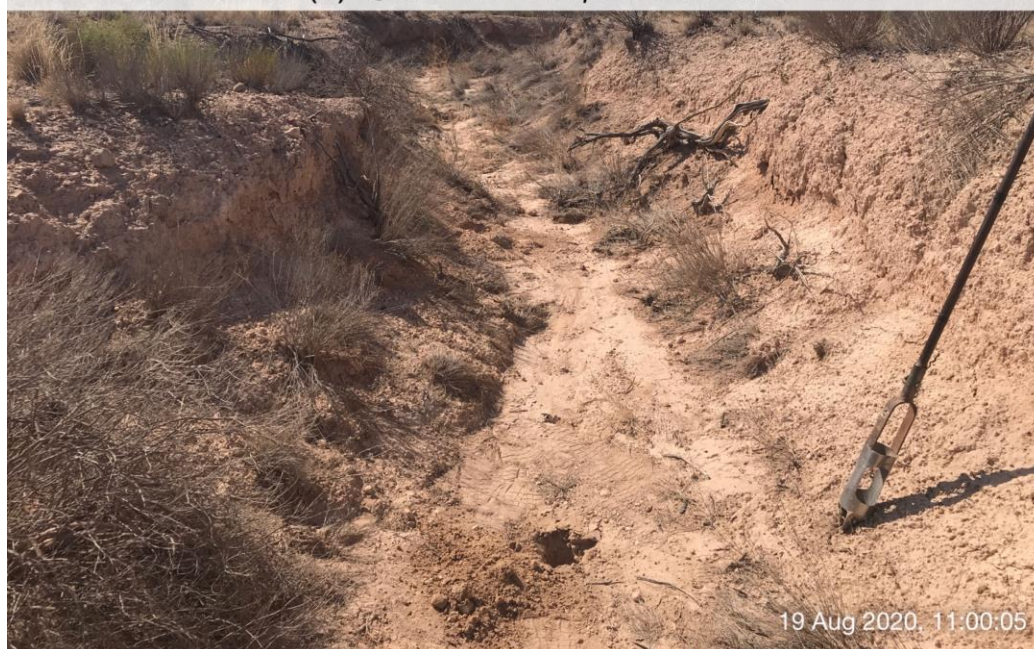
View Southeast, area of AH-3 and AH-4

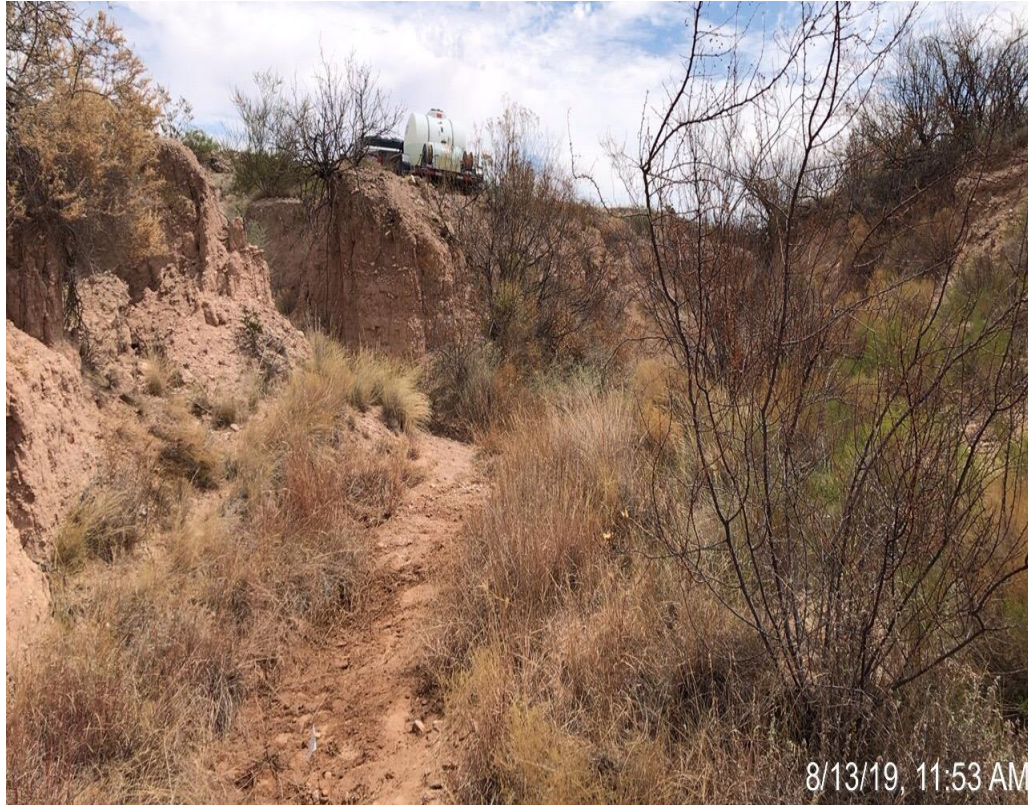
View East, area of AH-7

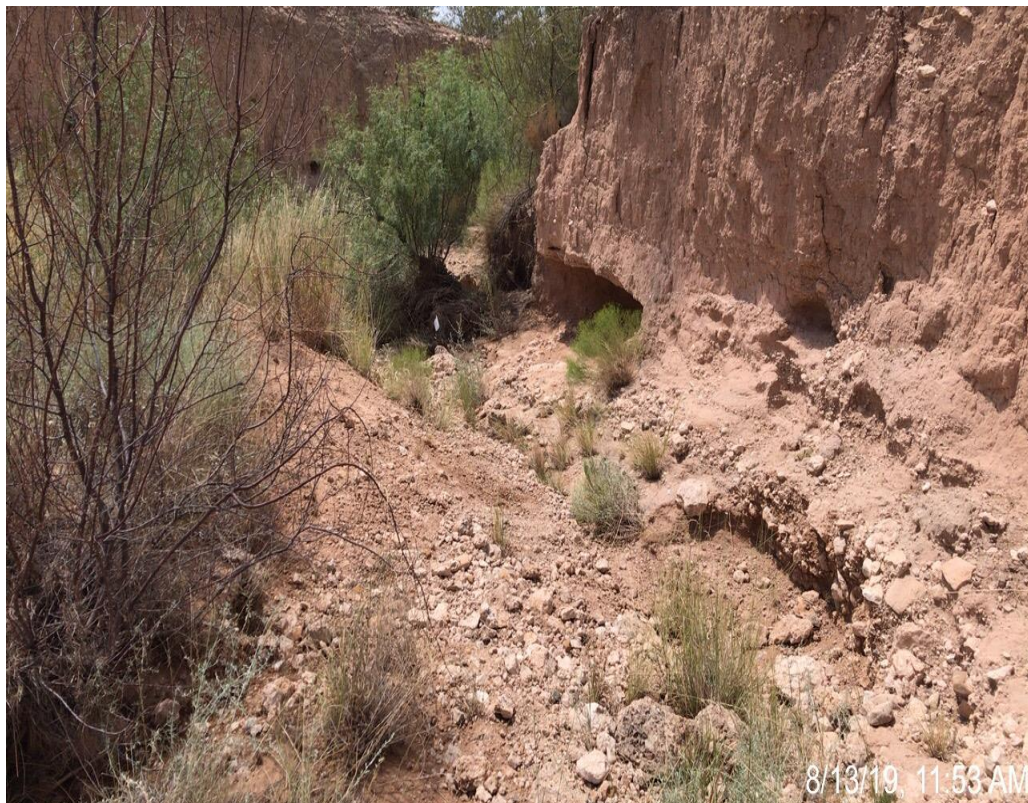
View West, area of AH-8

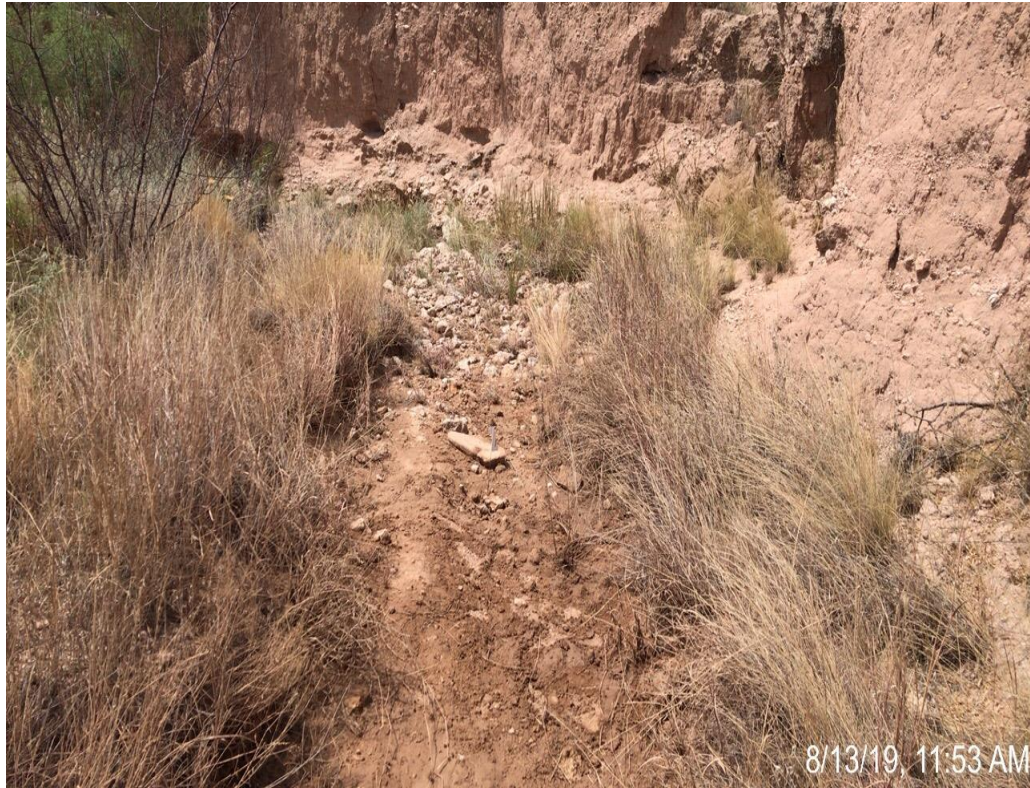
View South, area of AH-9

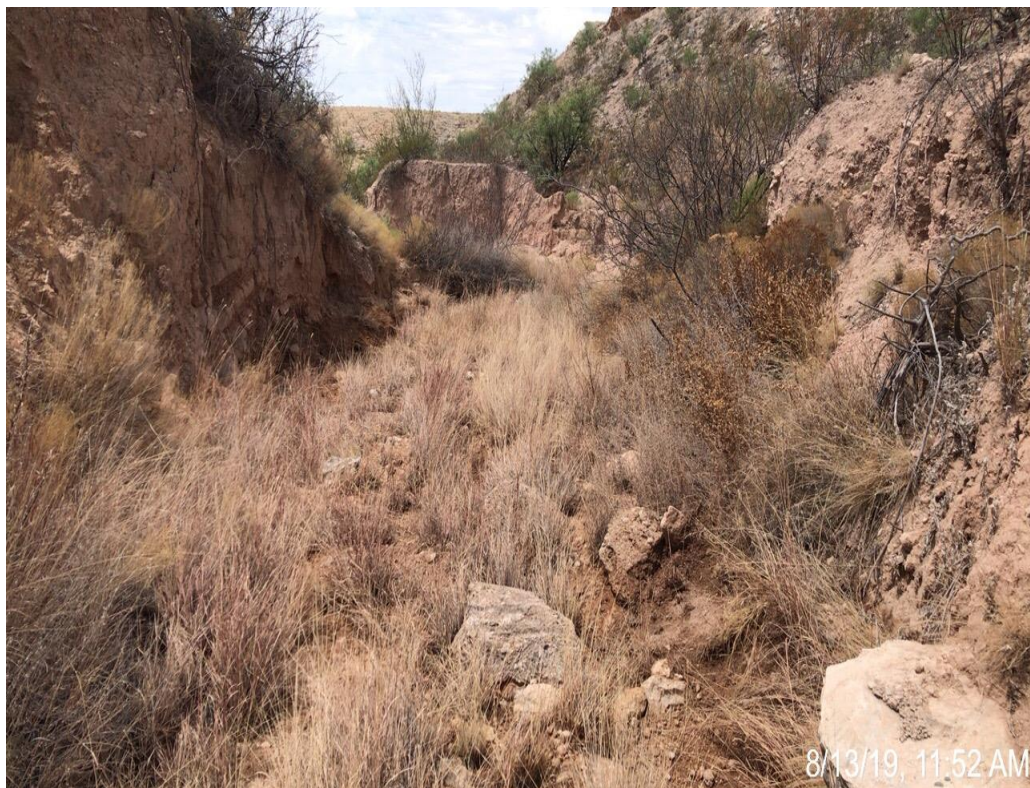
View South, area of AH-10 and AH-11

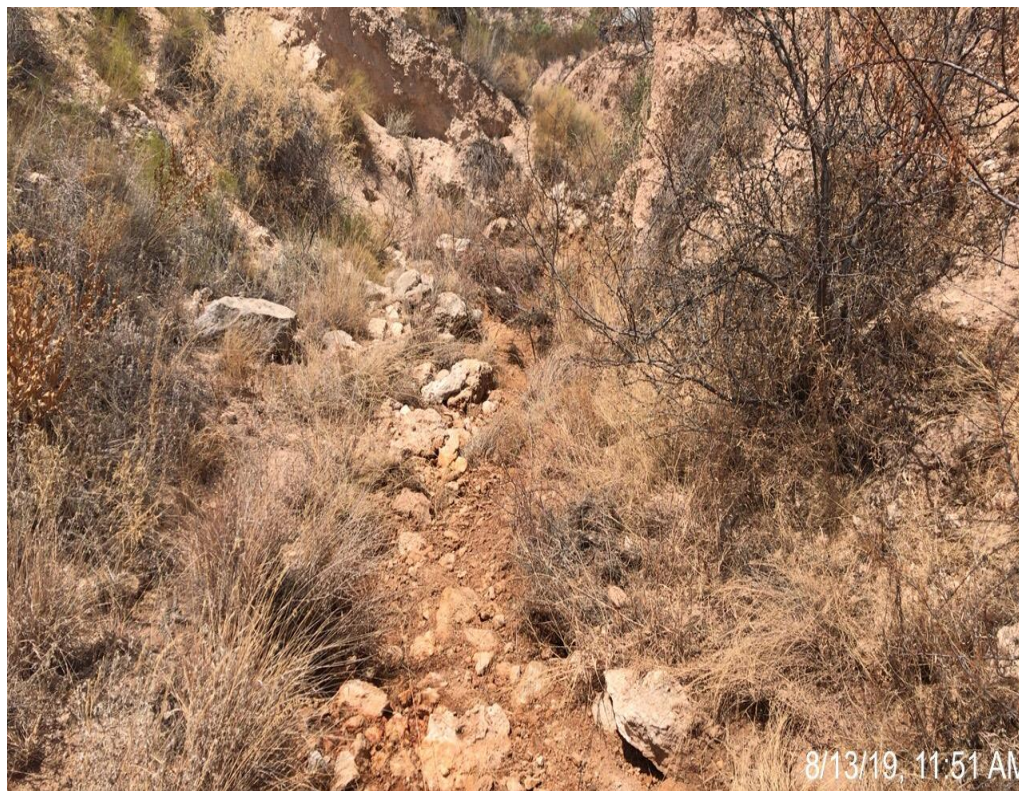
View West, area of AH-12, AH-3, and AH-14

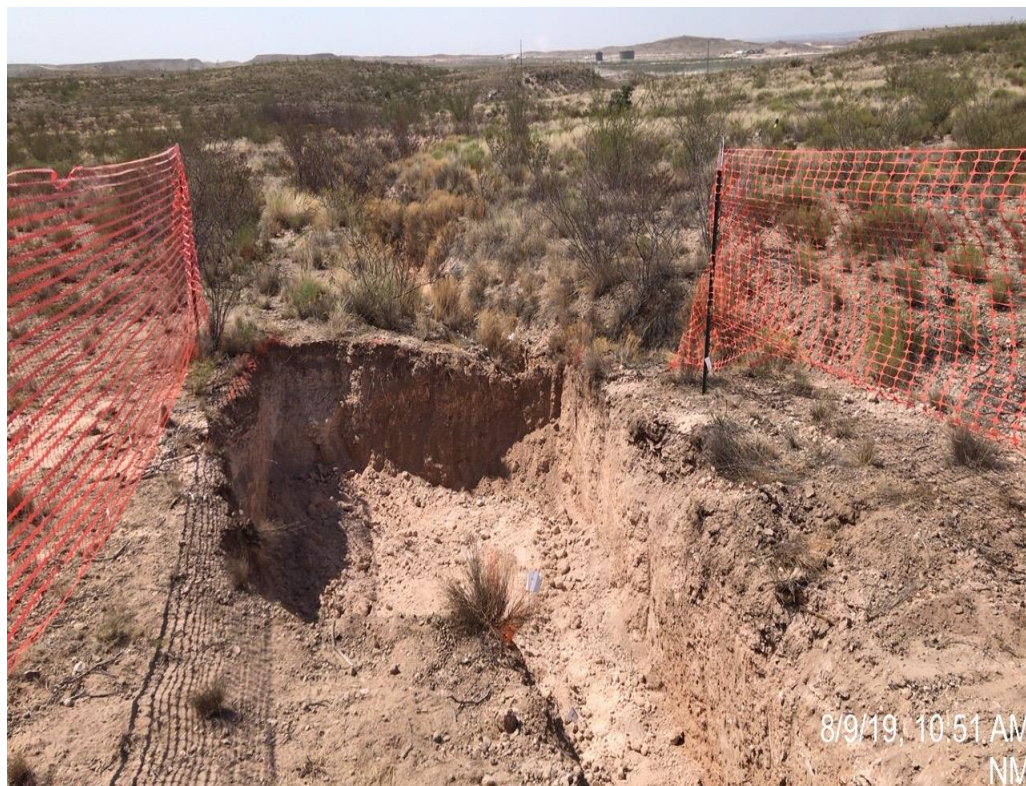
View South, area of bottomhole 1

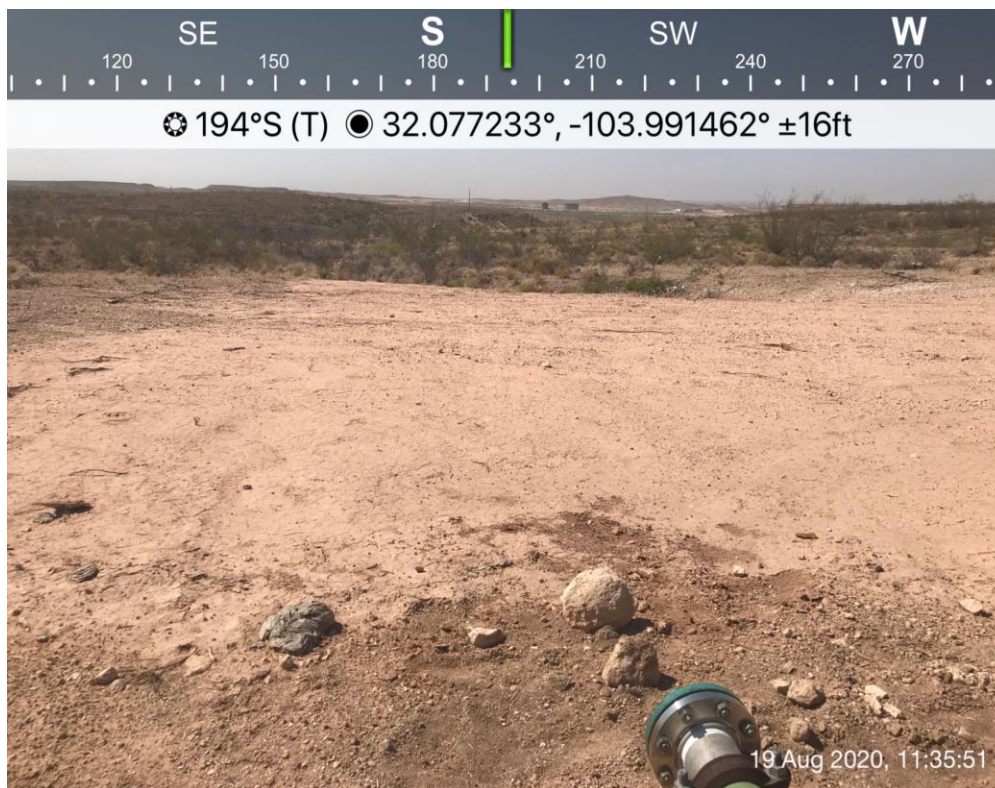
View South, area of Bottom Hole 1

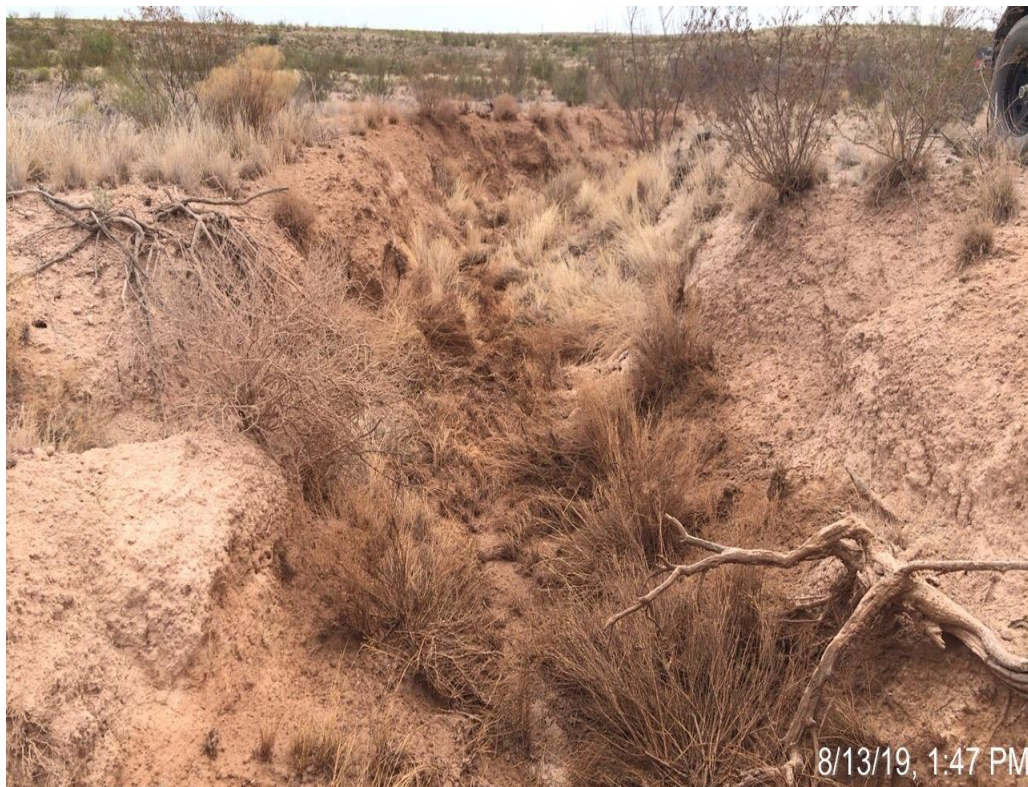
View South, AH-5 and AH-6

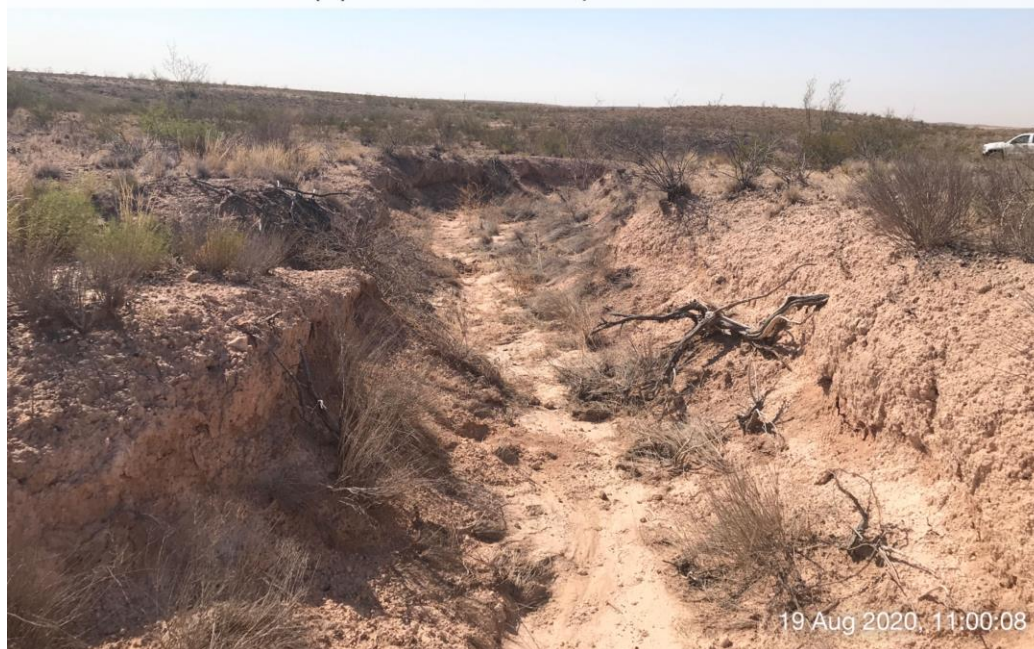
View Southeast, area of AH-3 and AH-4

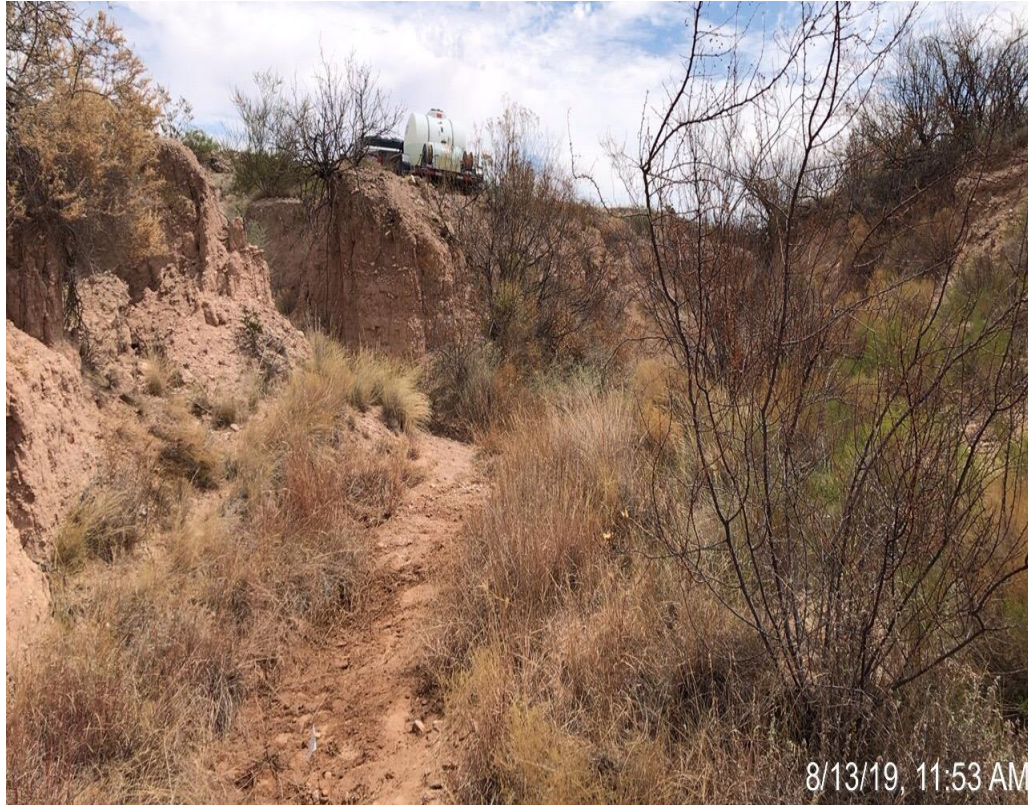
View East, area of AH-7

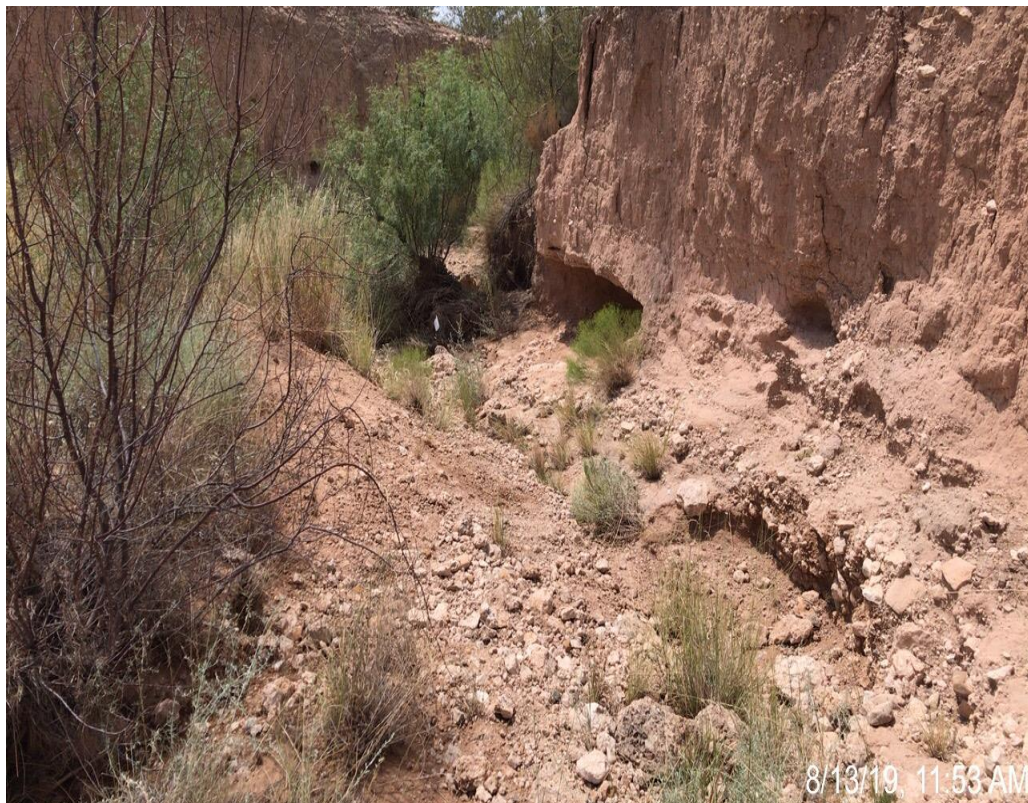
View West, area of AH-8

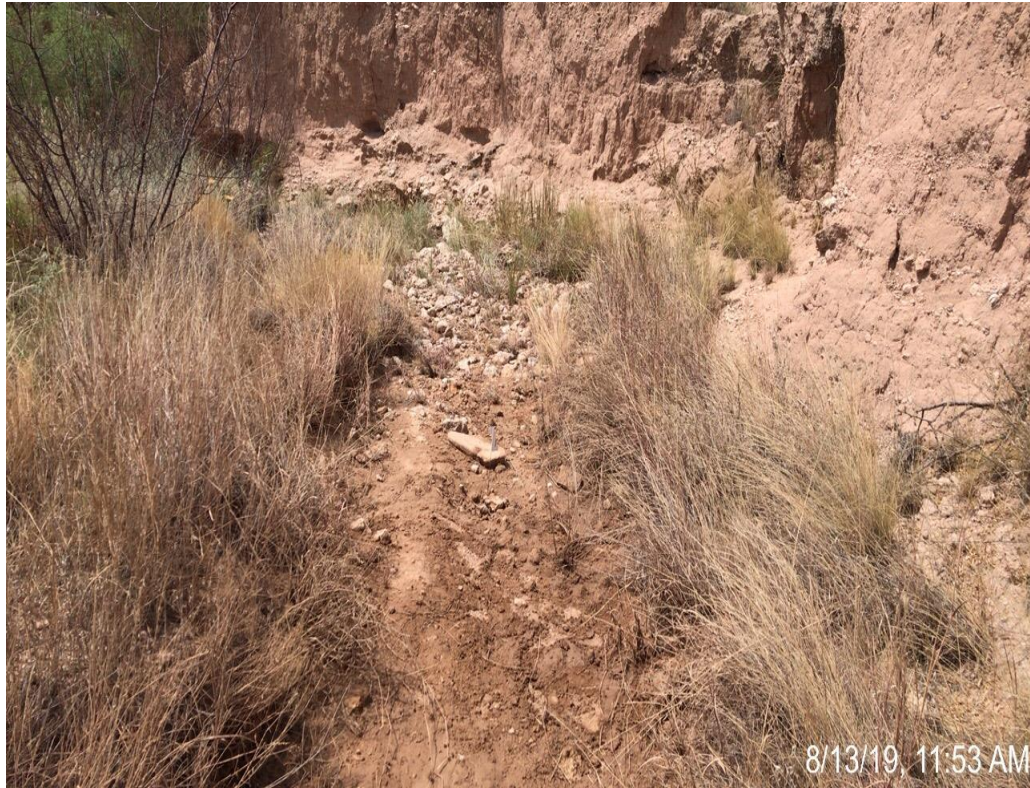
View South, area of AH-9

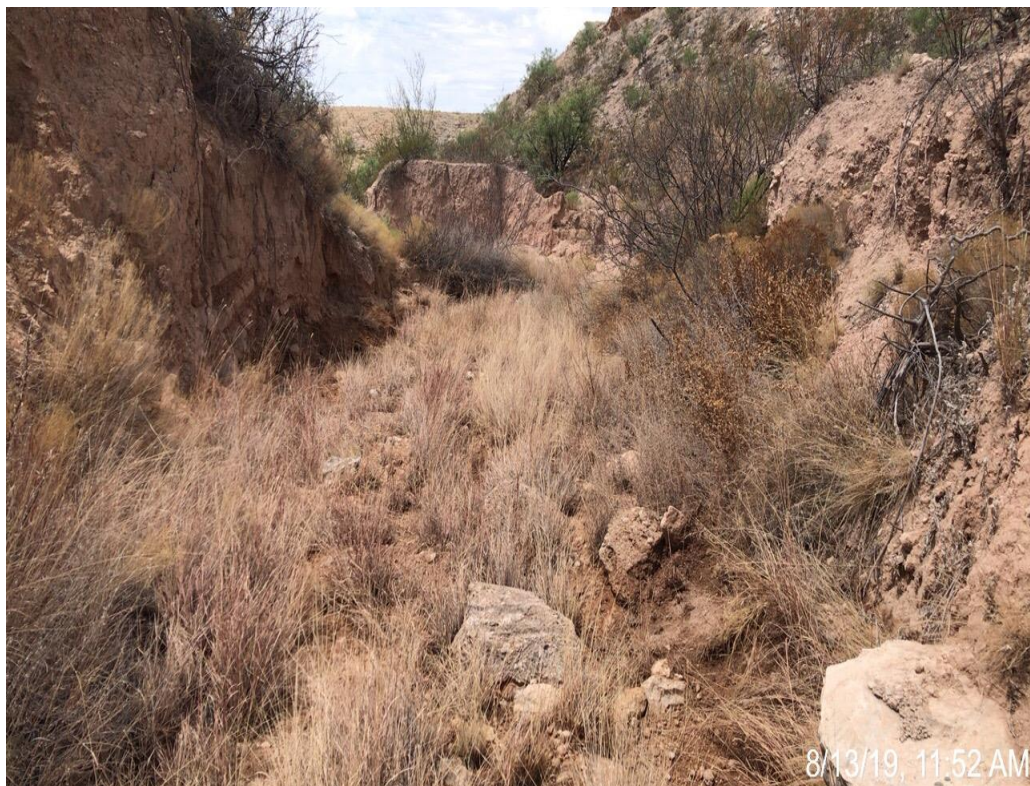
View South, area of AH-10 and AH-11

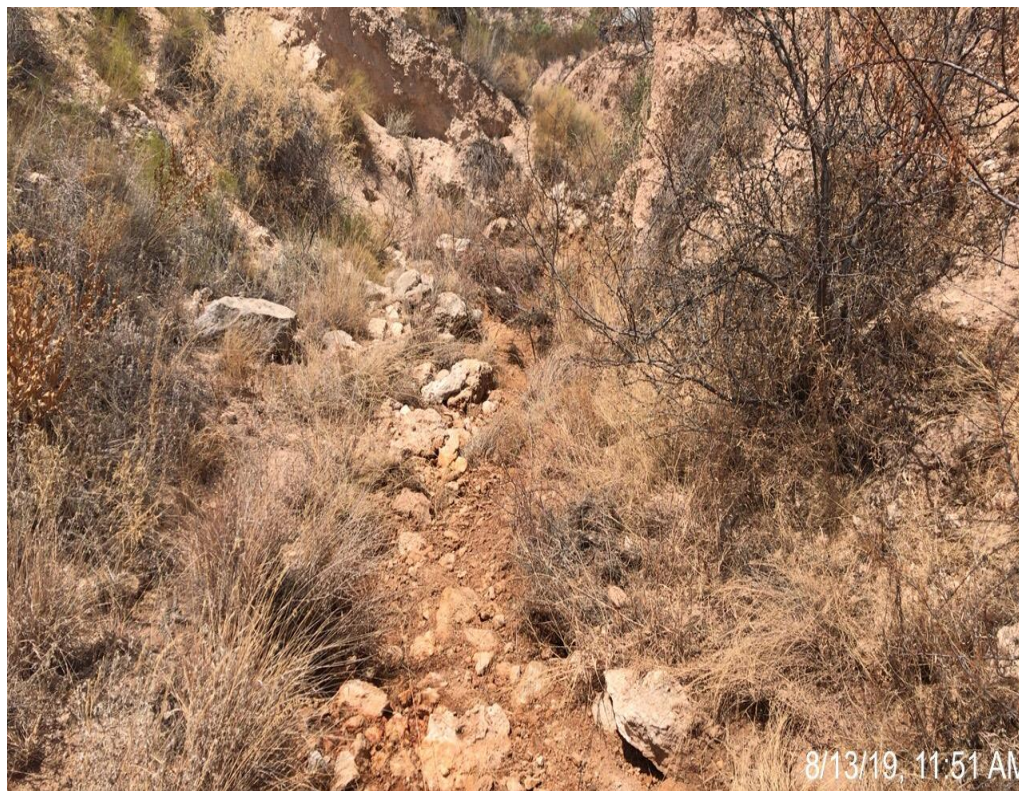
View West, area of AH-12, AH-3, and AH-14
