**Subject: Closure Request
Harvest Midstream Company
Milagro Gas Plant
Incident #NAPP2121445477
San Juan County, New Mexico**

FIGURE 1
SITE LOCATION MAP
MILAGRO GAS PLANT
SEC 12 T29N R11W
SAN JUAN COUNTY, NEW MEXICO
HARVEST MIDSTREAM COMPANY

PHOTOGRAPHIC LOG		
HARVEST MIDSTREAM COMPANY	MILGARO GAS PLANT SAN JUAN COUNTY, NEW MEXICO	TE090321012

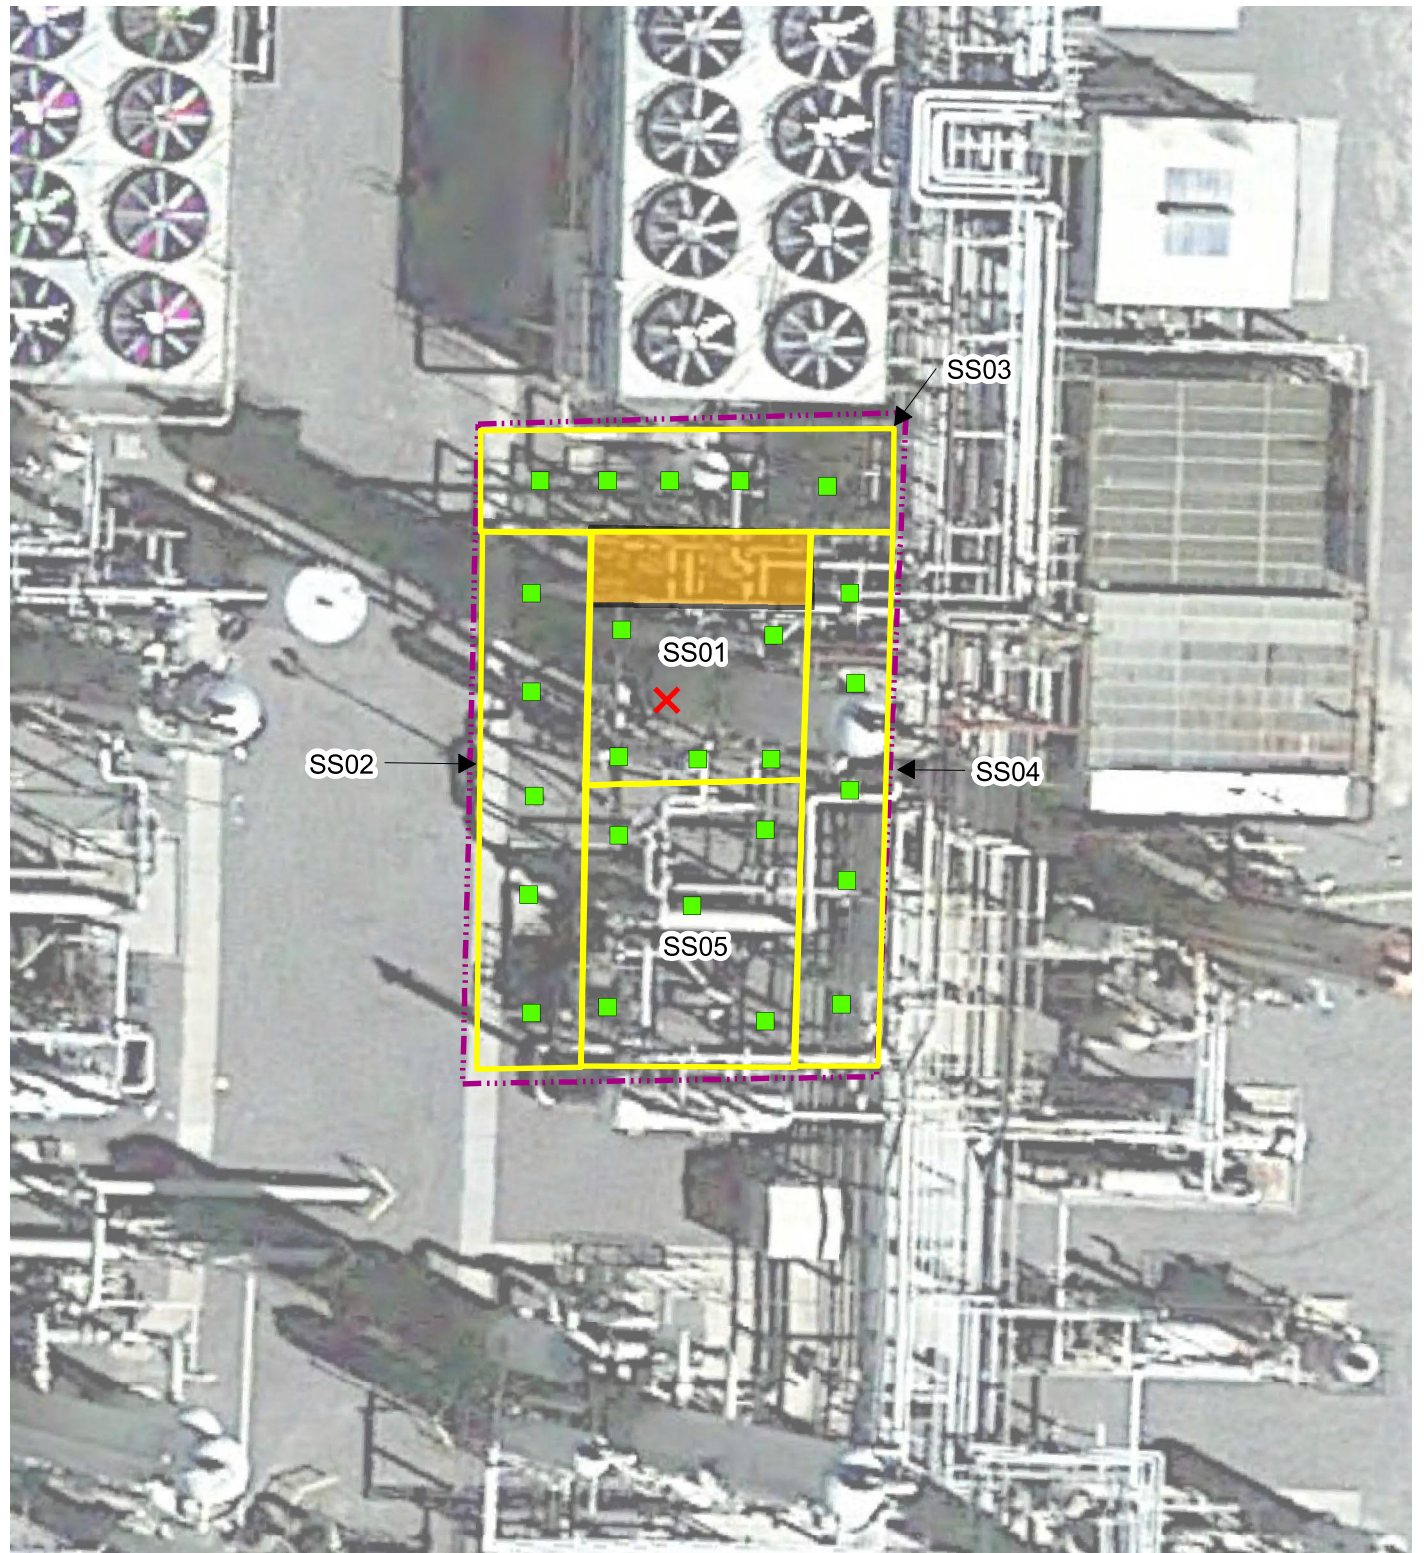
FIGURE 4
CONFIRMATION SOIL SAMPLE
LOCATIONS (SEPTEMBER 2021)
MILAGRO GAS PLANT
SEC 12 T29N R11W
SAN JUAN COUNTY, NEW MEXICO
HARVEST MIDSTREAM COMPANY

- X RELEASE LOCATION
- ALIQUOT SOIL SAMPLE LOCATION
- CONCRETE PAD
- AREA OF CONCERN
- COMPOSITE SOIL SAMPLE (9/7/2021)

Analytical results indicated that TPH-DRO concentrations were detected in composite soil samples SS01 and SS03 but TPH concentrations were compliant with NMOCD Table 1 Closure Criteria. TPH concentrations were below laboratory detection limits in the other soil samples. The pH results ranged from 7.70 to 9.45 standard units. No BTEX or chloride concentrations were not detected in any of the composite soil samples above laboratory-reporting limits. Analytical results are summarized on Table 1. Laboratory analytical reports and COC documentation for the composite soil samples are included as Enclosure A. A photographic log from the sampling is included as Enclosure B.

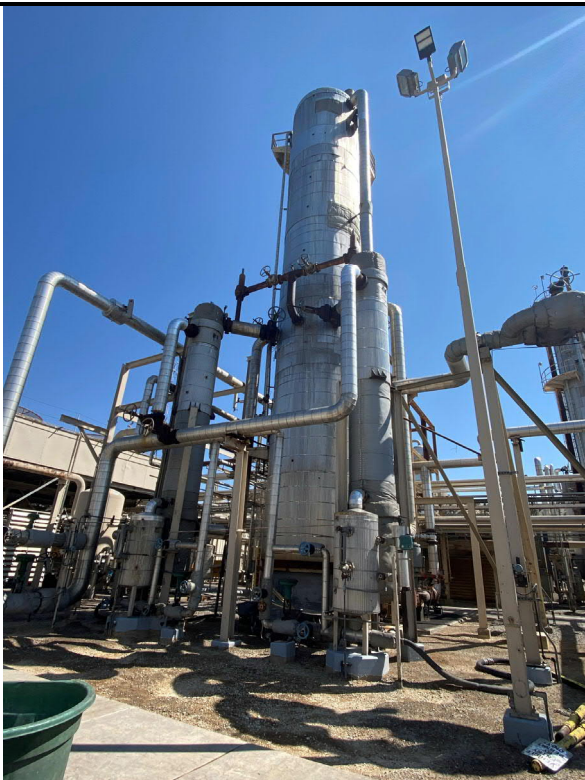
Photo No.	Date	
1	9/7/2021	
View of release location (Amine Stripper)

A photograph of a tall, cylindrical industrial vessel, identified as the Amine Stripper, at the Milgaro Gas Plant. The vessel is surrounded by a complex network of pipes, ladders, and structural steel. A tall light pole stands to the right of the vessel. The ground is gravel, and a green container is visible in the lower left corner.

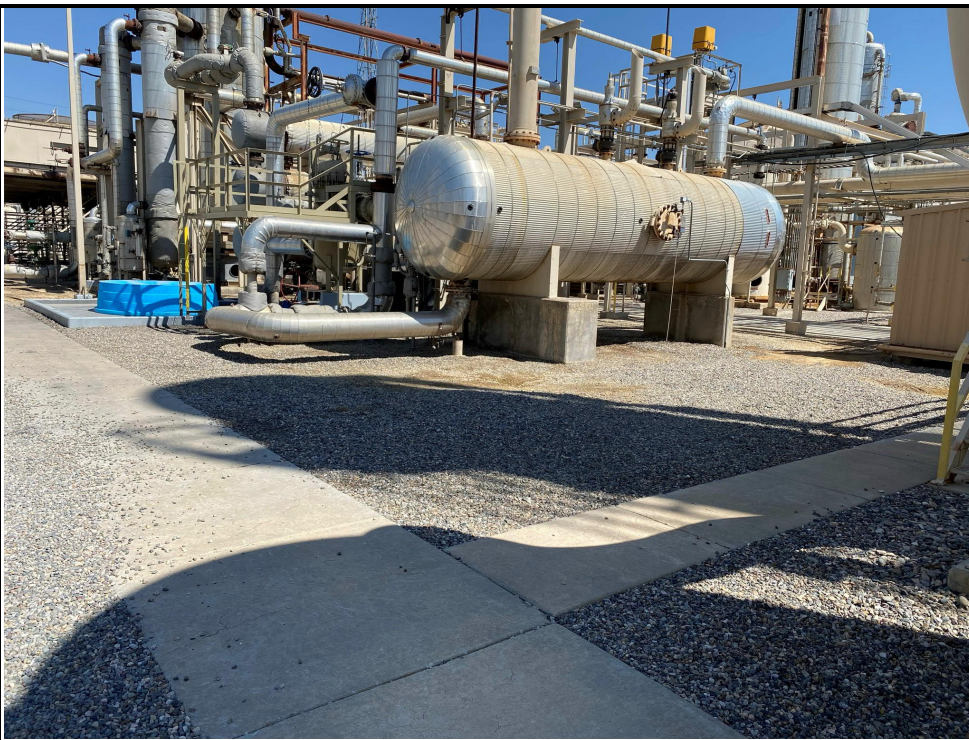
3	9/7/2021	
View of area affected by the release just south of Amine Stripper

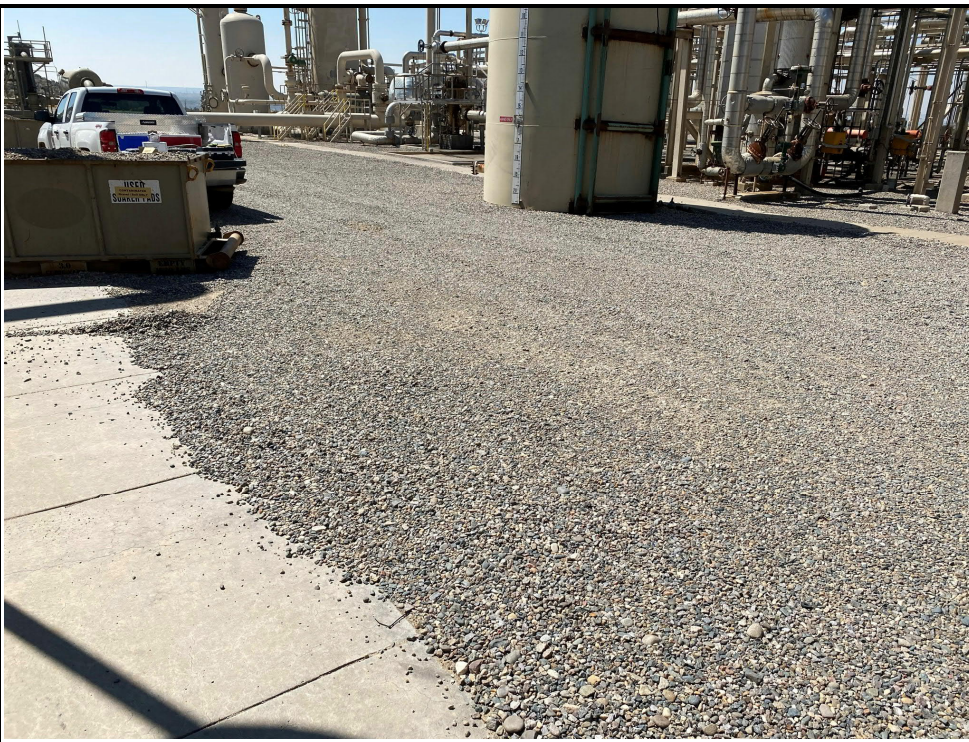
Photo No.	Date	
5	9/7/2021	
View of western edge of the affected area.

A wide-angle photograph showing a gravel-covered area next to a concrete sidewalk. In the background, there is industrial equipment, including large storage tanks and pipes, and a white pickup truck parked near a green dumpster. The scene is brightly lit, suggesting a sunny day.
