**Re: Closure Letter  
NM DW STATE #003  
API #: 30-025-32955  
RP#: 1RP-5038  
Lea County, NM**

COG Operating, LLC (COG) is pleased to submit for your consideration the following closure report for the NM DW State #003. This release occurred on April 30, 2018. Following the releases a site assessment of the impacted soils was conducted. A remediation work plan was submitted to and subsequently approved by the New Mexico Oil Conservation Division (NMOCD) and New Mexico State Land Office (NMSLO). A copy of the work plan is attached.

**NM DW STATE #003**

### COG – NM DW STATE #003 (Leak Date: 4/30/18)

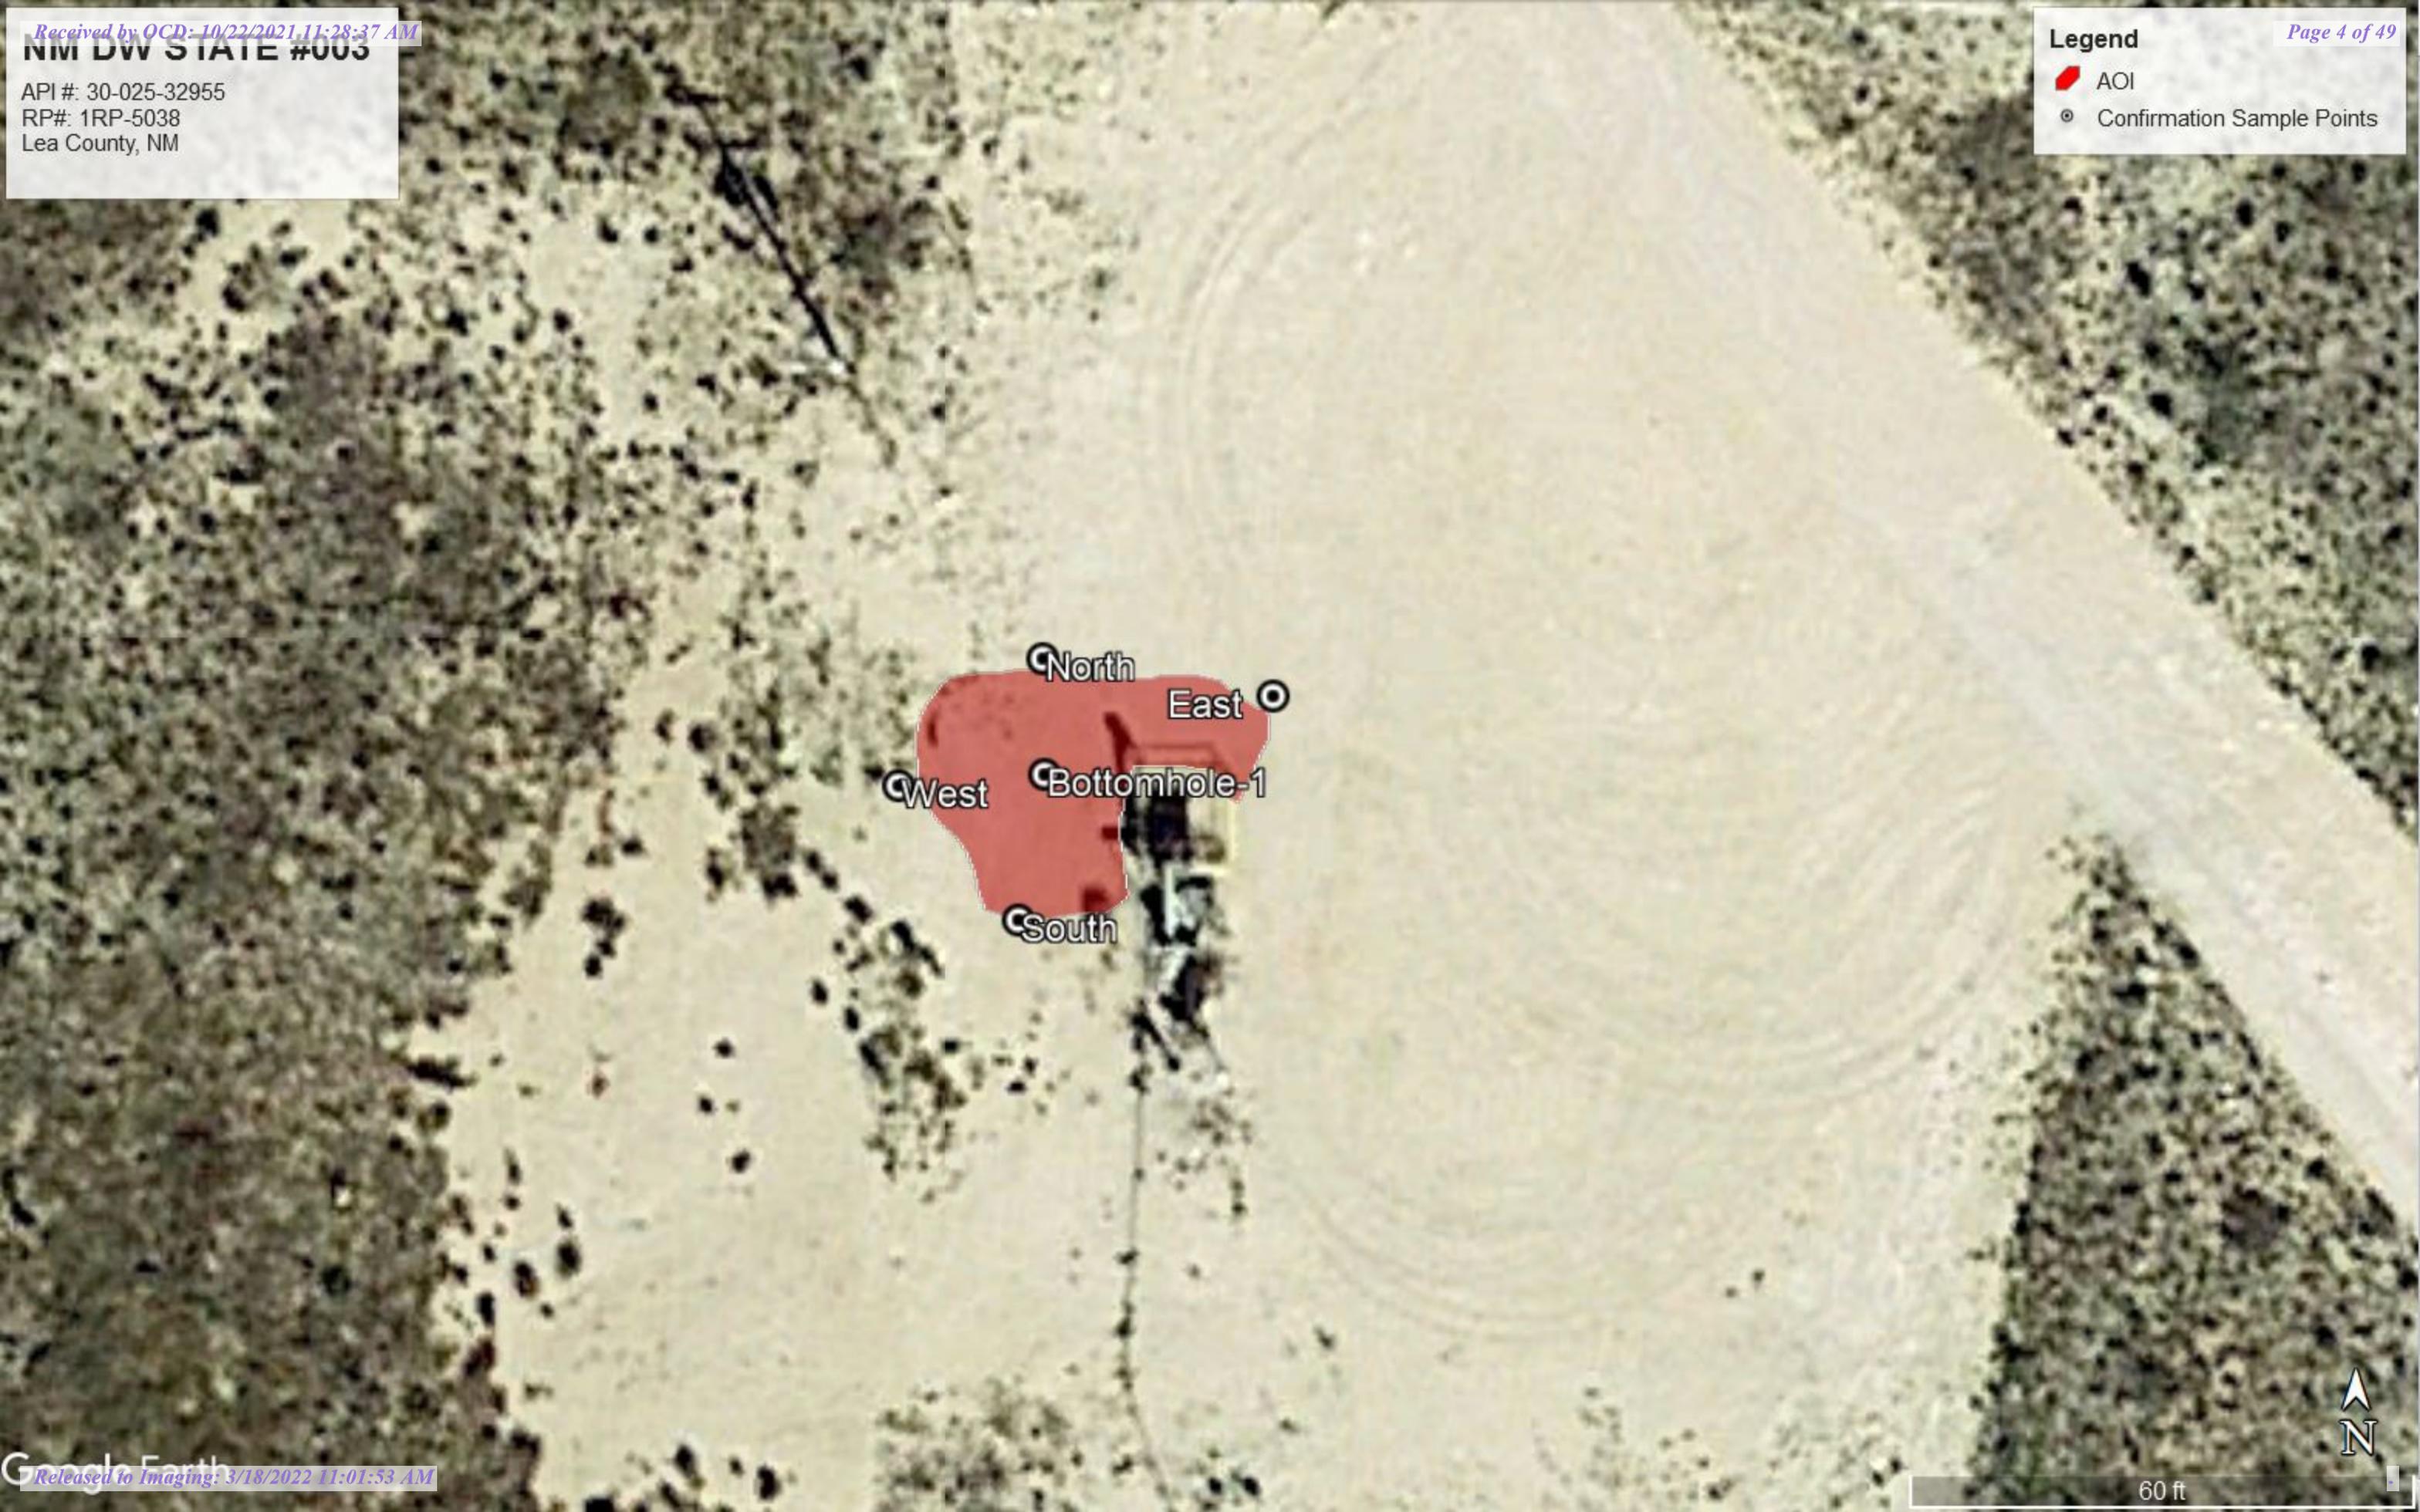
# APPENDIX I

API #: 30-025-32955  
RP#: 1RP-5038  
Lea County, NM

Confirmation Sample Points

- The impacted areas of SP-1, SP-2, and SP-3 were excavated to a depth of one (1) foot BGS.
- All of the excavated material was transported to an NMOCD approved solid waste disposal facility.
- The excavation was backfilled with like material and contoured to match the surrounding location.

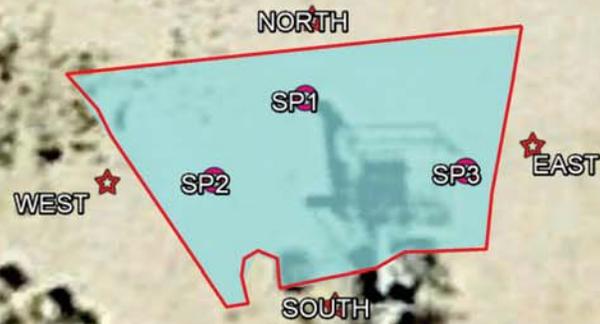
***COG will excavate the spill area as depicted on the following site diagram. The entire leak area (blue shade on diagram) will be excavated to a depth of 1 foot.***

1 ft Excavation across entire leak area
-

Leak Area
-

Sample points

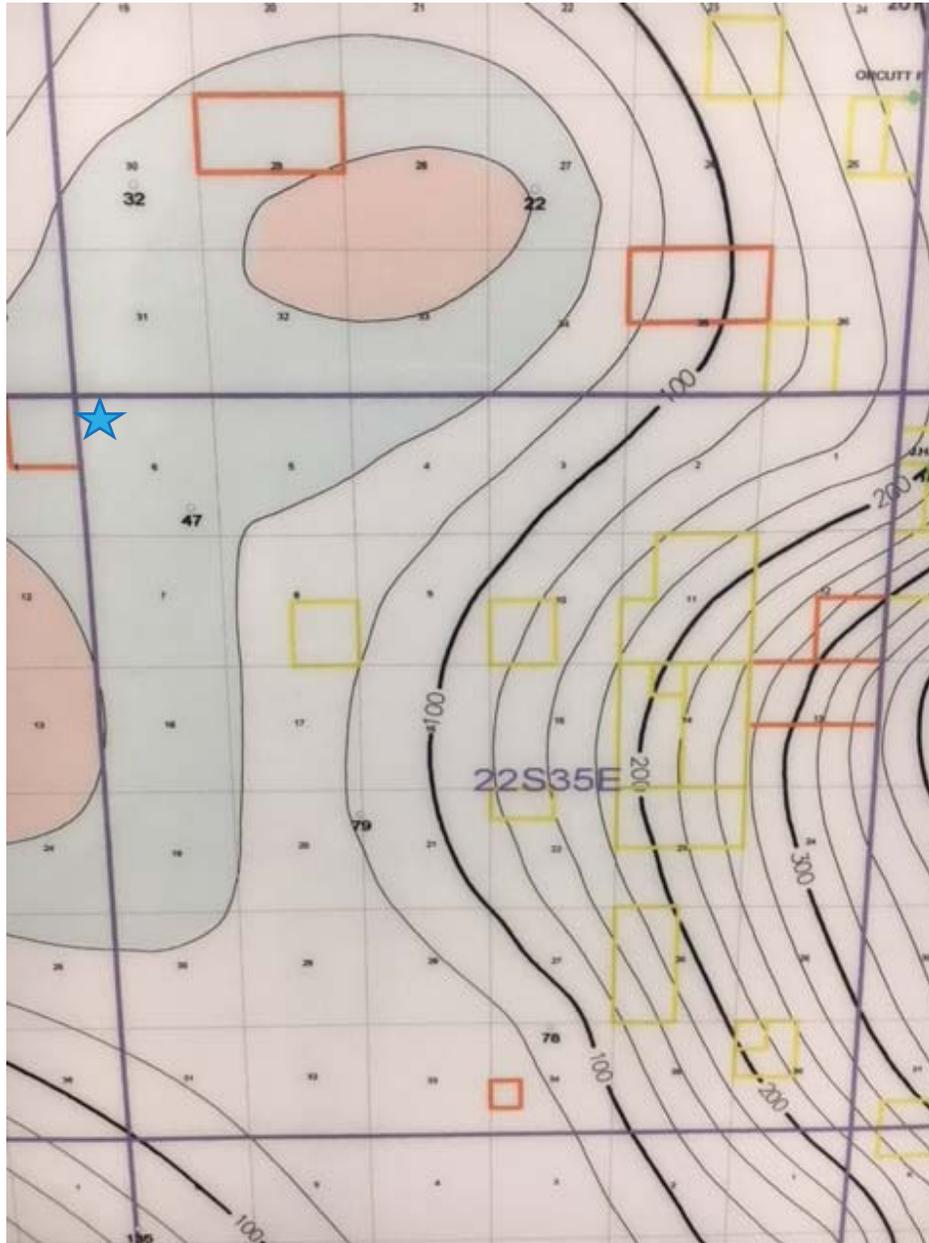
WEST, N 32.42643 W-103.41293

**COG, NM DW State #003**  
**U/L D, Section 6, T22S, R35E**  
**Groundwater: <50'**
