Release Notification

CLOSURE REPORT

**Huerfanito #82M Pipeline Release
NW 1/4, S25 T27N R9W
San Juan County, New Mexico**

September 14, 2020
Ensolum Project No. 05A1226086

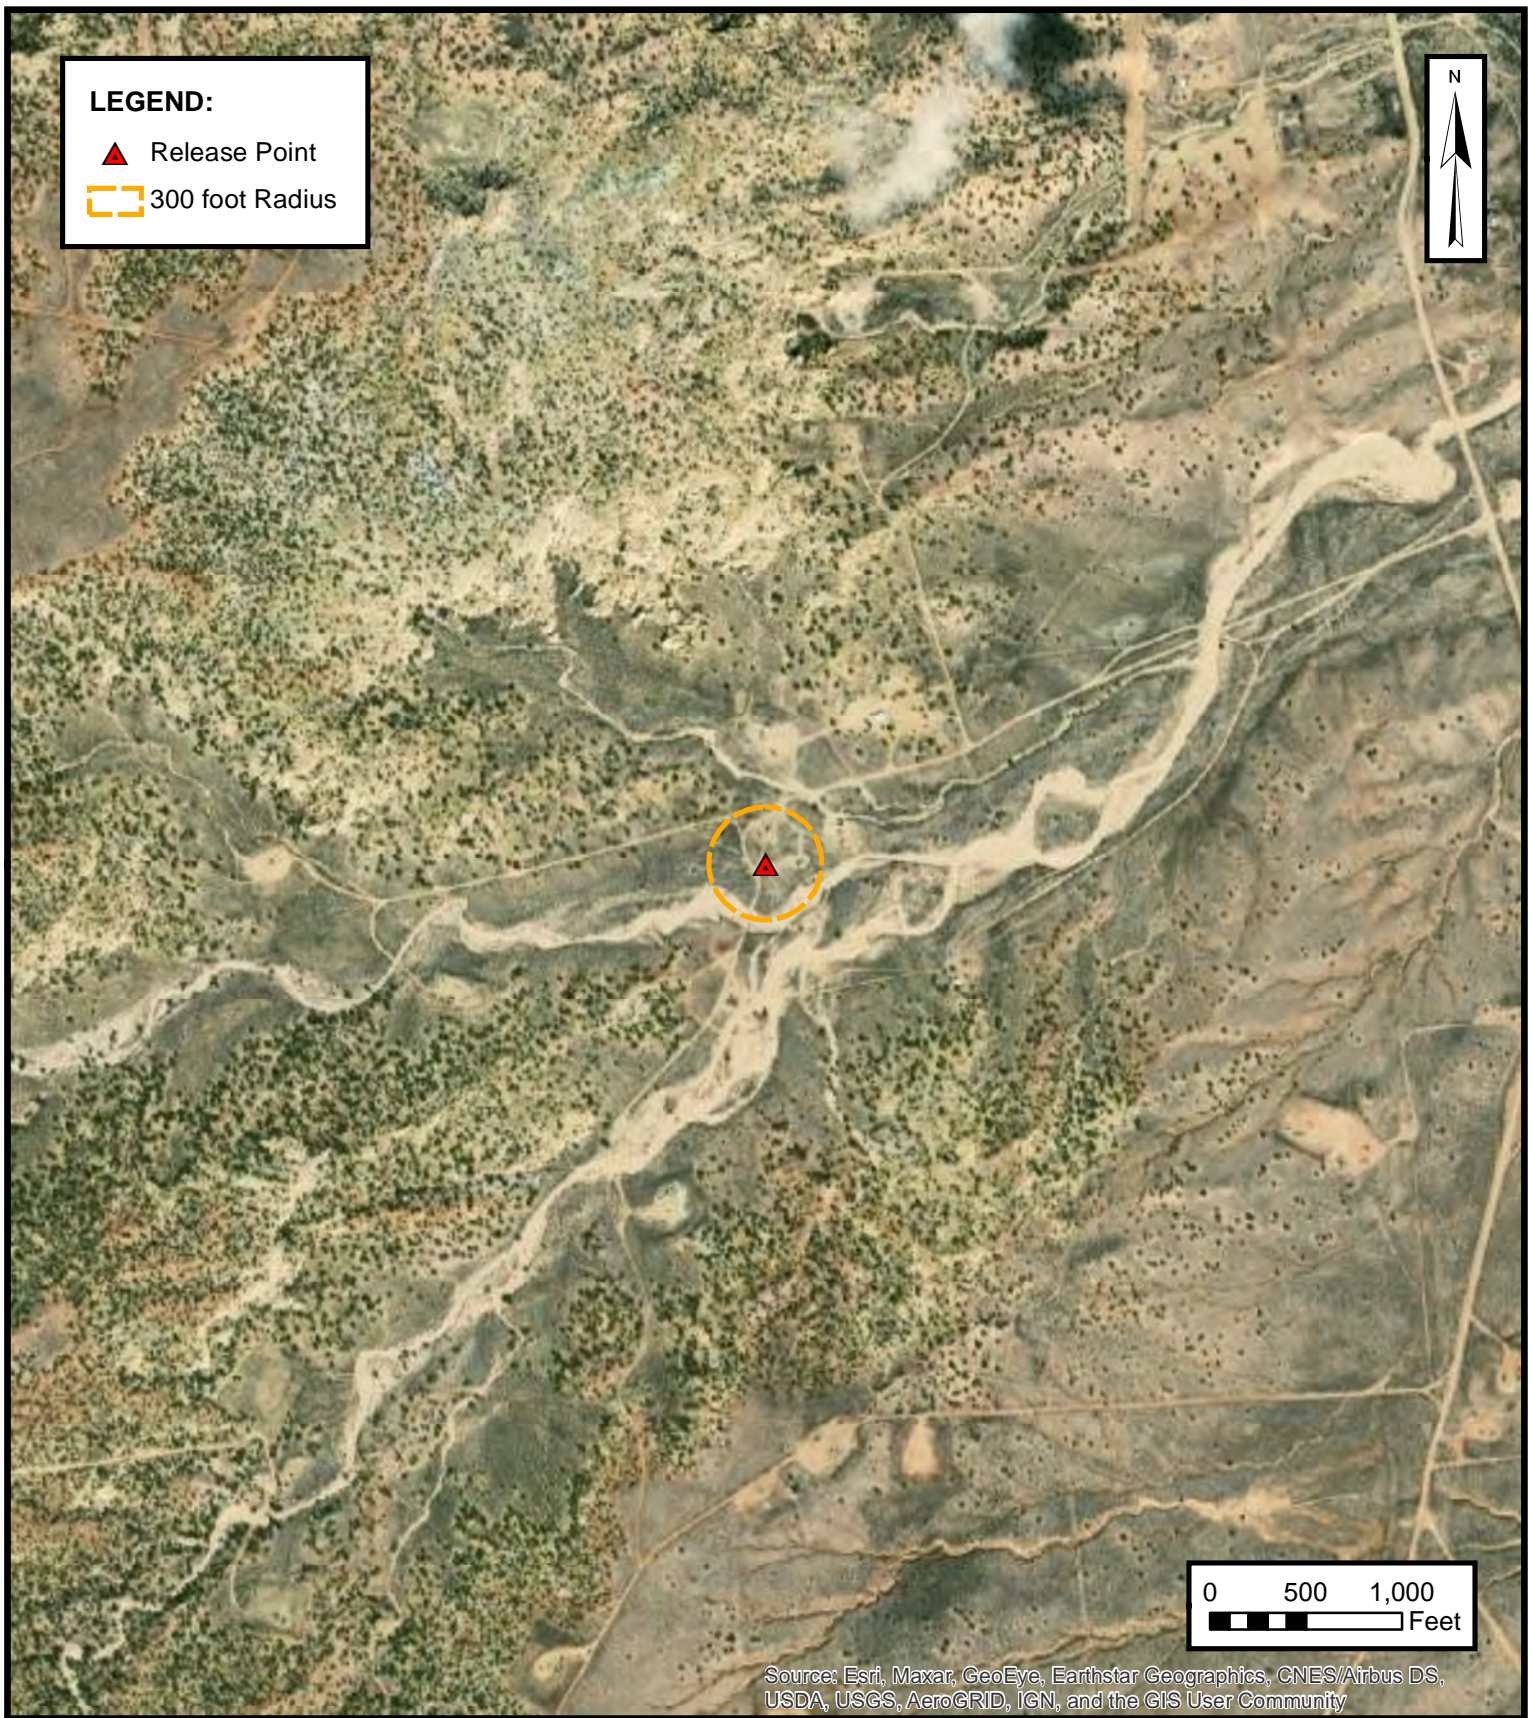
FIGURE**D**

- The Site is not located within 200 feet of a lakebed, sinkhole, or playa lake.
- The Site is not located within 300 feet of a permanent residence, school, hospital, institution, or church. The nearest permanent residences are located approximately 855 feet (northeast) and 945 feet (southeast) from the Site.

**300-FOOT RADIUS
OCCUPIED STRUCTURE IDENTIFICATION**

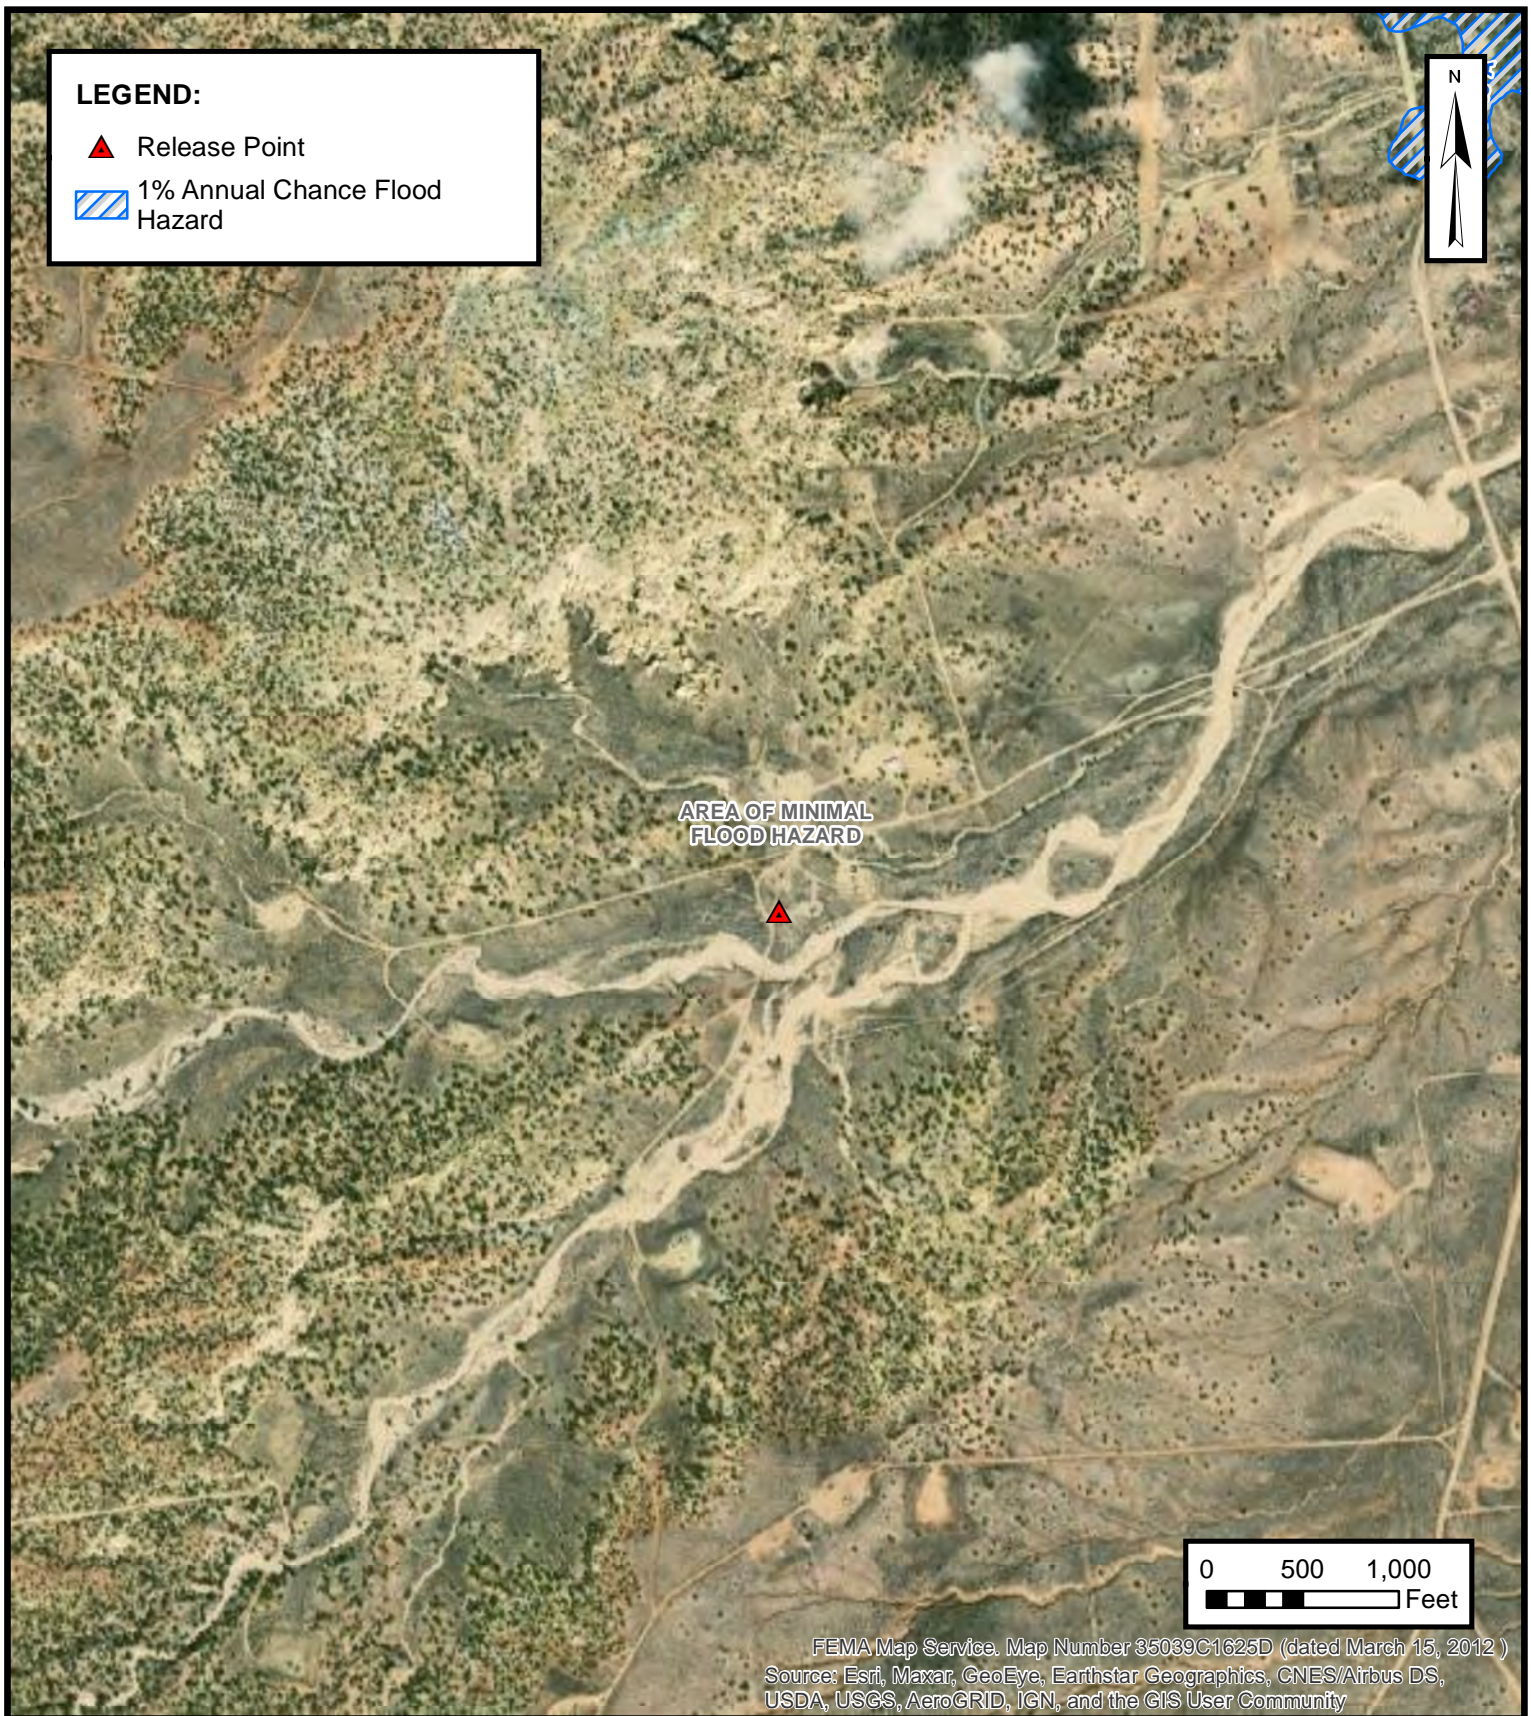
FIGURE
H

- The Site is not located within an unstable area.
- Based on information identified in the Federal Emergency Management Agency (FEMA) National Flood Hazard Layer (NFHL) geospatial database, the Site is not located within a 100-year floodplain.

100-YEAR FLOOD PLAIN MAP
ENTERPRISE FIELD SERVICES, LLC
HUERFANITO #82M
NW ¼, S25 T27N R9W, San Juan County, New Mexico
36.550869° N, 107.746550° W

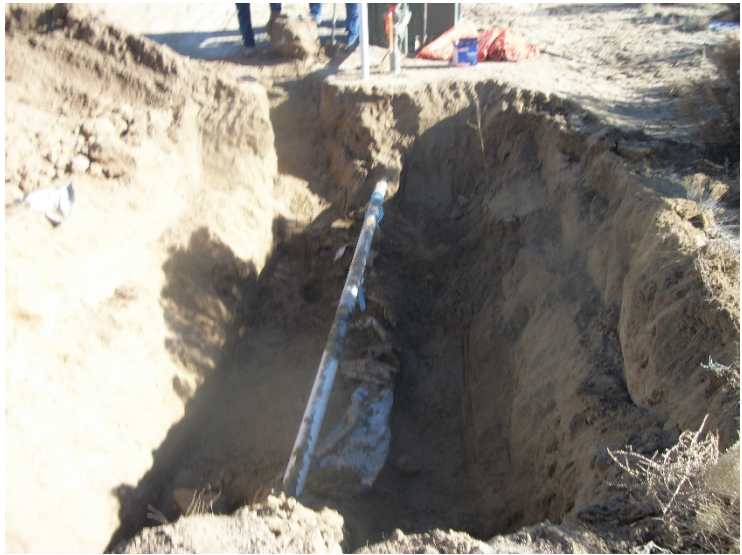
**Photograph 1**

The final excavation measured approximately 12 feet long and six (6) feet wide at the maximum extents. The maximum depth of the excavation measured approximately five (5) feet bgs.

Photograph Description: View of the final pipeline repair excavation.

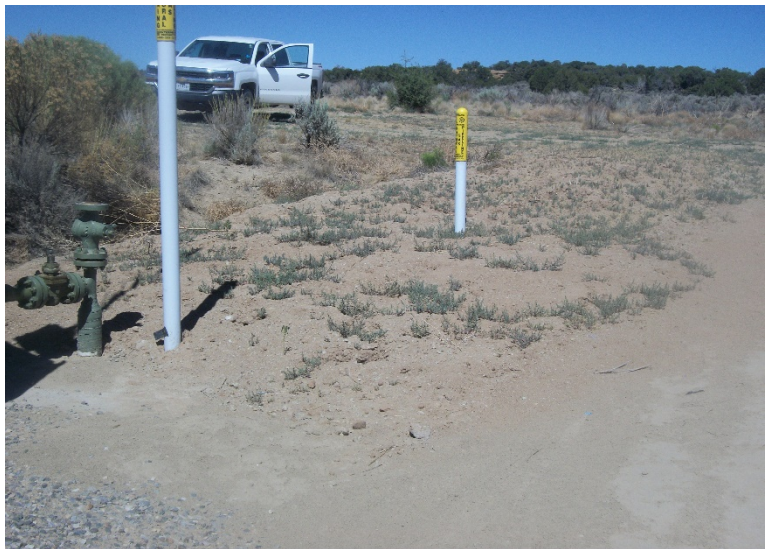
**Photograph 2**

Photograph Description: View of the excavation after initial restoration.

The excavation was backfilled with imported fill and was then contoured to the surrounding grade. Enterprise will re-seed the Site with an approved seeding mixture.

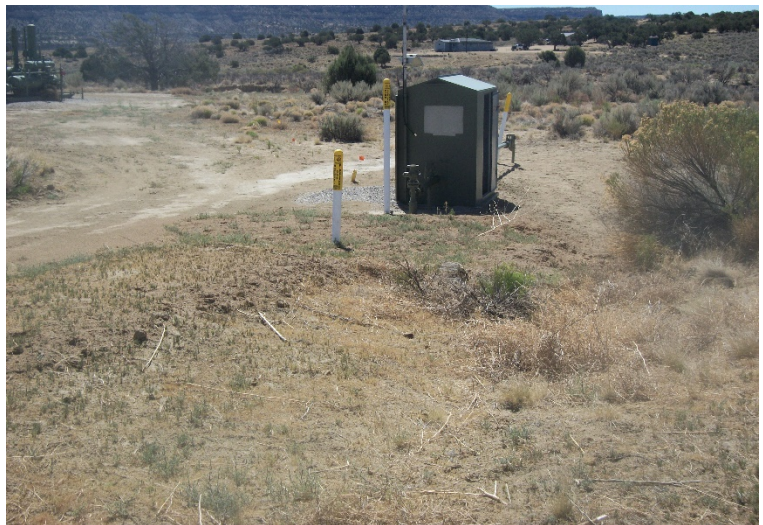
**Photograph 3**

Photograph Description: View of the excavation after initial restoration.
