# **MILAGRO GAS PLANT**

## **RELEASE DELINEATION AND DEFERRAL REQUEST**

**JANUARY 16, 2020**

**RE: Release Delineation and Deferral Request  
Harvest Four Corners, LLC  
Milagro Gas Plant  
San Juan County, New Mexico**

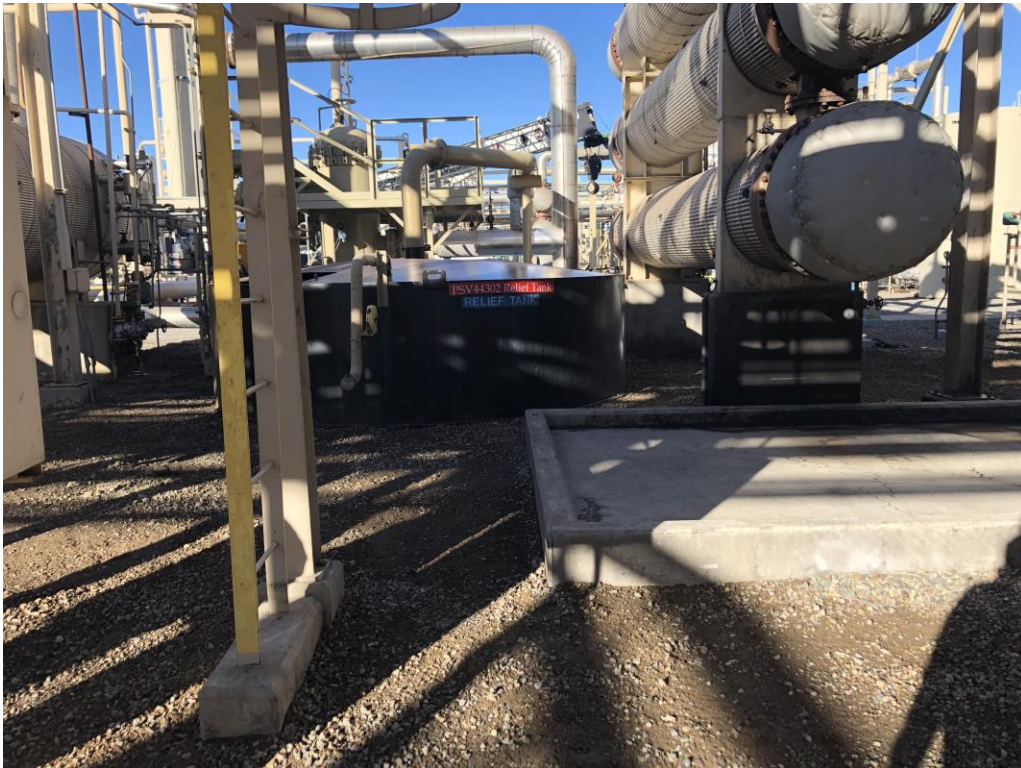
On October 20, 2019, a pipe seal failed, causing liquid amine/water solution to be discharged into an above ground relief tank that measures approximately 4 feet tall and 12 feet in diameter. With this discharge, the tank overflowed and caused approximately eight barrels (bbls) of amine/water solution to be released onto the ground within the gas plant onto structural fill and crushed aggregate. On October 21 and 22, 2019, Harvest personnel were able to use hand tools to remove the top two to four inches of impacted material (comprised of soil and gravel) with observable odors and/or staining. Approximately 10 cubic yards of material was removed and disposed of offsite at Industrial Ecosystems, Inc (IEI), located in Aztec, New Mexico.

**Photograph 1:** View looking West at relief tank where amine/water solution was released.

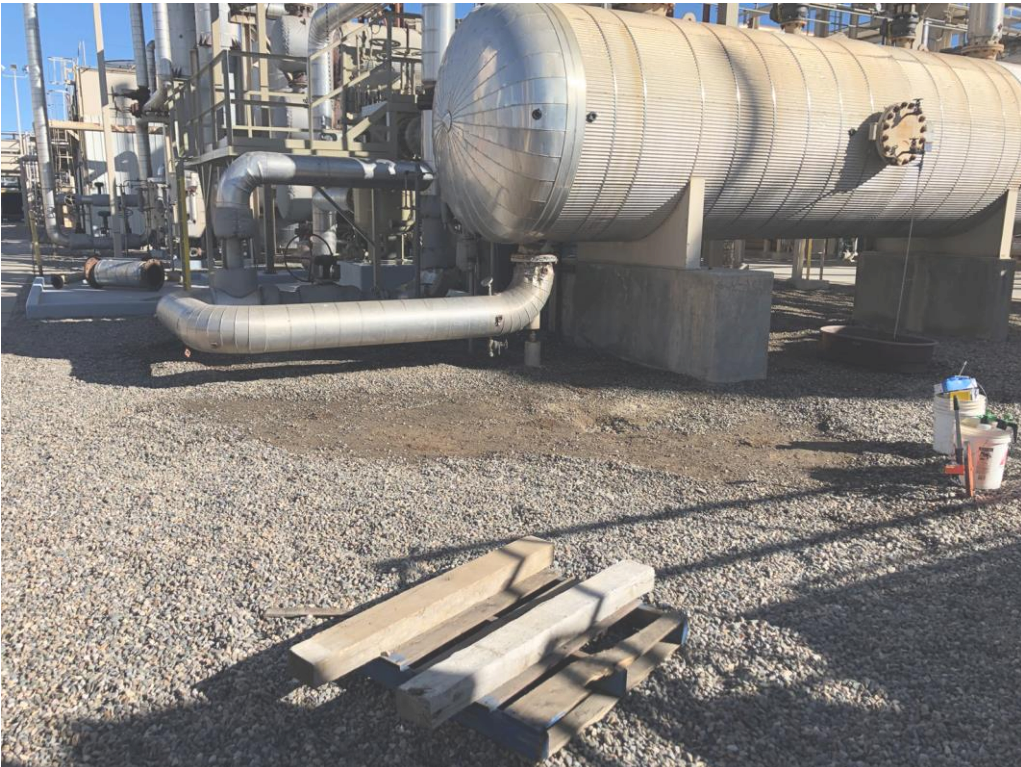
**Photograph 2:** View from southwest corner of the release area looking North.

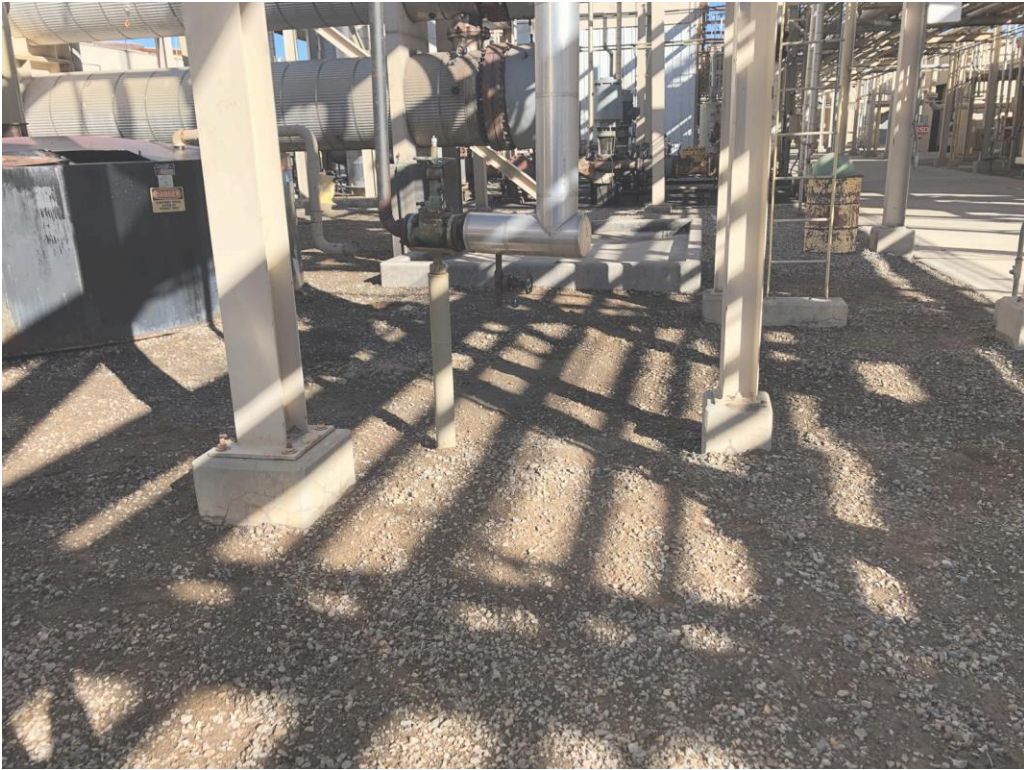
**Photograph 3:** View from southeast corner of the release area looking North.

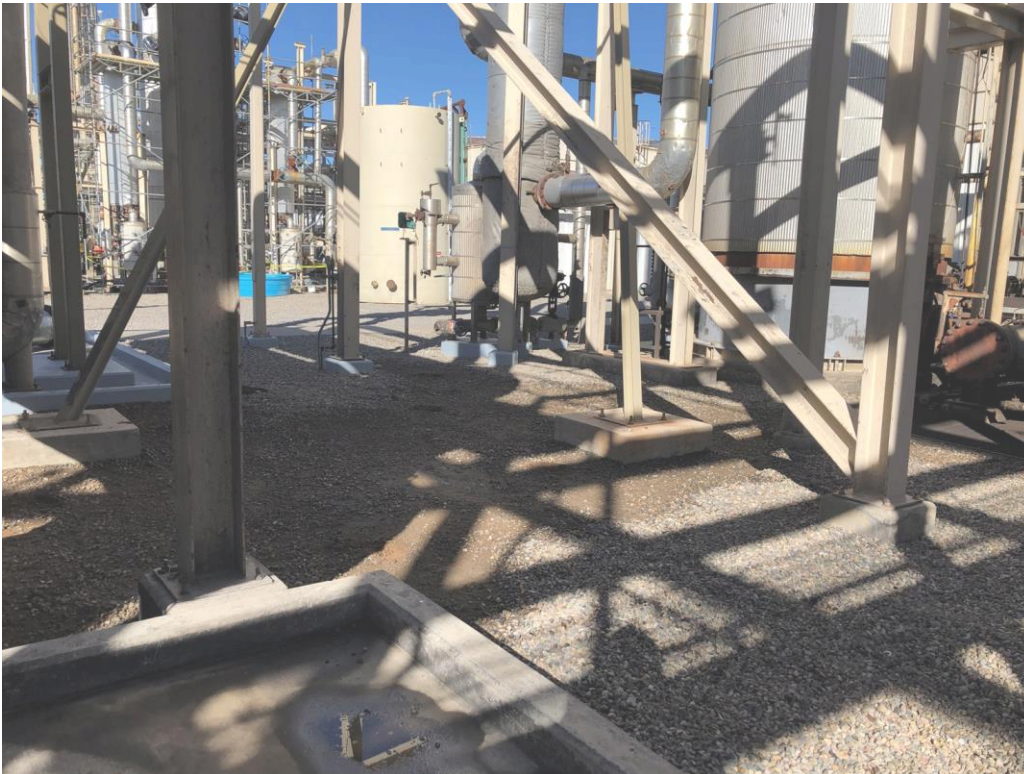
**Photograph 4:** View on North side of the relief tank looking West.
