Enterprise CTB

Closure Report

E-12-17S-30E

nRM2126347439

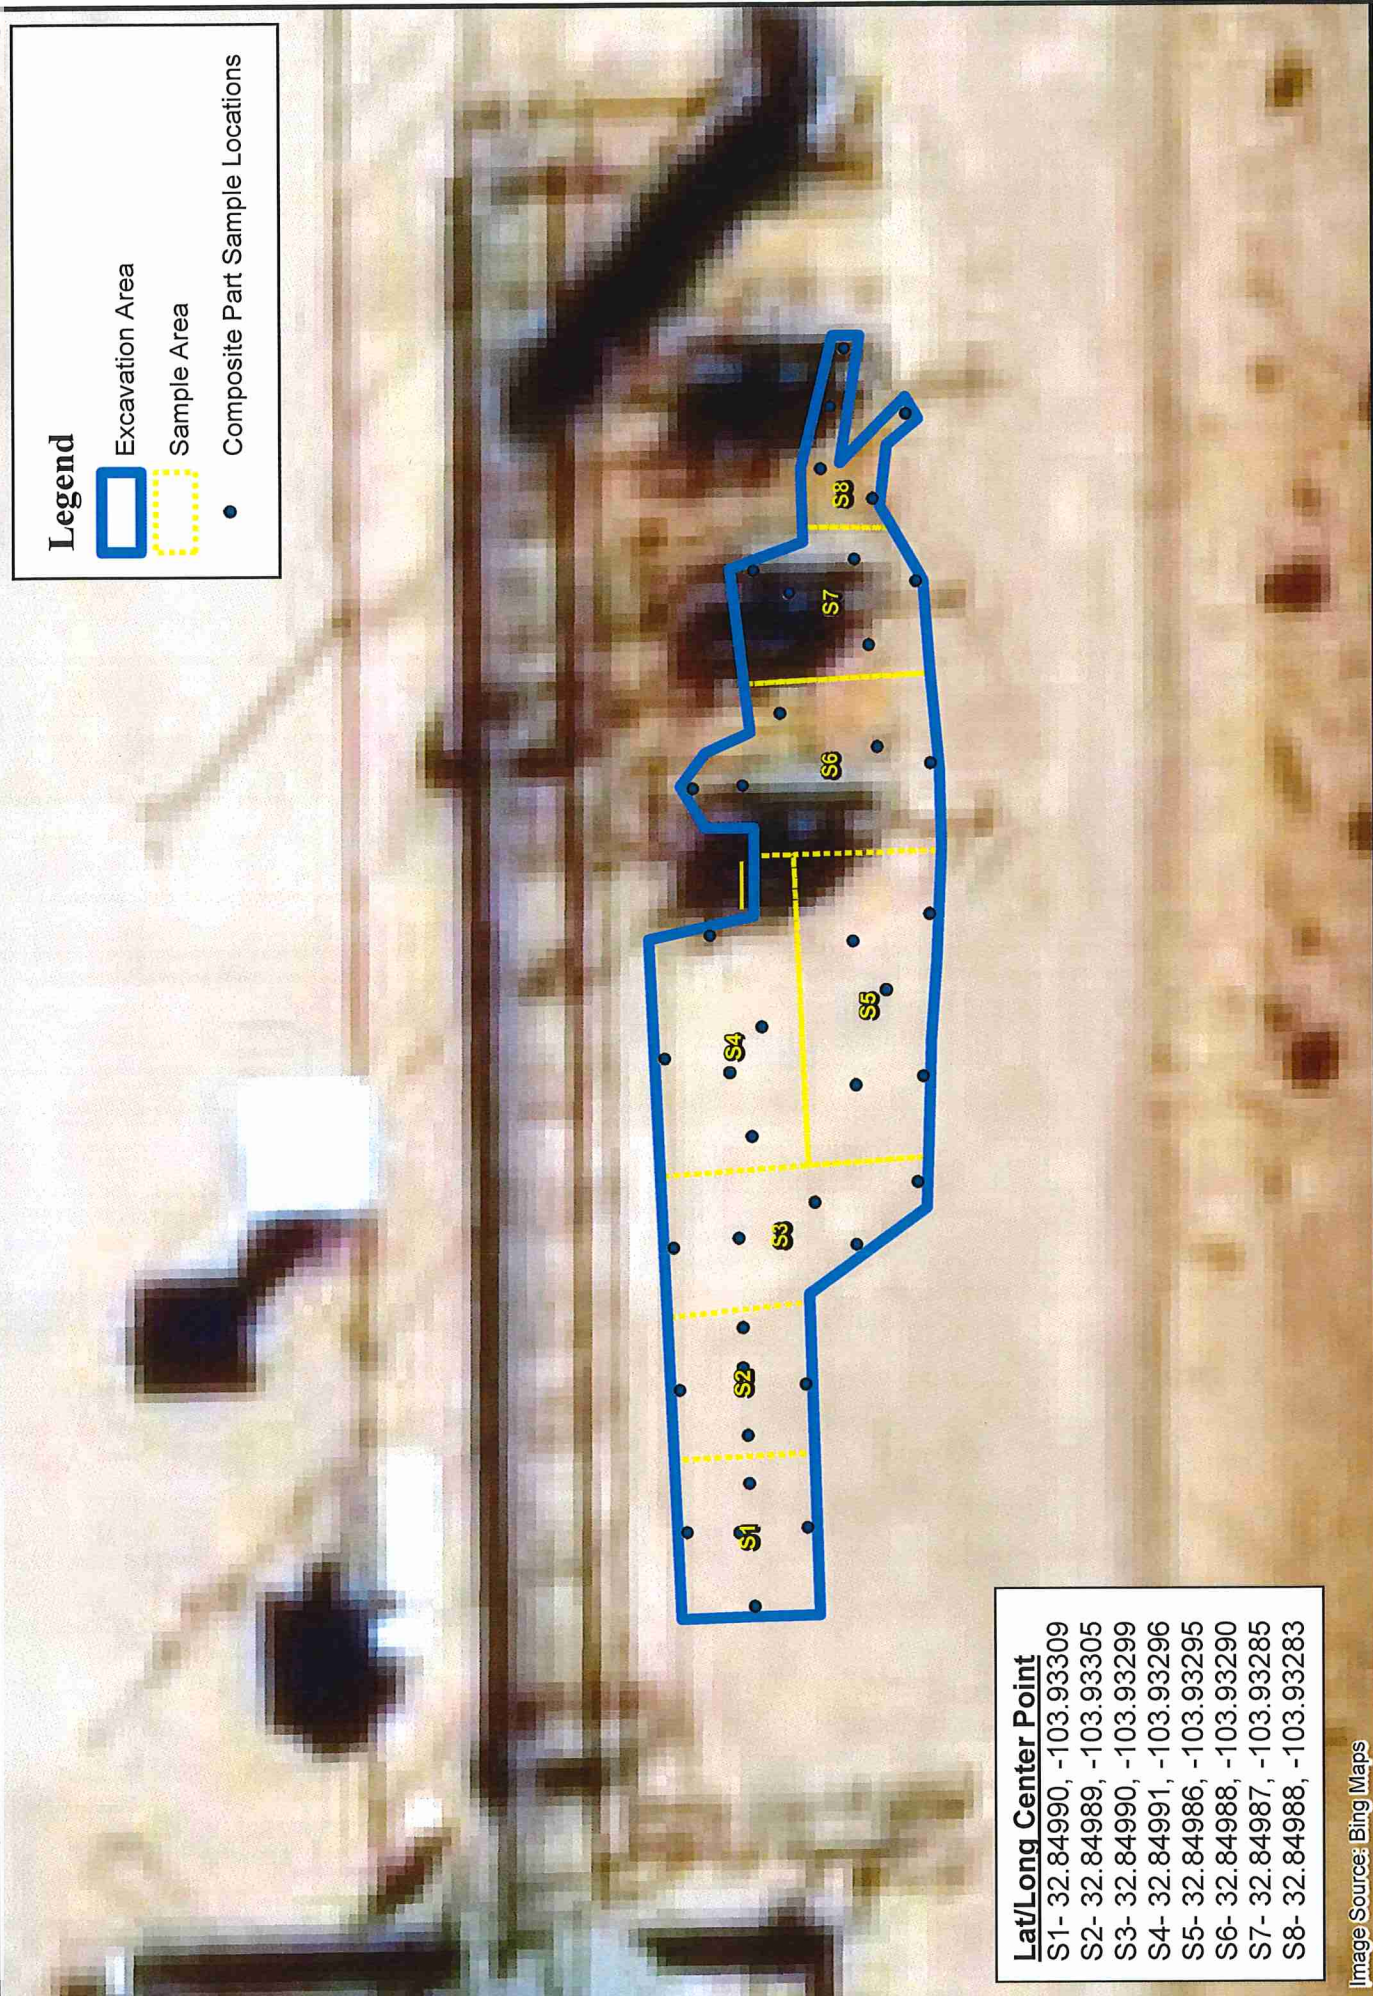
Figure 1

Site Map with Sample Points

| Lat/Long Center Point | |
| S1- | 32.84990, -103.93309 |
| S2- | 32.84989, -103.93305 |
| S3- | 32.84990, -103.93299 |
| S4- | 32.84991, -103.93296 |
| S5- | 32.84986, -103.93295 |
| S6- | 32.84988, -103.93290 |
| S7- | 32.84987, -103.93285 |
| S8- | 32.84988, -103.93283 |

EOG Resources, Inc. excavated to a depth of two (2) feet bgs prior to confirmation sampling activities conducted on December 18, 2020 (results enclosed). Analytical data from that sampling activity displayed results to be below Table 1 thresholds and NMAC 19.15.29.13 requirements. All samples were 5-point composite with no one sample representing greater than 200 square feet. Notification for sampling activities were sent to NMOCD and BLM on December 15, 2020. All excavated soil was hauled to a NMOCD approved facility for disposal, then the excavated area was backfilled to grade with caliche. The remediated area was not reseeded because it is on an active production pad. A C-141 Final Report is hereby submitted to NMOCD requesting closure of the site.

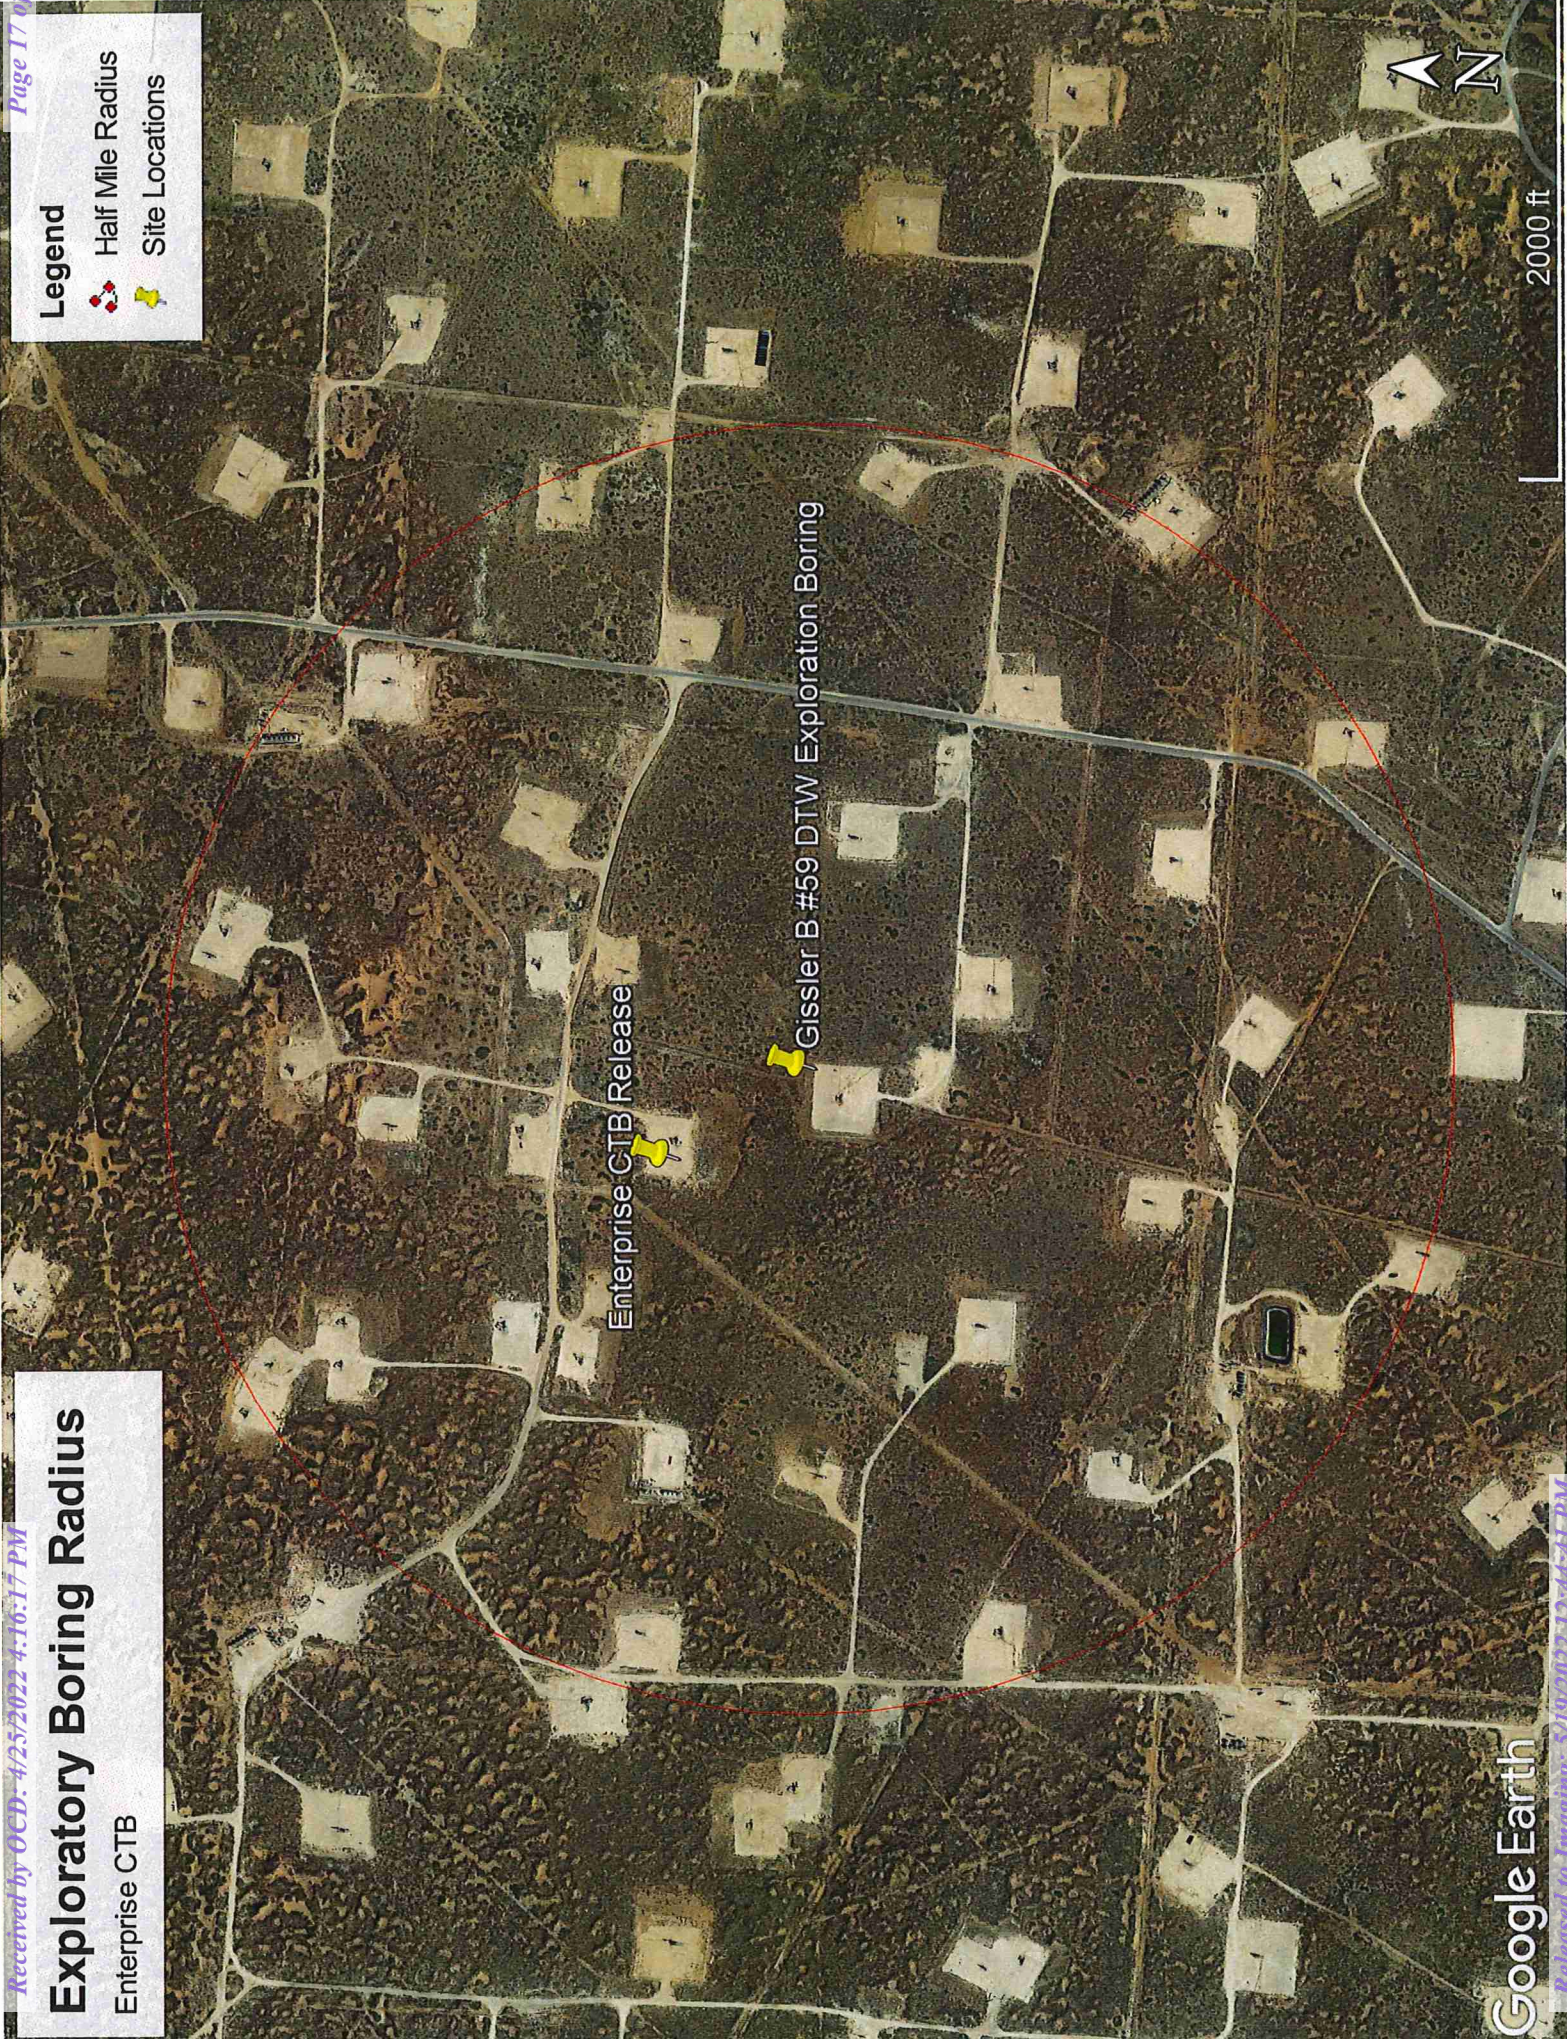
Exploratory Boring Radius

On May 20, 2021, Talon installed a temporary well at the following GPS coordinates, 32.848420 N latitude and 103.931751 W longitude to approximately 105 feet below ground surface (bgs.) which is located within a half mile from the site. The well was left open for 72 hours and a water level meter was utilized to determine the presence or absence of groundwater. No groundwater was detected, and the temporary well was plugged and abandoned. Depth to groundwater for this site is greater than one hundred (100) feet bgs. Watercourses in the area are dry except for infrequent flows in response to major precipitation events, with the nearest body of surface water being Dimmitt Lake at approximately 2 miles away. The site does not lie within a 100-year floodplain or overly an unstable area such as karst geology.

Enterprise CTB

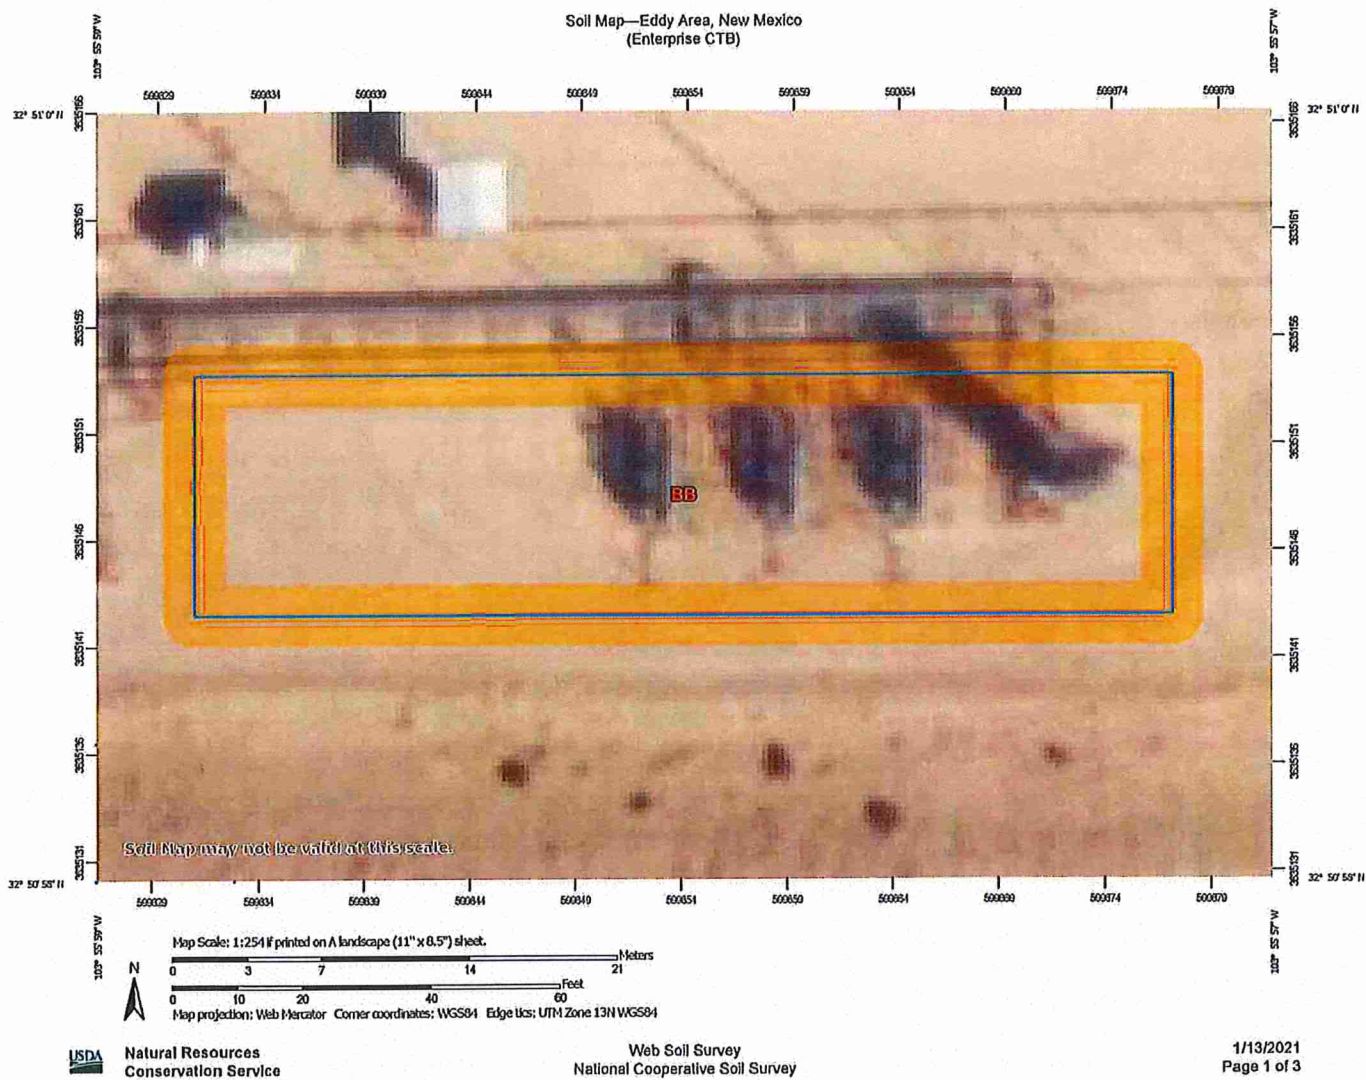
Soil Map—Eddy Area, New Mexico
(Enterprise CTB)

USDA Natural Resources Conservation Service (NRCS) classifies soil in the area of the release as Berino complex, with 0-3% slopes.

| Map Unit Symbol | Map Unit Name | Acres in AOI | Percent of AOI |
|---|---|---|---|
| BB | Berino complex, 0 to 3 percent slopes, eroded | 0.1 | 100.0% |
