May 19, 2022

**Re: Release Characterization and Remediation Work Plan  
ConocoPhillips  
Warren Unit #137 Flowline Release  
Unit Letter L, Section 27, Township 20 South, Range 38 East  
Lea County, New Mexico  
Incident ID NAPP2131930937**

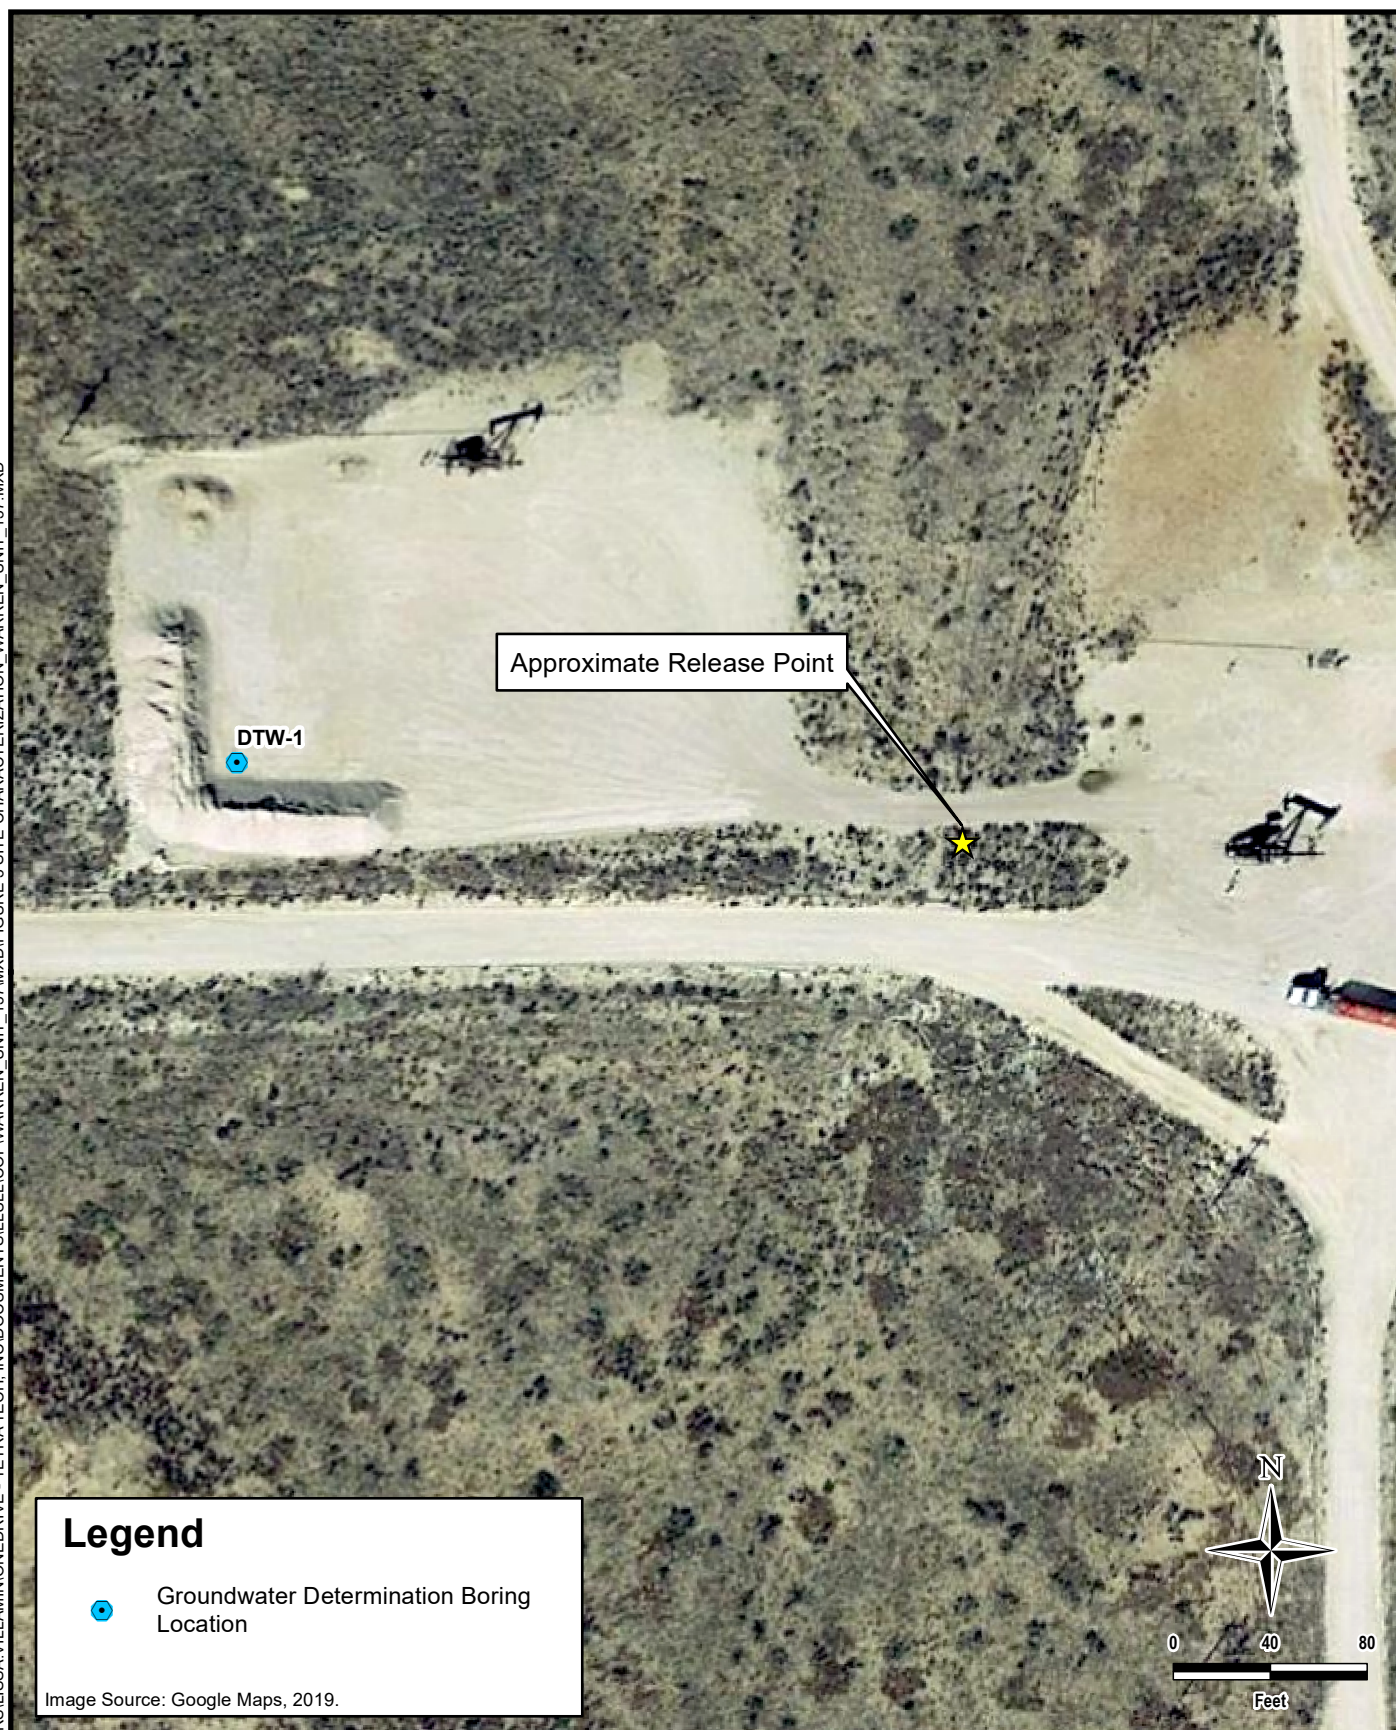
<b>TETRA TECH</b> <a href="http://www.tetrattech.com">www.tetrattech.com</a> 901 West Wall Street, Suite 100 Midland, Texas 79701 Phone: (432) 682-4559 Fax: (432) 682-3946	<b>CONOCOPHILLIPS</b> NAPP2131930937 (32.542210°, -103.143314°) LEE COUNTY, NEW MEXICO	PROJECT NO.: 212C-MD-02704 DATE: APRIL 08, 2022 DESIGNED BY: LMV
	<b>WARREN UNIT #137 FLOWLINE RELEASE SITE CHARACTERIZATION</b>	Figure No. <b>3</b>

A site characterization was performed and no watercourses, sinkholes, residences, schools, hospitals, institutions, churches, springs, private domestic water wells, playa lakes, wetlands, incorporated municipal boundaries, subsurface mines, or floodplains are located within the distances specified in 19.15.0029 New

Mexico Administrative Code (NMAC). The Site is within a New Mexico oil and gas production area and is in an area of low karst potential.

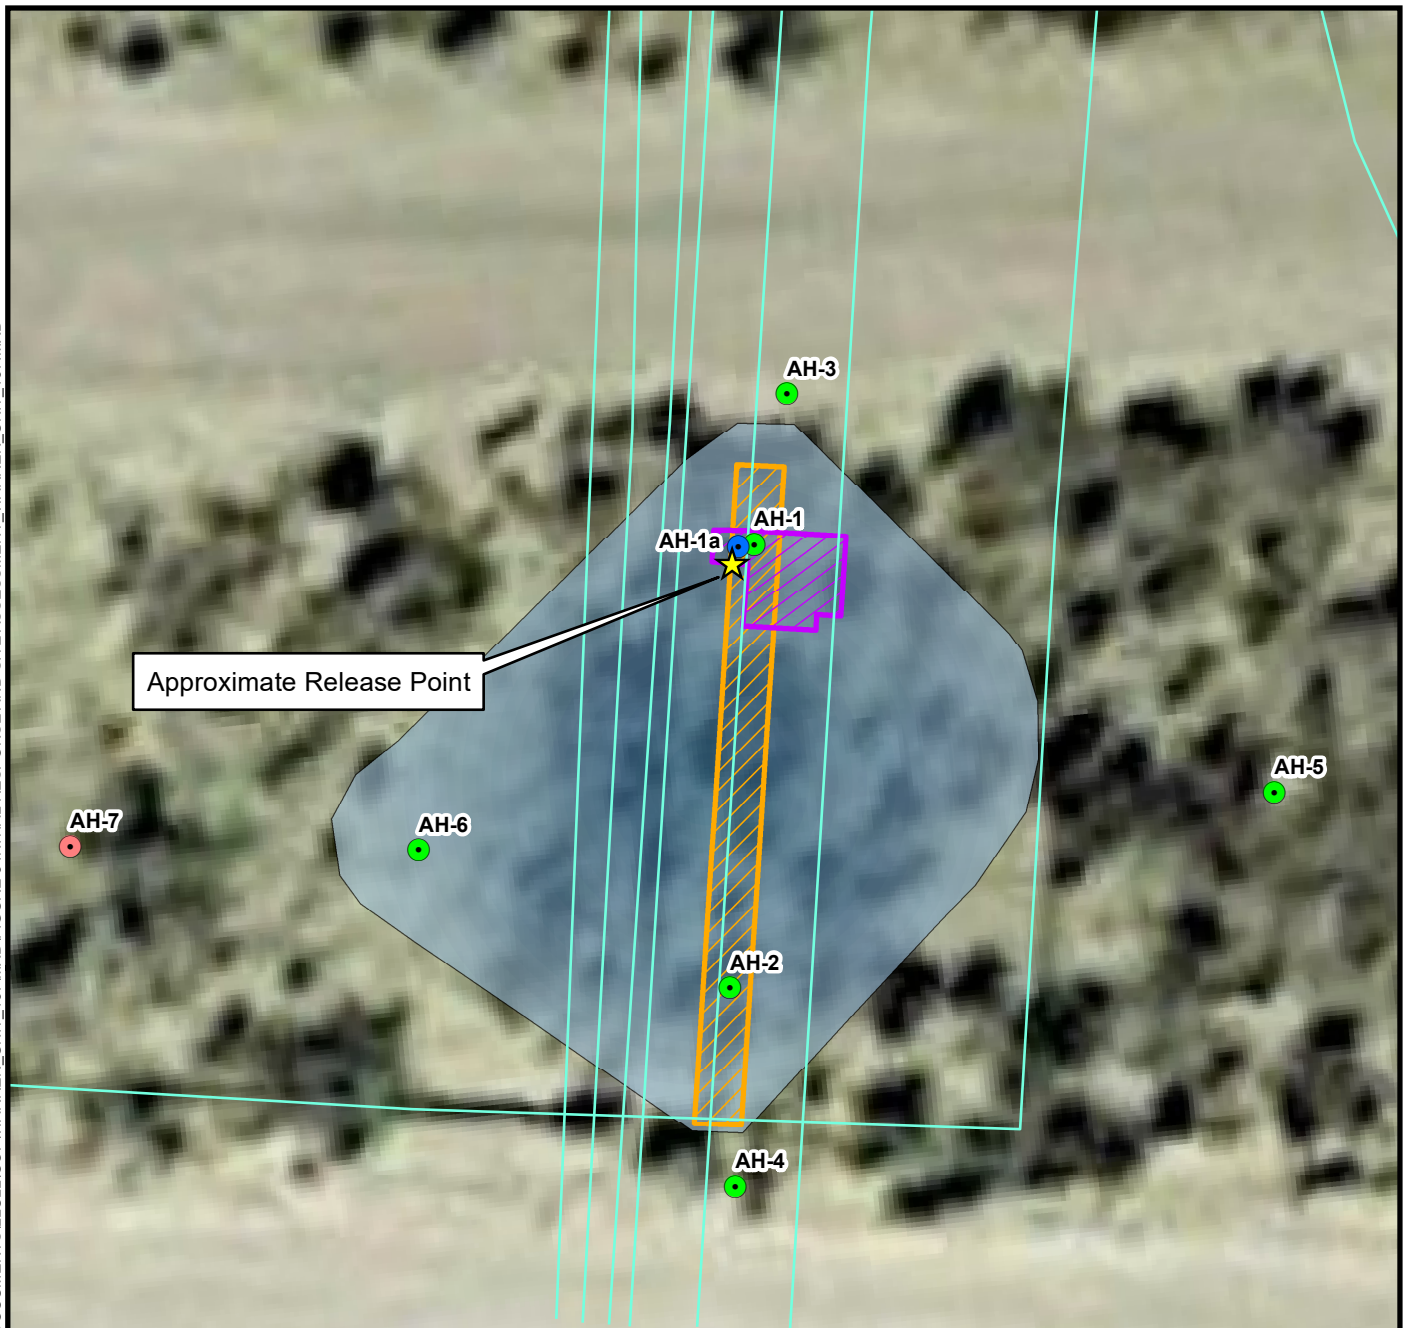
**4**

DOCUMENT PATH: C:\USERS\LISSA.VILLAMONEDRIVE - TETRA TECH, INC\DOCUMENTS\ULLULL\CORWARREN\_UNIT\_137\MXD\FIGURE 5 INITIAL RESPONSE AND SITE ASSESSMENT\_WARREN\_UNIT\_137.MXD

- Boring Location - Hand Auger (5/30/2021)
- Boring Location - Hand Auger (3/31/2022)
- Boring Location - Hand Auger (4/12/2022)
- Subsurface Flowline
- Approximate Release Extent
- Hydro-Excavated Area - 7' BGS
- Initial Response Excavation - 18" BGS

A total of seven (7) soil samples were collected from the sample locations and transferred under chain of custody and analyzed within appropriate holding times by Cardinal. The soil samples were analyzed for TPH via Method 8015 Modified, chloride via Method SM4500Cl-B, and BTEX via Method 8021B. Photographic documentation of site conditions during the additional site assessment activities is included in Appendix F.

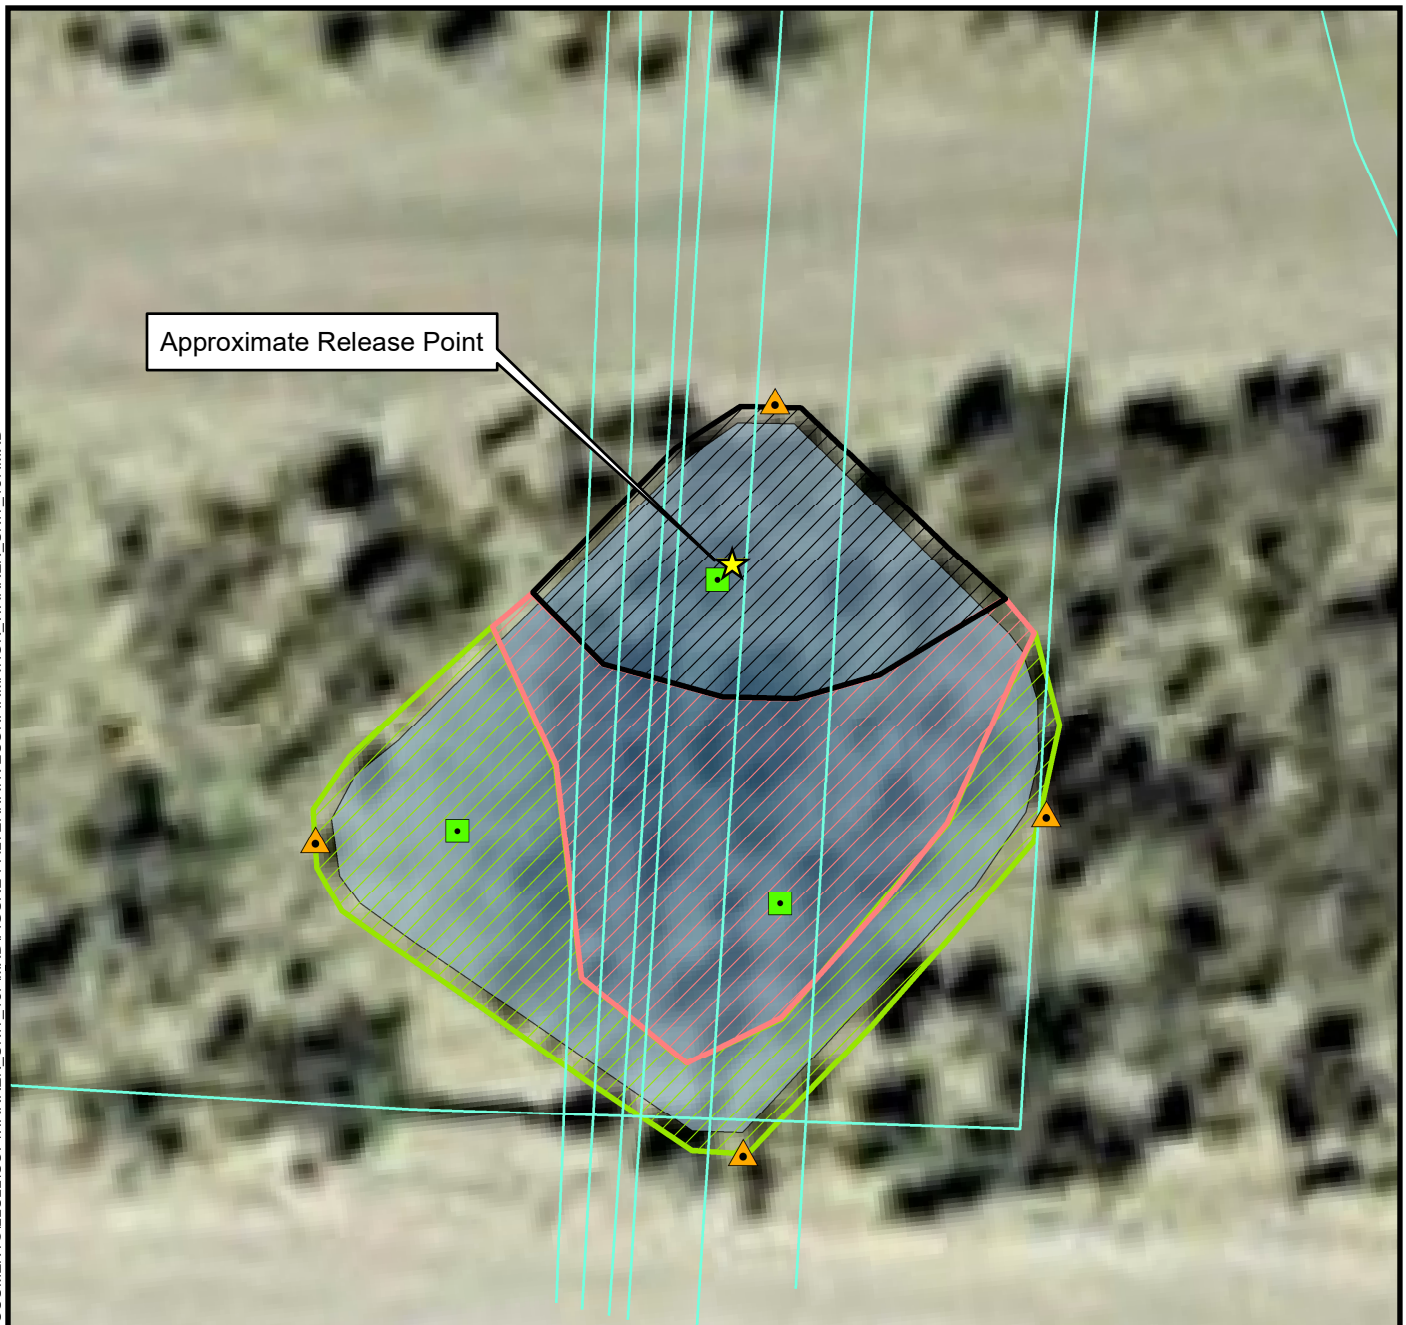
DOCUMENT PATH: C:\USERS\LISSA.VILLAMINIONEDRIVE - TETRA TECH, INC\DOCUMENTS\137MXD\FIGURE 7 ALTERNATIVE CONFIRMATION WARREN\_UNIT\_137.MXD

- Floor Confirmation Sample Location
- ▲ Sidewall Confirmation Sample Location
- Subsurface Flowline
- Approximate Release Extent
- Proposed Excavation - 2' BGS
- Proposed Excavation - 7' BGS
- Proposed Excavation - 16' BGS

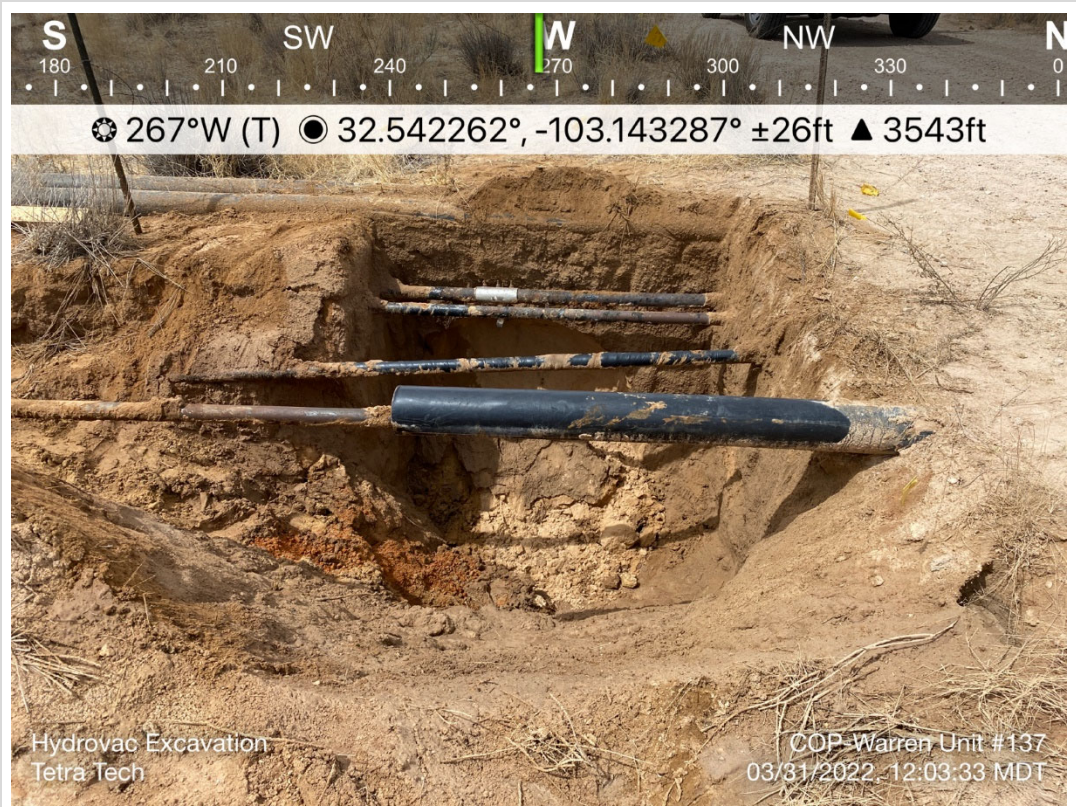
TETRA TECH, INC. PROJECT NO. 212C-MD-02704	DESCRIPTION	Hydrovac excavation of subsurface lines.	2
	SITE NAME	ConocoPhillips Warren Unit 137 Flowline Release	3/31/2022

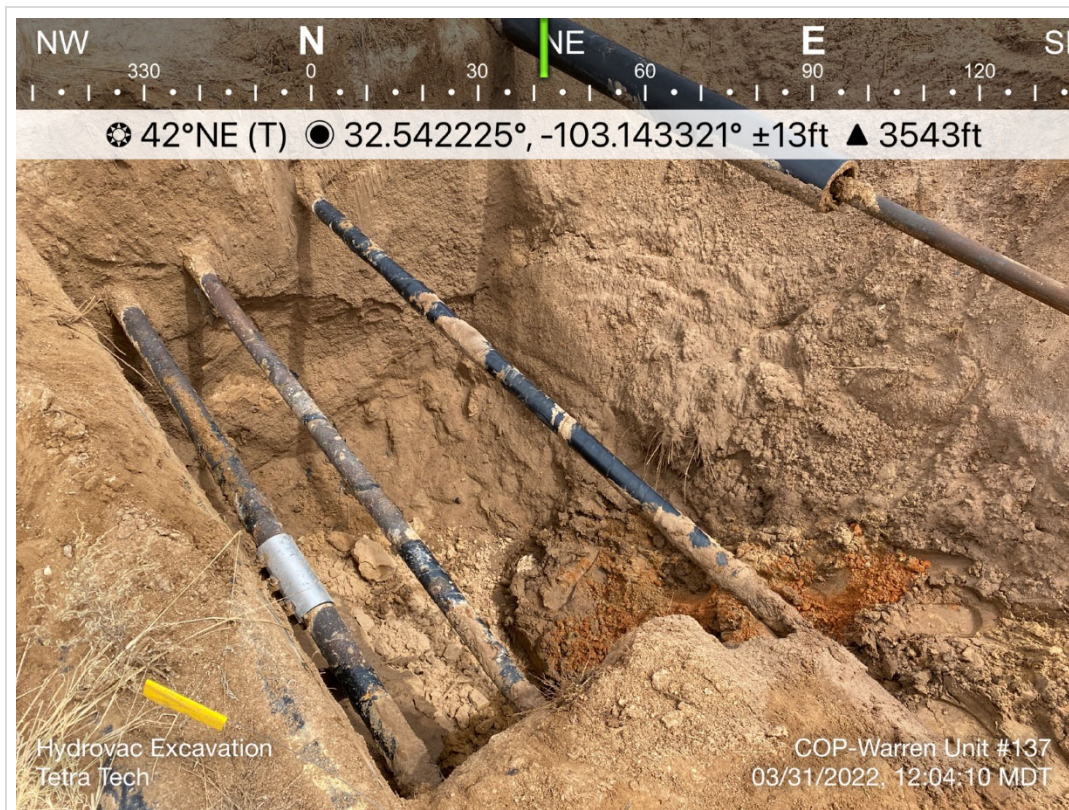
TETRA TECH, INC. PROJECT NO. 212C-MD-02704	DESCRIPTION	Hydrovac excavation of subsurface lines.	3
	SITE NAME	ConocoPhillips Warren Unit 137 Flowline Release	3/31/2022
