## Release Notification

Site Name: Jicarilla 35 8	Site Type: Well
Date Release Discovered: 8/4/2020	API# (if applicable): 30-039-22096

**Well Name: Jicarilla 35 8 Located in Section 36, Township 25 North, Range 5 West, Rio Arriba, New Mexico.**

**RE: Rupture disc on separator failed causing produced oil and water to spray covering an area approximately 10' x 20' and a trail of mixed oil/water running approximately 60' off separator pad. The release estimated at 4bbls of mixed produced oil and water. LOGOS plans to clean up the stained area and remove soil and brush. Jicarilla requested LOGOS to remove the separator to clean historic staining under and around the separator.**

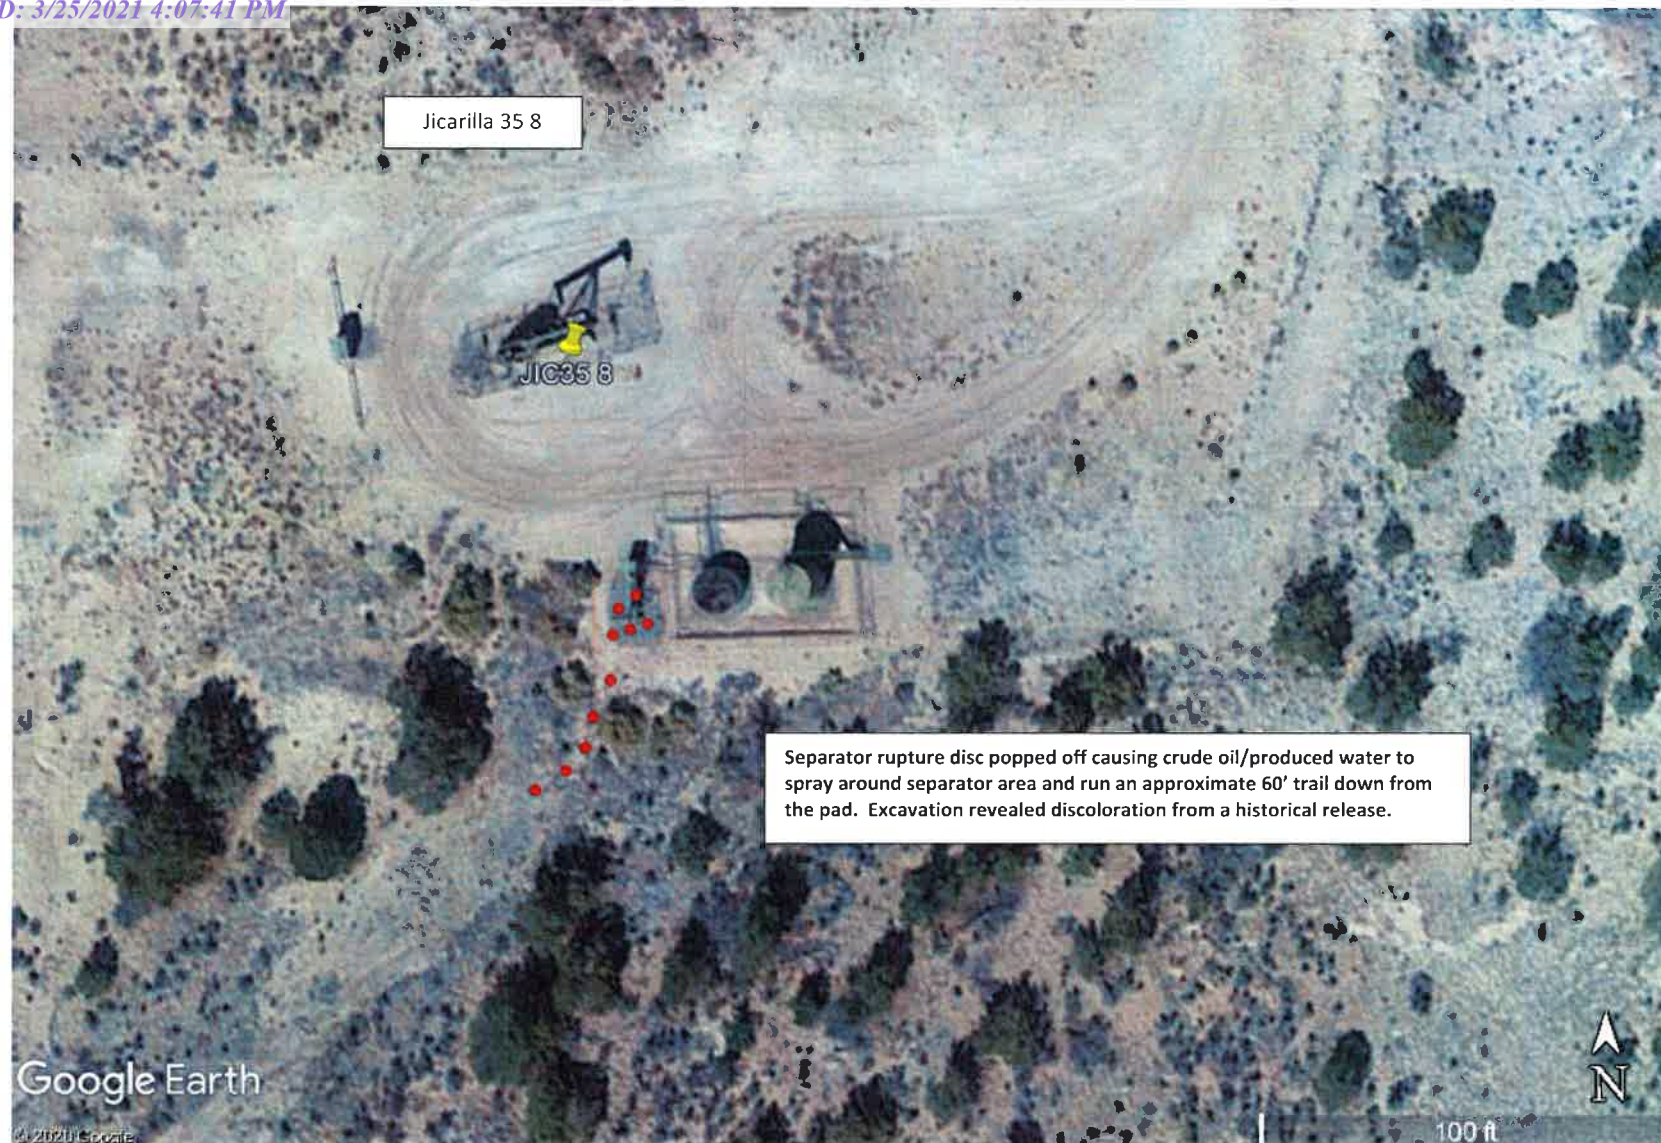
Aerial Site Map

composite samples were collected, as documented in the enclosed Aerial Site map. The one 5-point sample from the trail (Lab #1) passed but the second 5-point sample from the separator (Lab #2) did not pass.

Soil Grab Sampling

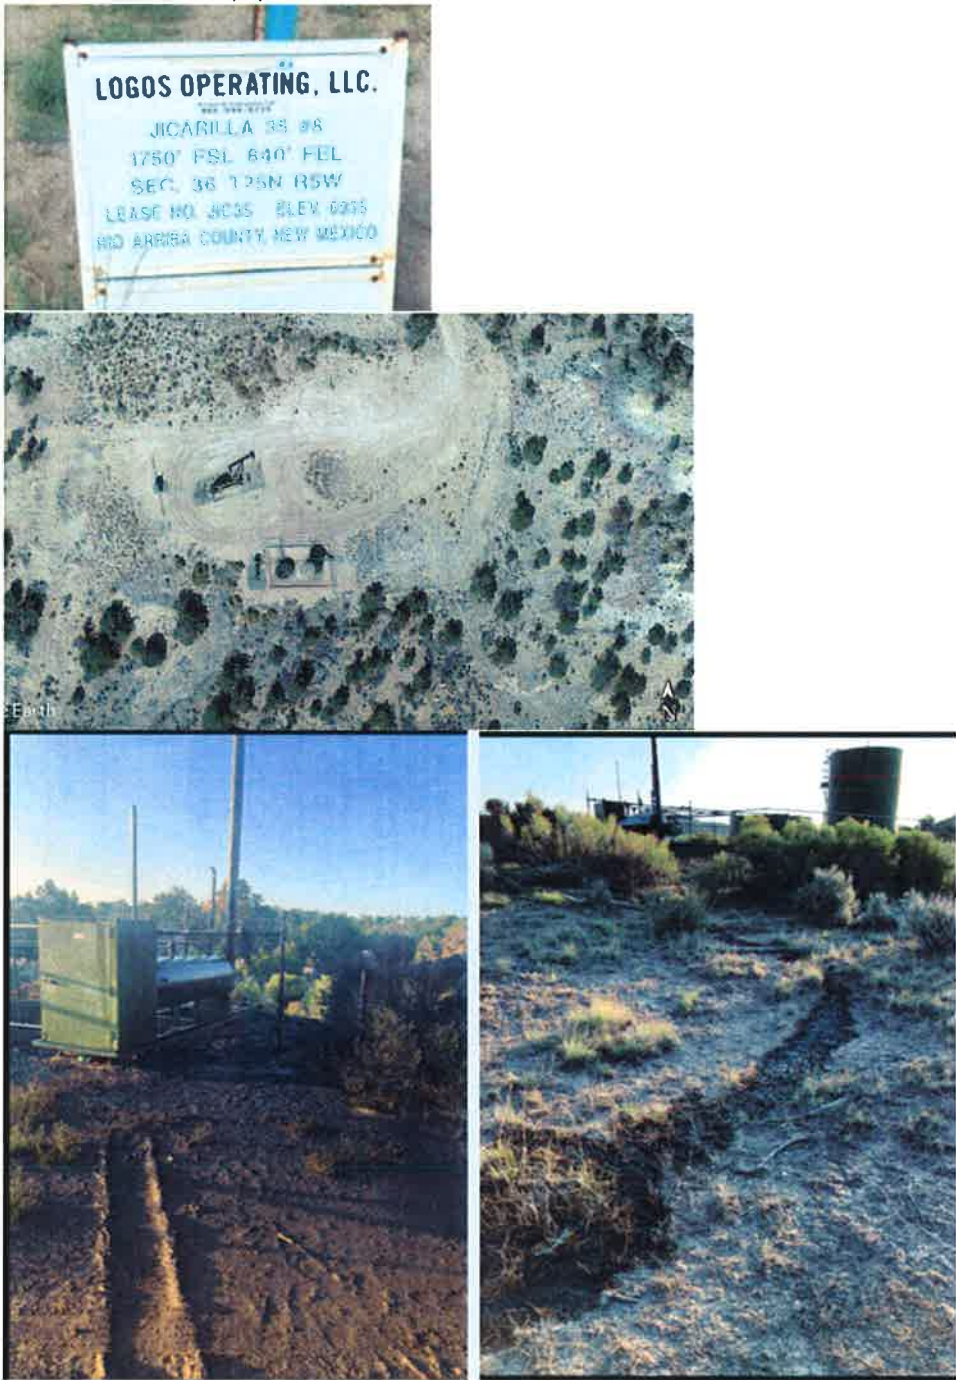
JICARILLA 35 8 – 08/4/20 SITE AREA SPILL

On August 4, 2020, operator arrived on location around 11am and found fluid spraying and leaking from separator. Well was shut in. LOGOS picked up oil-soaked soil and raked in oil sponge. Separator was repaired. The surface owner (Jicarilla) was notified on August 5, 2020 of the release.

Operator arrived on location 8/4/20 around 11am and found fluid spraying and leaking from separator. Rupture disc on separator failed. The area that was affected was 20' around the separator and approximately 60' past the separator. It had made a trail of oil going down off location. Estimated at approximately ½ bbl of oil. Picked up oil soaked soil and raked in oil sponge. Separator was repaired.
