EOG Resources, Inc.
Ten Mile BBE State Com #1
Closure Report
G-33-14S-28E
Chavez County, New Mexico
NAPP2205446342

April 29, 2022

Ten Mile BBE State Com #1
G-33-14S-28E
Vicinity Map

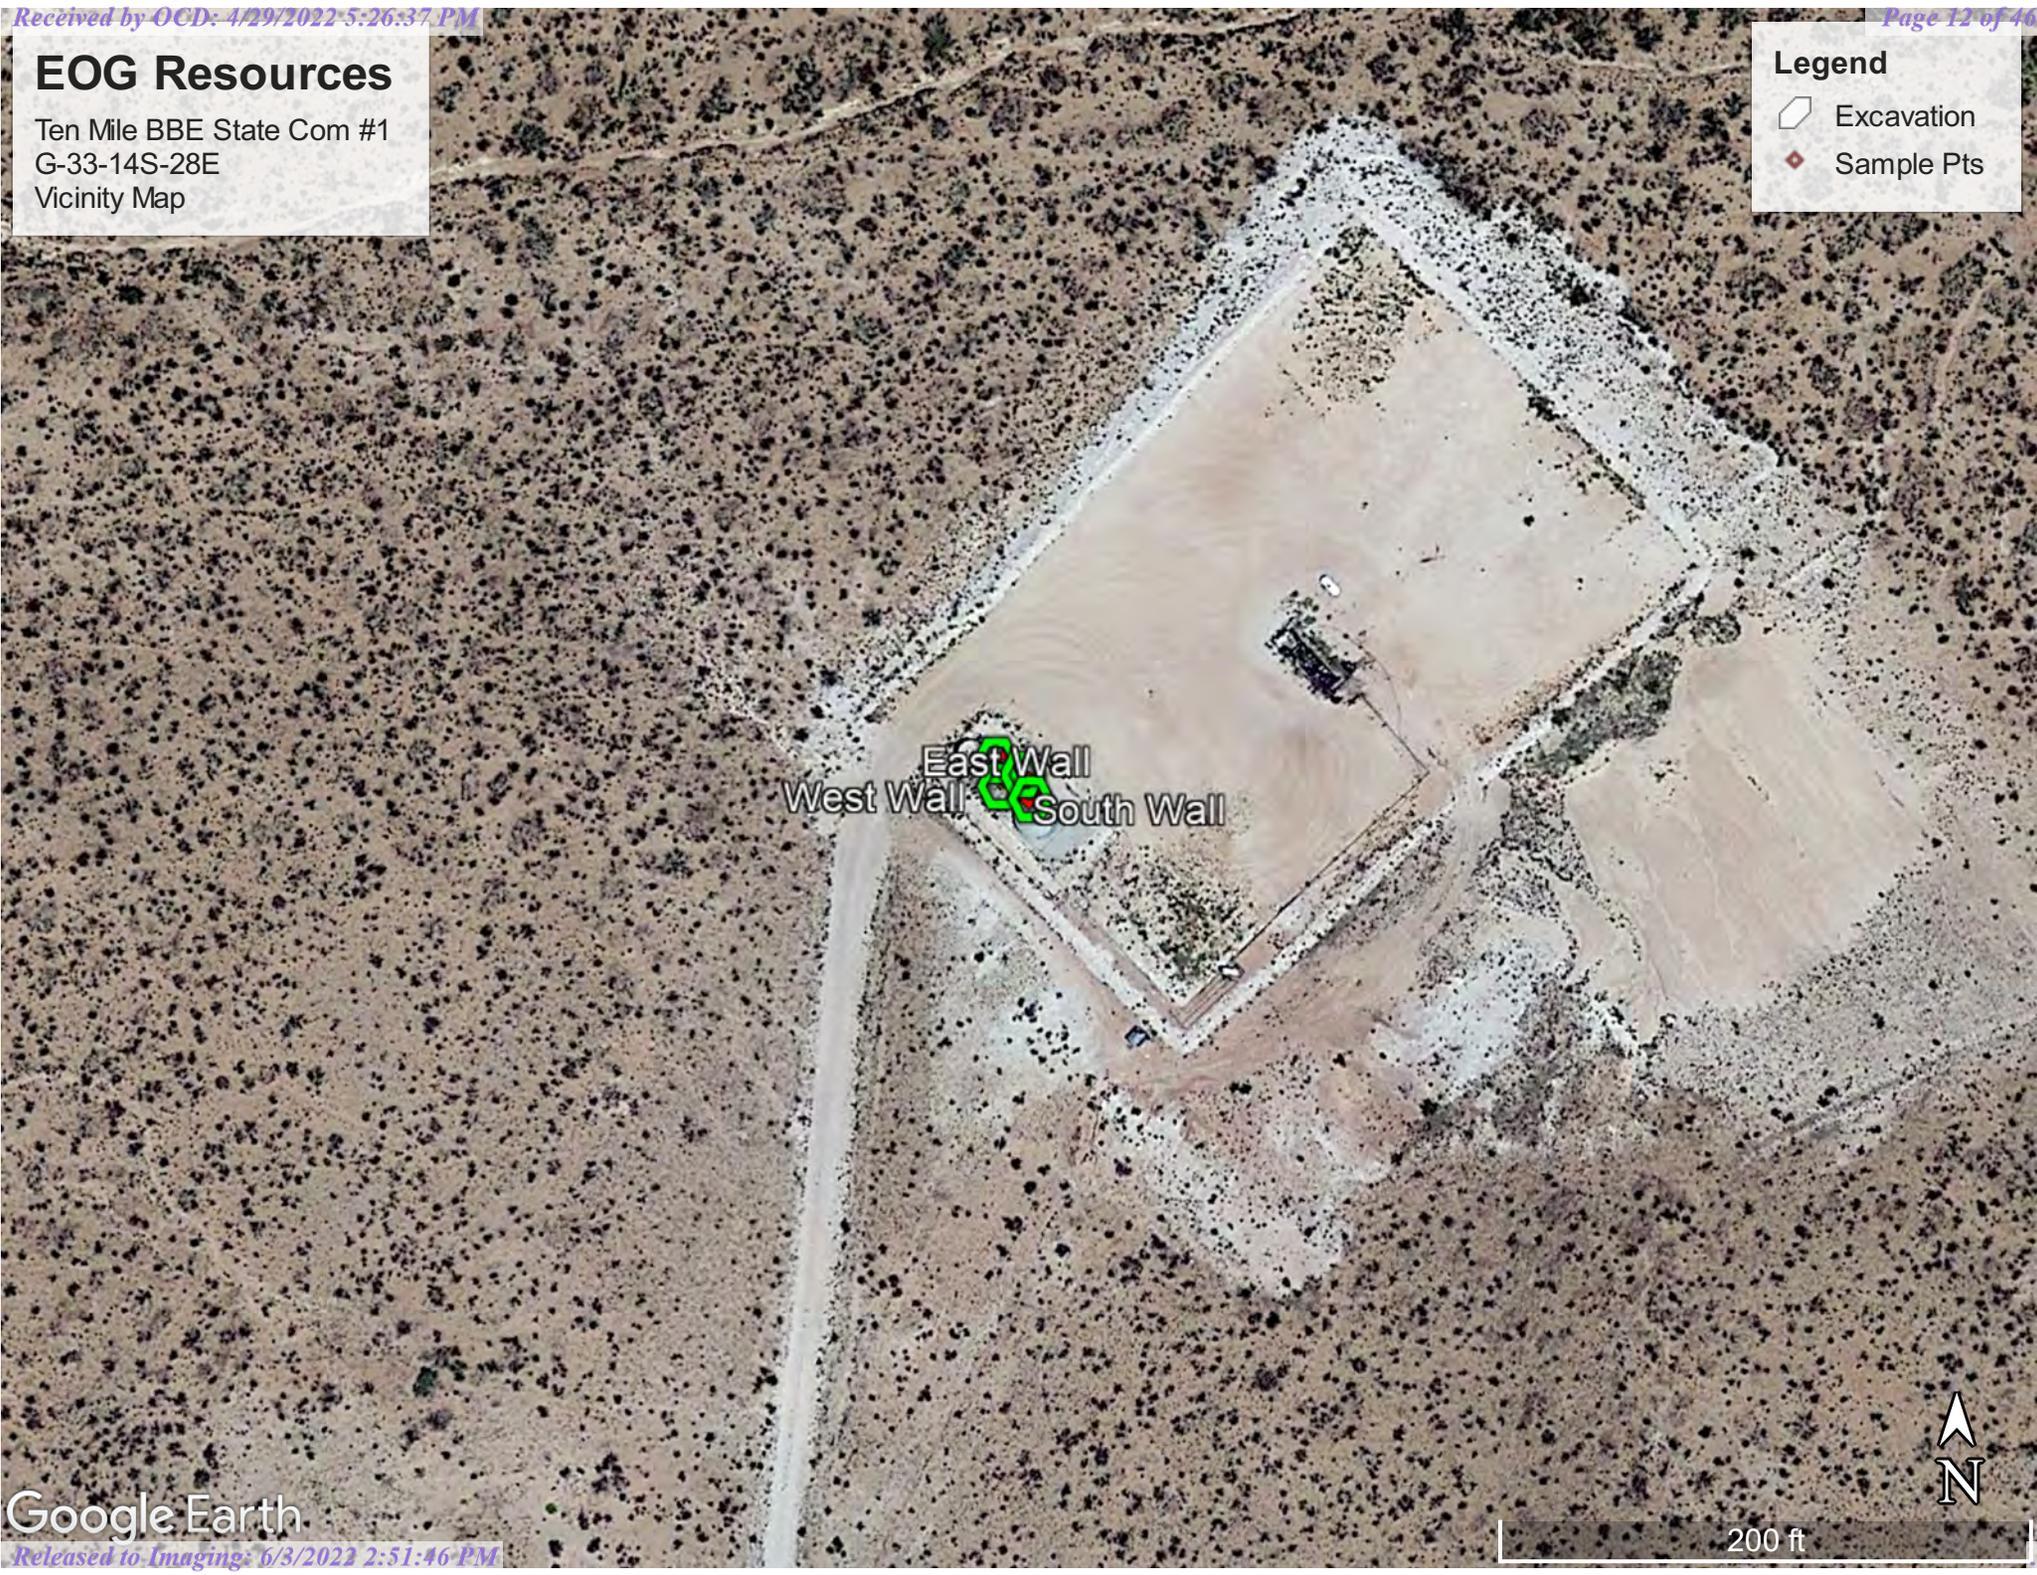
In February of 2022, SESI personnel performed sampling to determine vertical extent of the release. SESI advanced two test trenches within the leak area, as the area of concern was isolated to the soil underneath the reacquainted tanks. The samples were properly packaged and preserved and sent to Hall Laboratories for analysis. The results of the testing are captured in the summary below:

East Wall
West Wall
South Wall

Based on the results of the delineation, which included confirmation sampling as indicated above, SESI, determined the impacted soil had been removed during the delineation as demonstrated by the laboratory analysis, and no further excavation was needed to remediate the site. Subsequently, the site was backfilled with native soil. Pictures of the remediation are included in this report. The Vertical extent of the release was caught at a depth of 8' in the second test trench, and a depth of 2' in the first. Confirmation samples of the depth, and side walls showed no further migration.

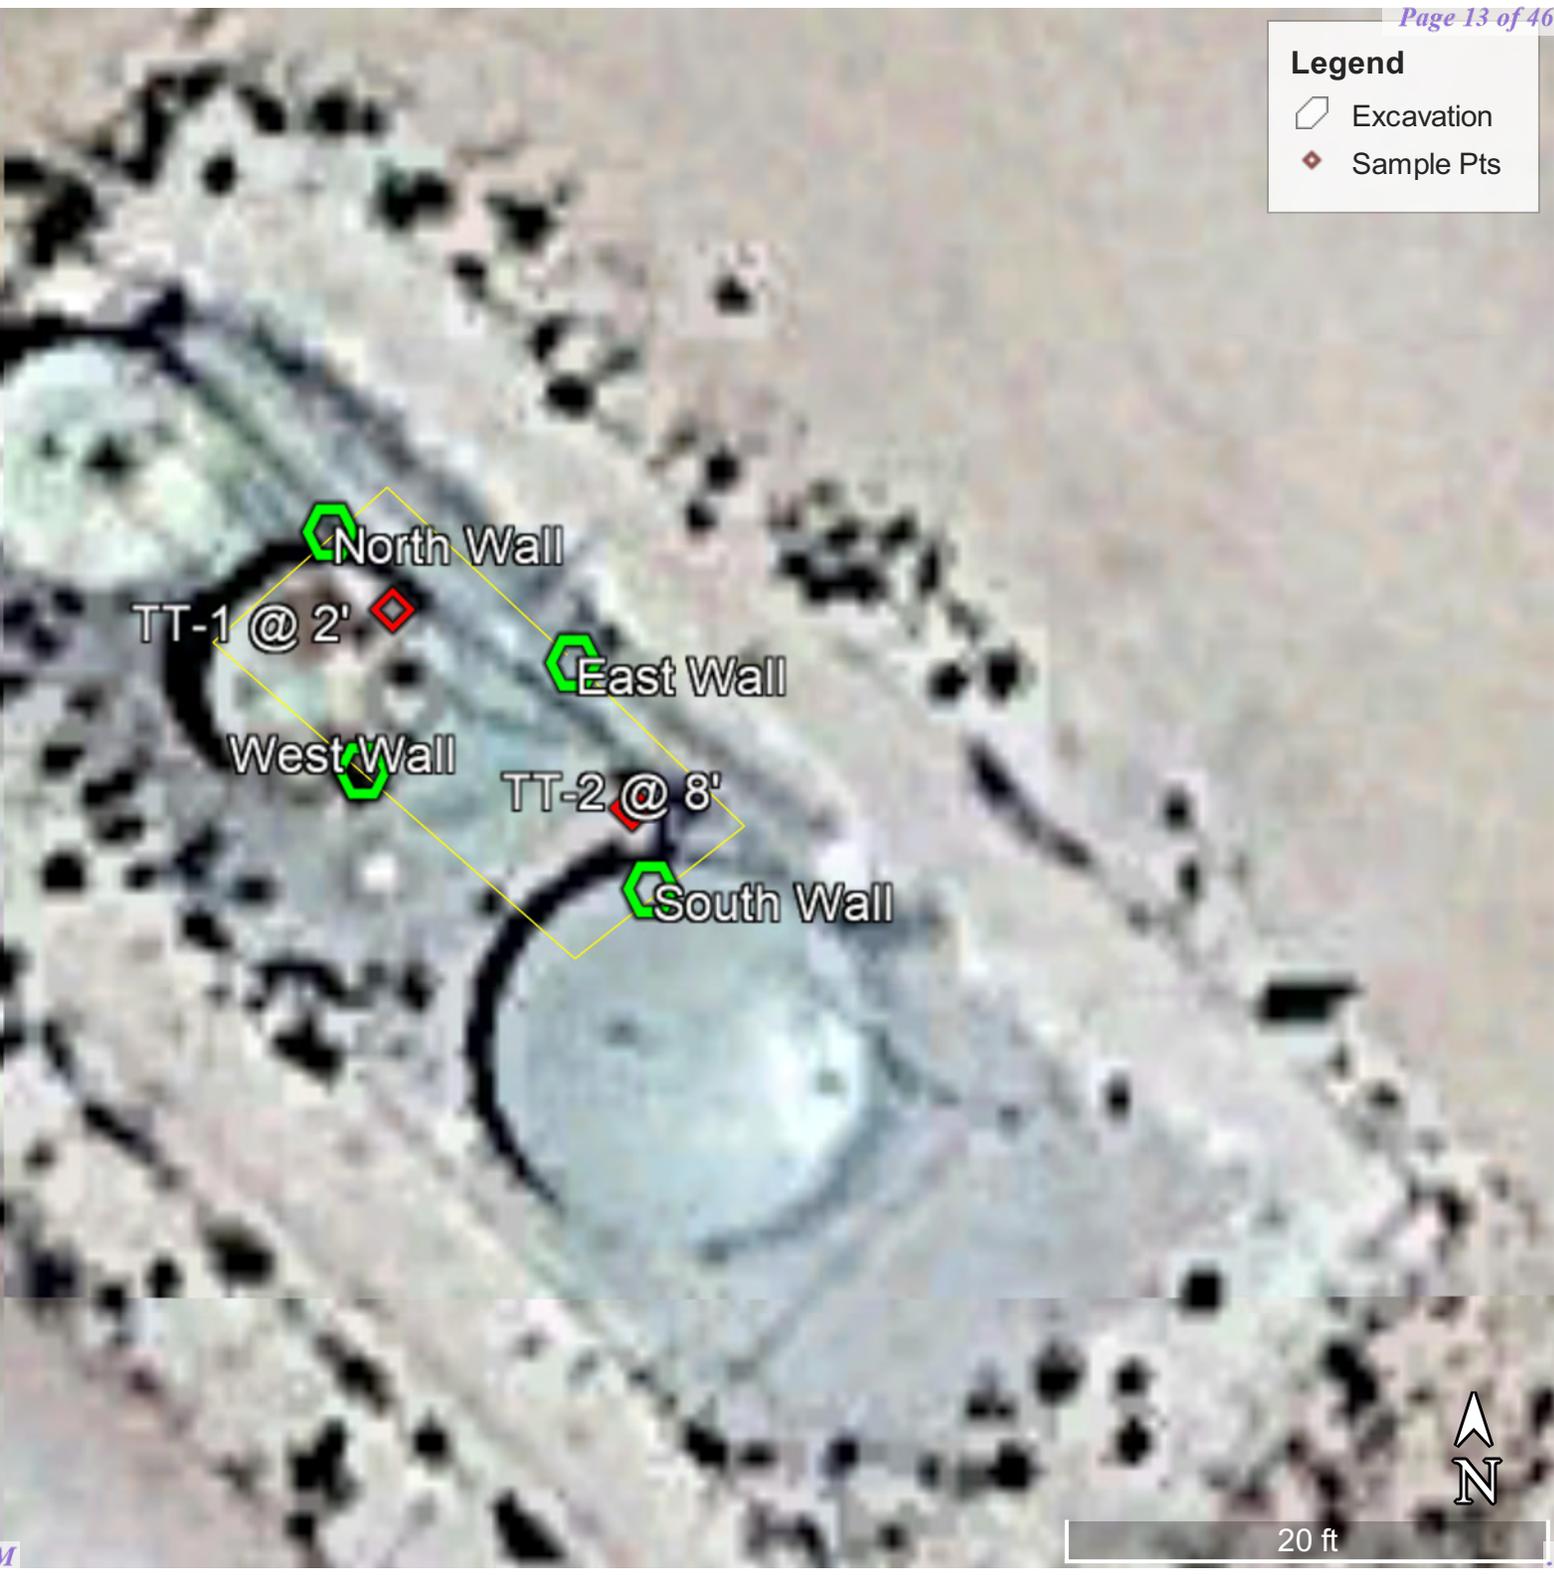
Ten Mile BBE State Com #1
G-33-14S-28E
Site Map w/ Sample Pts

- Excavation
- Sample Pts
