RE: IRP-2402 WBDU 11

WBDU # 11
(Located in UL-O SECTION 4, T21S, R37E of Lea County, NM)
(GPS Reading of 32°-30'-09.0"-N & 103°-09'-57.3"-W)
API # 30-025-20069

Spill Remediation Report

Phoenix Environmental, LLC.
P.O. Box 1856
Hobbs, New Mexico 88240

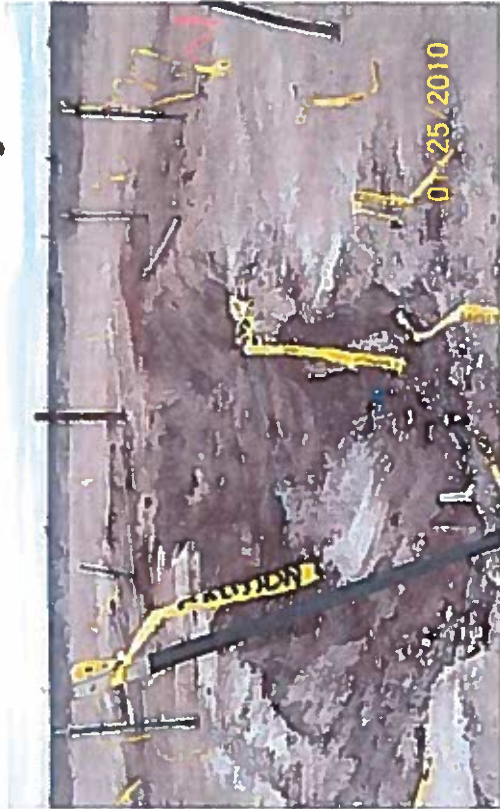
Photo # 2 Spill site at start of clean up

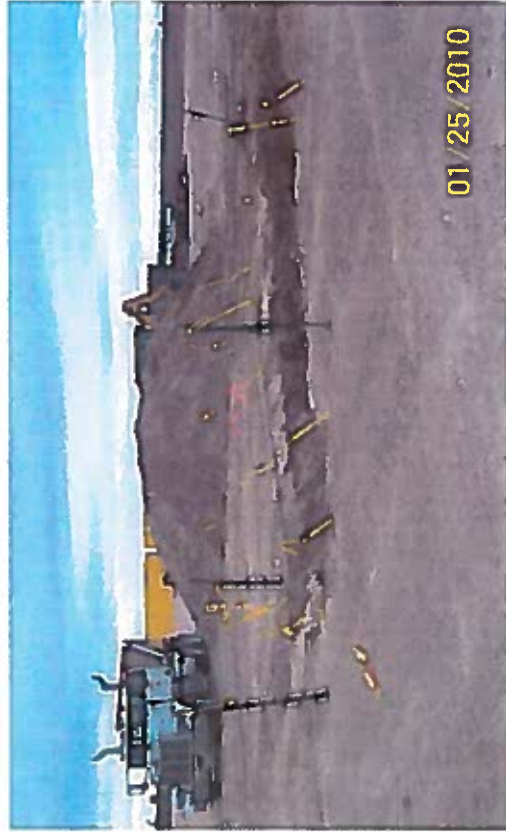
Photo # 3 Stockpile impacted soils at start of clean up

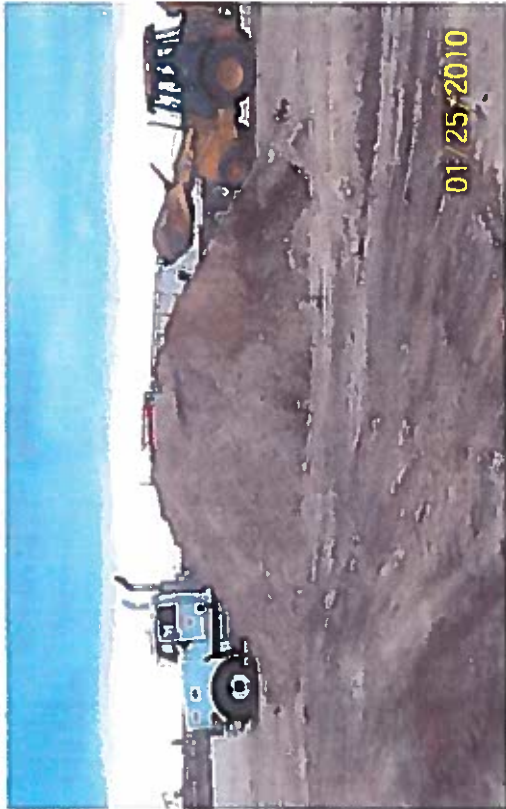
Photo # 4 Loading of impacted soils for off site disposal

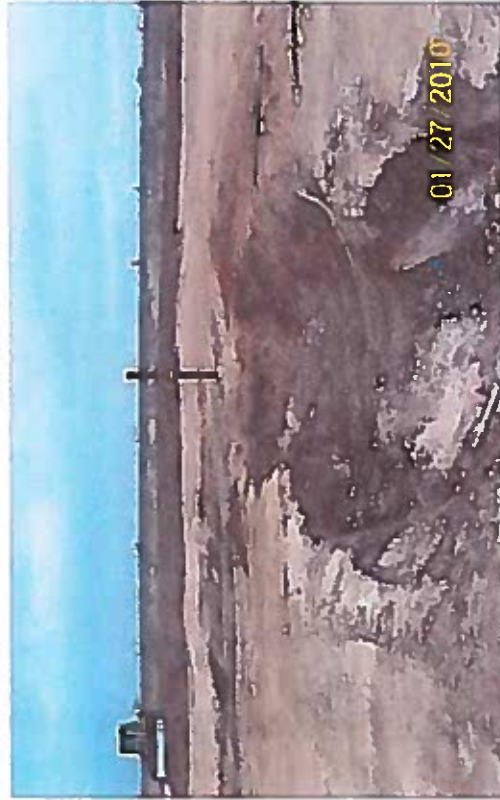
Photo # 5 Spill site after removal of impacted soils

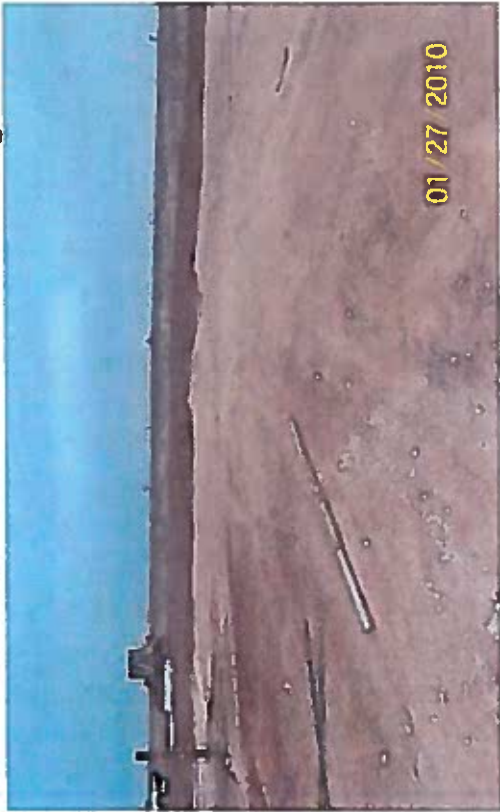
Photo # 6 Pulling top soil over site before reseeding

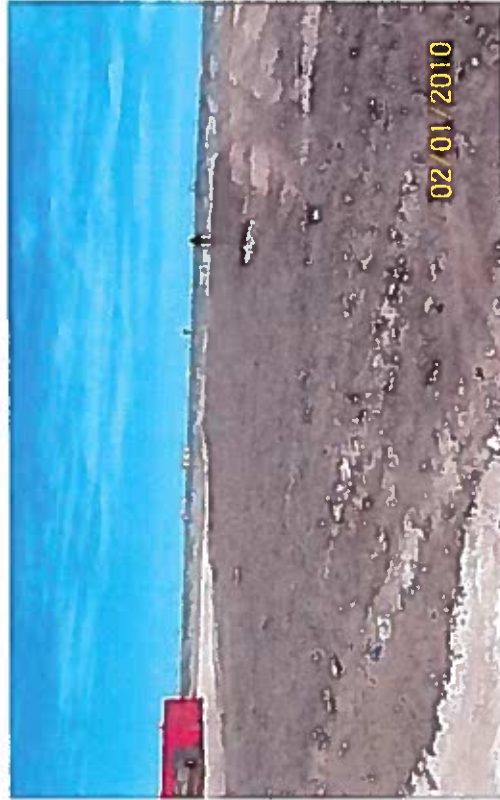
Photo # 7 Site after top soil placement

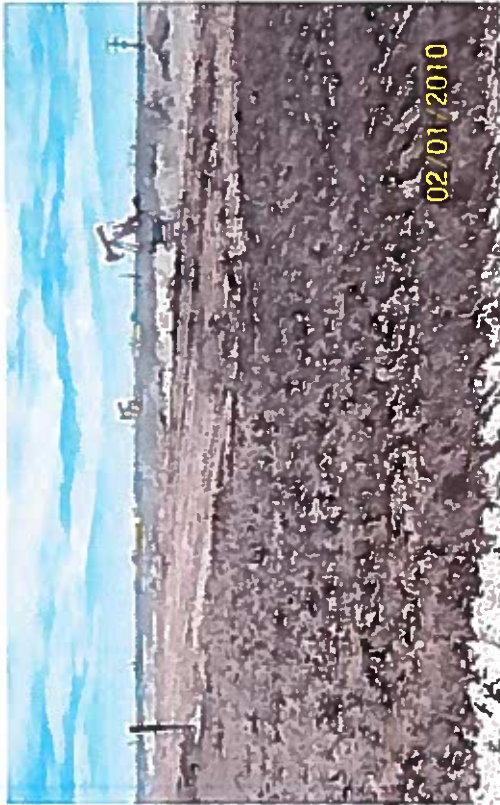
Photo # 8 Site after reseeding
