RE: IRP-1786 EBDU 48

Attachment: Closure Report Dated October 28, 2019

## Environmental Site Summary & Closure Request

Site Name: EBDU #48 NMOCD Reference#: 1RP-1786

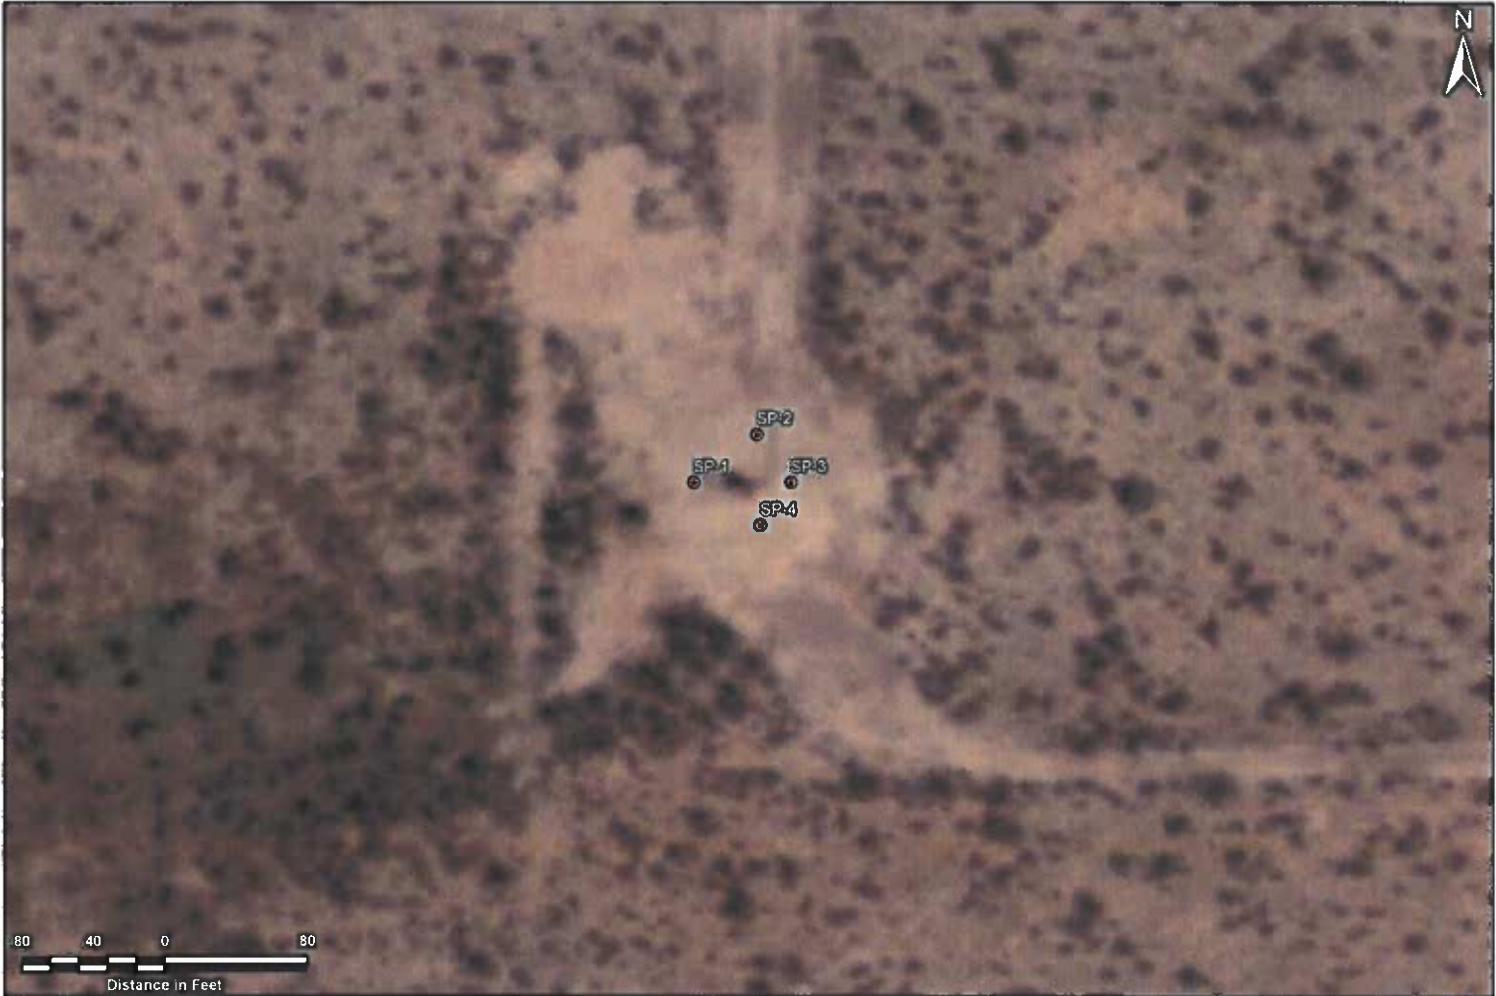
**Figure 3**  
**Sample Location Map (Historical Aerial)**  
**Apache Corporation**  
**EBDU #48**  
**Lea County, New Mexico**  
**NMOCD Reference #: 1RP-1786**

Locations of the auger holes are depicted in Figure 2, "Sample Location Map", and Figure 3, "Sample Location Map (Historical Aerial)". Laboratory analytical results are summarized in Table 1, and an analytical report is provided in Appendix C.
