Remediation and Closure Report

State 14 Com 4
Eddy County, New Mexico
Incident # nAPP2121620119

Subject: **Remediation and Work Plan**
State 14 Com 2
Eddy County, New Mexico
Incident #nAPP2121620119

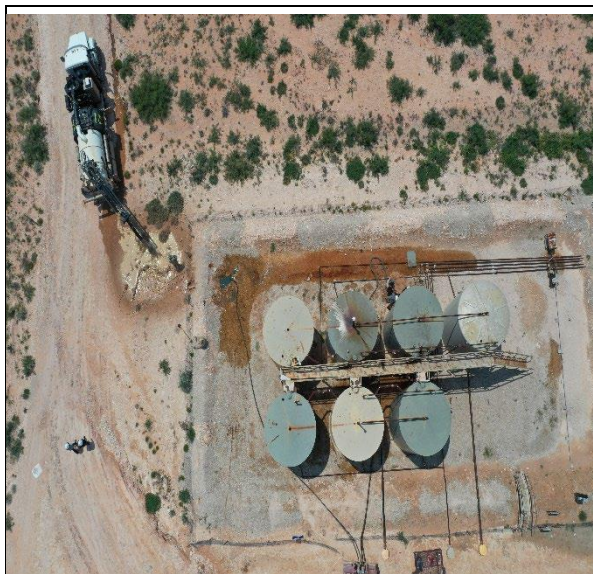
**Photograph No.1 Description:**

Spill Source-Containment Impact

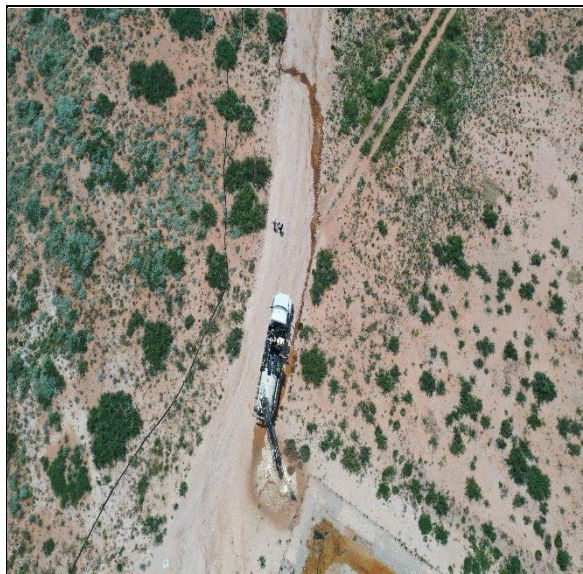
**Photograph No.2 Description:**

Spill traversing lease road

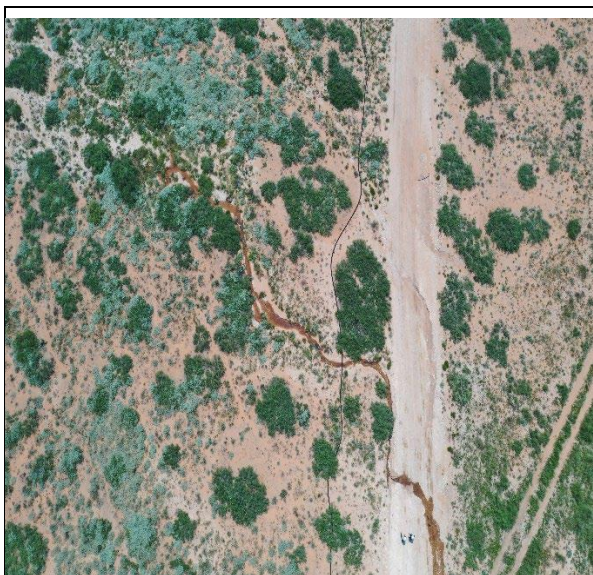
**Photograph No.3 Description:**

Spill exits lease road-traverses pasture

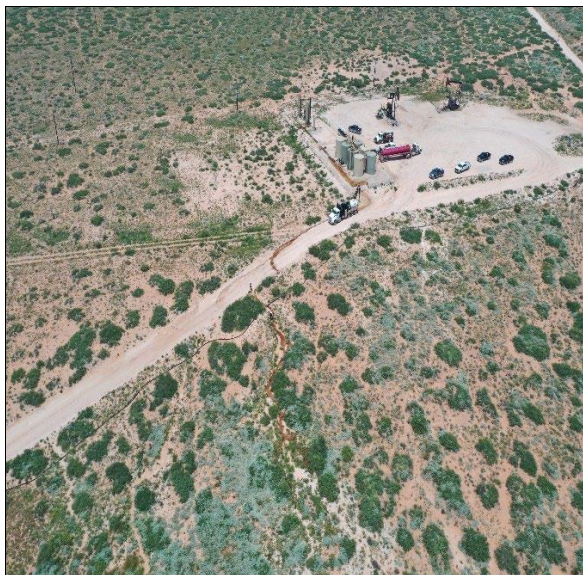
**Photograph No.4 Description:**

Excavation of Lease Road and Pasture

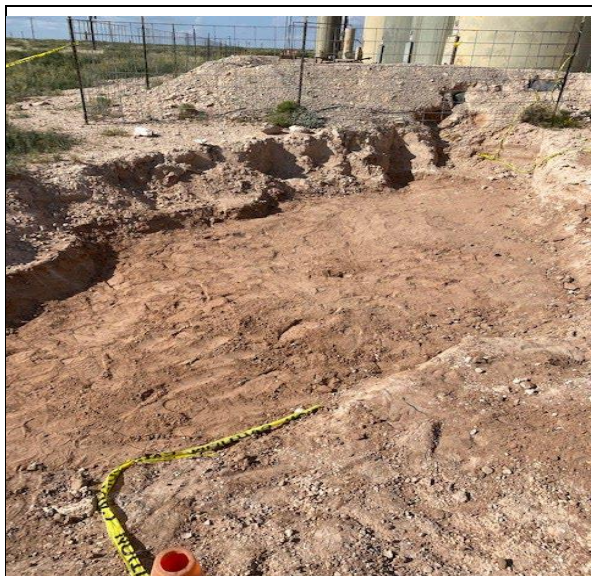
Photograph No.5 Description:

Excavation at Source

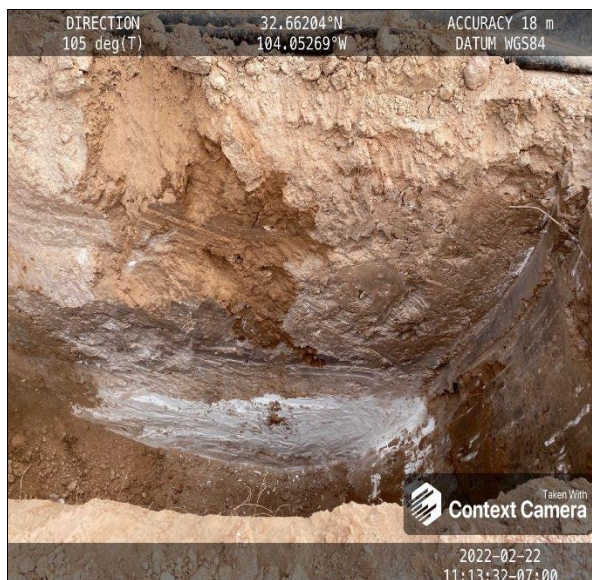
Photograph No.6 Description:

Test Trench Rock Refusal 9' bgs

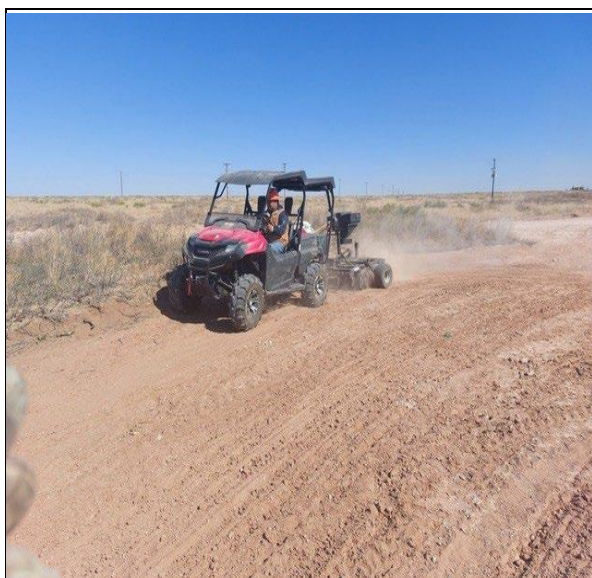
Photograph No.5 Description:

Seeding adjacent to lease road

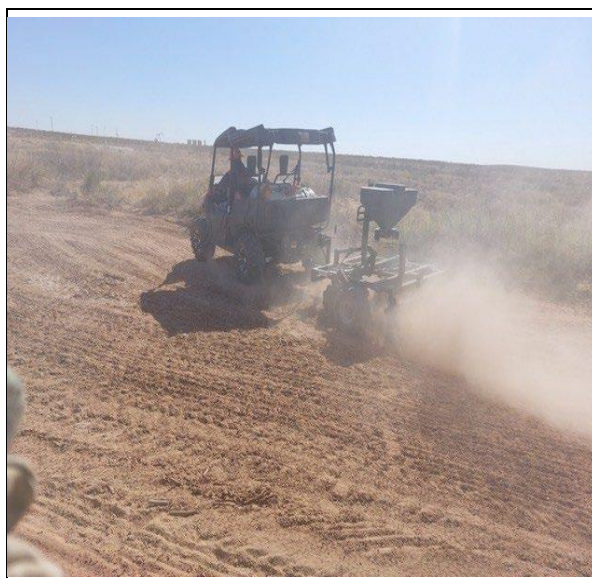
Photograph No.6 Description:

Seeded Pasture Area

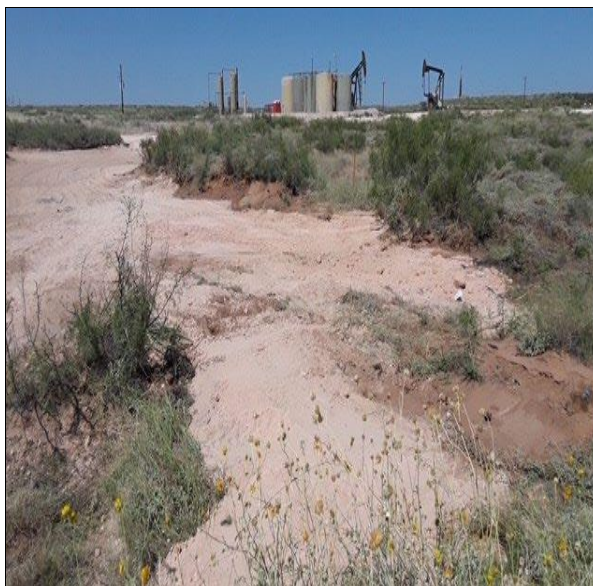
Photograph No.5 Description:

Lease Road backfilled to grade

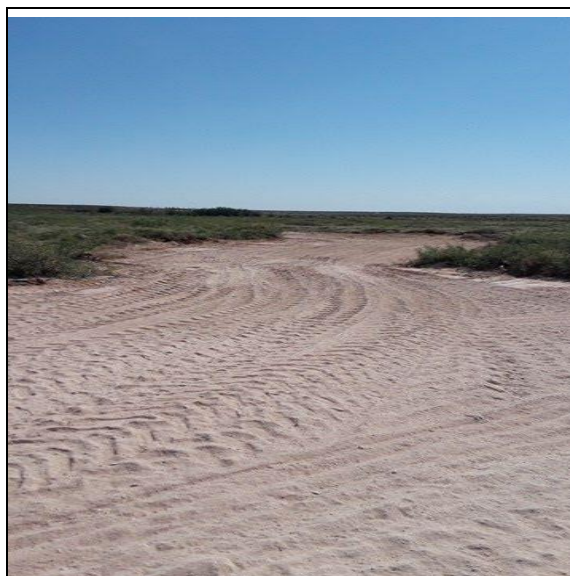
Photograph No.6 Description:

Pasture area backfilled to grade

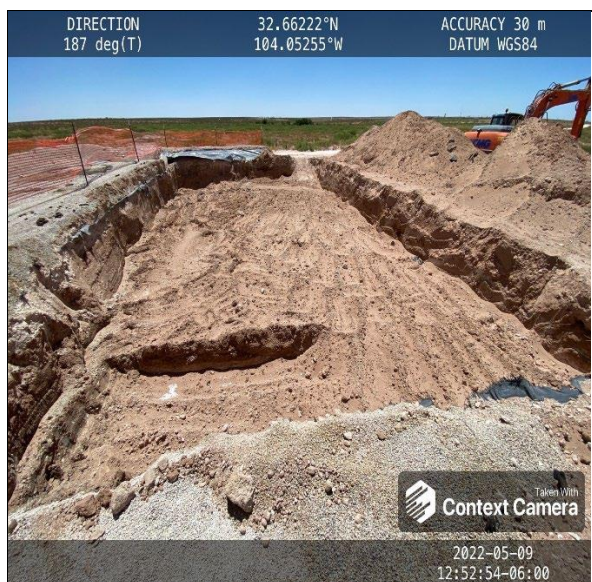
Photograph No.7 Description:

Excavation of Containment area @ 4.5'

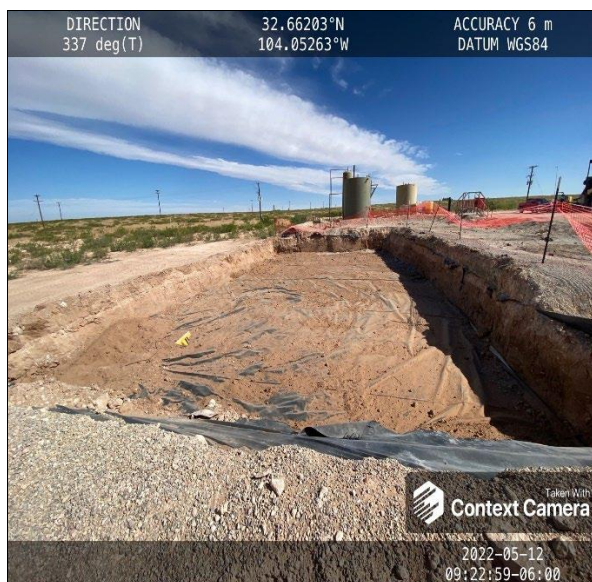
Photograph No.8 Description:

Liner seated and keyed in at 4.5'

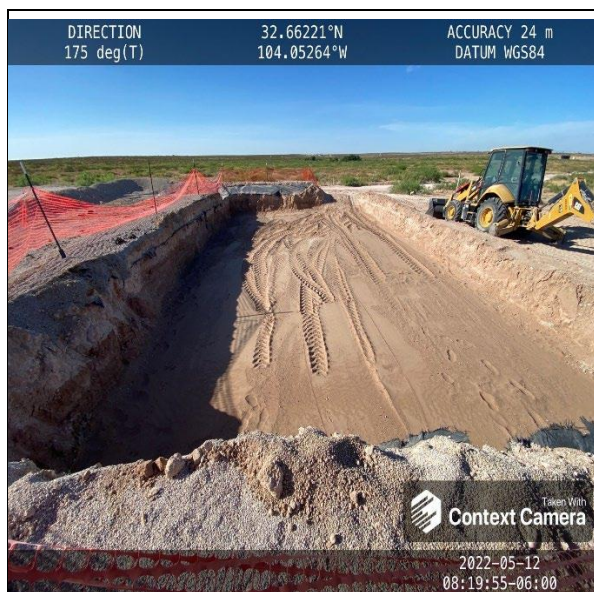
Photograph No.9 Description:

Liner topped and prepped with layer of sand

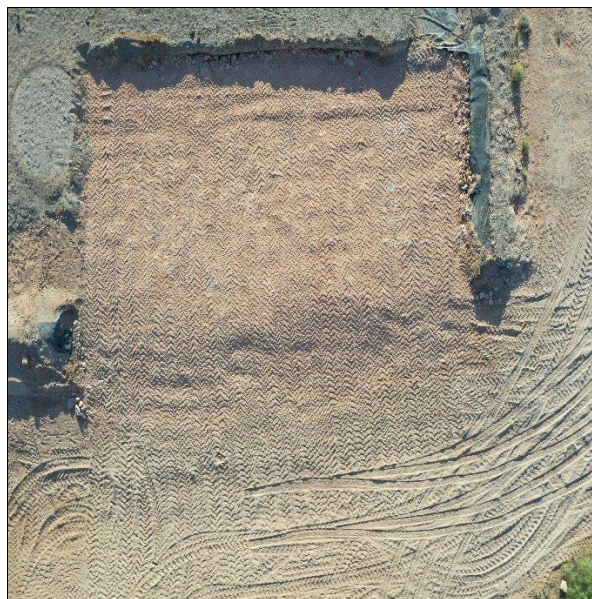
Photograph No. 10 Description:

Liner capped with caliche and compacted to grade

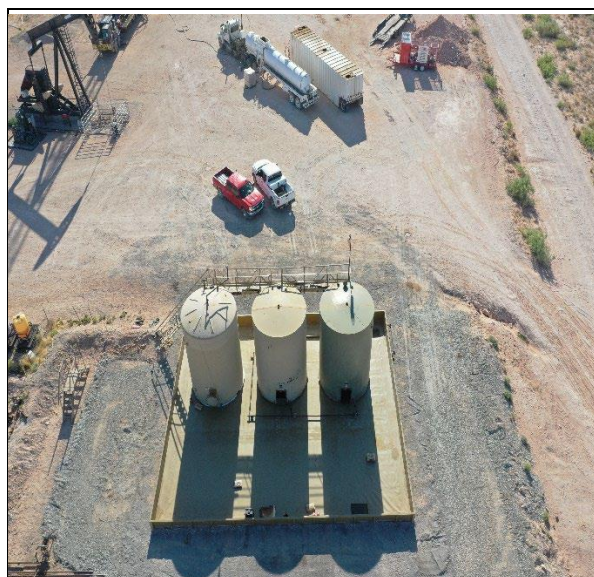
Photograph No.11 Description:

Reconstruction of facility

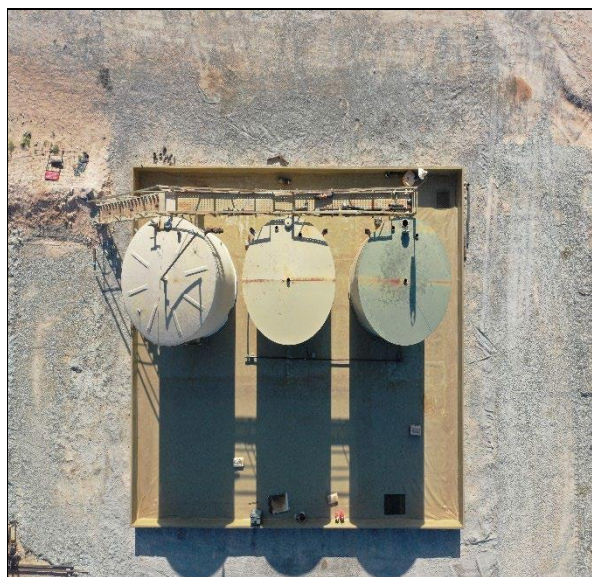
Photograph No.12 Description:

Aerial of containment and tanks
