## **Remediation and Closure Report**

Cascade 28 Federal 85,86H ROW  
Incident# nAPP2205617791  
Lea County, New Mexico

Subject: **Remediation and Closure Report**  
Cascade 28 Federal 85,86H ROW  
Lea County, NM

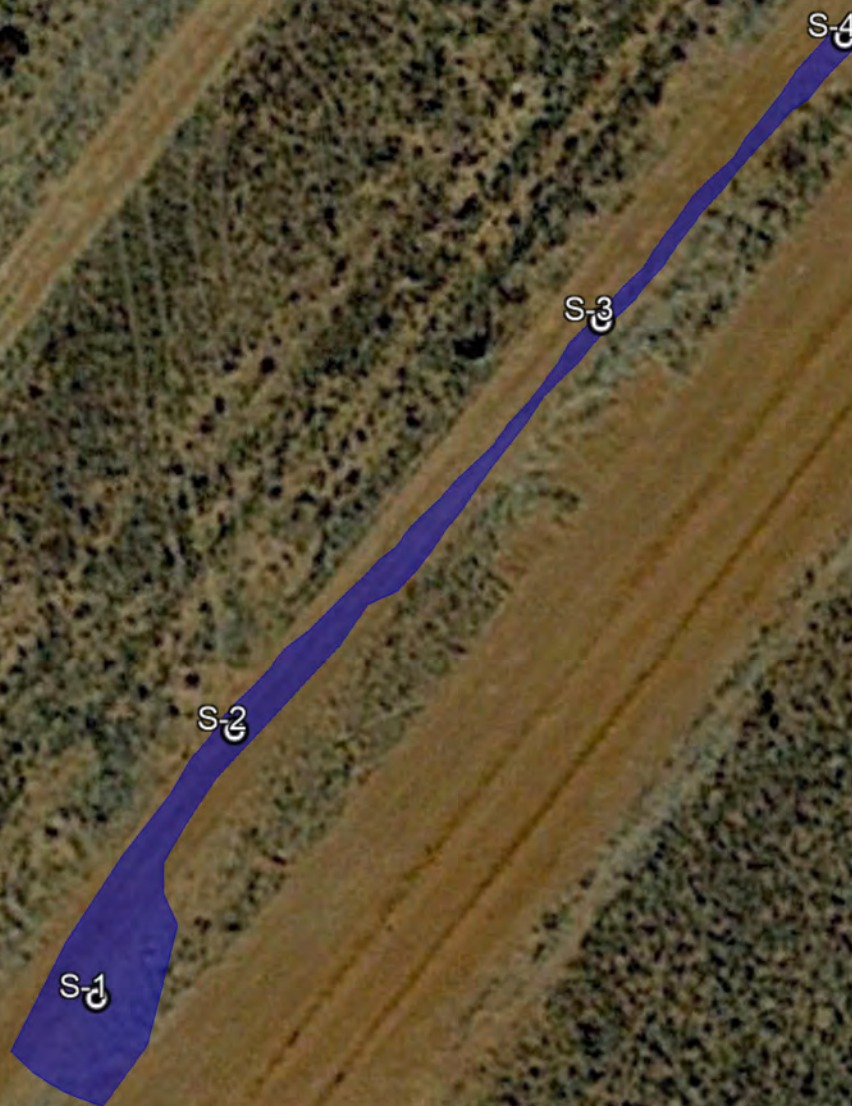
# Cascade 28 Federal 85,86H ROW

- Assessment Sample
- Release Area

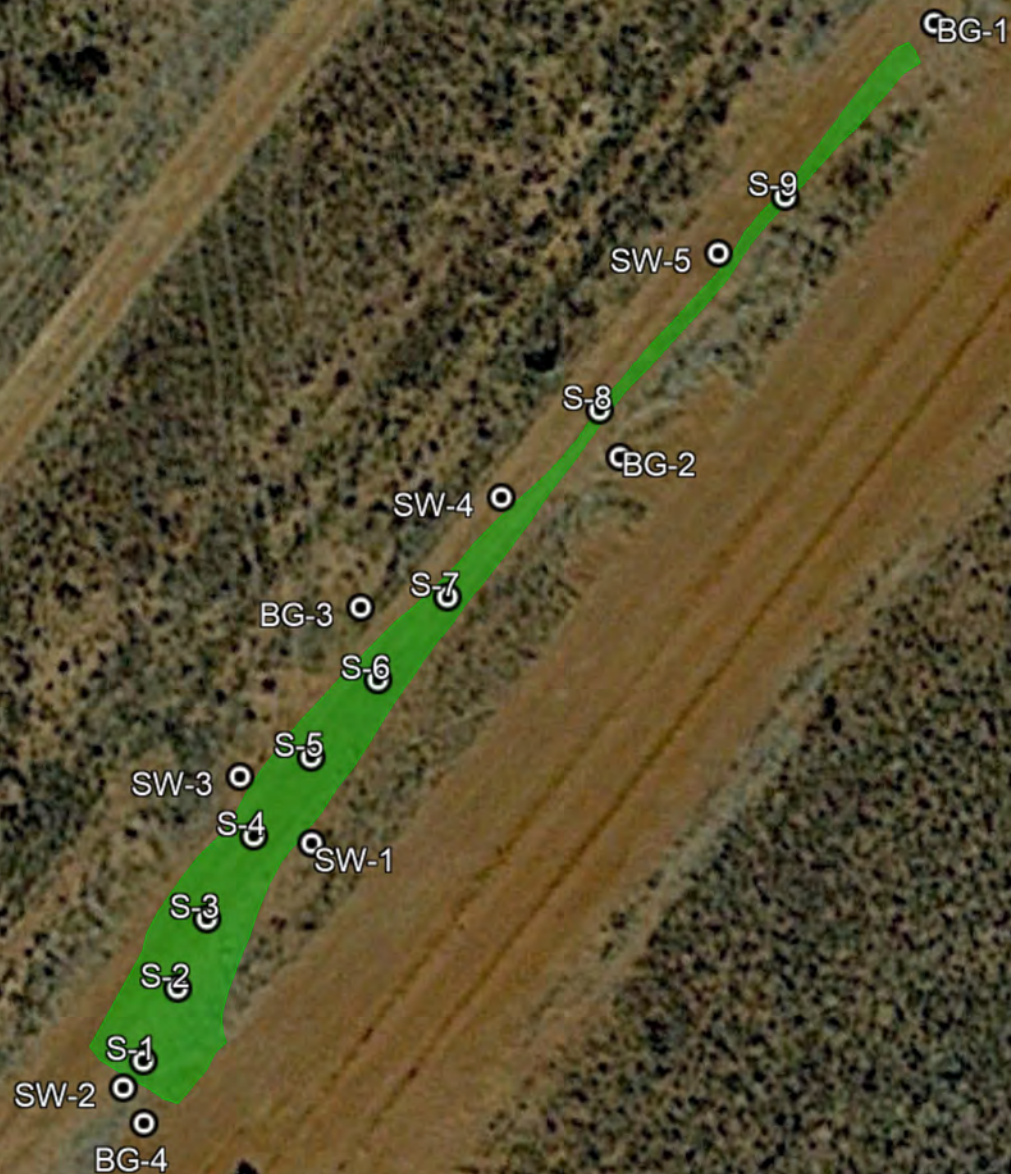
# Cascade 28 Federal 85,86H ROW

- 2-3ft. Excavation
- Composite Confirmation Sample/Background sample

- The impacted areas in the vicinity of confirmation sample points S-2 and S-4 through S-7 were excavated to a depth of 2-feet BGS.
- The impacted areas near sample points S-1, S-3, S-8, and S-9 were excavated to 3-feet BGS.
- Composite confirmation samples were obtained from the bottoms and sidewalls of the excavated areas to verify that all contaminants above closure criteria had been removed. The results are shown on Table 2 and the corresponding lab reports may be found in [Appendix VI](#).
- All the excavated material (208yds) was hauled to Lea Land, a NMOCD approved solid waste disposal facility.
- The excavated area was backfilled with new topsoil at depth and brought to grade, machine compacted and contoured to match the surrounding area.
- The Final C-141 formally documenting the remedial actions is attached in [Appendix III](#).
