**RE: Liner Inspection and Closure Report
Renegade BGP Federal #001H
API No. 30-025-39768
GPS: Latitude 32.04874 Longitude -103.41406
UL- D, Section 18, Township 26S, Range 35E
NMOCD Reference No. NRM2023460138**

Liner Integrity Inspection Report

Name of Site: Renegade BGP Fed 1H **Incident #:** NRM2023460138

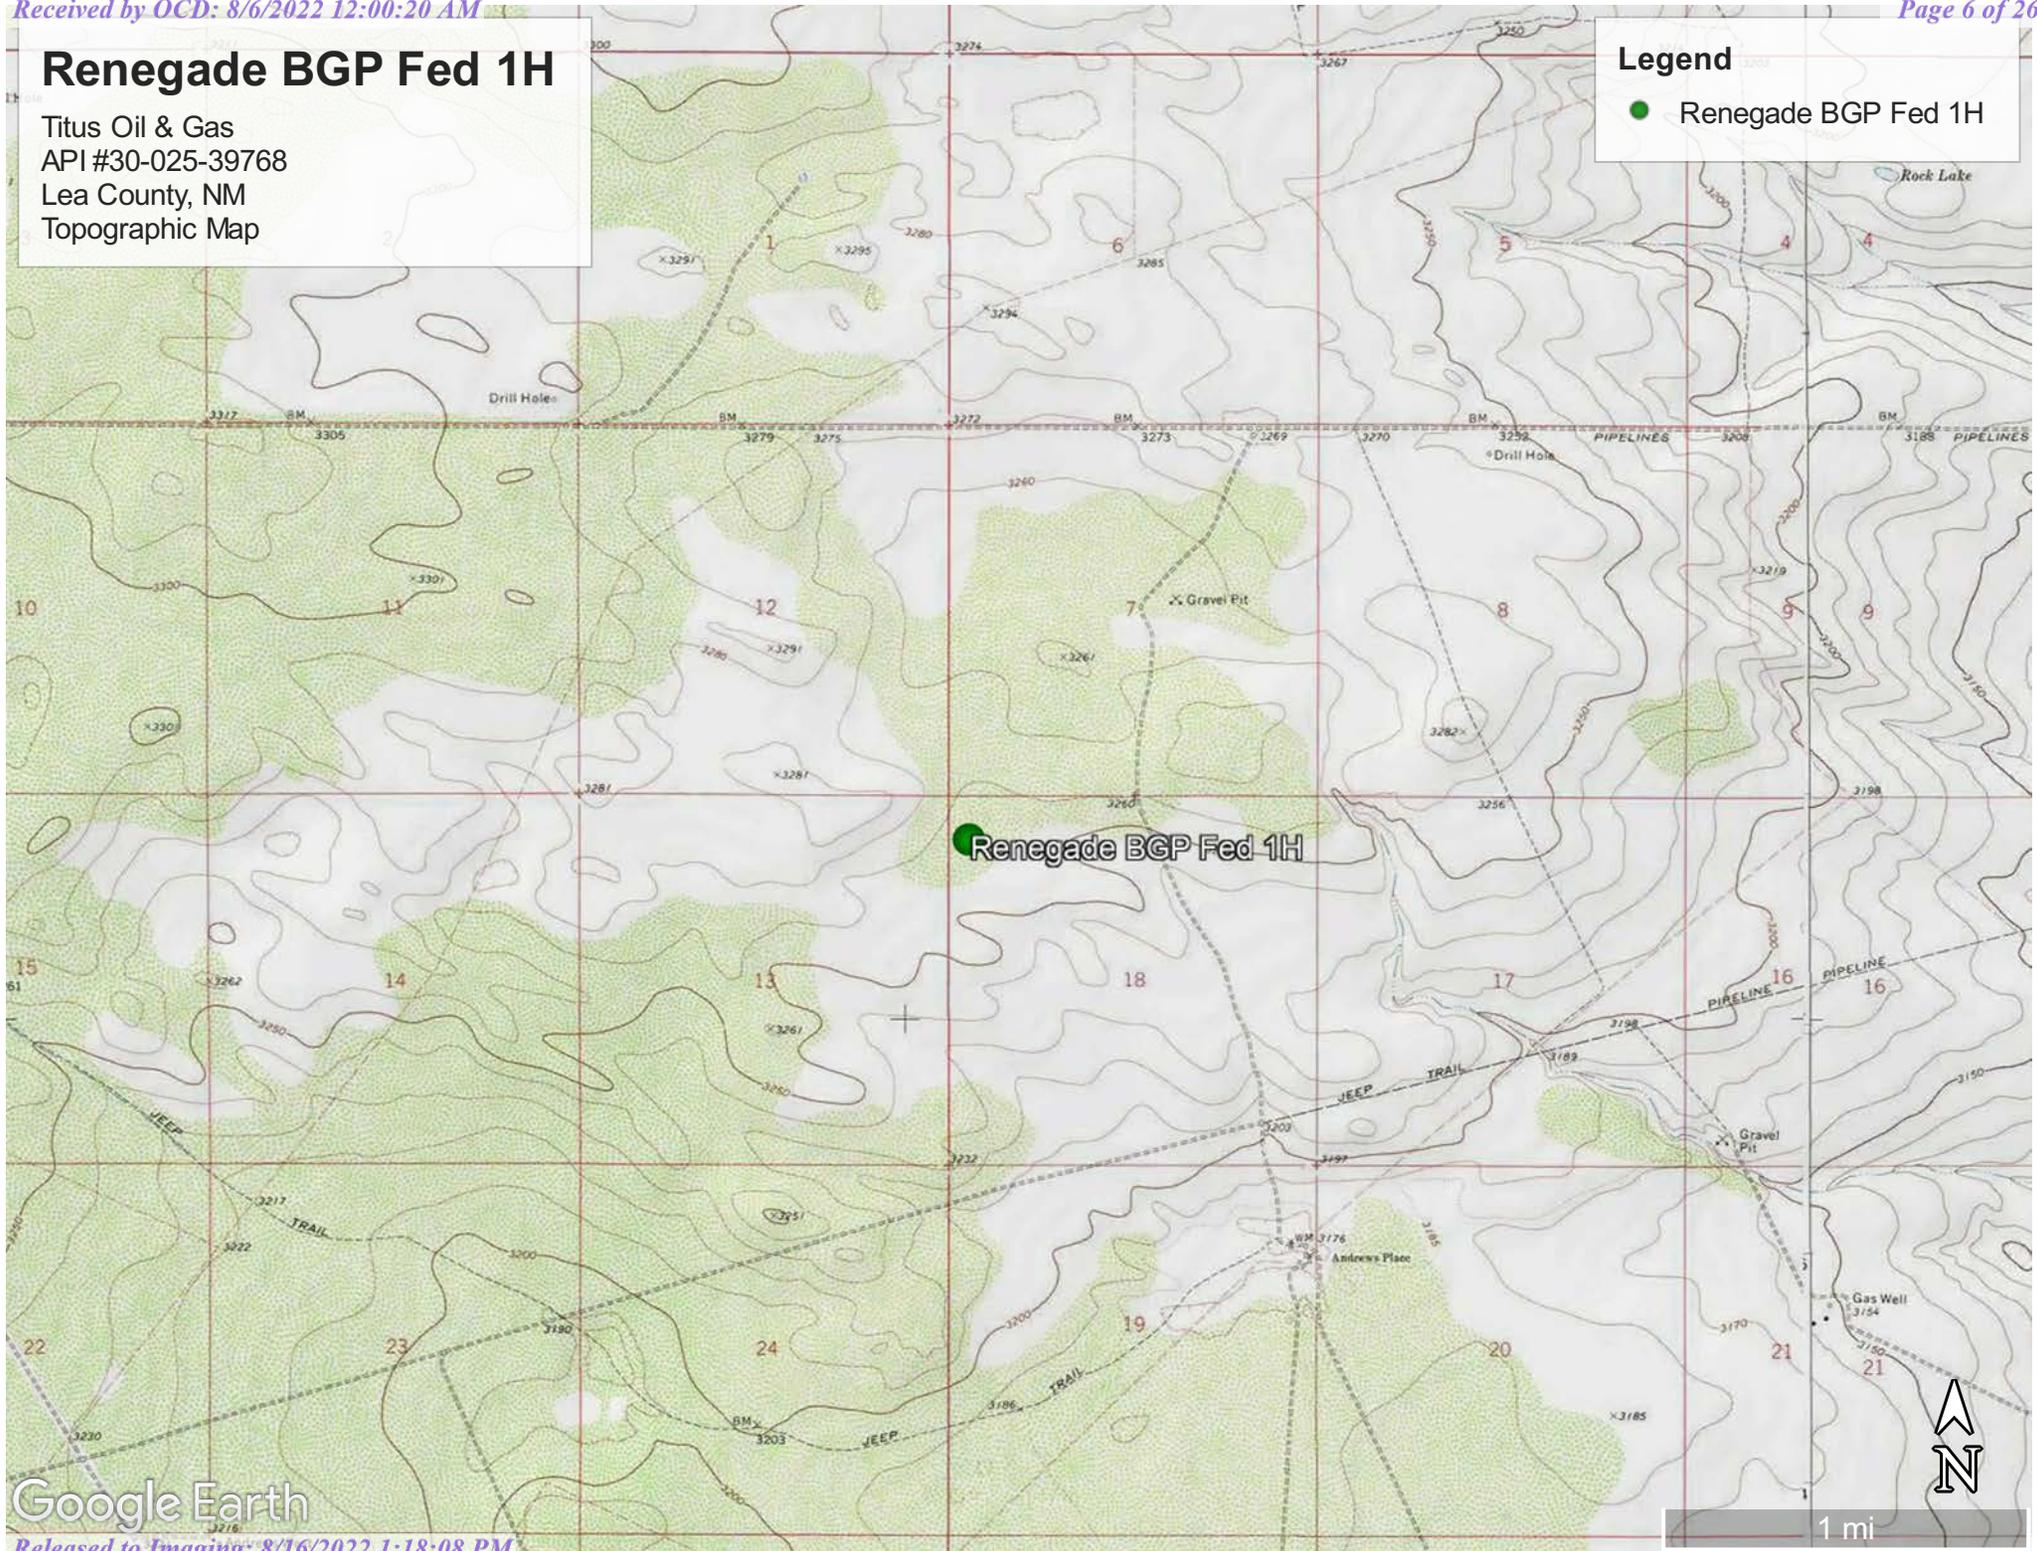
Titus Oil & Gas
API #30-025-39768
Lea County, NM
Topographic Map

Based upon New Mexico Office of the State Engineer well water data, depth to the nearest groundwater in this area is 300 feet below grade surface (BGS). According to the United States Geological Survey well water data, depth to the nearest groundwater in this area is 224 feet BGS. See Appendix A for referenced water surveys. The Renegade is in a low karst area (Figure 3). A Topographic Map can be found in Figure 2.

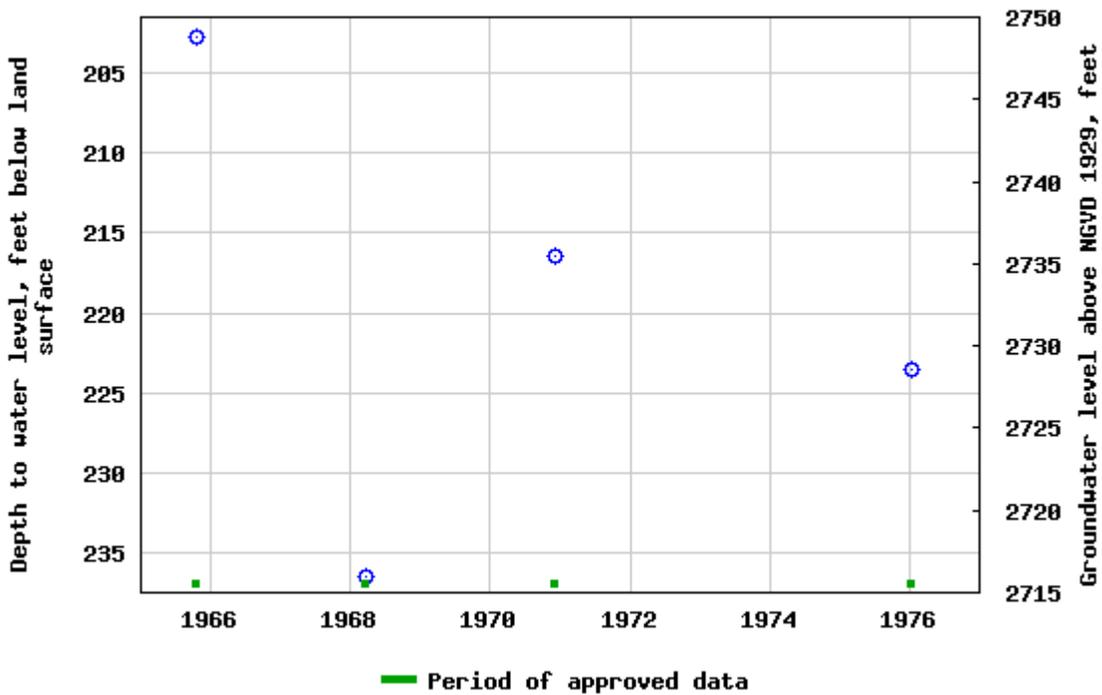
USGS 320138103181201 26S.36E.19.14224

The depth of the well is 700 feet below land surface.

Breaks in the plot represent a gap of at least one year between field measurements.

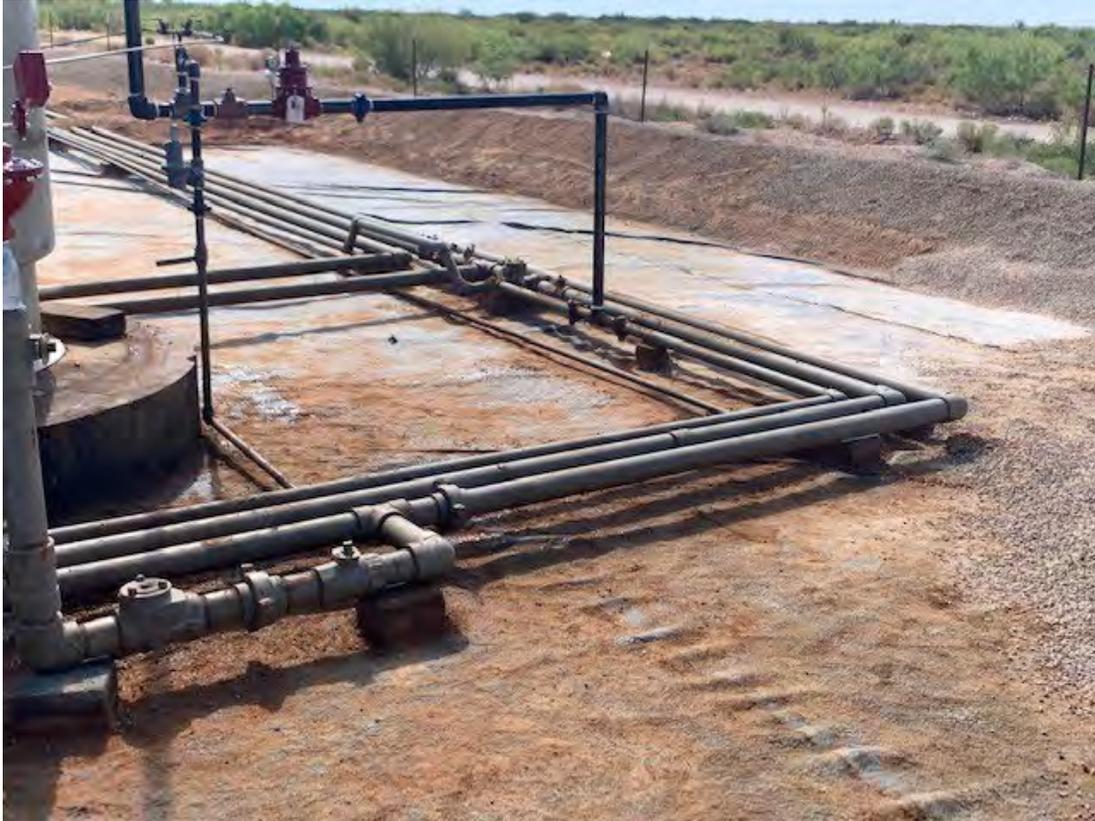
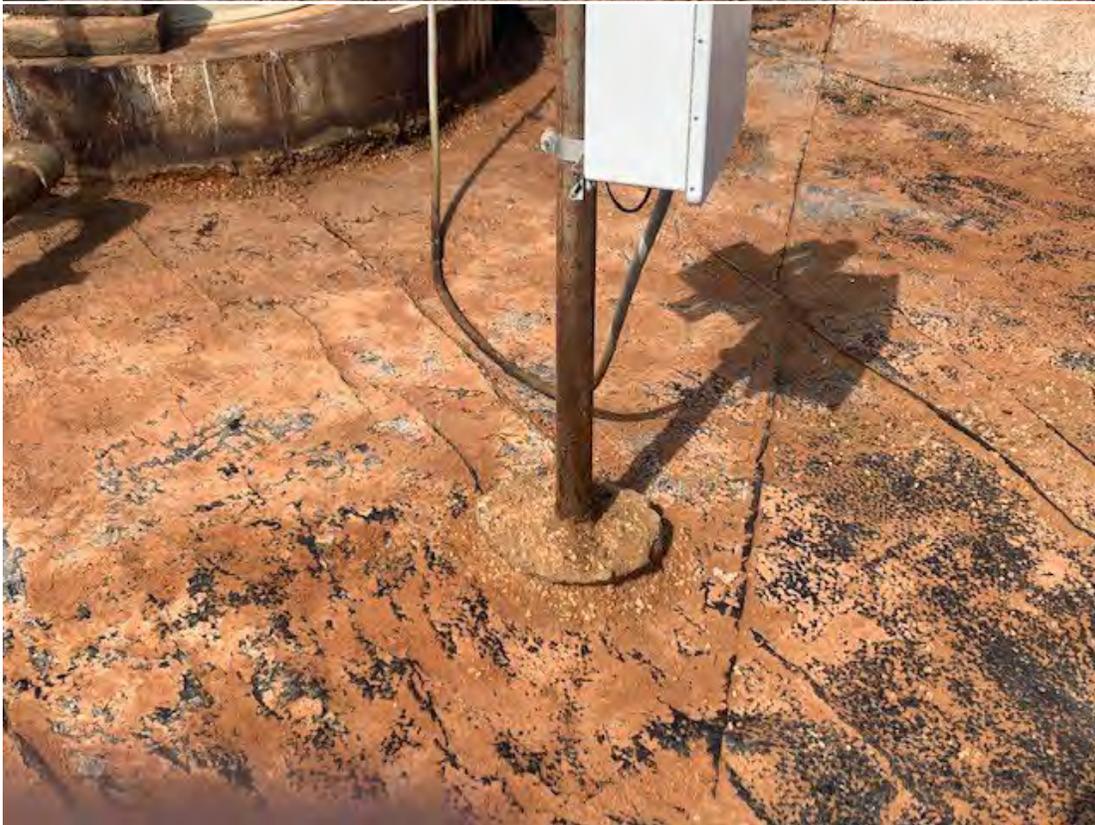
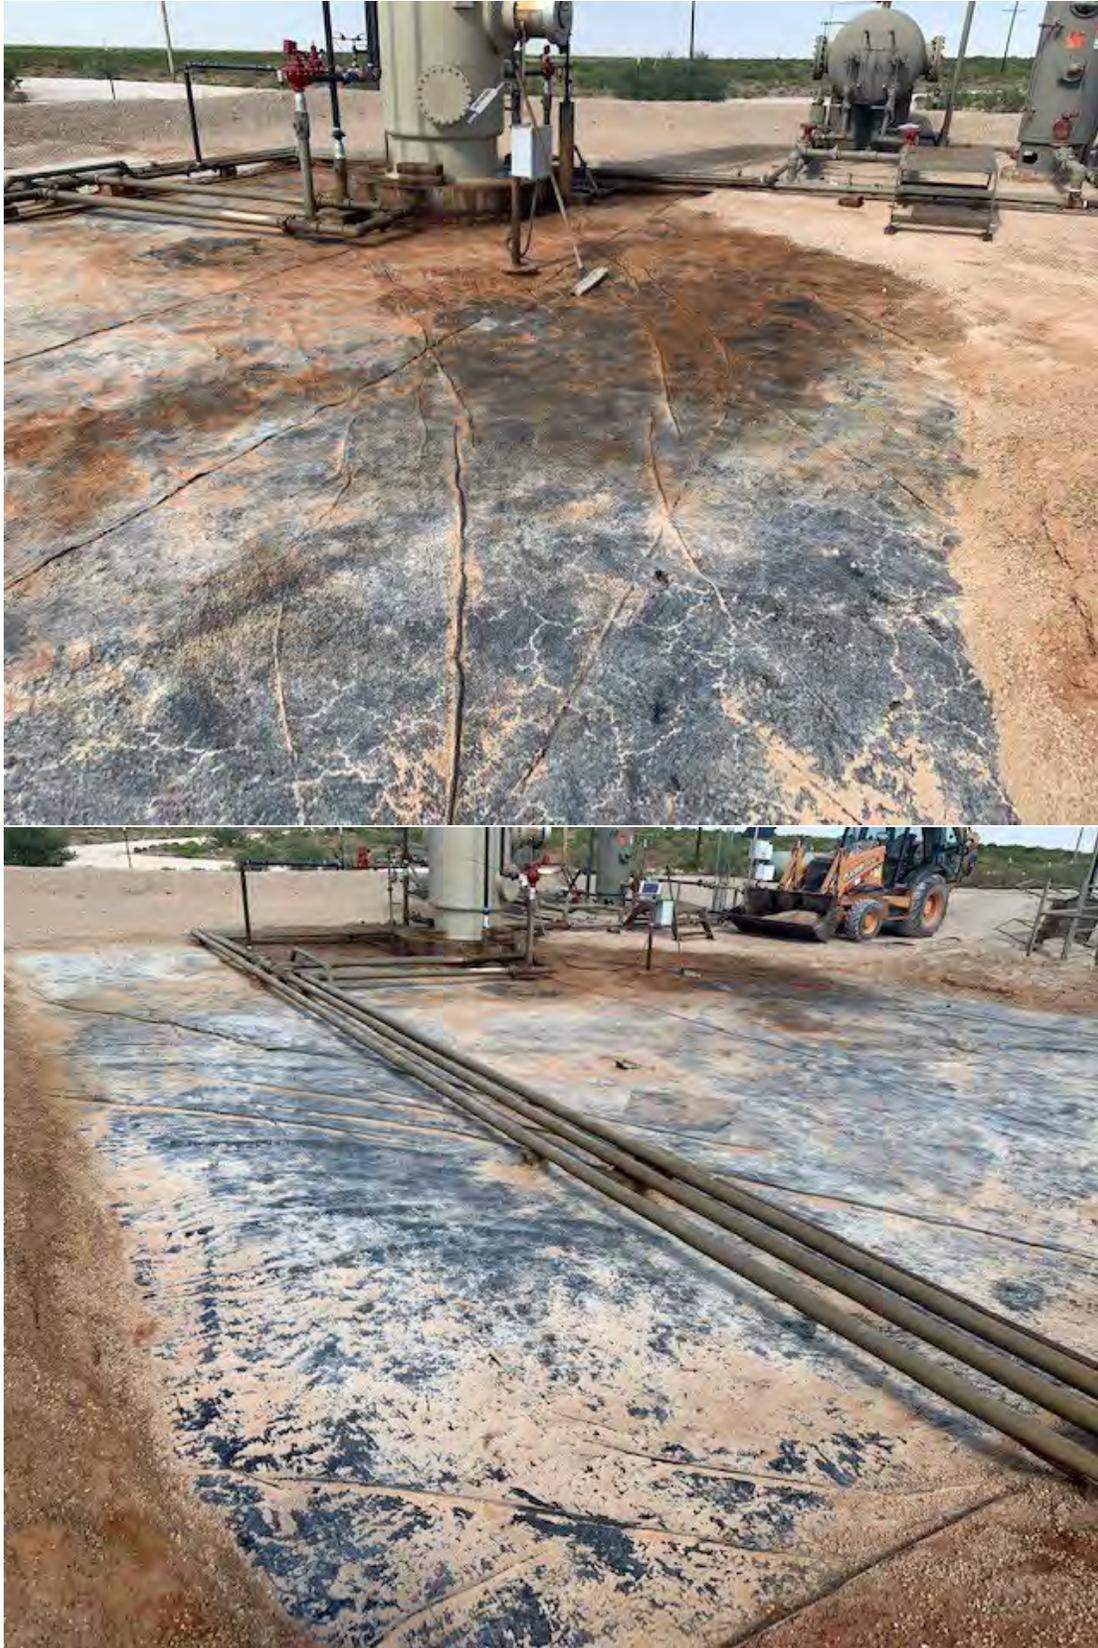
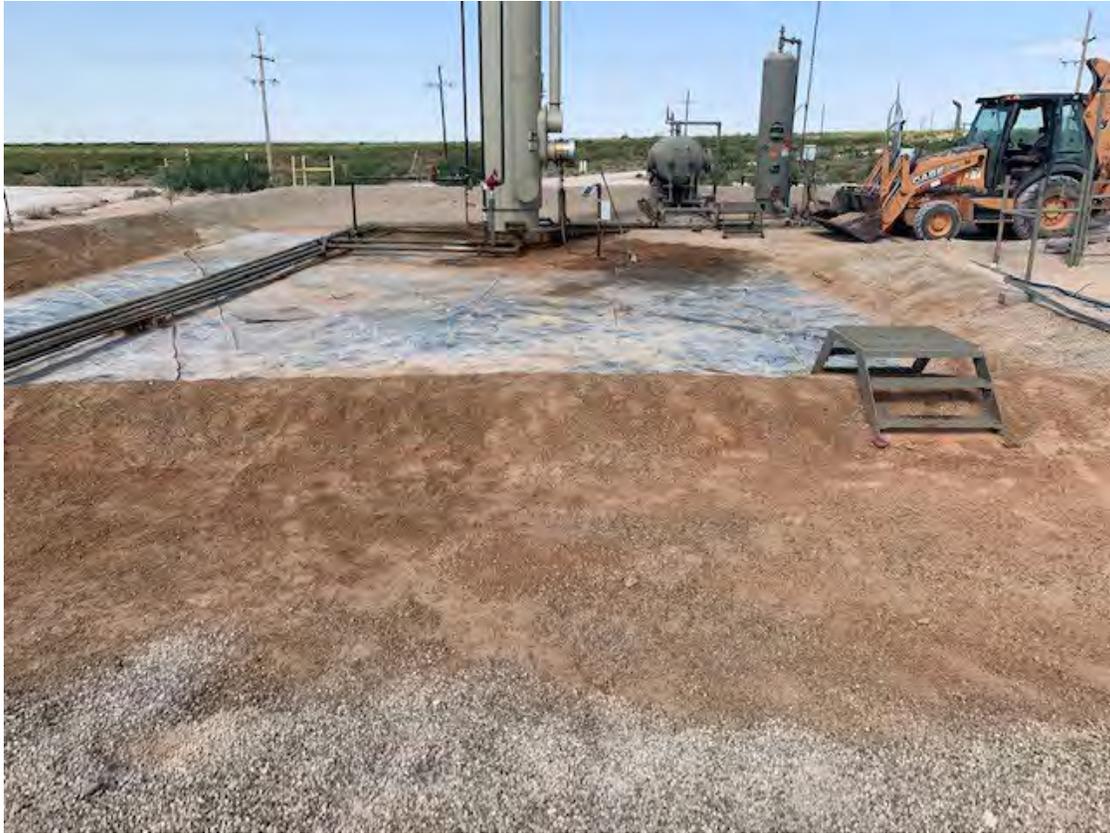
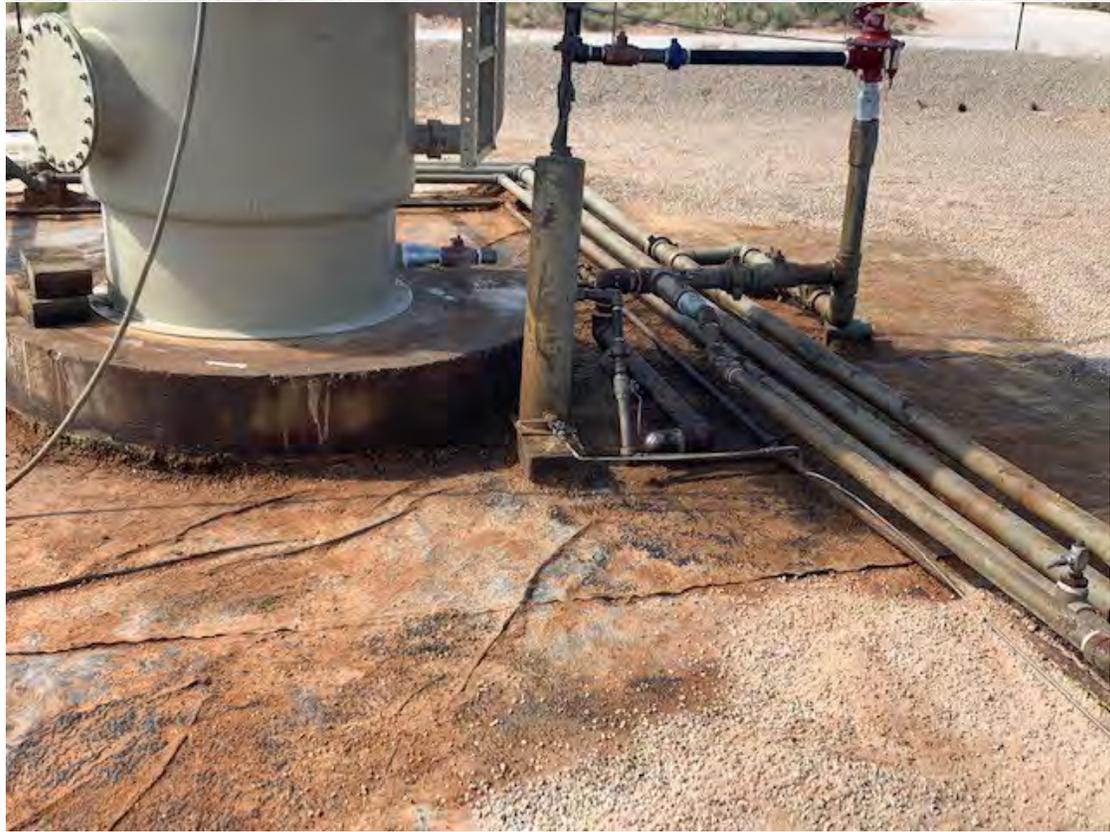
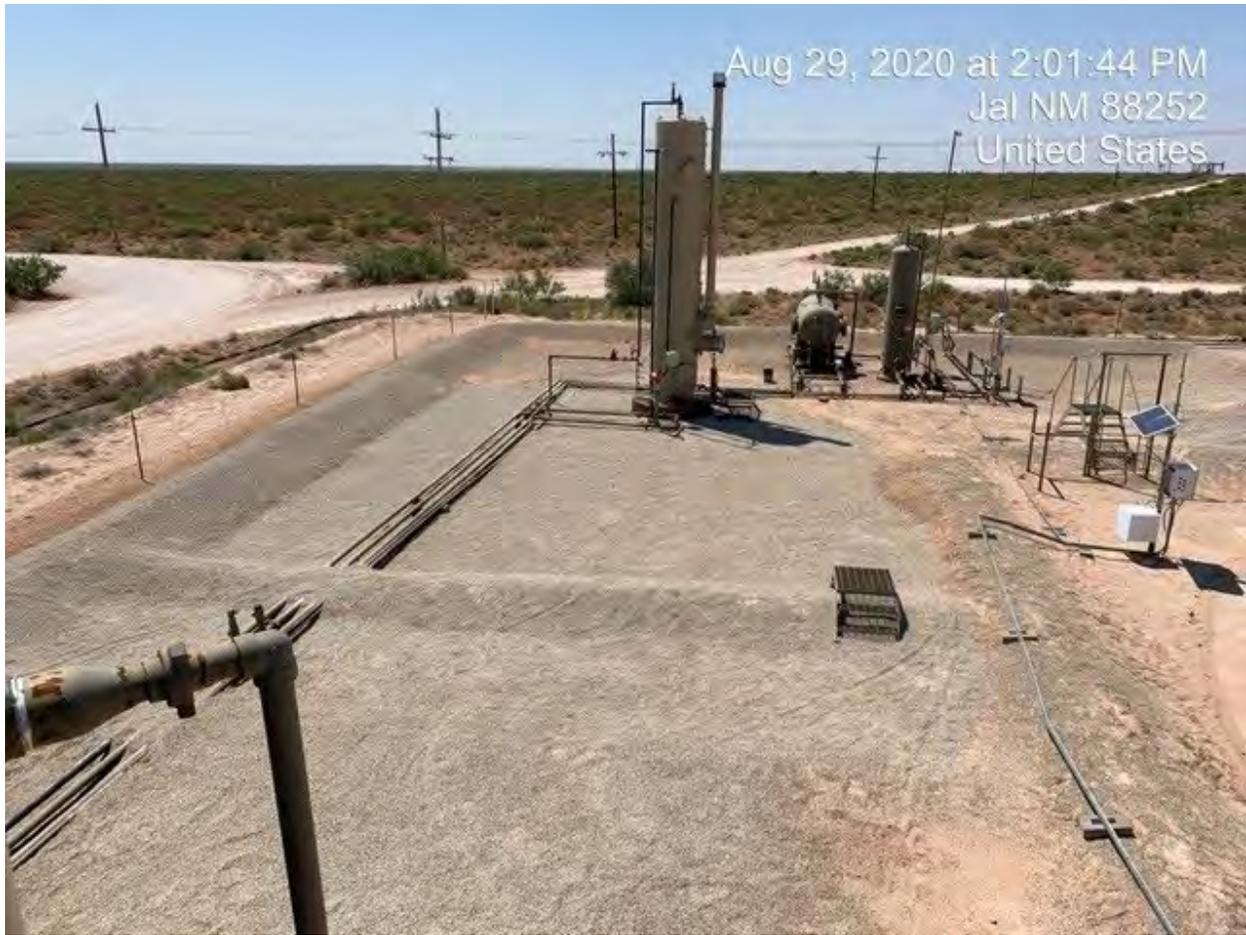
Photographic Documentation

On August 29, 2020, after sending the 48-hour notification via email, Titus removed the gravel from the spill area of the containment then conducted a liner inspection at this location. Two older patches were found that were not in the immediate spill area. These patches were inspected anyway, and the conclusion was their adhesive seals were completely intact maintaining the patches' integrities. We concluded that this liner and containment maintained its integrity and was able to retain the fluids. The liner inspection form and photographic documentation can be found in Appendix C.

Older patches were found under the gravel, upon further inspection, their adhesive seals are both completely intact.

Created By	Condition	Condition Date
rhamlet	We have received your closure report and final C-141 for Incident #NRM2023460138 RENEGADE BGP FEDERAL #001H, thank you. This closure is approved. On future liner inspections, please make sure the liner has been power washed so the surface of the liner can be clearly inspected. If this is not accomplished on the next liner inspection, the closure report will be denied.	8/5/2022
