April 15, 2022

**Re: Release Characterization, Reclamation Work Plan, and Release Closure Request
ConocoPhillips
Heritage Concho
SRO SWD #101 Tank Release
Unit Letter G, Section 5, Township 26 South, Range 28 East
Eddy County, New Mexico
Incident ID# nMLB1121352991
2RP-805**

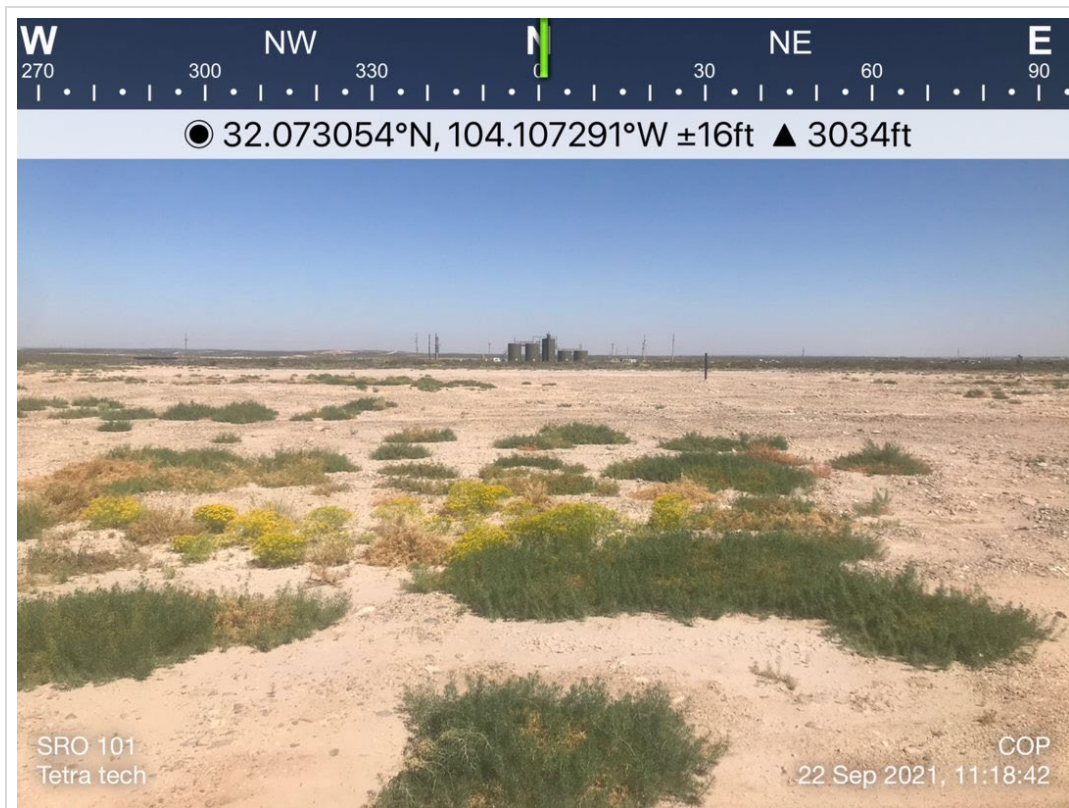
TETRA TECH, INC. PROJECT NO. 212C-MD-02725	DESCRIPTION	View north of the release area.	1
	SITE NAME	HConcho - SRO SWD #101 (P&A)	9/22/2021

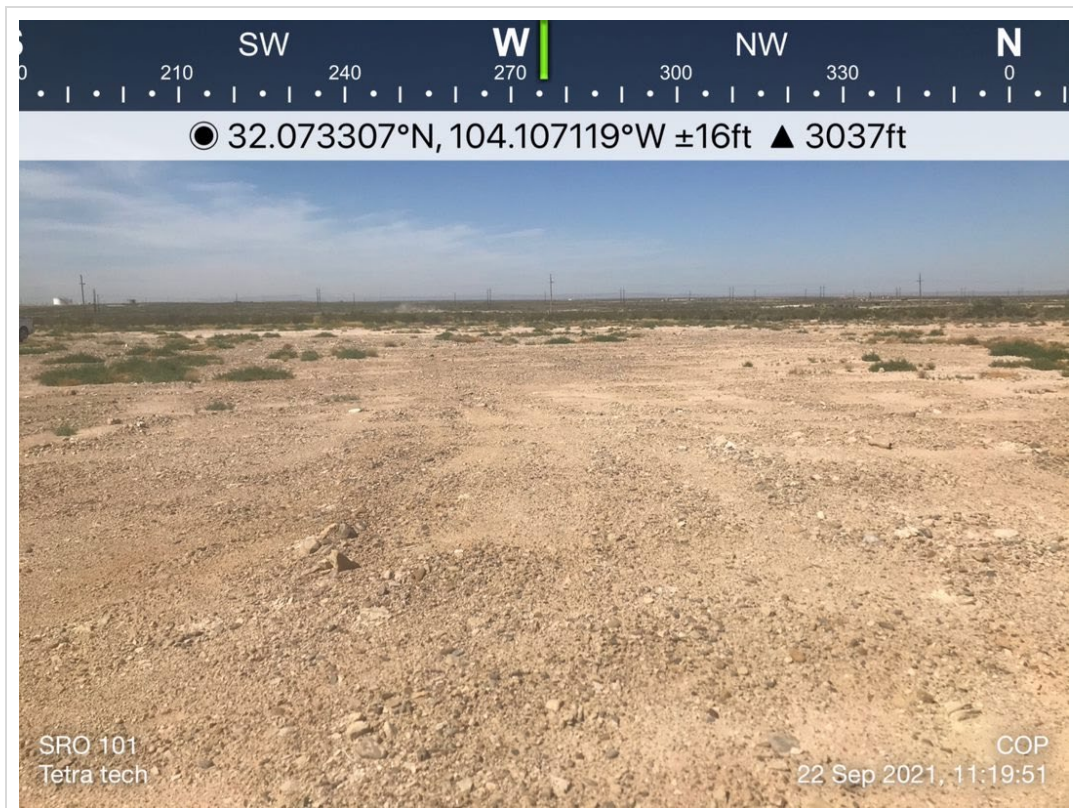
TETRA TECH, INC. PROJECT NO. 212C-MD-02725	DESCRIPTION	View west of the release area.	3
	SITE NAME	HConcho - SRO SWD #101 (P&A)	9/22/2021

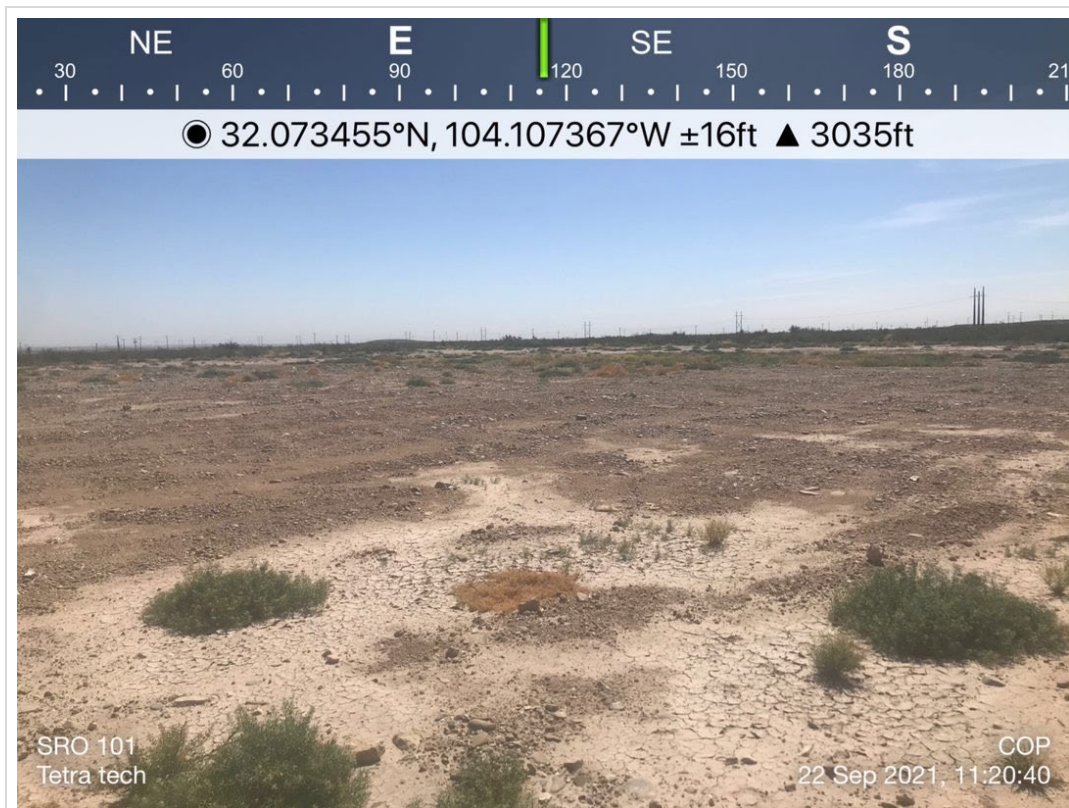
TETRA TECH, INC. PROJECT NO. 212C-MD-02725	DESCRIPTION	View east southeast of the release area.	5
	SITE NAME	HConcho - SRO SWD #101 (P&A)	9/22/2021

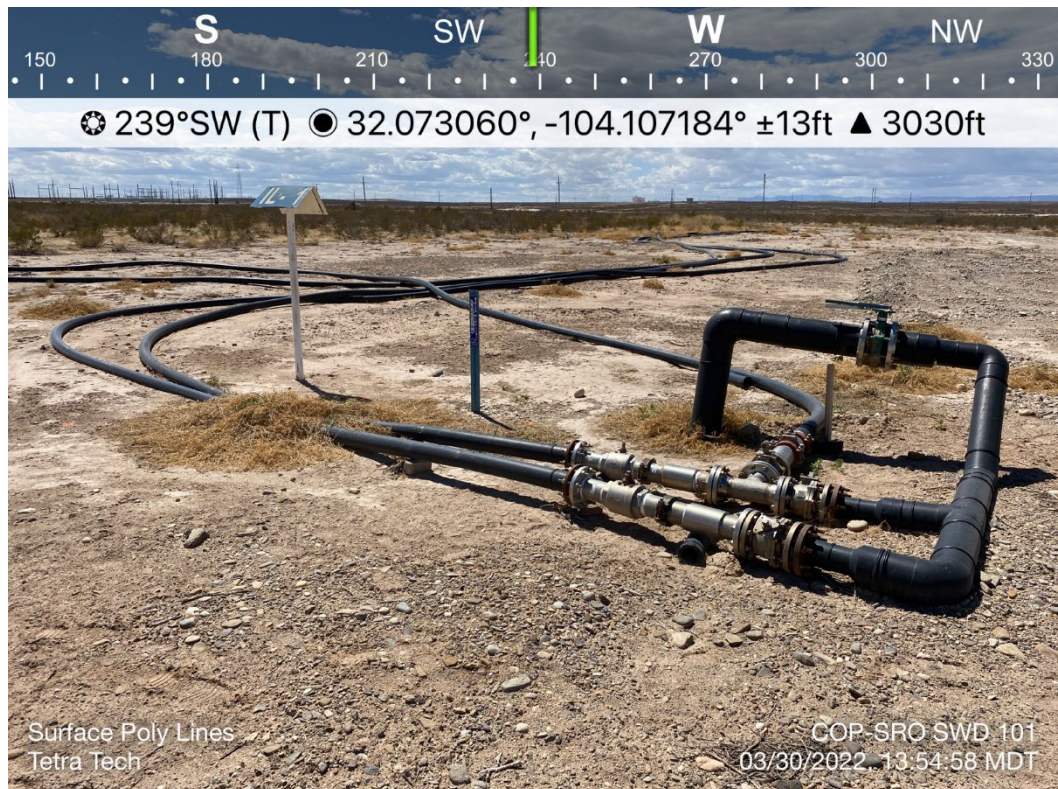
TETRA TECH, INC. PROJECT NO. 212C-MD-02578	DESCRIPTION	View southwest of surface poly lines in the southern portion of the release area.	8
	SITE NAME	HConcho - SRO SWD #101 (P&A)	3/30/2022

Re-seeding of the Site is recommended to aid in revegetation. Coordination with the New Mexico State Land Office (NMSLO) as the landowner will be conducted prior to commencement of the proposed Site restoration activities. The backfilled and otherwise unvegetated areas of the lease pad will be ripped (once each way), seeded, and the dozer track imprinted to aid in revegetation. Areas of the pad exhibiting
