Form C-141

State of New Mexico
Oil Conservation Division

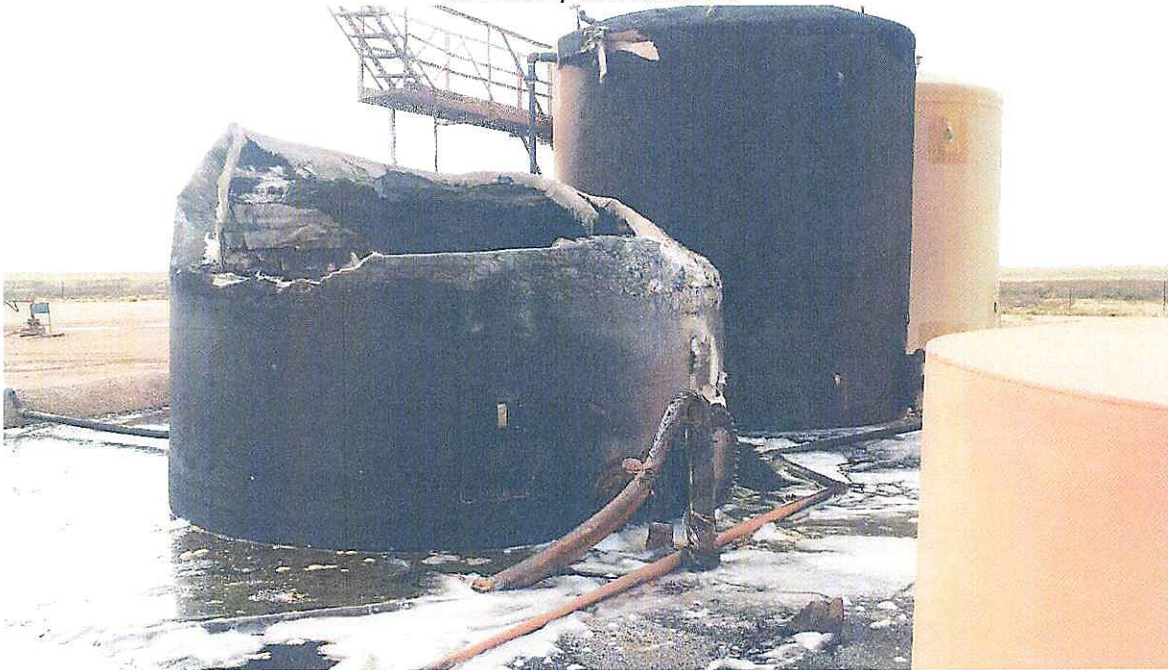
Photograph 2: Original Secondary Containment Holding All Released Liquids

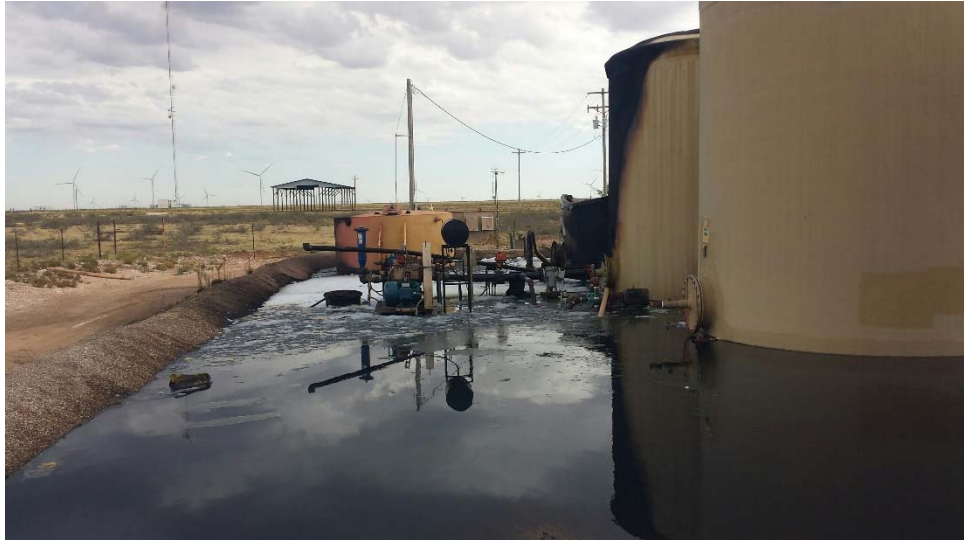
Photo of
Release
contained in
earthen berm.
No staining is
observed
outside of the
earthen berm.
Photo Date:
9/1/2019

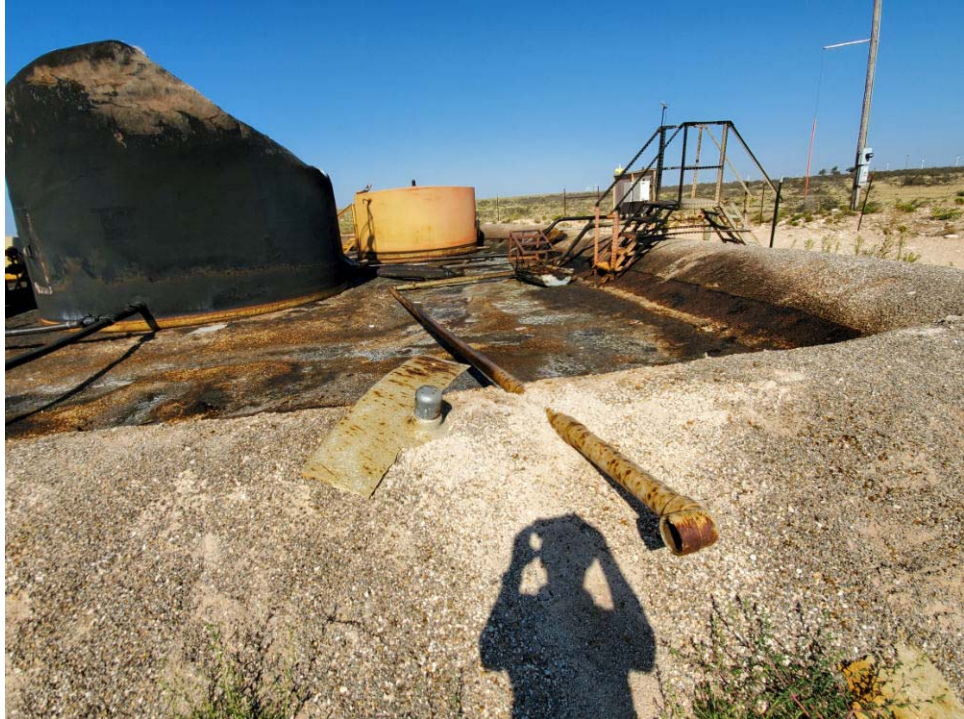
Photo of lined
earthen berm
after fluids
were removed.
No staining is
observed
outside of the
earthen berm.
Photo Date:
9/3/2019

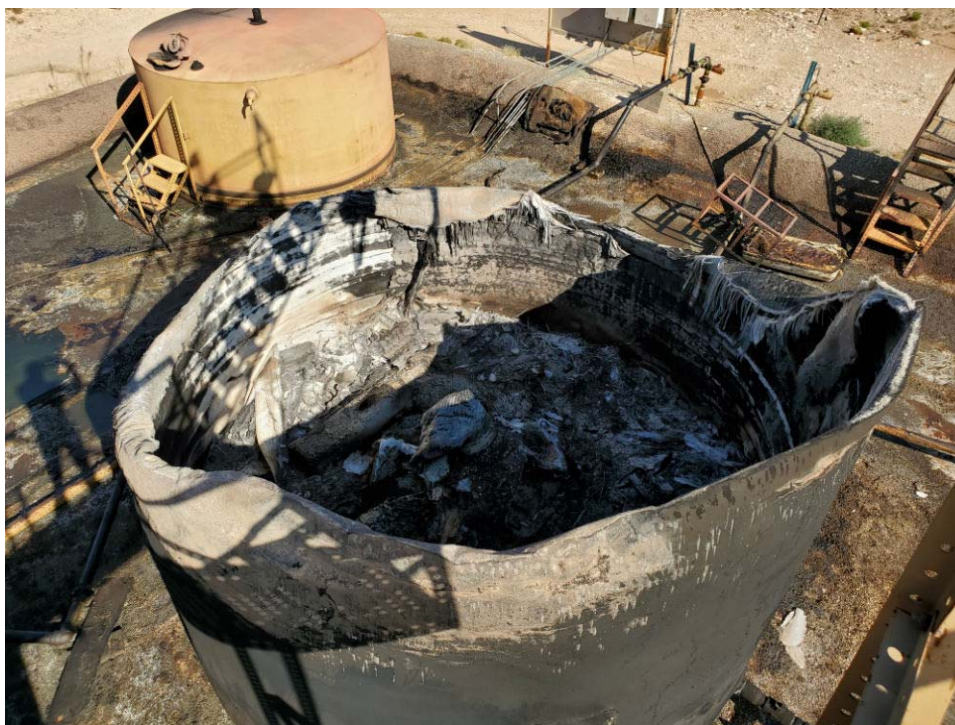
Photo of lined
earthen berm
after fluids
were removed.
No staining is
observed
outside of the
earthen berm.
Photo Date:
9/3/2019
