Remediation Excavation Closure Report

Dazed BDZ Federal Com #2

API #30-015-33428 Unit E, Section 3, T21S, R24E Eddy County, New Mexico Incident ID: nAPP2202733281

May 26, 2022 Project #19034-0008

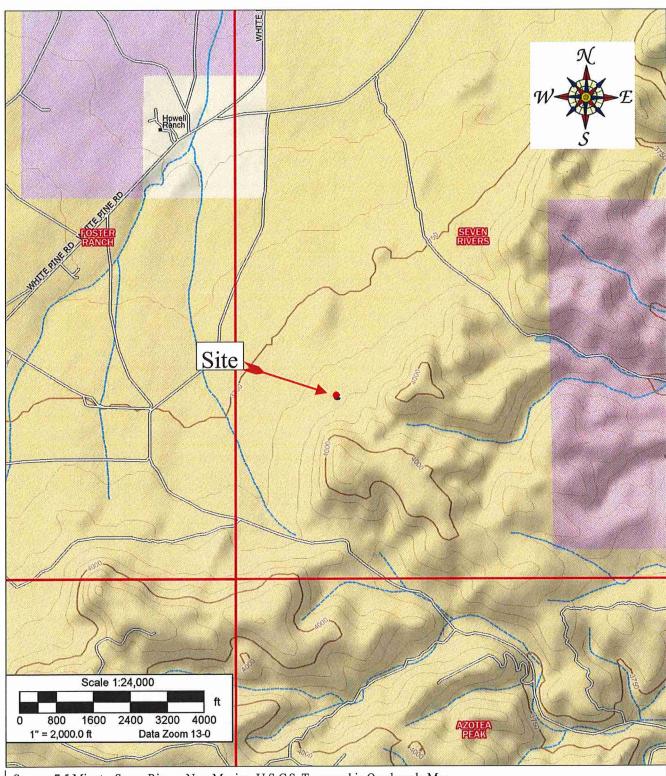
Figure #1

Site Assessment Report Dazed BDZ Federal Com #2 Unit E, Section3, T21S, R24E Eddy County, New Mexico 32.511004, -104.493439

Vicinity Map

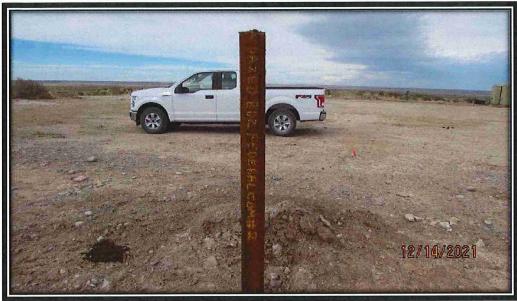
Picture 1: P&A Marker

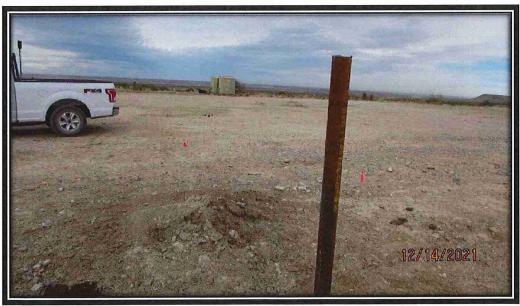
Picture 2: View of Pin Flagged Area East of P&A Marker

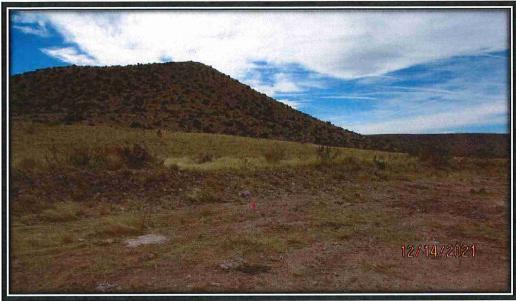
Picture 3: View of Pin Flagged Area in Southeast Corner of Well Pad

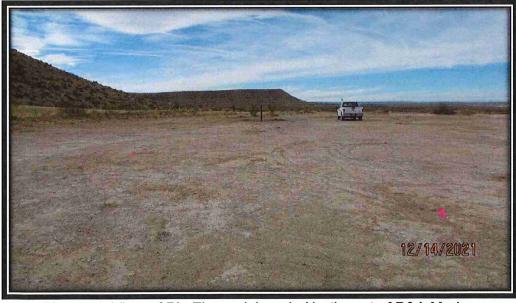
Picture 4: View of Pin Flagged Area in Northwest of P&A Marker

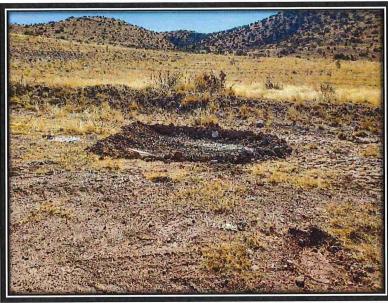
Picture 5: View of Southeast Excavation

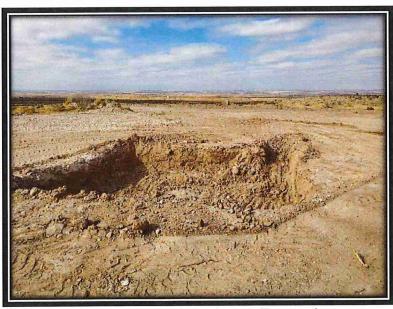
Picture 6: View of Northwest Excavation

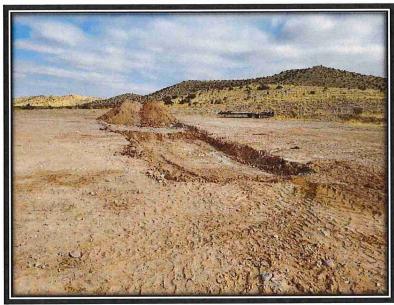
Picture 7: View 1 of Main Excavation

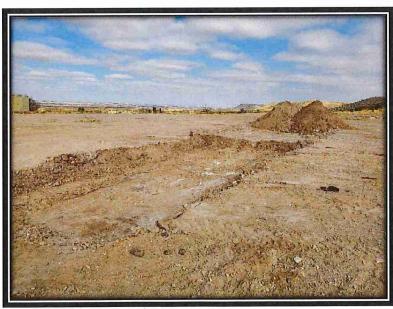
Picture 8: View 2 of Main Excavation

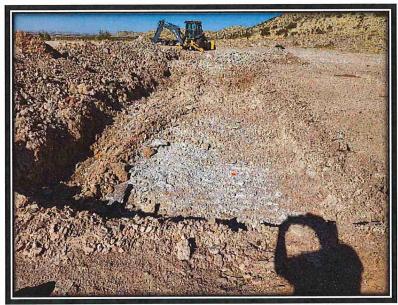
Picture 15: CS-23 through CS-26 (looking East)

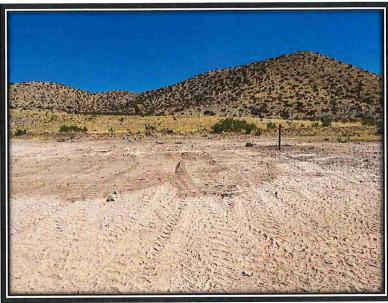
Picture 17: View of Backfilled Area

Envirotech personnel completed the sampling of three (3) remediation excavations that were completed at the Dazed BDZ Federal Com #2. EOG contractors backfilled the excavation with non-waste containing material on May 18, 2022. Based on the analytical results, all contaminants of concern are below the NMOCD reclamation criteria; therefore, Envirotech recommends requesting a No Further Action status regarding the remediation excavations.

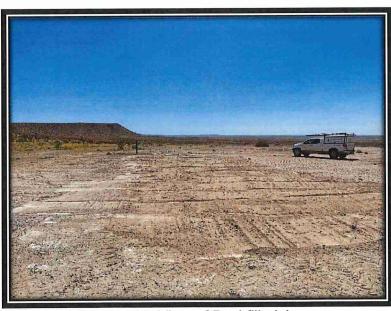
Picture 18: View of Backfilled Area

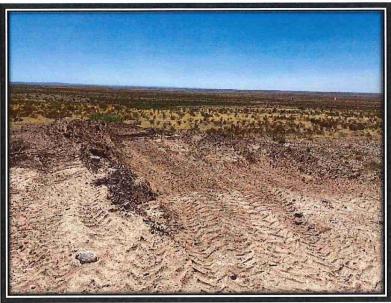
Picture 19: View of Backfilled Area

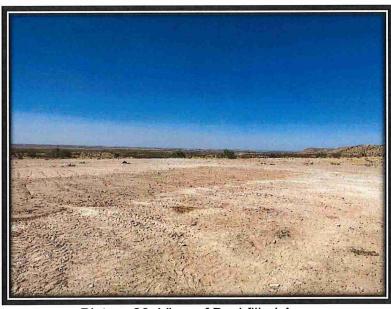
Picture 20: View of Backfilled Area
