Report Type: Closure Request 1RP-5001

General Site Information:					
Site:	Jefe BSJ Fed Com #1H				
Company:	EOG Resources, Inc.				
Section, Township and Range	Unit O	Sec. 32	T 25S	R 32E	
Lease Number:	API No. 30-025-40722				
County:	Lea County				
GPS:	32.080260° N			103.695740° W	
Surface Owner:	State				
Mineral Owner:	State				
Directions:	From the intersection of HWY 128 and CR 1, travel south on CR 1 for 10.4 miles, turn west onto lease road for 1.85 mi, turn north for 0.9 mi, turn east and continue for 0.75 mi to location.

Release Data:	
Date Released:	3/21/2018
Type Release:	Produced Water
Source of Contamination:	Water Line
Fluid Released:	75 bbls
Fluids Recovered:	35 bbls

Re: Closure Request for the EOG Resources, Jefe BSJ Fed Com #1H, Unit O, Section 32, Township 25 South, Range 32 East, Lea County, New Mexico. 1RP-5001.

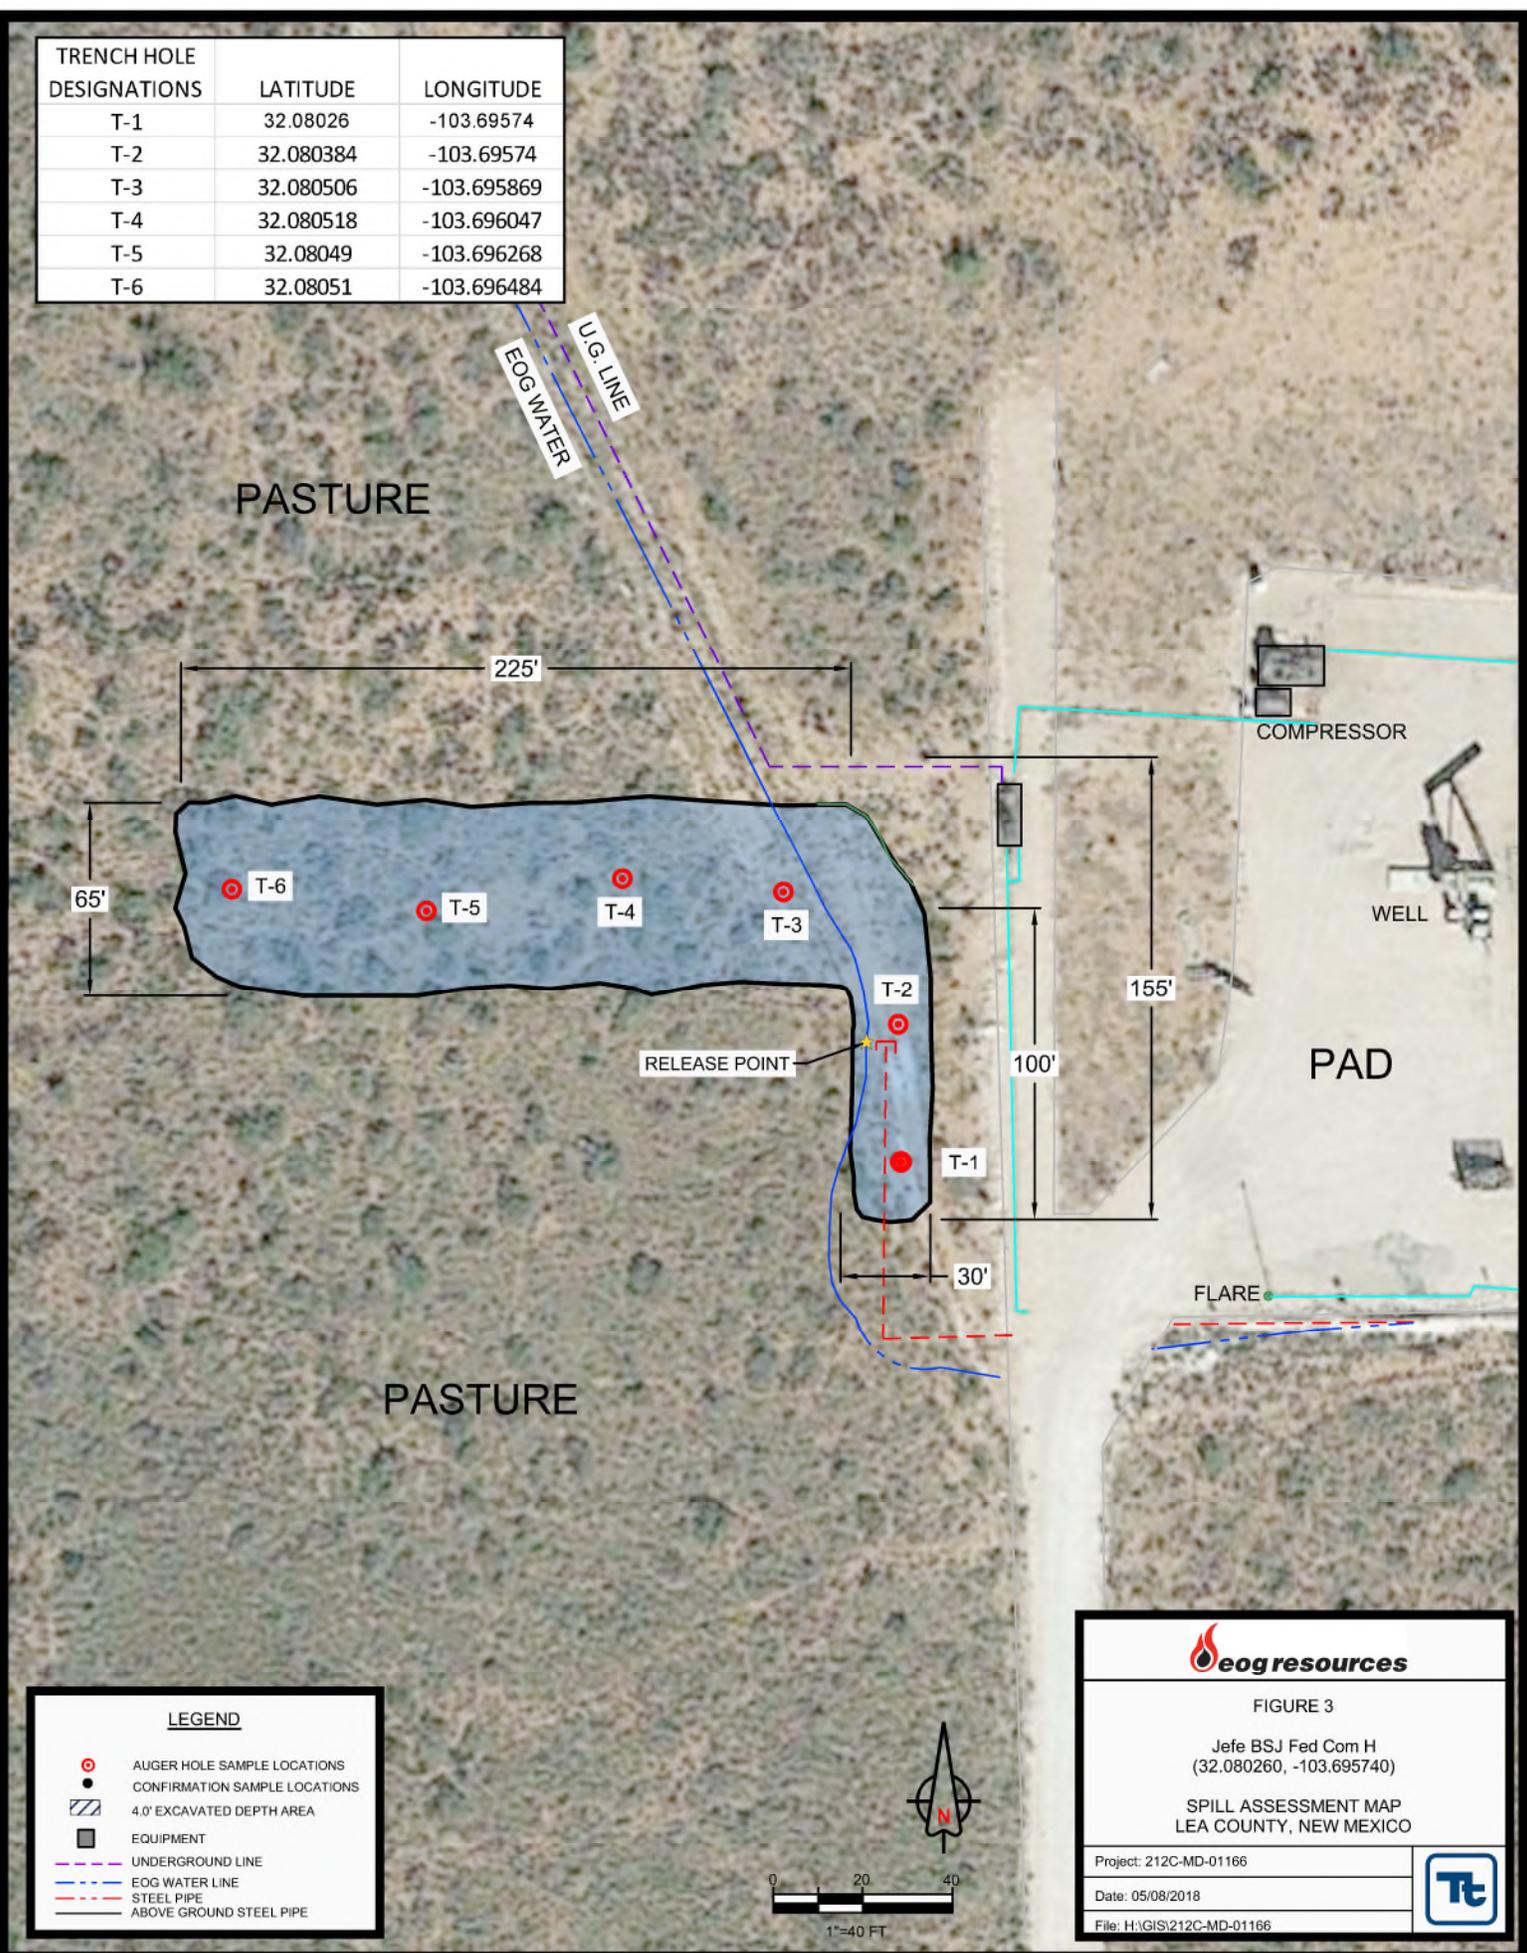
TRENCH HOLE DESIGNATIONS	LATITUDE	LONGITUDE
T-1	32.08026	-103.69574
T-2	32.080384	-103.69574
T-3	32.080506	-103.695869
T-4	32.080518	-103.696047
T-5	32.08049	-103.696268
T-6	32.08051	-103.696484

LEGEND	
	AUGER HOLE SAMPLE LOCATIONS
	CONFIRMATION SAMPLE LOCATIONS
	4.0' EXCAVATED DEPTH AREA
	EQUIPMENT
	UNDERGROUND LINE
	EOG WATER LINE
	STEEL PIPE
	ABOVE GROUND STEEL PIPE

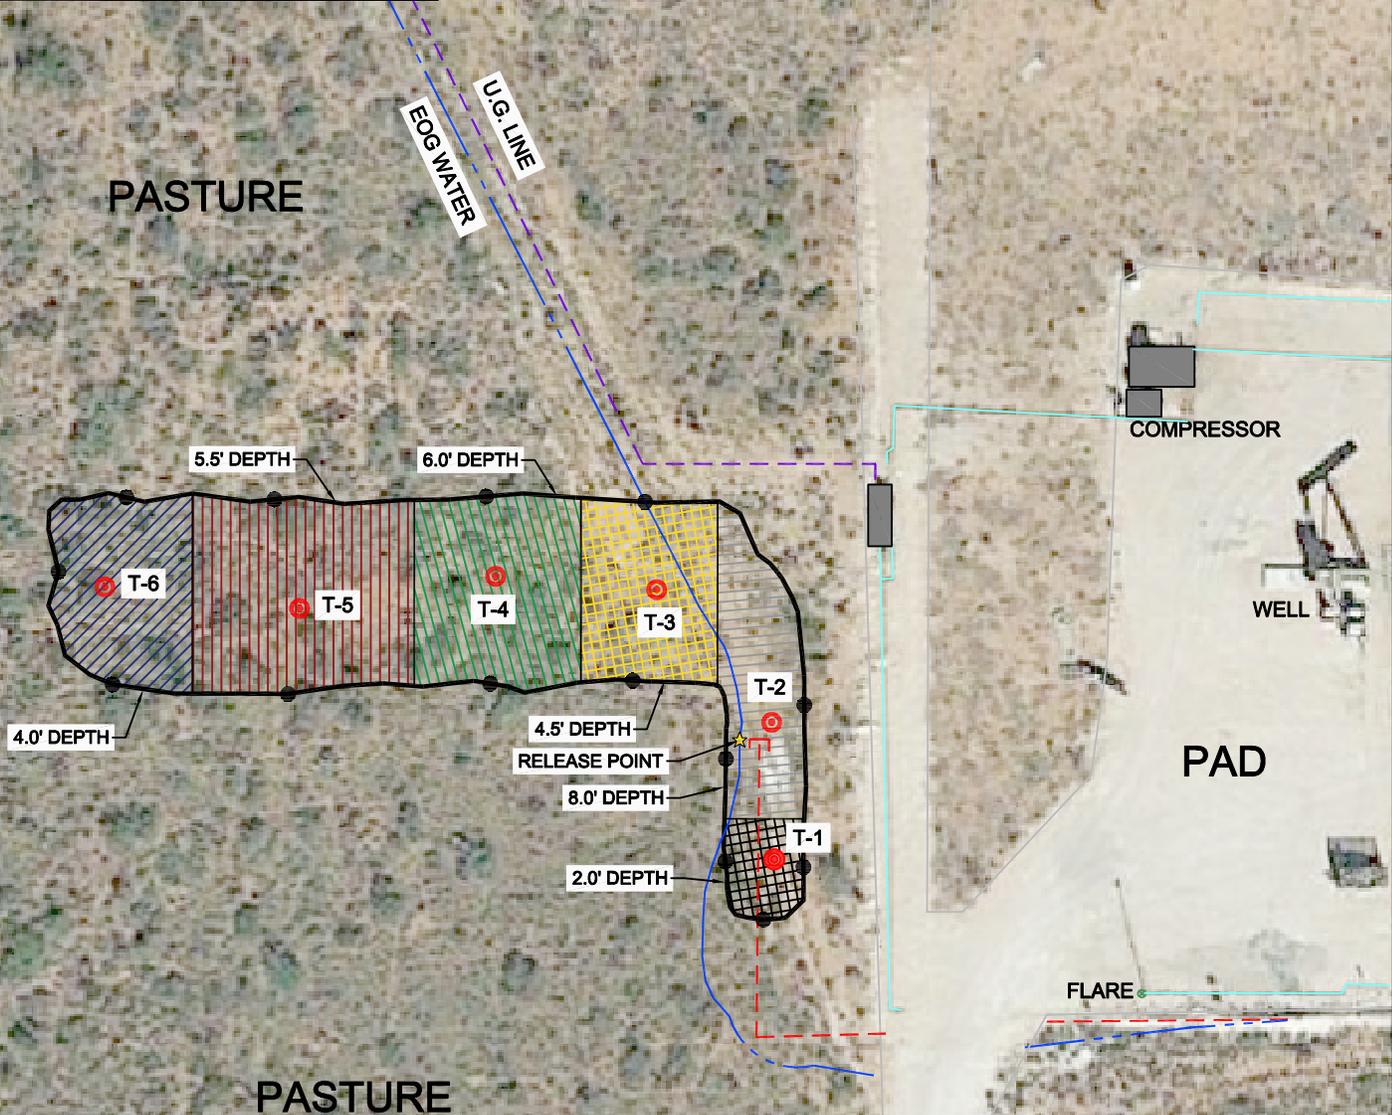
TRENCH HOLE DESIGNATIONS	LATITUDE	LONGITUDE
T-1	32.08026	-103.69574
T-2	32.080384	-103.69574
T-3	32.080506	-103.695869
T-4	32.080518	-103.696047
T-5	32.08049	-103.696268
T-6	32.08051	-103.696484

- AUGER HOLE SAMPLE LOCATIONS
- CONFIRMATION SAMPLE LOCATIONS
- 4.0' EXCAVATED DEPTH AREA
- 5.5' EXCAVATED DEPTH AREA
- 6.0' EXCAVATED DEPTH AREA
- 4.5' EXCAVATED DEPTH AREA
- 8.0' EXCAVATED DEPTH AREA
- 2.5' EXCAVATED DEPTH AREA
- EQUIPMENT
- UNDERGROUND LINE
- EOG WATER LINE
- STEEL PIPE
- ABOVE GROUND STEEL PIPE

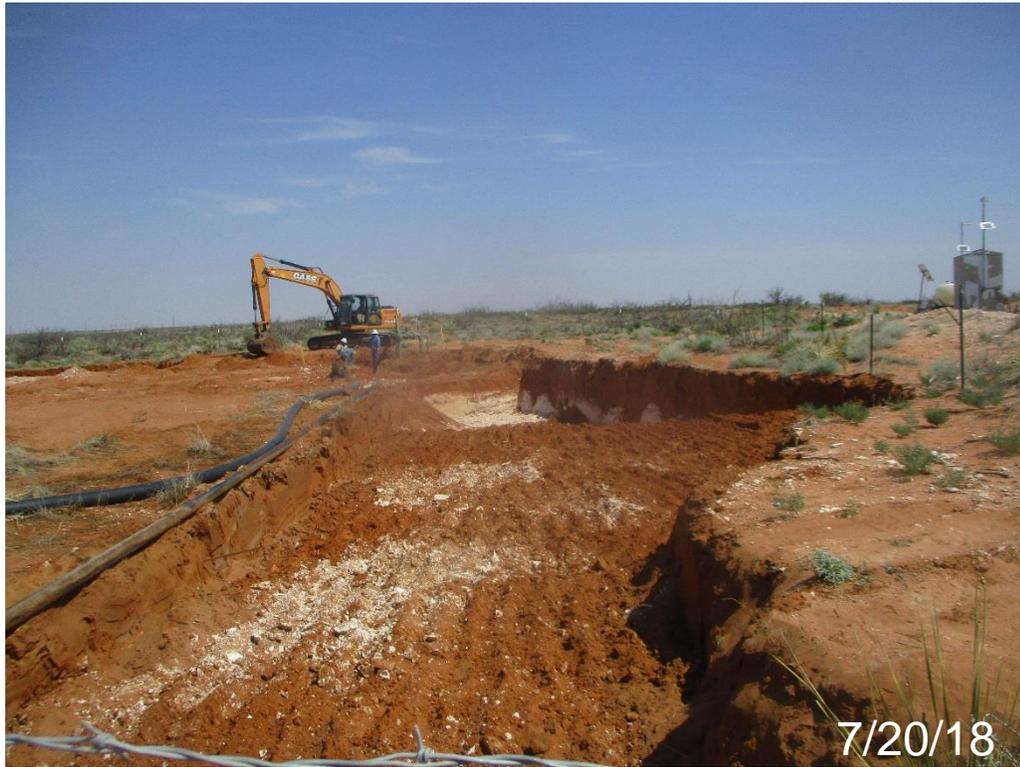
View North- Excavated Area of T-1 and T-2

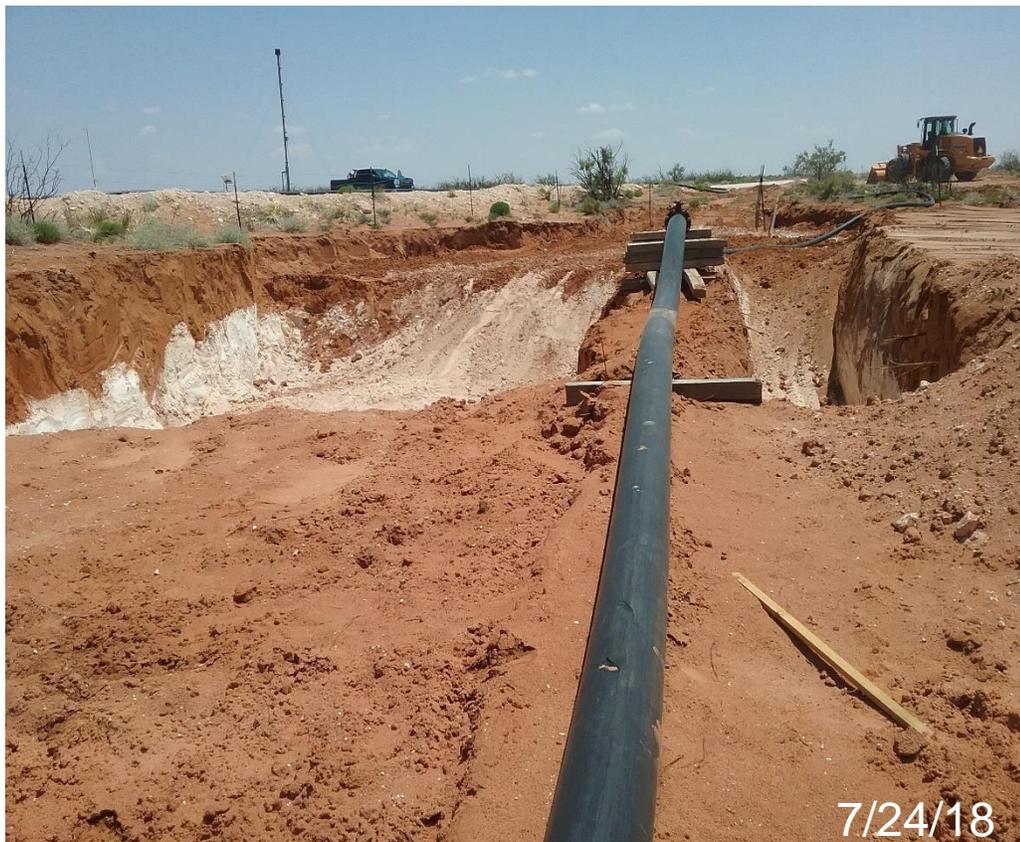
View South- Excavated -Area of T-2

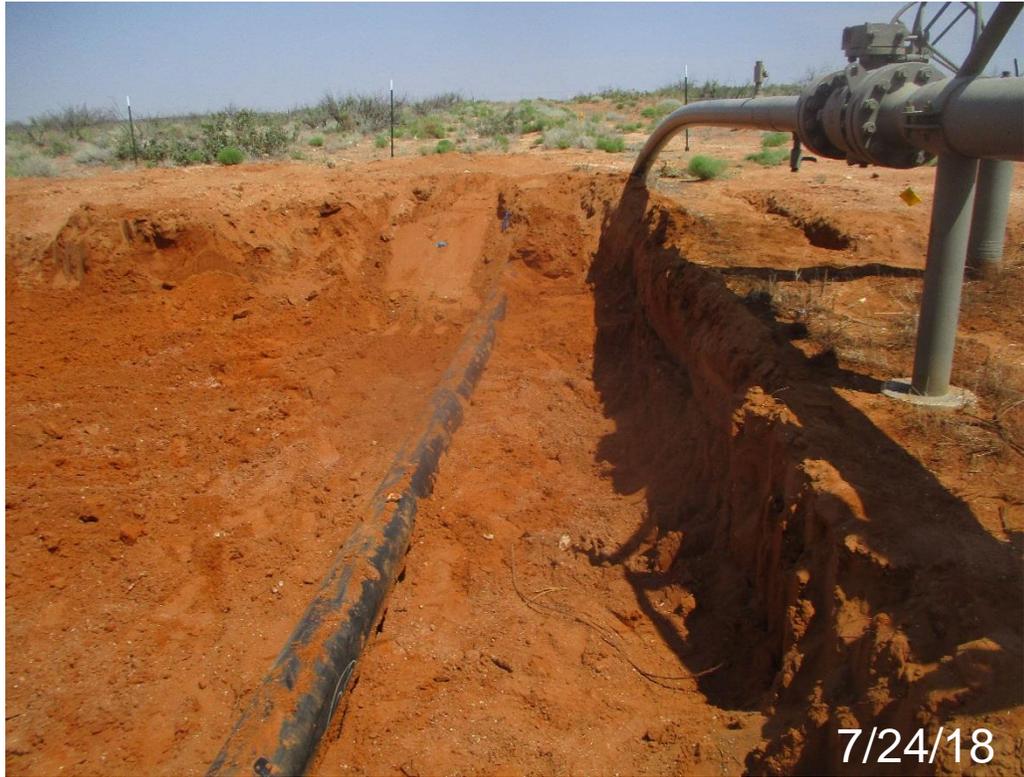
View North- Excavated Area of T-3

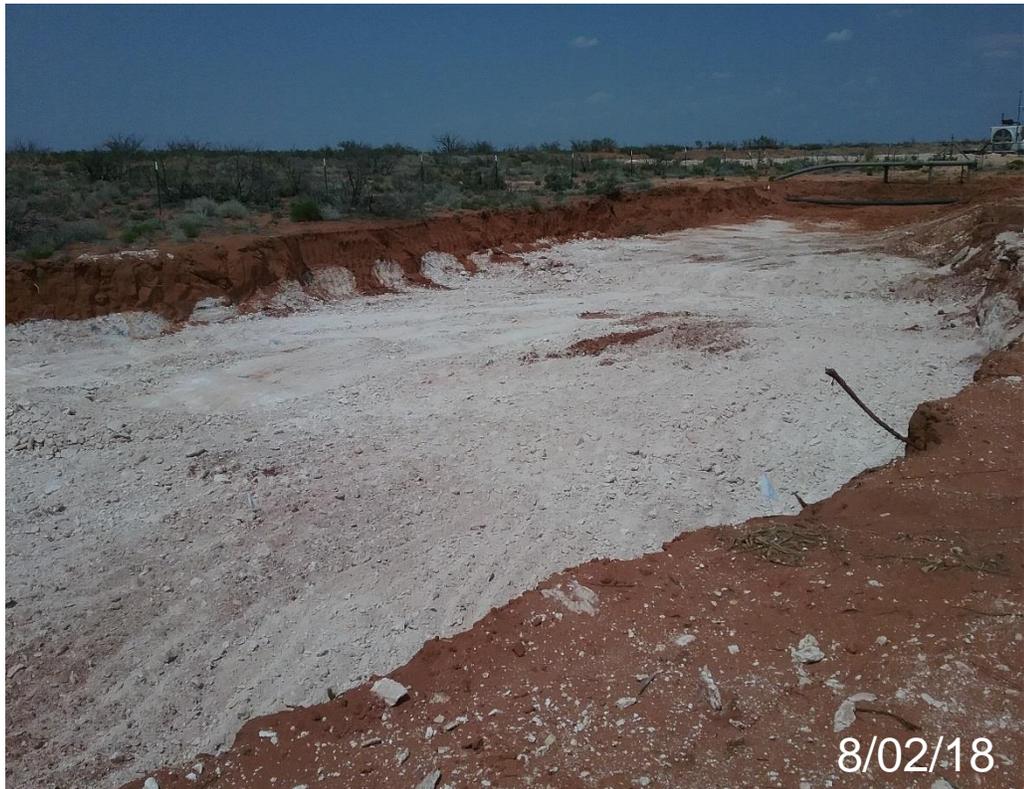
View Northeast- Excavated Area of T4 and T-3

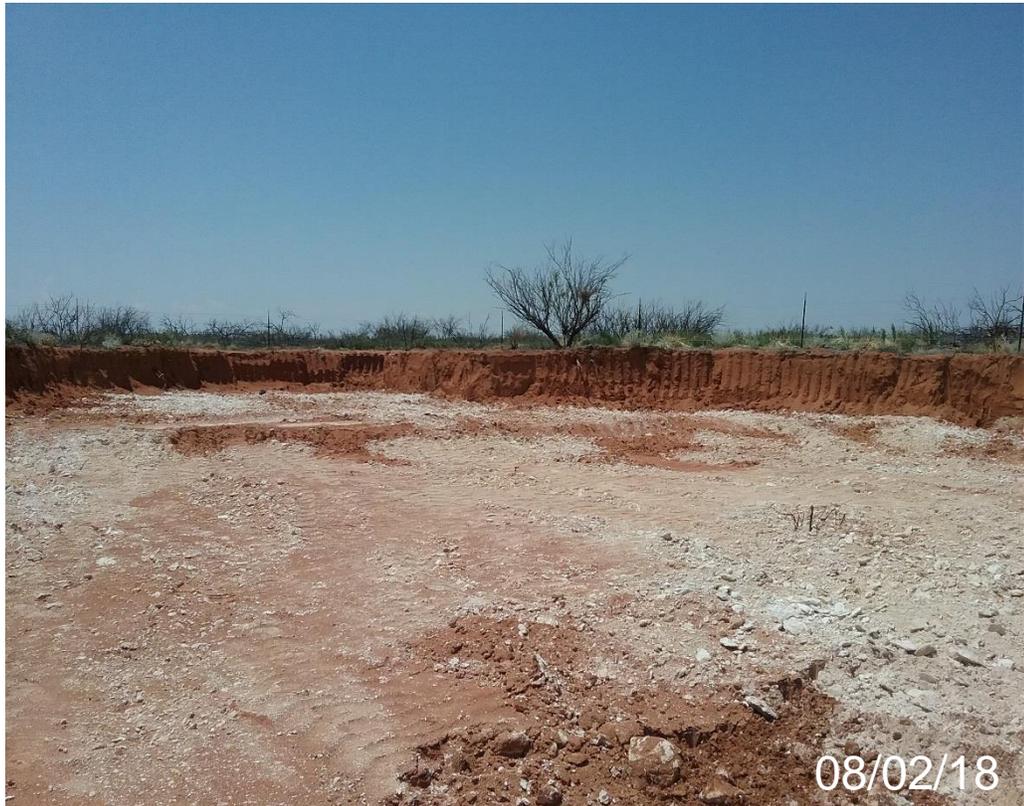
View West- Excavated Area of T-5

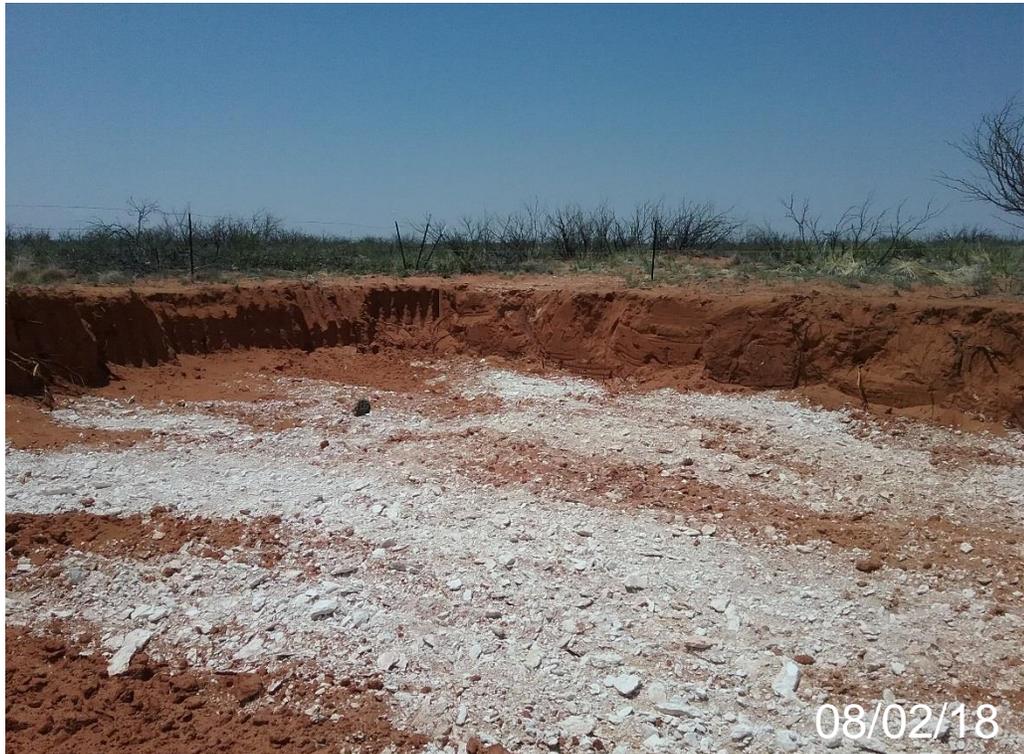
View West- Excavated Area of T-6
