## Release Notification

Site Name Beowulf 33 State Com 601H	Site Type Production Facility
Date Release Discovered 06/28/17	API# (if applicable) 30-025-43431

Cause of Release: Produced water was released from a water hauler truck on the side of a production well pad 130bbls released and 0bbls were recovered. Lease operator discovered the spill and notified EOG environmental group. The soils that impacted were removed; material was transported offsite for proper disposal. The excavated areas were then backfilled with clean material to surface grade.

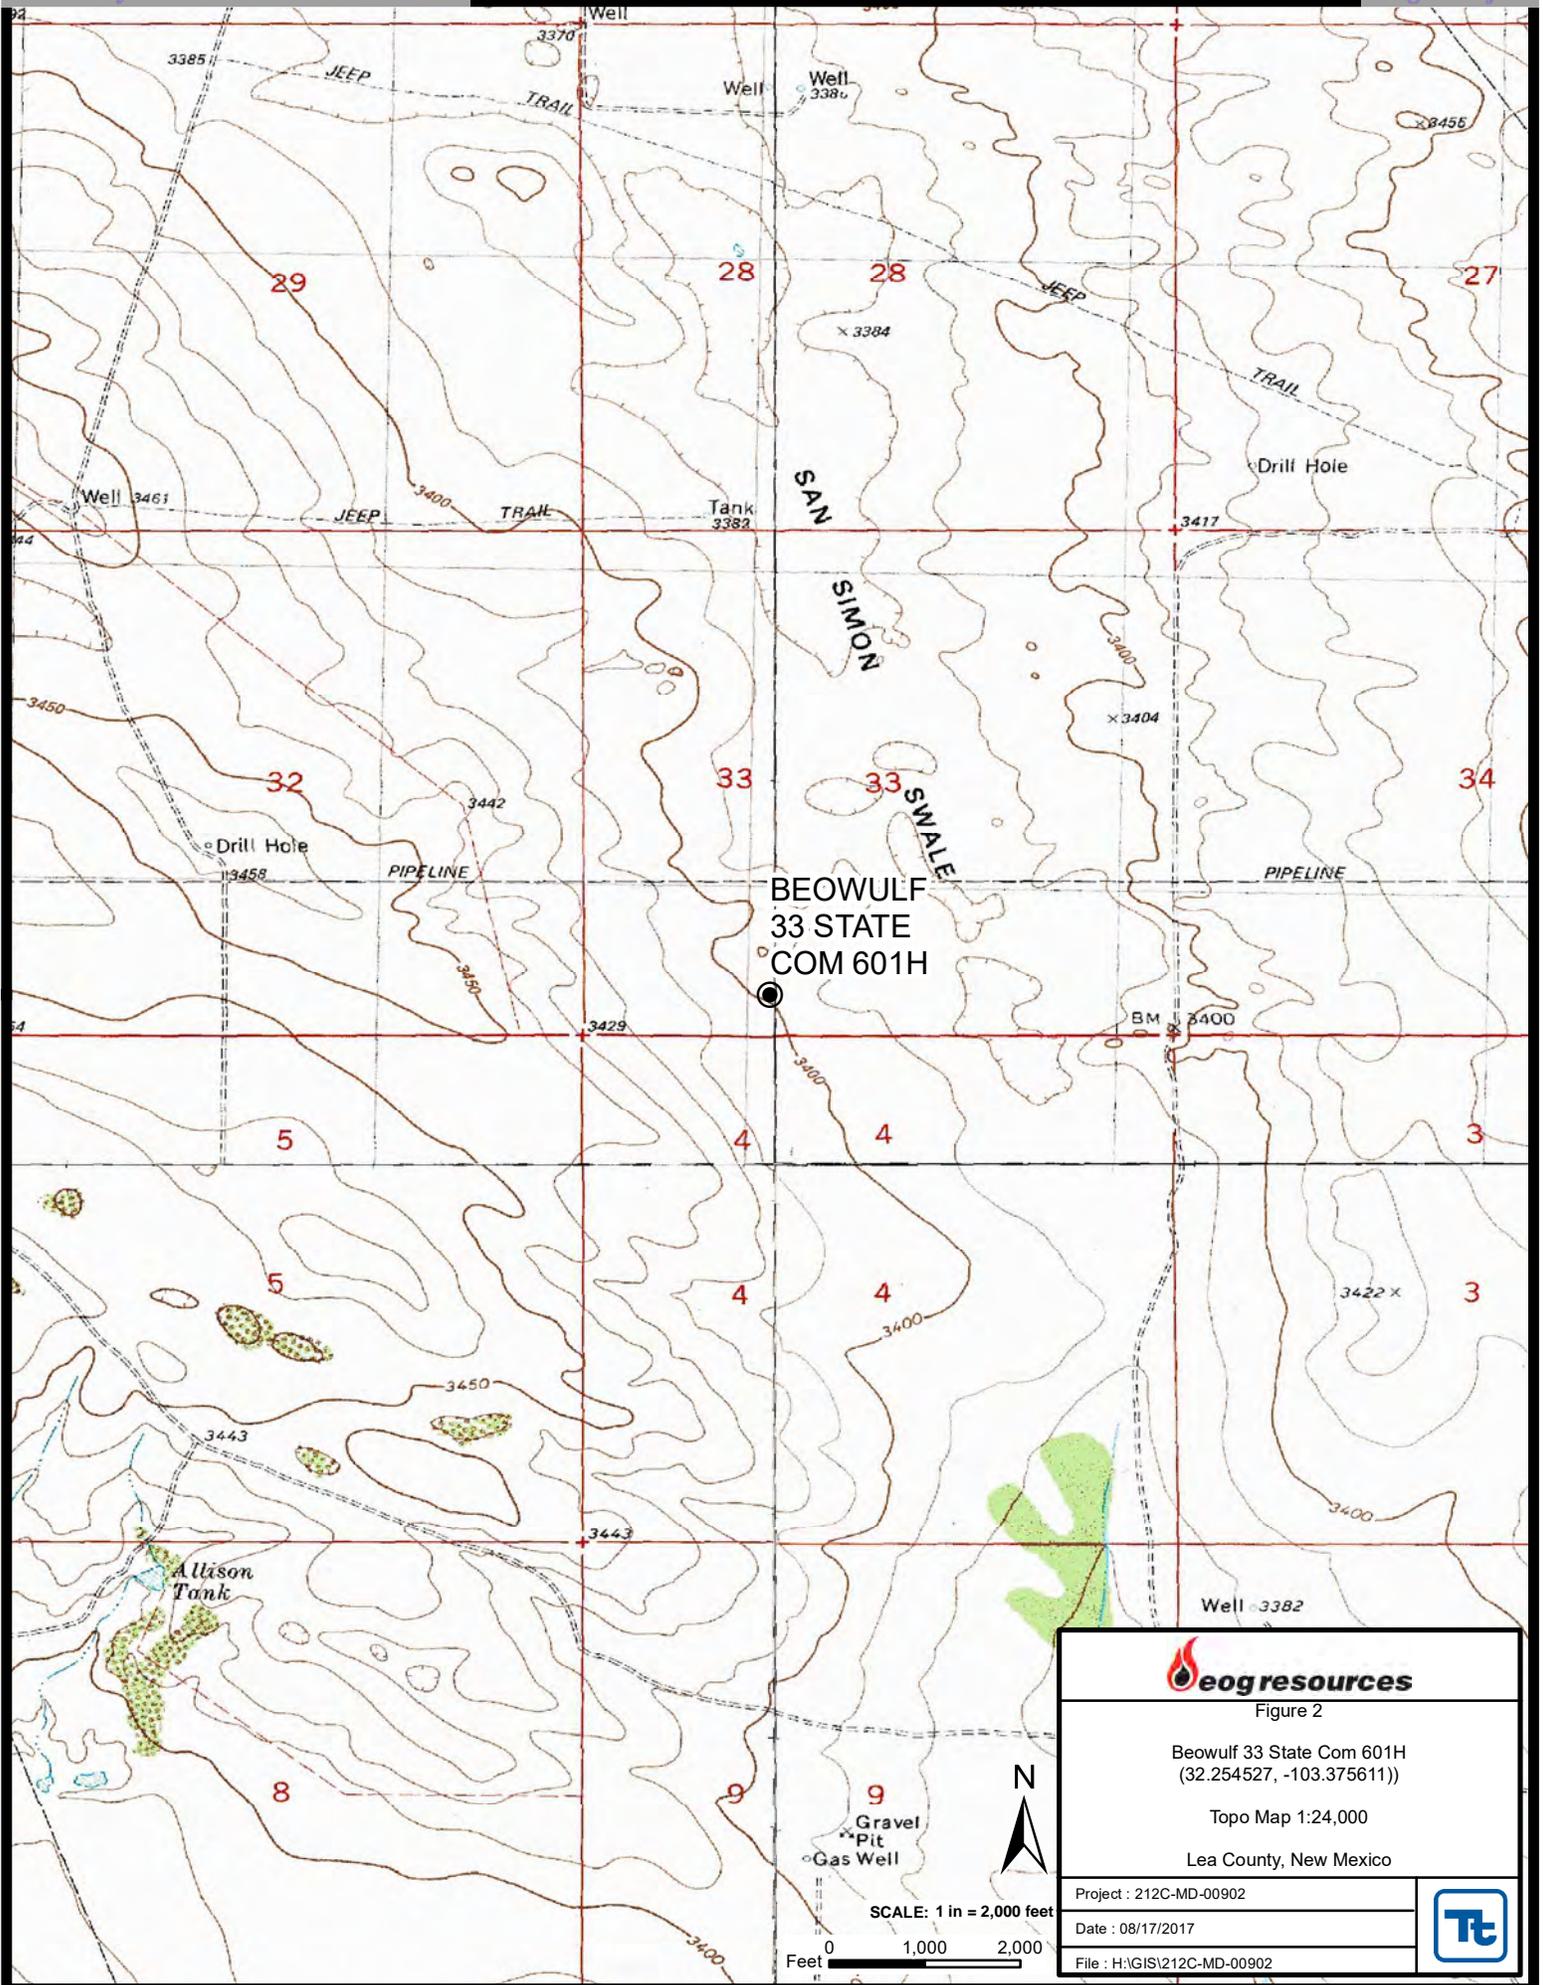
**Geog resources**  
 Figure 2  
 Beowulf 33 State Com 601H  
 (32.254527, -103.375611)  
 Topo Map 1:24,000  
 Lea County, New Mexico

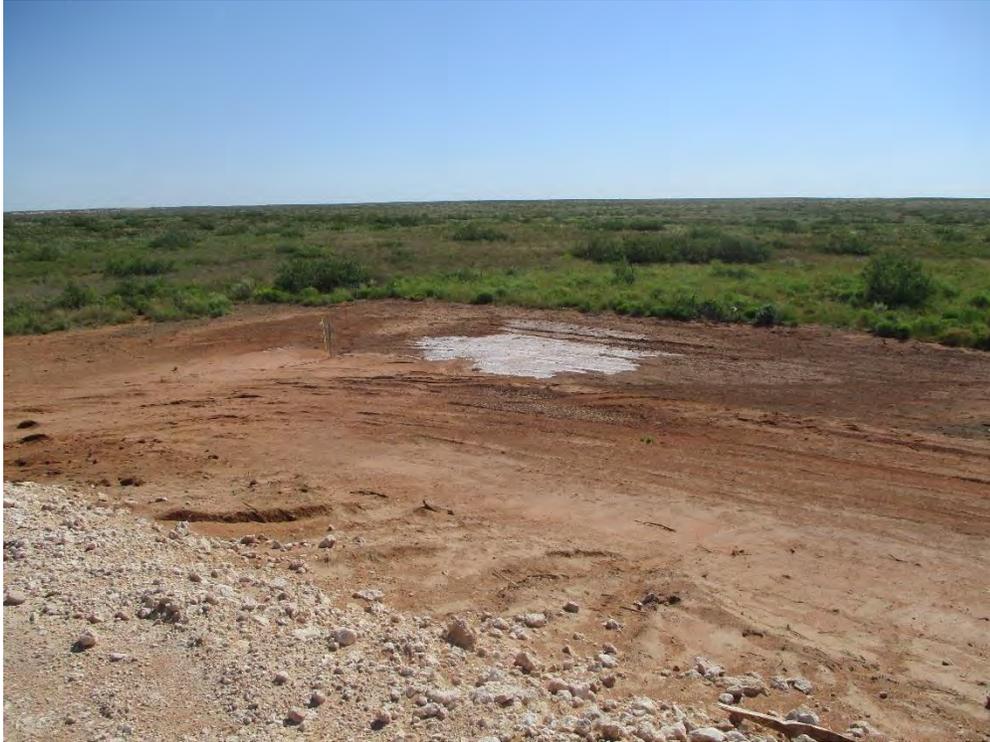
View North East, Trench #1

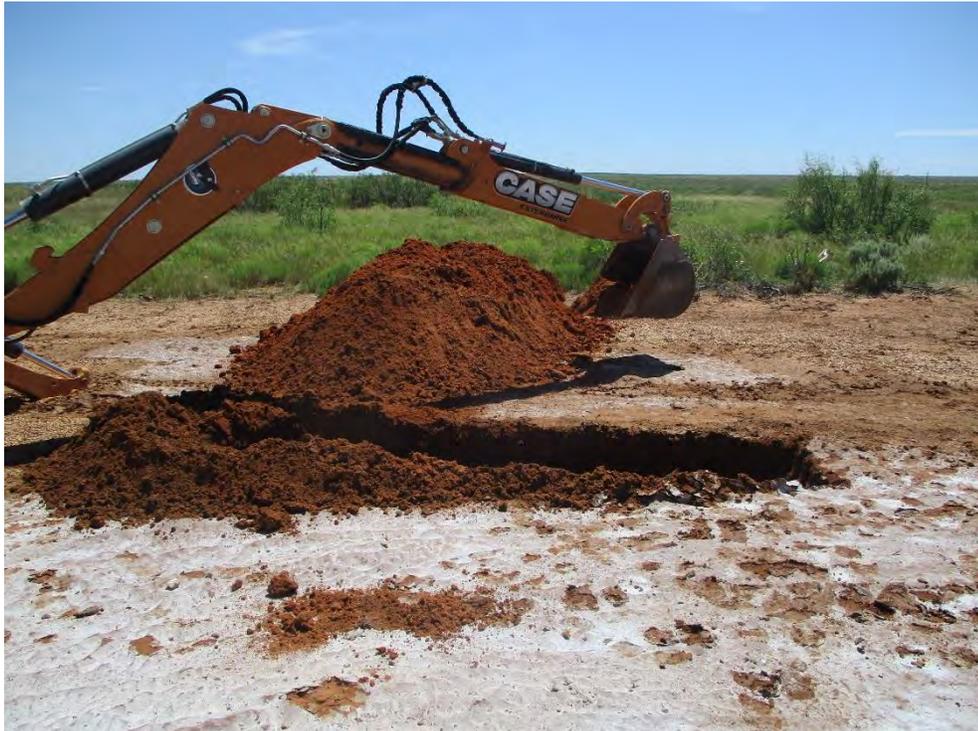
View East, Trench#1

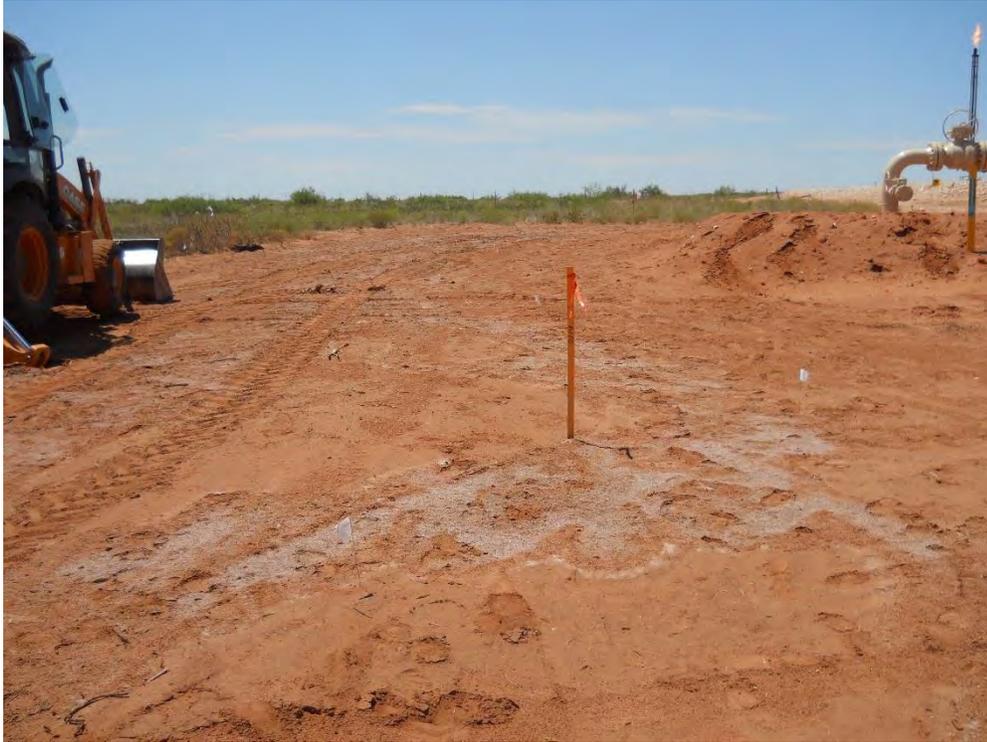
View South, Trench#2

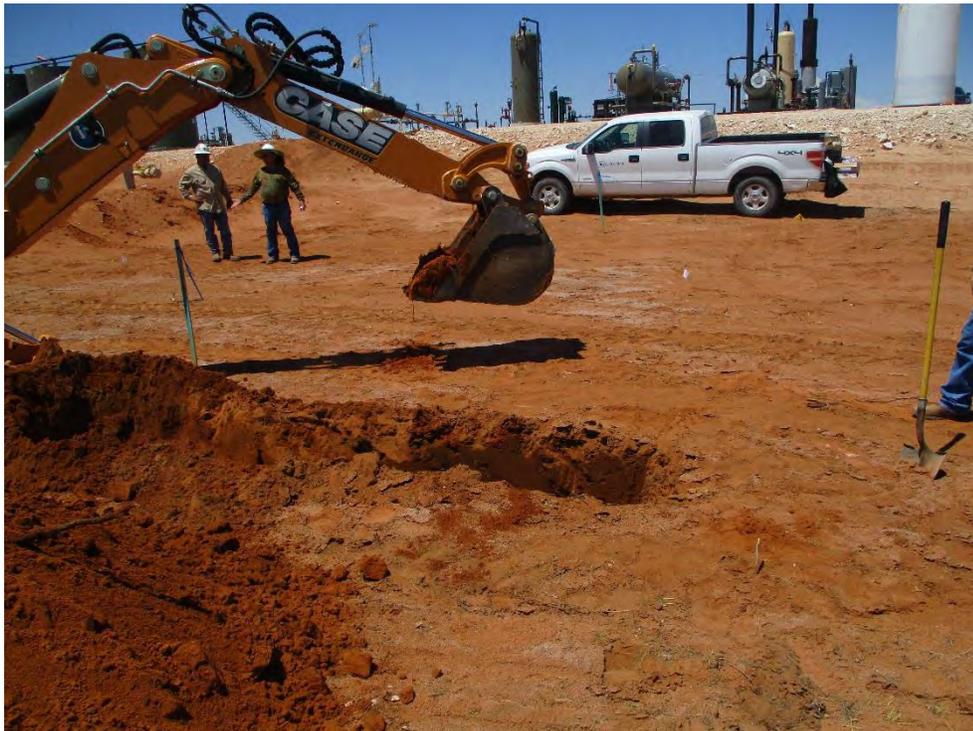
View West, Trench #2

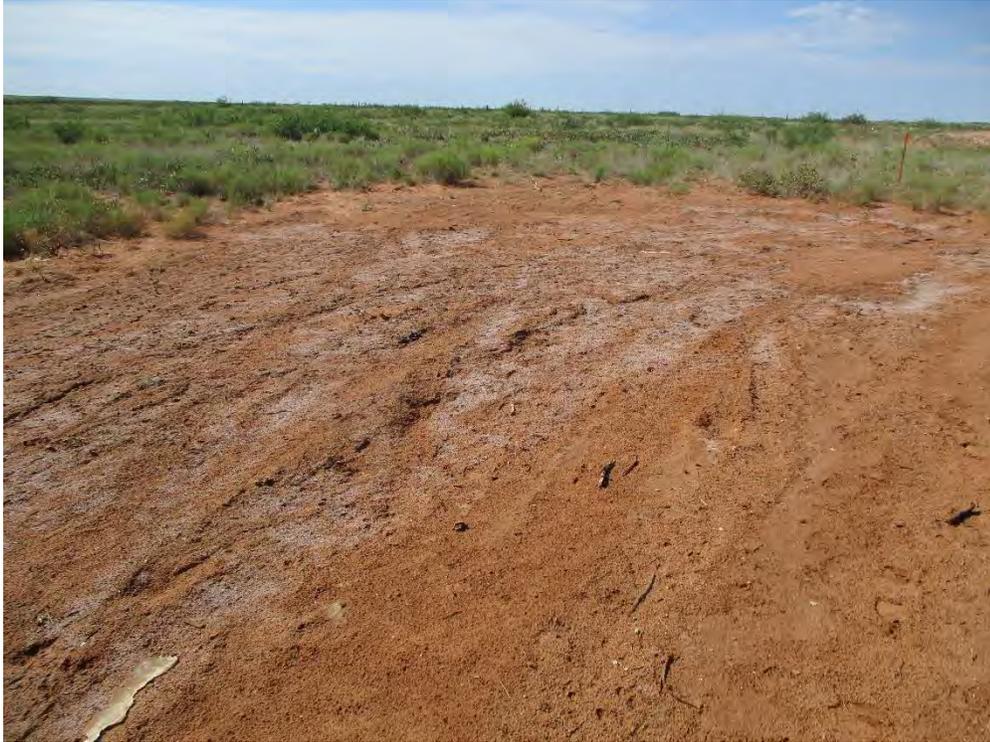
View South, Trench#3

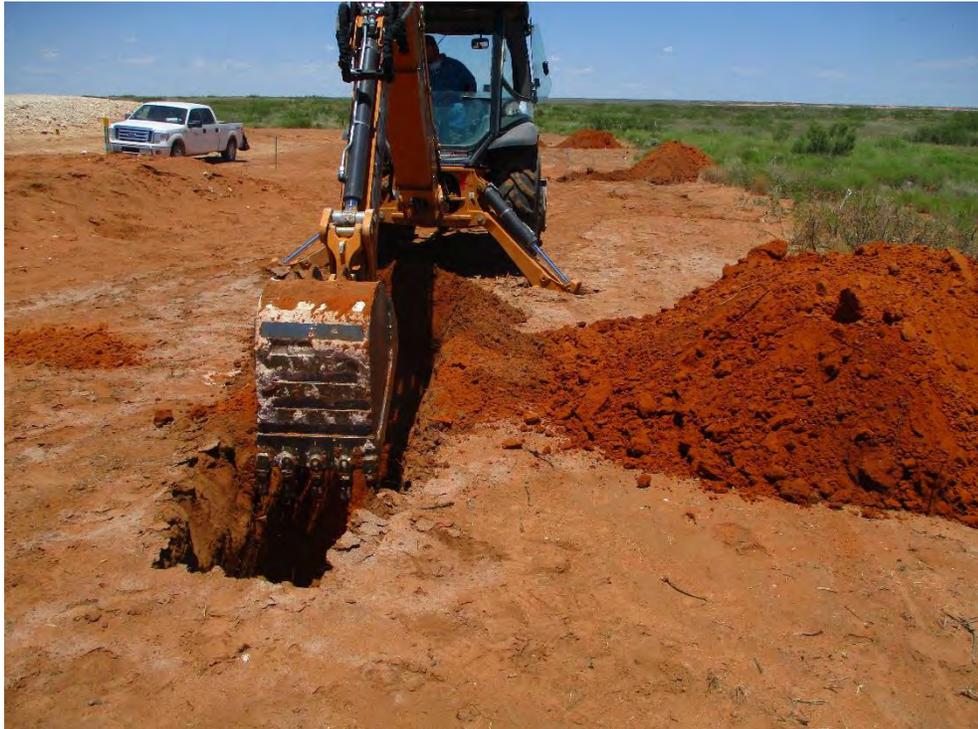
View North, Trench #3

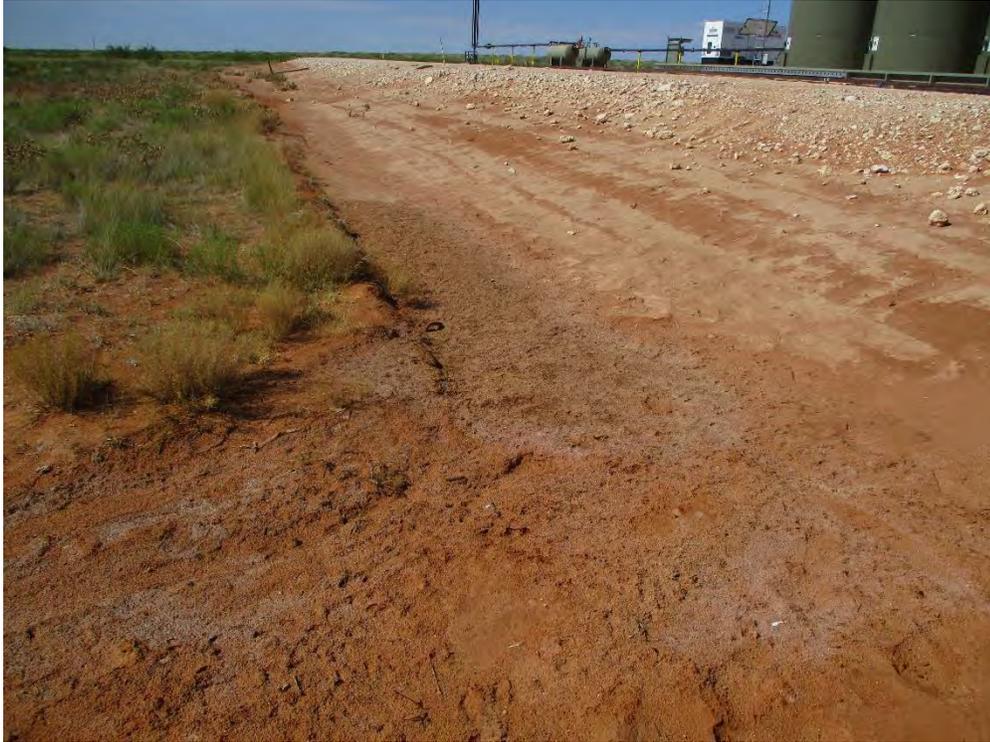
View South West, Trench #4

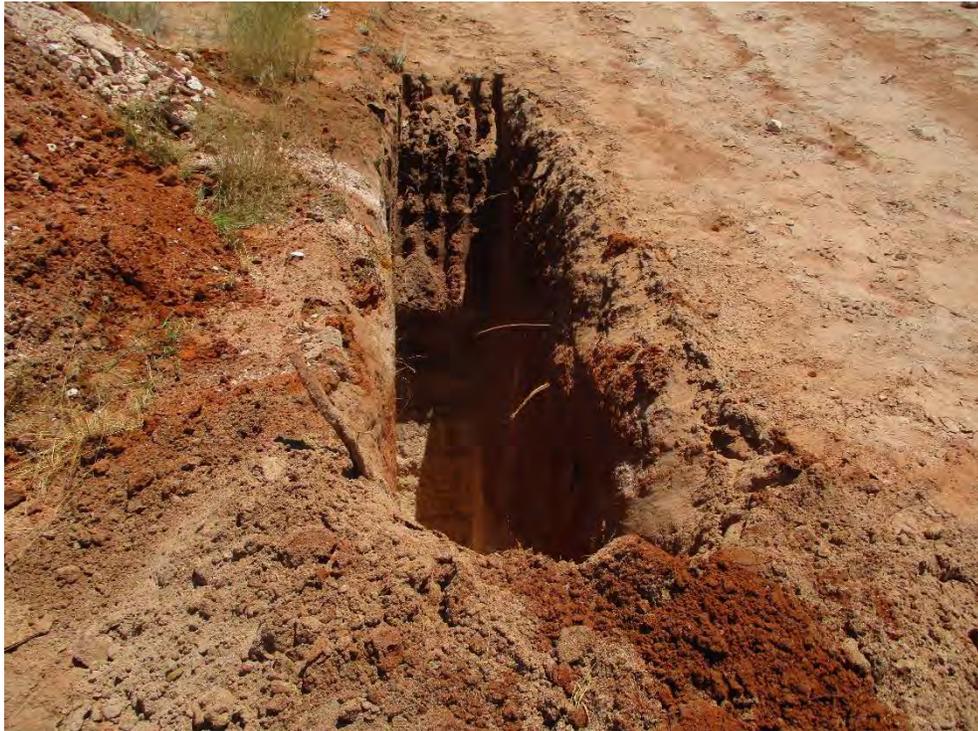
View South, Trench #4

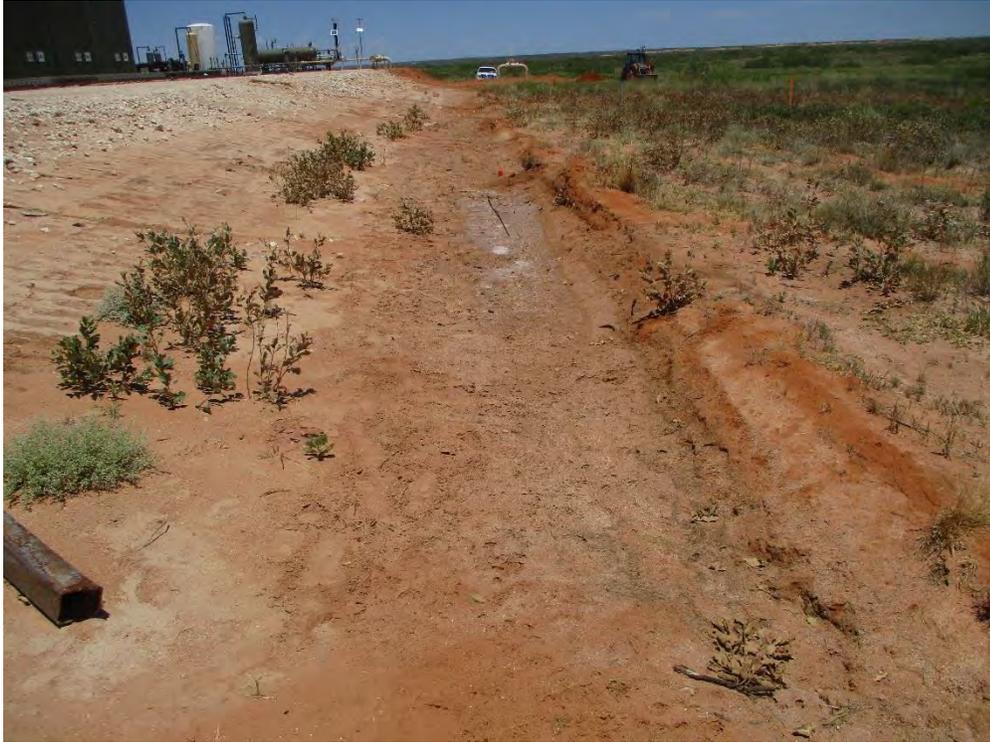
View North, Trench #5

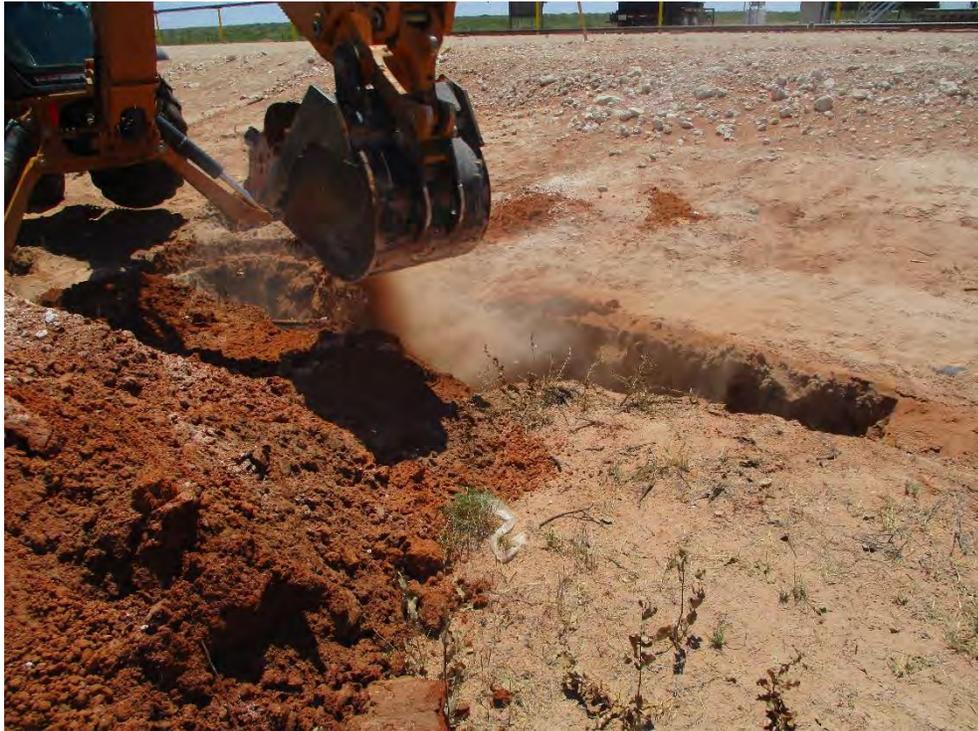
View West, Trench #5

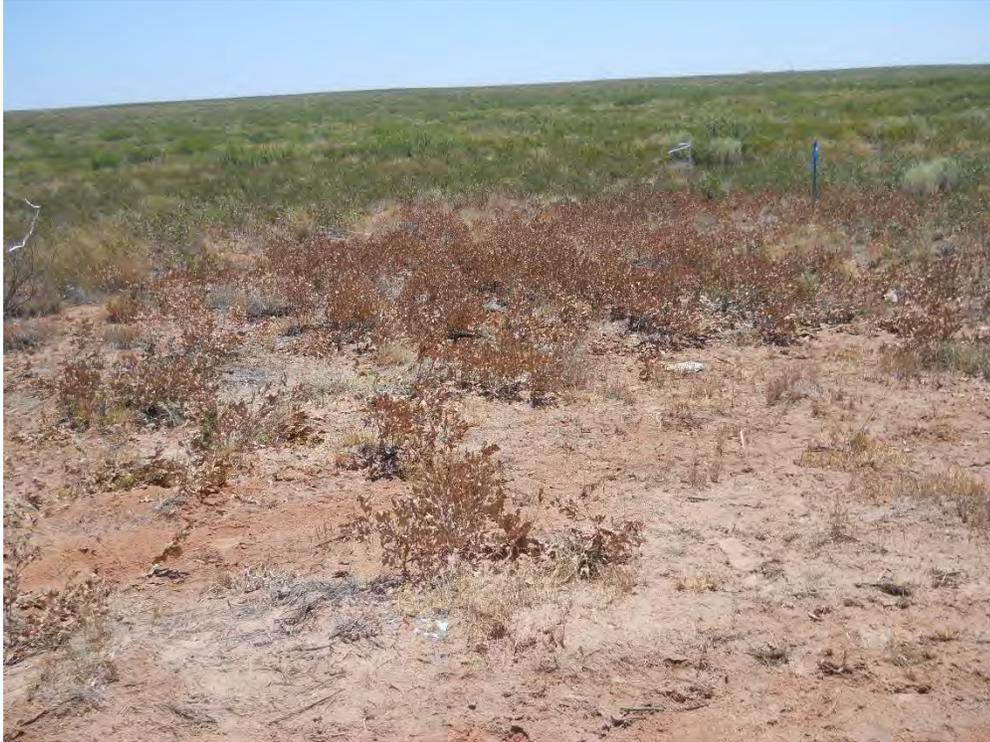
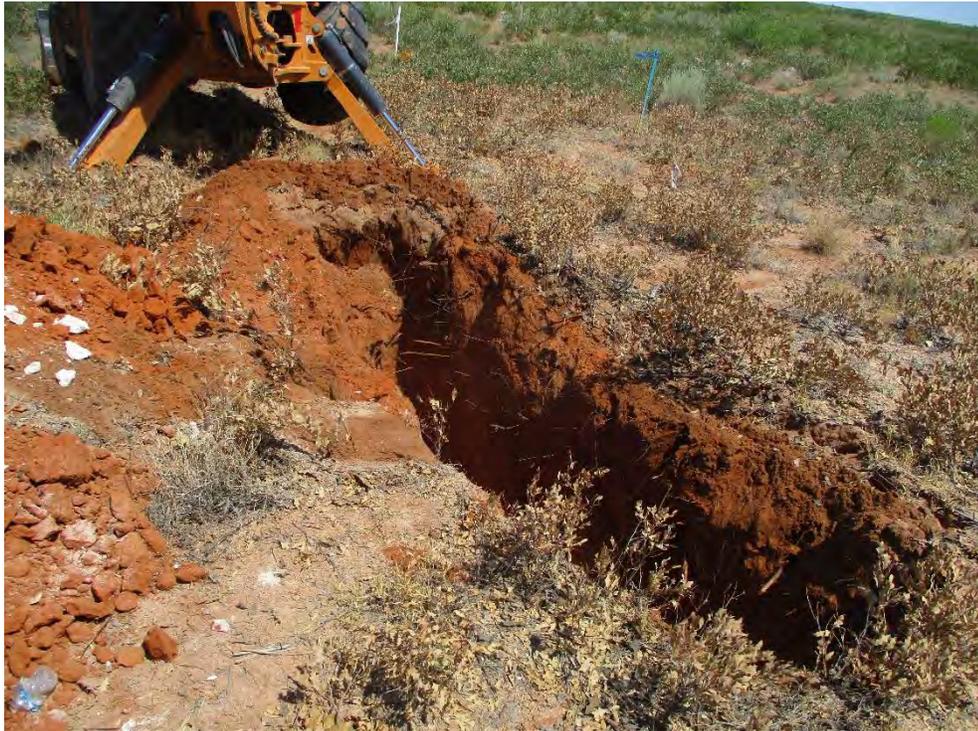
View East, Pasture Area Trench #6

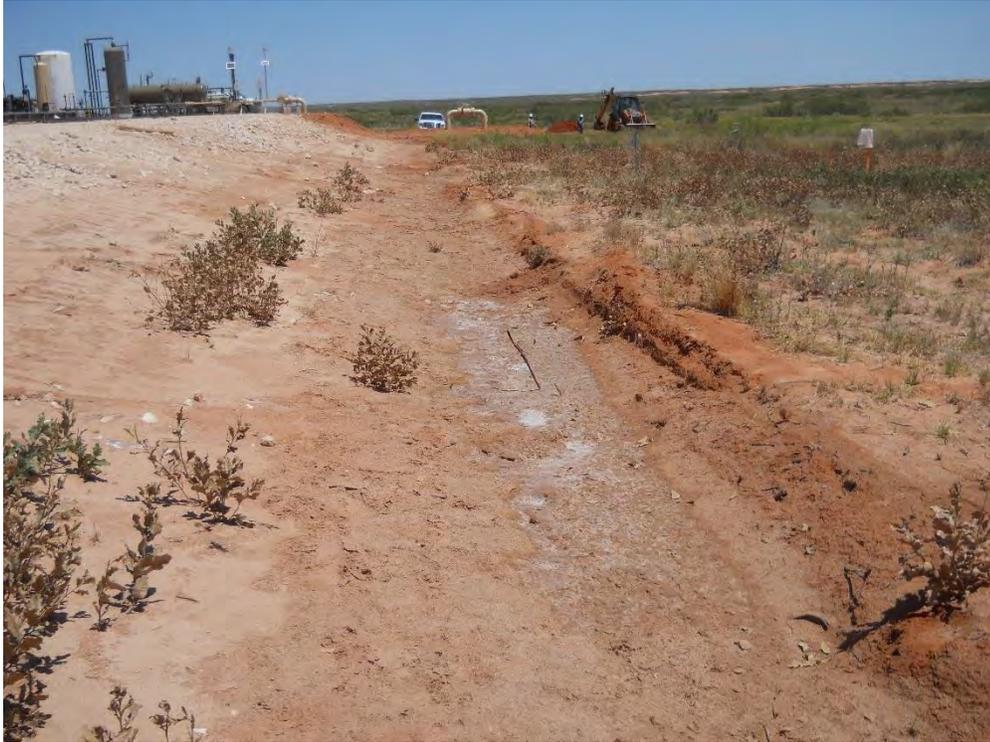
View North, Trench #7

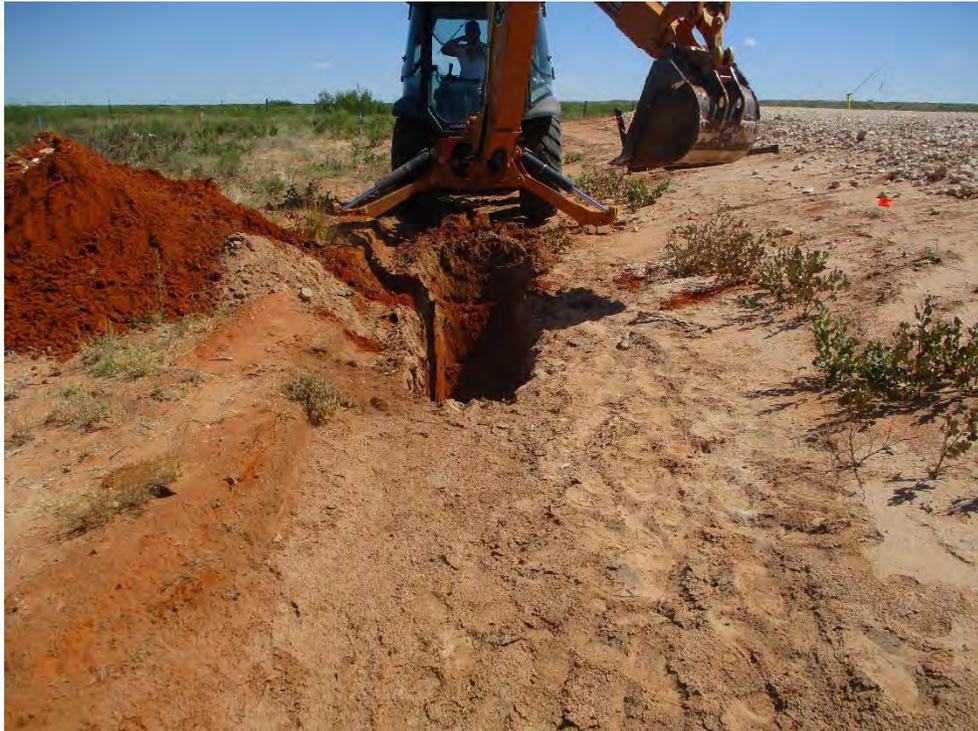
View South, Trench #7

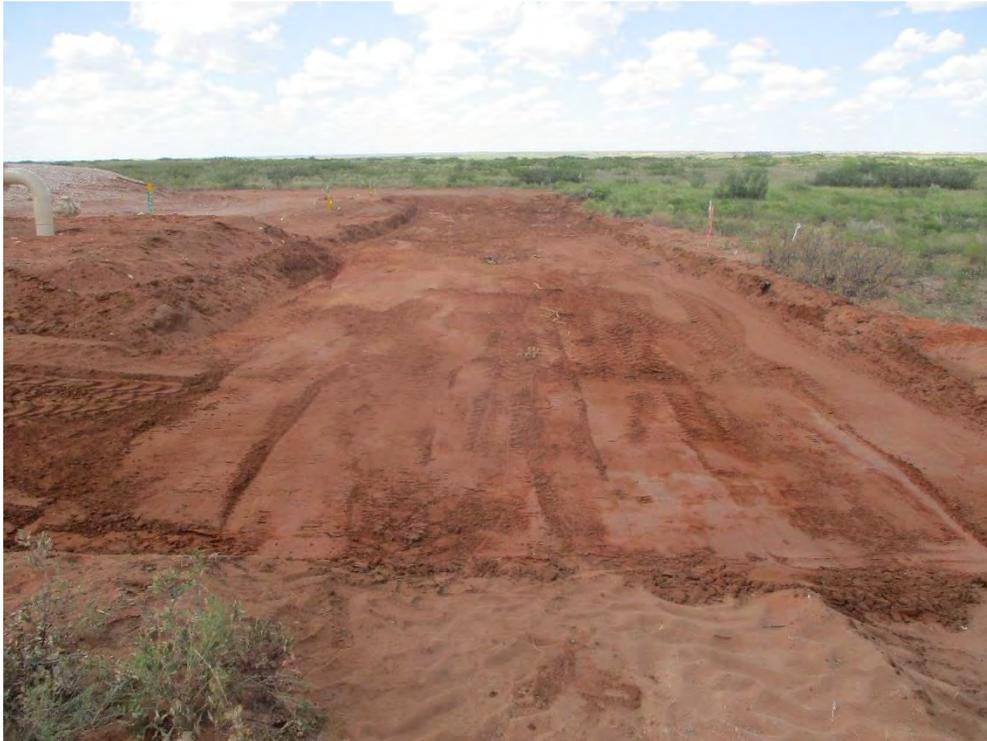
View North, Excavation Area T1, T2, T3 (1.5' )

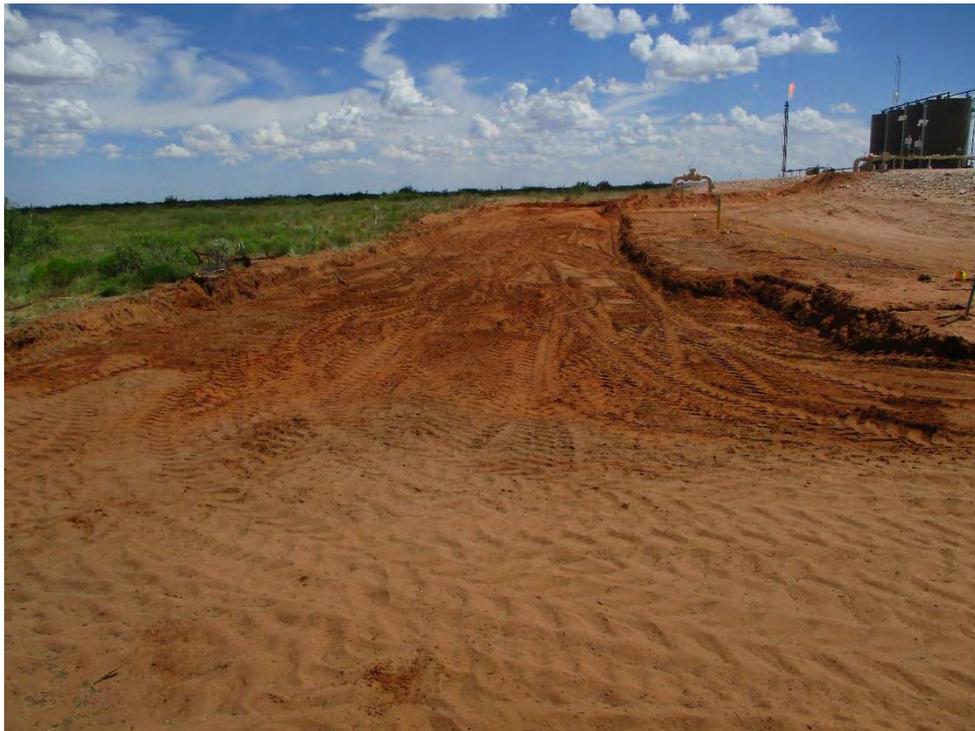
View South, Excavation Area T1, T2, T3 (1.5' )

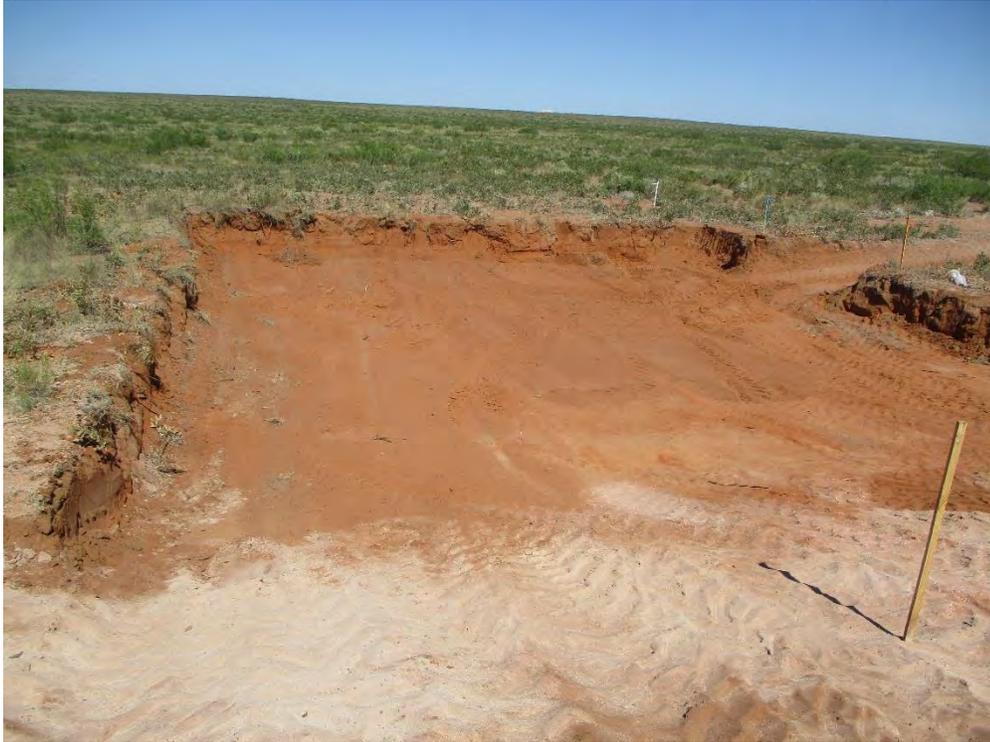
View East, Excavation Pasture Area T#6 (3')

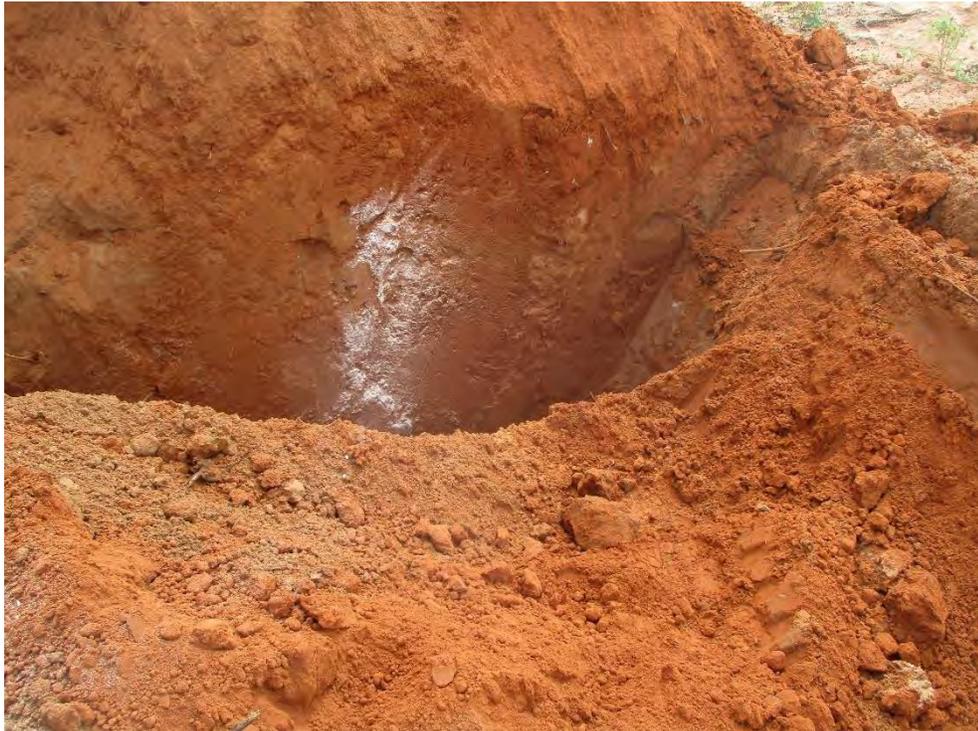
View South, Re-Trench#5

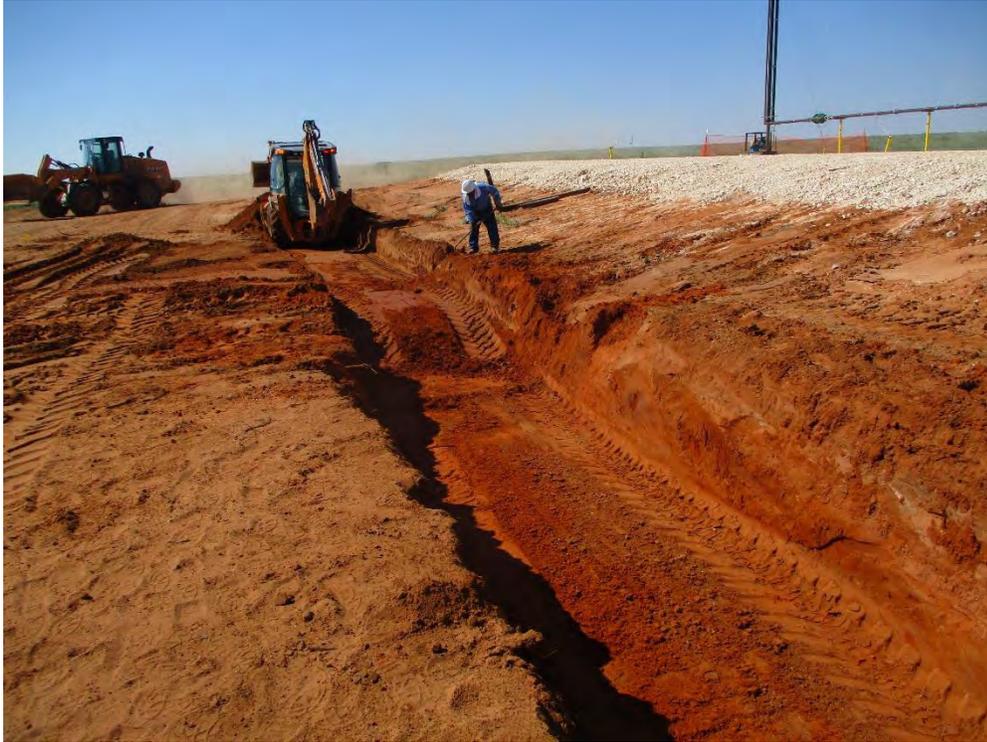
View South, Excavated Area T-5, T-7

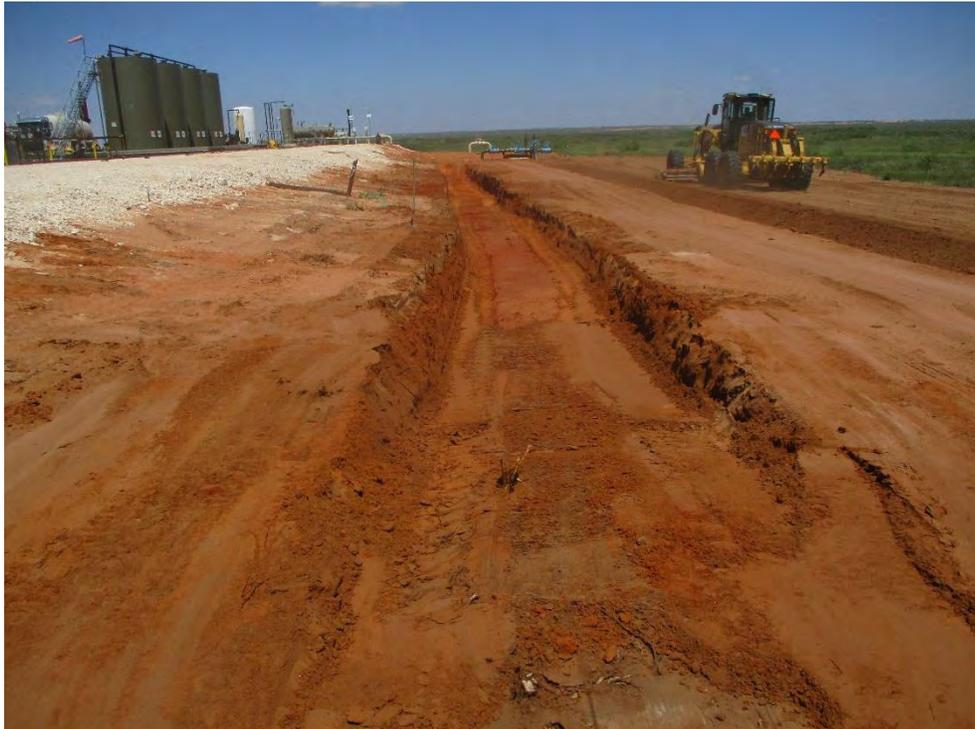
View North, Excavated Area T-7, T-5, T-4
