**Closure Report**

**Belco AIA Federal Battery**

**Unit J Sec 14 T20S R32E  
1RP-4290**

**Produced Water Release**

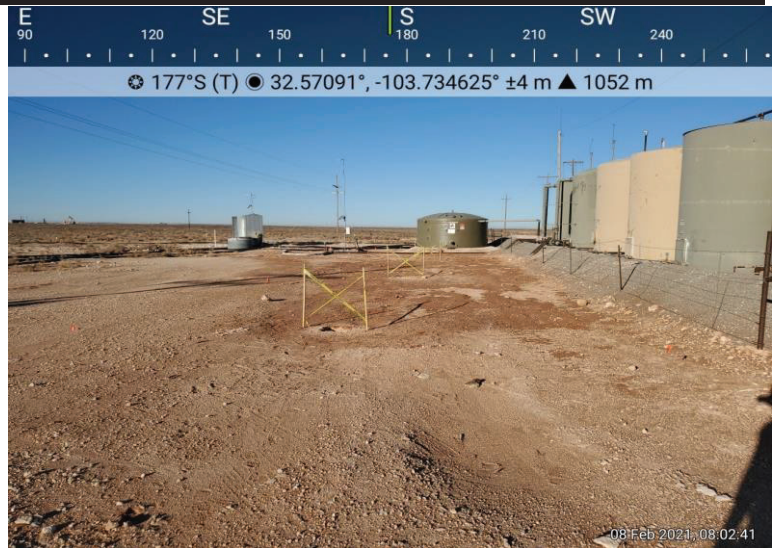
### Photograph No. 1

**Description:**  
View West of impacted area S-1

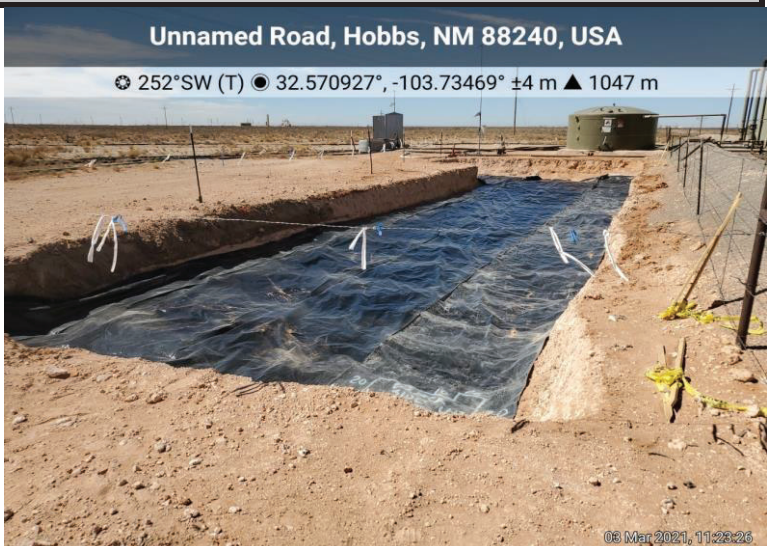
### Photograph No. 3

**Description:**  
View West, of liner instillation

New Tech Global Environmental personnel were onsite from February 3, 2021, through February 22, 2021, to supervise the remediation activities and collect confirmation samples. The area of S-1 was excavated to a depth of 2.5'-3.0' below surface. A new 20 mil-liner was installed at 3.0' below surface as the old liner's integrity had slight tears to ensure and prevent vertical migration of any future spills.
