Closure

**RE: Closure Request
8" Cedar Breaks
Incident Number nAPP2213248307
Eddy County, New Mexico**

Frontier Field Services	8" Cedar Breaks Eddy County, NM	nAPP2213248307
--------------------------------	--	-----------------------

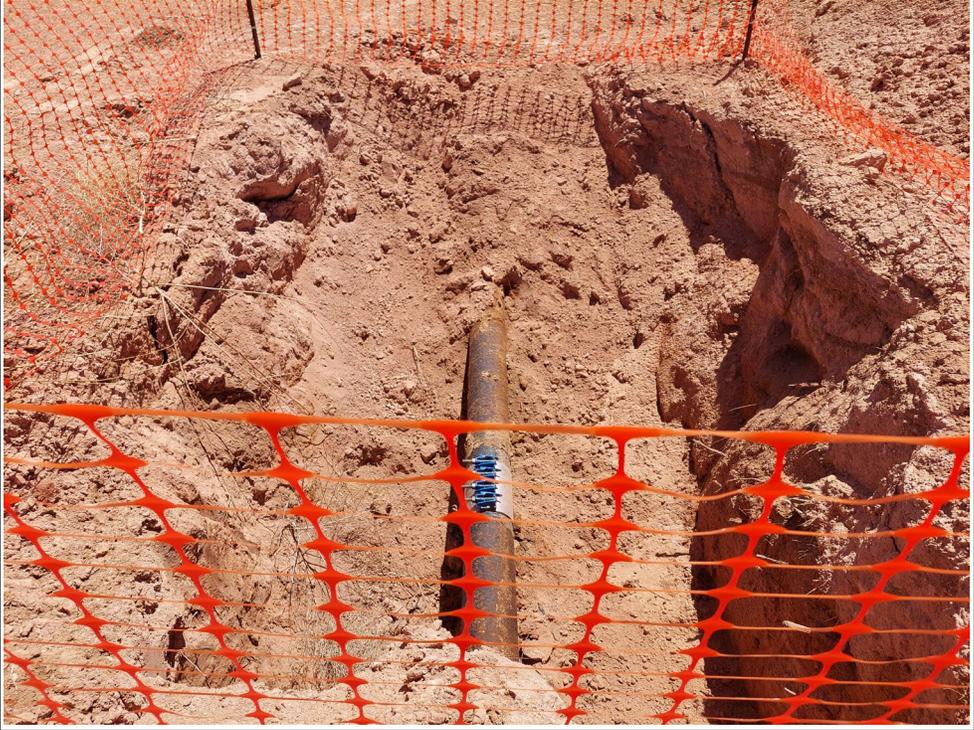
Photo No.	Date	
1	May 26, 2022

View of initial excavation extent before WSP assessment facing west.

Following the release, initial excavation of impacted soil (via visual observation) was undertaken by a third party contracted by Frontier. The impacted soil was transported and properly disposed of at the Lea Land Landfill Facility under Frontier-approved manifests. After the completion of initial excavation activities, the excavated area was secured with fencing.

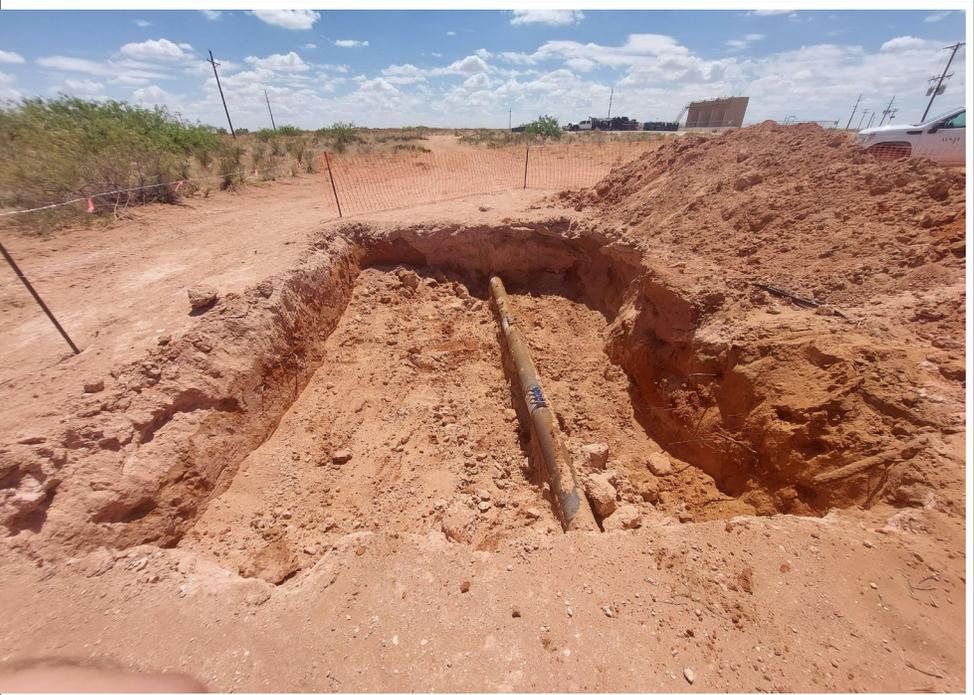
Photo No.	Date	
2	June 15, 2022

View of final excavation extent facing west

The final excavation area measured approximately 340 square feet in lateral extent at a depth of 6 feet bgs. A total of approximately 76 cubic yards of impacted soil was removed throughout excavation activities. The impacted soil was transported and properly disposed of at the Lea Land disposal in Carlsbad, New Mexico. Manifests pertaining to contaminated soil disposal can be made available upon request. Following completion of confirmation sampling, the excavation area was backfilled and recontoured to match preexisting site conditions. The Site will be reseeded with a BLM approved seed mixture (BLM seed mix #2) at BLM approved application rates. Re-seeding will be performed in the fall or early spring to take advantage of seasonal moisture, with the end goal of establishing revegetation consistent with local natural vegetation density.

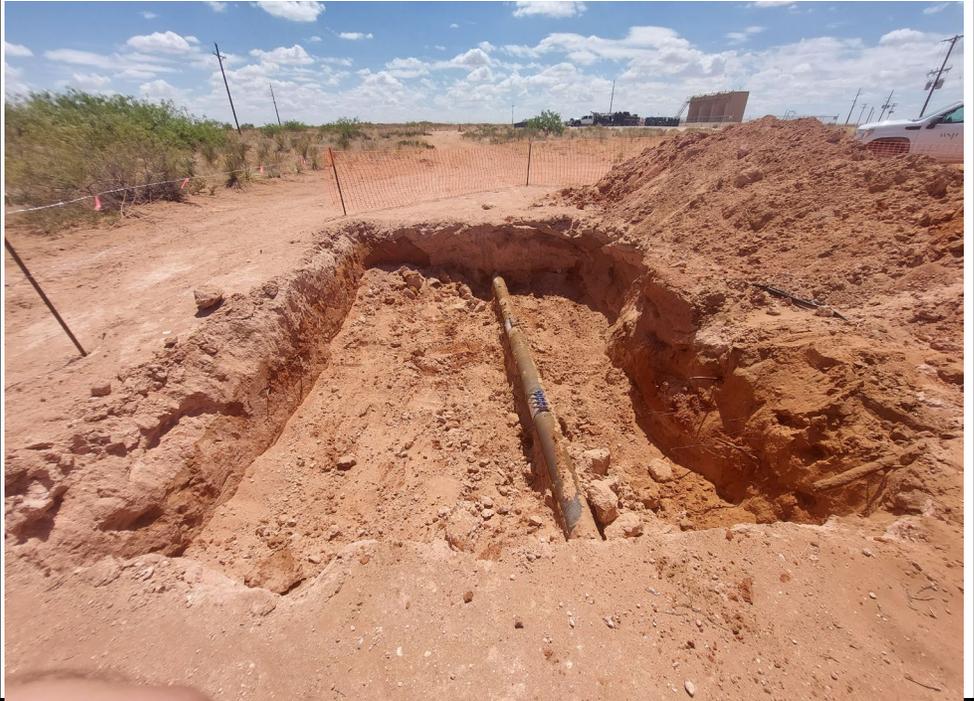
Photo No. 3	Date June 15, 2022

View of final excavation extent facing east

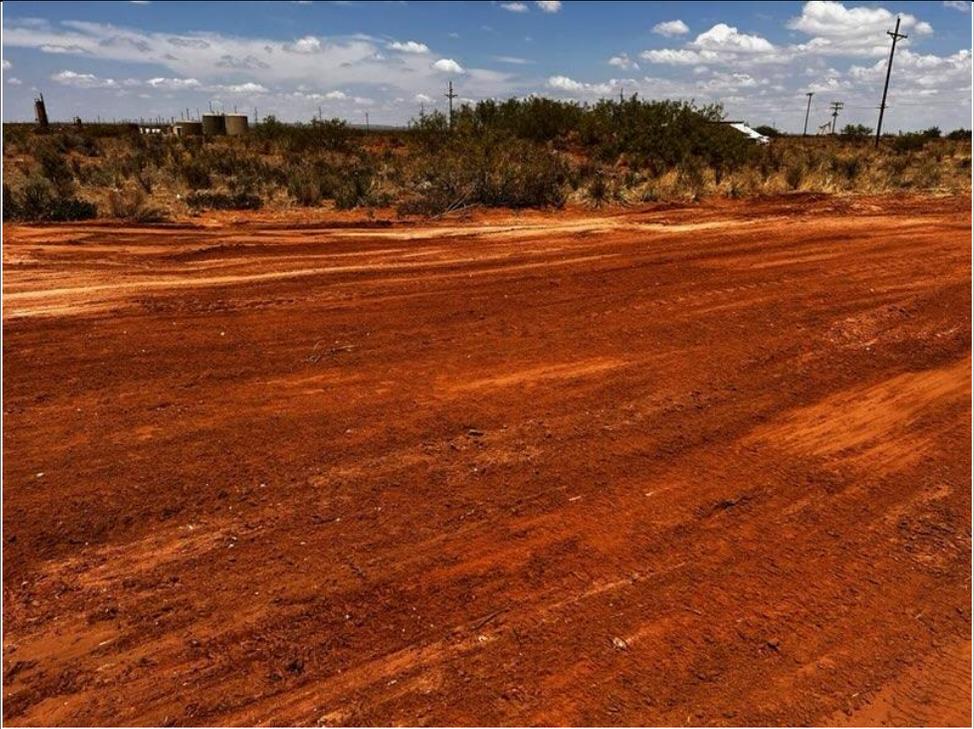
Photo No. 4	Date July 5, 2022

View of backfilled excavation facing south

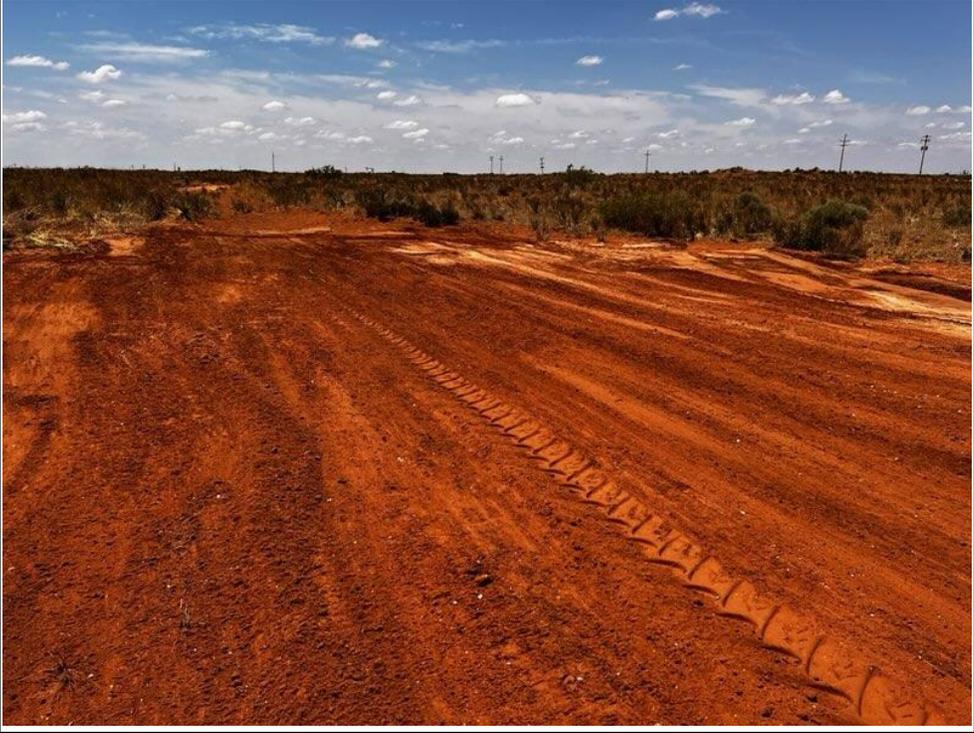
Photo No.	Date	
5	July 5, 2022

View of backfilled excavation facing west
